# Behavior of Cold-Formed Steel Metal Industrial Buildings

### ***Behavior of Cold-Formed Steel Metal Industrial Buildings***

This paper presents research focused on understanding the observed behavior of cold-formed steel (CFS) metal buildings during Hurricane Harvey, which made landfall Friday, August 25, 2017 between Port Aransas and Port O'Connor, Texas. Through the Geotechnical Extreme Event Reconnaissance (GEER) association (funded by the National Science Foundation) a team of structural engineers and researchers performed rapid and detailed assessments of structural damage caused by the hurricane. The National Science Foundation gathered photographs, damage assessments sheets, and three-dimensional laser point cloud data of severely damaged cold-formed steel industrial buildings. The Port Aransas County Airport experienced severe damage to several cold-formed steel small aircraft hangars. The failure of one of these hangars is the basis for this investigation. The laser point cloud data was utilized to create a model of a hangar structure in MASTAN2. Multiple analyses were completed in MASTAN2 to determine the failure mode and damage propagation mechanisms. Also, analyses

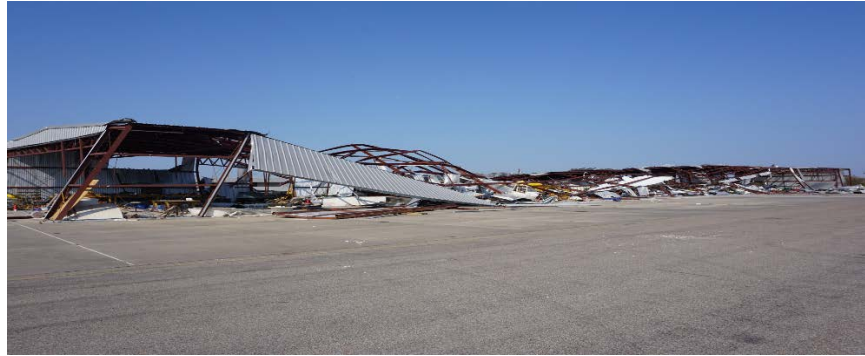
*Figure 1 Damaged Hangar Structure at Port Aransas County Airport. Photo taken on September 9, 2017 during GEER reconnaissance trip*

This work is motivated by the structural damage caused by Hurricane Harvey. On August 23, 2017, Hurricane Harvey made landfall between Port Aransas and Port O'Connor, Texas. The Hurricane caused \$125 billion in damages and destroyed over 135,000 homes (worldvision.org 2018) In early September, the Geotechnical Extreme Event Reconnaissance (GEER) association (funded by the National Science Foundation) sent a team of researchers and structural engineers to parts of Texas to assess the level of damage caused by the Hurricane. During the trip, researchers and engineers filled out detailed rapid damage assessments sheets, photographed damaged structures, and collected laser point cloud data of severely damaged structures. The laser point cloud data has been made available to the public via the University of Nebraska-Lincoln website. The fundamental basis of this research is the laser point cloud data of a severely damaged hangar structure at the Port Aransas County Airport. The hangar structure is constructed of structural cold-formed steel and hot-rolled steel structural members. A photograph of the damaged hangar structure is shown below in Figure 1. Images of the laser point cloud data of the collapsed hangar structure is shown below in Figure 2.

The laser point cloud data of three cold-formed steel structures were collected in Port Aransas, Texas. Professor Wood and a research student, from the University of Nebraska-Lincoln, carefully collected the laser point cloud data in Port Aransas, and graciously upload the data to the University of Nebraska-Lincoln website for easy access and navigation. The basis of this research is the laser point cloud data of a hangar structure at the Port Aransas County Airport. The hangar structure was constructed of hot-rolled steel and structural cold-formed steel members. The structure had a metal roof covering, which was complete destroyed during Hurricane Harvey. The hanger structure experienced an extensive amount of damage and can be classified as a structural collapse because a large middle portion of the roofing system collapsed on itself and brought the building to the ground.
