Data in Brief

Data Article

SDNET2018: An annotated image dataset for non-contact concrete crack detection using deep convolutional neural networks

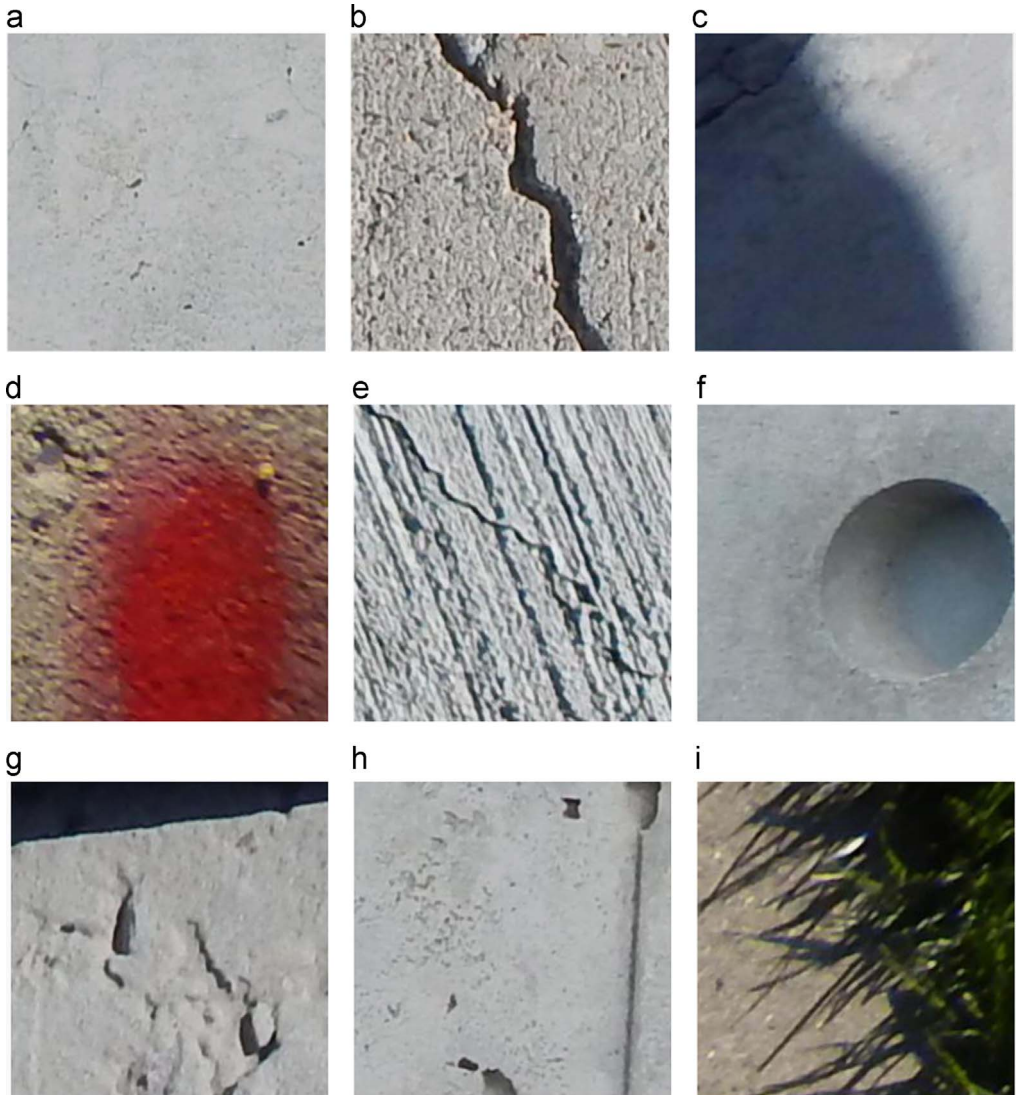
Fig. 1. SDNET2018 images include (a) fine cracks, (b) coarse cracks, (c) shadows, (d) stains, (e) rough surface finishes, (f) inclusions and voids, (g) edges, (h) joints and surface scaling, and (i) background obstructions.

Images of bridge decks were taken at the Systems, Materials, and Structural Health (SMASH) Laboratory at Utah State University, where a number of full scale bridge deck sections were stored. Images of walls and pavements were taken on Utah State University campus. Table 1 lists the number of cracked, non-cracked, and total sub-images of each type included in SDNET2018. The sample images in Fig. 1 show the range of crack widths, surface conditions, and other environmental factors represented within SDNET2018. Images are 256 × 256-px RGB image files in .jpg format. Each image
