Architectural Engineering -- Faculty Publications

# A Practitioner's Guide to Small Unmanned Aerial Systems for Bridge Inspection

Received: 15 October 2019; Accepted: 15 November 2019; Published: 19 November 2019

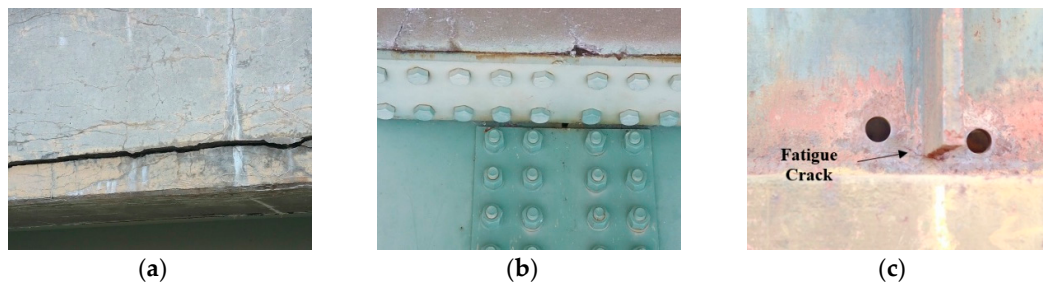
Figure 1. sUAS images of (a) efflorescence and delamination; (b) corrosion; (c) fatigue cracking.

Figure 1 shows several types of defects observable during sUAS assisted inspections. Figure 1a is a side view of a concrete bridge deck that shows surface cracking, efflorescence (white staining), and delamination. The surface cracks visible range in widths from 0.08 mm to 25 mm, are as long as 300 mm, and are fairly easy to detect with the naked eye. Other defects could include map cracking, which is indicative of alkali-silica reaction, or corrosion staining, which could indicate corrosion of embedded steel. Connections are a major area of concern for steel bridges. Figure 1b is a view of a connection in a steel superstructure with a concrete deck on top. The figure shows some corrosion in the upper flanges and plate connection, as well as spalling in the concrete deck. In rare cases, an inspector may find missing or loose fasteners in such a location. Distortion of plates may be visible. Significant corrosion is normally observable with little effort but quantifying the affected area and the net section loss may be difficult using a non-contact approach. The defects discussed above are all fairly large and certainly large enough to be observed with the naked eye. In most cases, they are also easy to access as they tend to occur on flat surfaces above deck or on the sides of girders. Fracture Critical Member (FCM) inspections are the most difficult and expensive bridge inspections to perform since hands-on inspections are required to detect possible fatigue cracks (within the arms-length of the region of interest). Fatigue cracks are very difficult to see and may have lengths shorter than 7 mm and widths narrower than 0.1 mm [13]. Fatigue cracks normally appear in the superstructure near large cross frames, welded stiffeners, or other complex geometries, making access difficult. Figure 1c shows a welded stiffener with weld and surface corrosion, as well as a

fatigue crack through the bottom weld. The fatigue crack is terminated on both ends with drilled holes, which are intended to arrest crack growth. A big challenge for commercial (off-the-shelf) sUAS for bridge inspection is the need for repeatable measurements of defects. In addition to identifying defects, inspectors must quantify them. For example, an inspector may need to record the number, location, and length of fatigue cracks, the area of spalls, or the percent section loss in corroded steel members. Defect characteristics can be estimated by comparison with objects of known dimensions, but the accuracy of these estimates depends on the distance between the sUAS and the target, the photographic quality, and the field of view. As such, there is a need to develop real-time reference measurements for sUAS assisted bridge inspection applications.

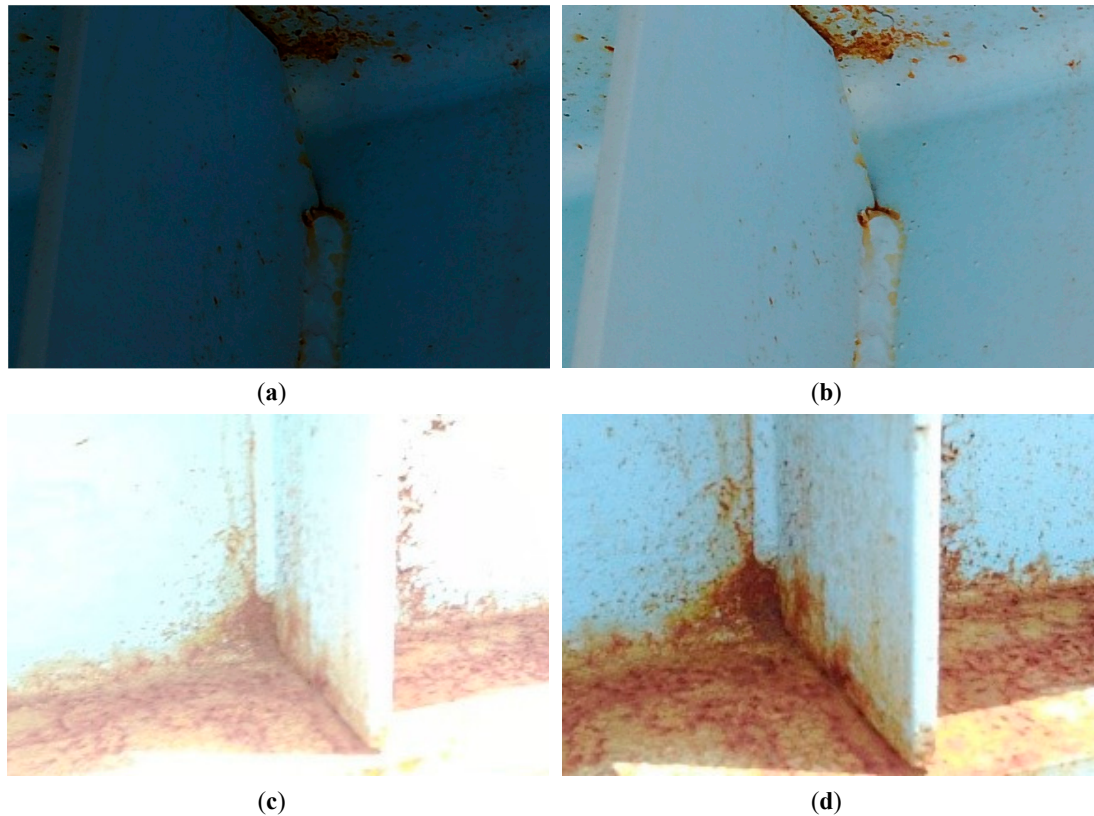
**Figure 2.** Small unmanned aerial system (sUAS) visual image consideration: (a) underexposure using auto mode; (b) underexposure adjusted; (c) overexposure; (d) overexposure adjusted

In general, sUAS-mounted camera sensors for bridge inspection should support remote viewing of images in real time so that the inspector can view inspection images and make decisions during the inspection flight—a discussion on real-time vs. post-flight inspections later in this paper provides more context to this statement. Among camera settings, exposure and zoom play a crucial task for UAS-assisted visual inspections. This allows the inspector to compensate for the various lighting conditions and standoff distances encountered during the inspection. Exposure is defined as the amount of light per unit area going through a visual sensor [15]. If the camera does not receive sufficient light, the image will be under-exposed, whereas, too much light can result in over-exposed images. Both over-exposed and under-exposed situations can prevent defect detection. Figure 2a shows a common scene of over-exposure on the sUAS-mounted camera, making it impossible to observe a poorly lit weld connection. In this case, increasing the camera exposure in the next image (Figure 2b) provided a better reference to rule out the presence of crack in the weld connection. Figure 2c shows another scene in which automatic exposure settings result in over-exposure of an inspection target (fatigue crack in a weld connection). It is impossible to detect any flaws in the over-exposed image, but the same image taken with manual control of exposure settings reveals a fatigue crack (Figure 2d).

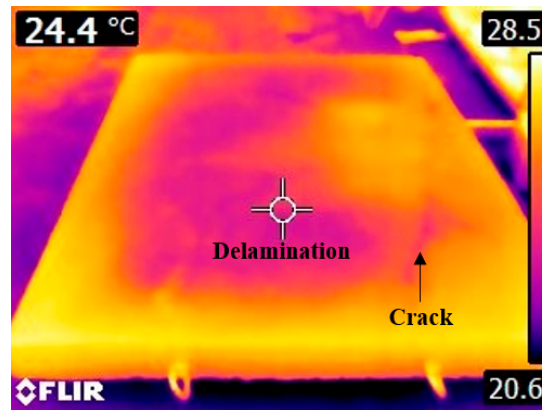
Figure 3. UAS thermal image showing surface and subsurface defects

Thermal infrared (TIR) camera sensors are frequently placed on sUAS. TIR sensors have been used since at least 1978 to identify delamination in concrete bridge decks [16]. This type of sensor can be integrated on some commercial sUAS to allow thermographic inspection of concrete bridge decks to identify delamination and other surface or subsurface defects [17]. Figure 3 shows a TIR image of a mock bridge deck, in which a subsurface delamination and a surface crack are both visible. In this figure, the surface and sub-surface defects, i.e., delamination and cracks, are both manifested as cold regions, since the cause faster heat loss than the regions with sound concrete. Multispectral and hyperspectral sensors gather data in the visible, thermal, and other spectra in a single package. While incredibly versatile, these sensors are also the most costly—often prohibitively.

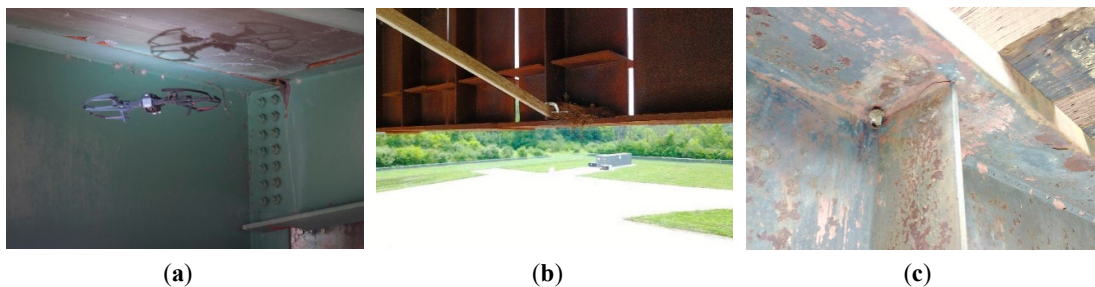
**Figure 4.** sUAS access and obstruction due to: (a) geometry; (b) cross-bracing and bird nest; (c) wasp nest

Pilots and inspectors will encounter significant obstructions during sUAS assisted bridge inspections. Access to the under-bridge environment is particularly difficult, even without the LOS requirements discussed above. Observation of some defects will require the sUAS to fly above the target, which can be very difficult. Many defects will appear in corners or at connections, which limits the achievable standoff distance (Figure 4a). Cross-frames and bracing can further obstruct access (Figure 4b). The under-bridge environment is also particularly fraught with cobwebs, nests, feces, and other debris. A bird's nest obstructs the inspection target in Fig 4b, and a wasp's nest obstructs the target in Figure 4c. Dirt, corrosion, or graffiti may also obscure the target. In one case, the authors were unable to detect a fatigue crack because it was obscured by markings made during previous manned inspections. Where a human inspector can easily clear debris or other obstructions, this is not an option with sUAS assisted inspections yet. Girder flanges are a likely home for wildlife-protected birds and have been known to hinder under-bridge inspections. The adoption of sUAS assisted inspection technology does not mitigate these concerns, which, in many cases, may result in a failed or unsuccessful inspection.

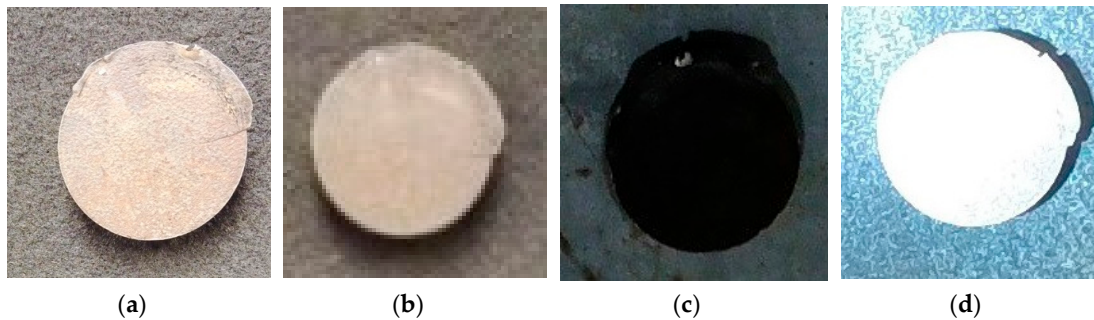
**Figure 5.** Images of the fatigue crack specimen captured by sUAS: (a) 0.2 m standoff distance; (b) 0.9 m standoff distance; (c) with 10 lx illumination; (d) with 6,000 lx illumination

A suitable platform for sUAS assisted FCM inspection must be capable of GPS-denied operation. Alternative navigation assistance systems will help the pilot comfortably navigate the sUAS near to the target and obstructions. Due to the previously discussed issues with stereo-vision positioning, a side mounted or upward facing positioning sensor may be preferred. The authors took photos of a fatigue crack specimen provided by the Idaho DOT to assess the effects of vibration and standoff distance on the ability to detect a fatigue crack in an sUAS inspection image. A fatigue crack is easily observable in the 3 o’clock position in Figure 5a, taken from a standoff distance of 0.2 m. When the standoff distance was increased to 0.9 m (Figure 5b), the crack is nearly undetectable. Similarly, Figure 5c and 5d show the effect of illumination on crack detectability. These pictures show that both lack and abundance of brightness can prevent the inspectors from detecting the crack.
