Performance Characteristics of Posts Embedded in Soil

Report # MATC-UNL: 057

MwRSF Research Report No. TRP-03-301-15

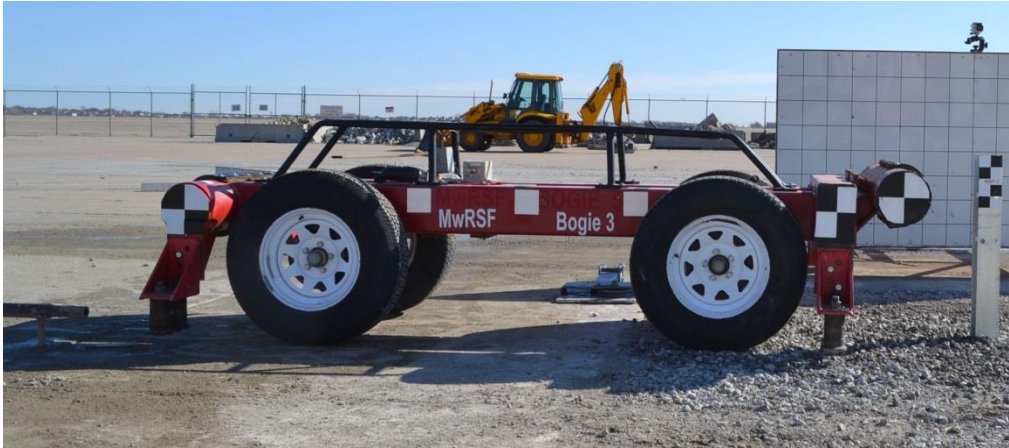
Figure 1. Rigid-Frame Bogie on Guidance Track

A rigid-frame bogie was used to impact the posts. A variable-height detachable impact head was used in the testing. The bogie head was constructed of an 8-in. (203-mm) diameter, ½-in. (13-mm) thick standard steel pipe, with ¾-in. (19-mm) neoprene belting wrapped around the pipe to prevent local damage to the post from the impact. The impact head was bolted to the bogie, creating a rigid frame with an impact height of 24⁷/₈ in. (632 mm). The bogie with the impact head is shown in Figure 1. The weight of the bogie with the addition of the mountable impact head and accelerometers was 1,893 lb (859 kg) for tests nos. WAP-1 through WAP-5 and 1,891 lb (858 kg) for tests nos. SYPW-1 through SYPW-4.

A pickup truck with a reverse cable tow system was used to propel the bogie to a target impact speed of 20.0 mph (32.2 km/h). When the bogie approached the end of the guidance system, it was released from the tow cable, allowing it to be free-rolling when it impacted the post. A remote braking system was installed on the bogie, allowing it to be brought safely to rest after the test.

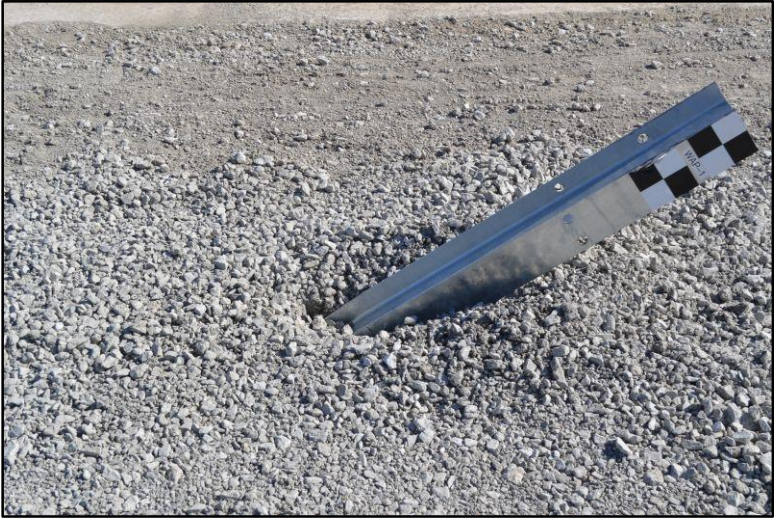
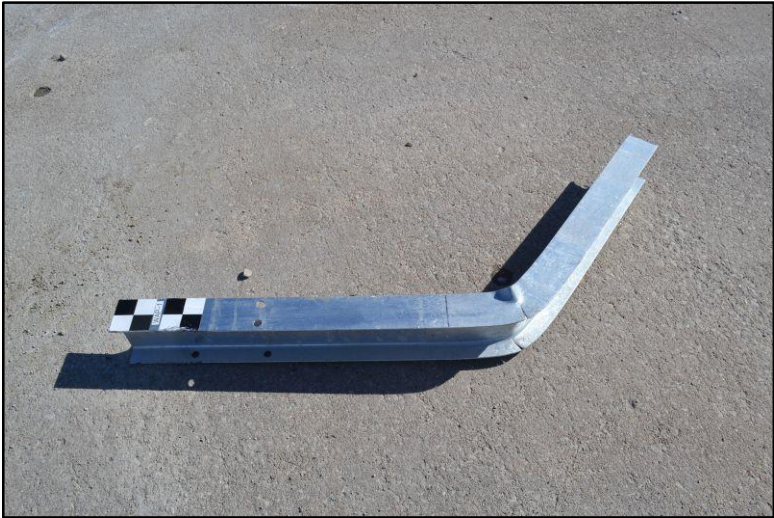
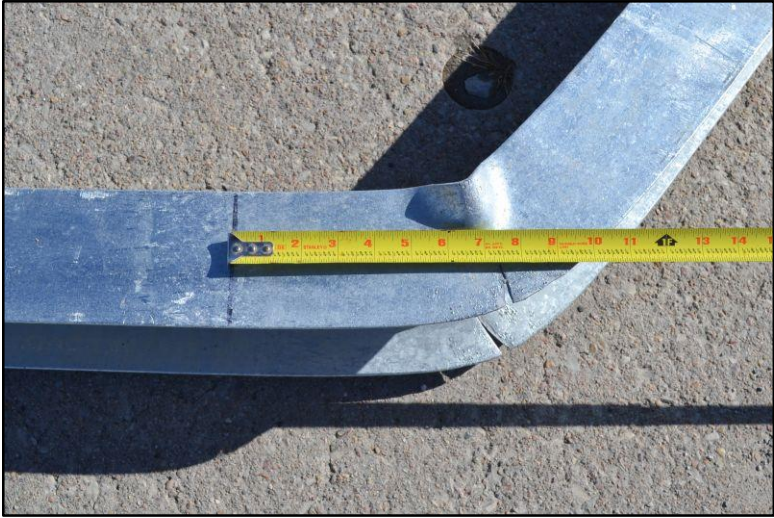
During test no. WAP-1, the bogie impacted the W6x8.5 (W150x12.6) steel post embedded 40 in. (1,016 mm) at a speed of 20.4 mph (32.8 km/h). Upon impact, the post began to rotate through the soil. Post rotation continued until the bogie overrode the post at a displacement of 36.5 in. (927 mm). The post bent and yielded approximately 8 in. (203 mm) below the groundline.

Figure 7. Time-Sequential and Post-Impact Photographs, Test No. WAP-1

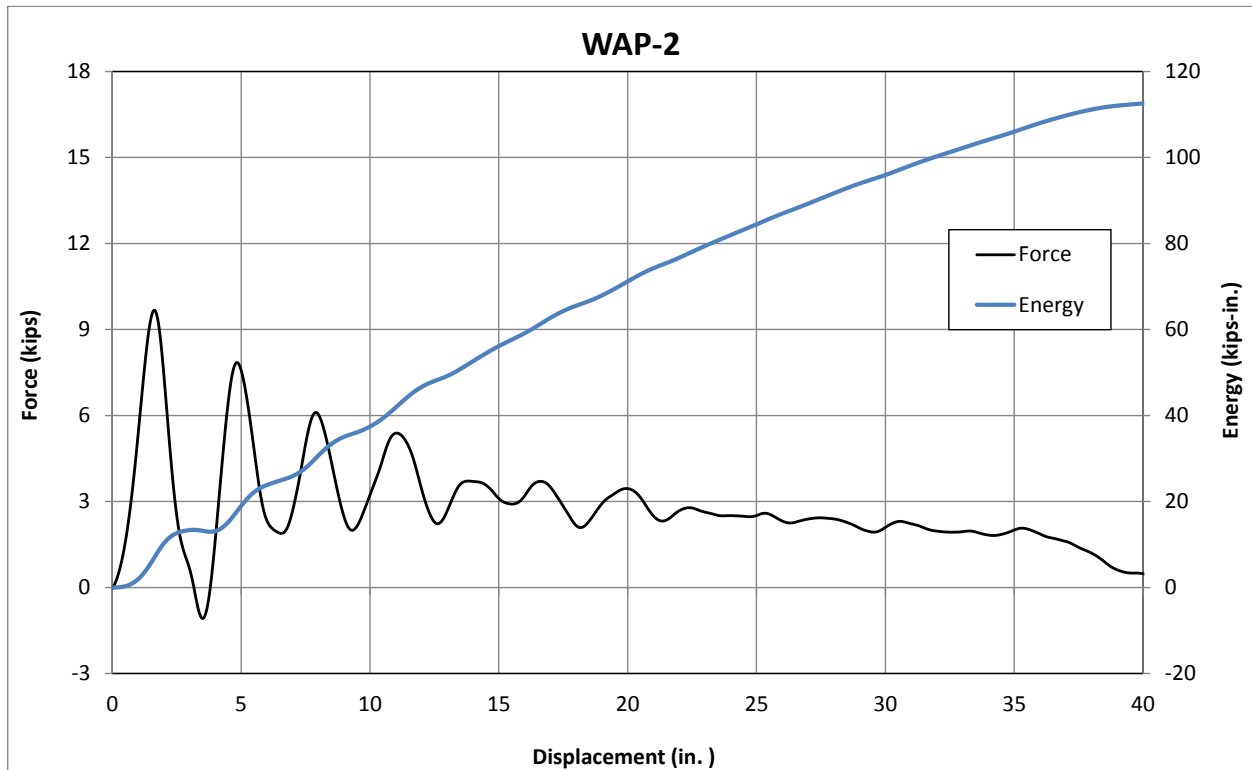
Force vs. deflection and energy vs. deflection curves created from the SLICE accelerometer data are shown in Figure 8. The forces rose to a peak force of 9.7 kips (43.1 kN) at 1.7 in. (43 mm) of deflection. The posts provided an average resistive force of around 4.0 kips (17.8 kN) through 12.0 in. (305 mm) of deflection. A total of 113.1 kip-in. (12.8 kJ) of energy was absorbed by the system before the bogie overrode the post at 41.5 in. (1,054 mm). Time-sequential and post-impact photographs are shown in Figure 9.

Figure 8. Force vs. Deflection and Energy vs. Deflection, Test No. WAP-2

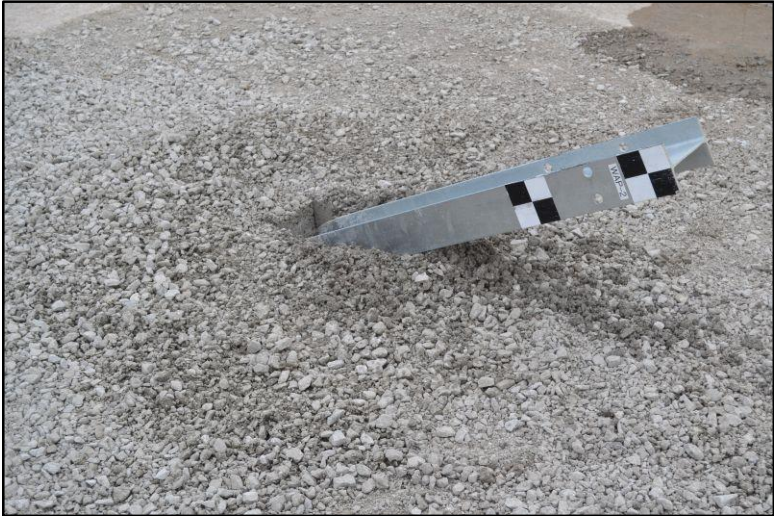
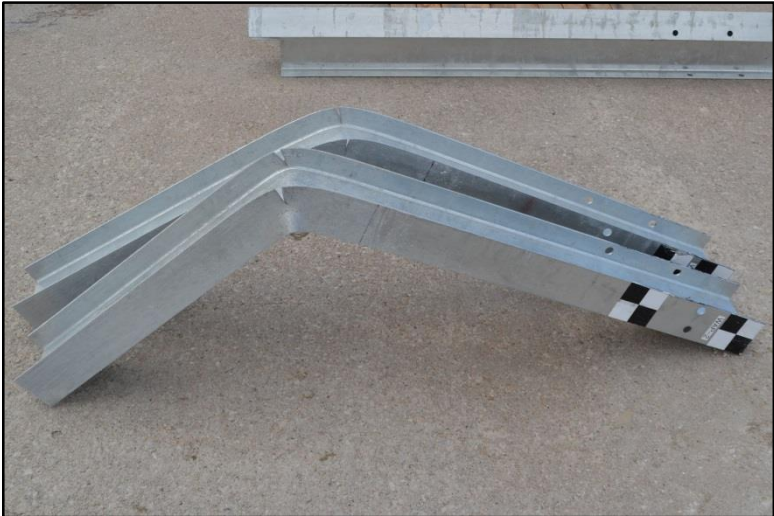
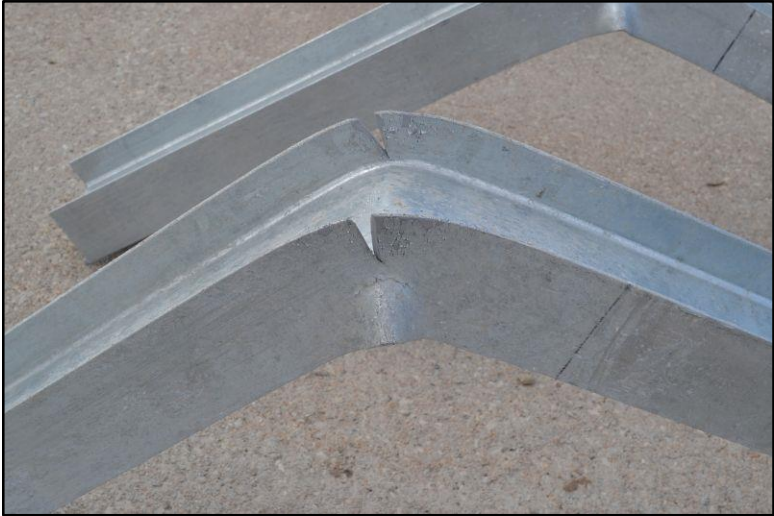
During test no. WAP-2, the bogie impacted the W6x8.5 (W150x12.6) steel post embedded 34 in. (864 mm) at a speed of 20.2 mph (32.5 km/h). Post rotation continued until the bogie overrode the post at a displacement of 41.5 in. (1,054 mm). The post bent and yielded approximately 8 in. (203 mm) below the groundline.

Figure 9. Time-Sequential and Post-Impact Photographs, Test No. WAP-2

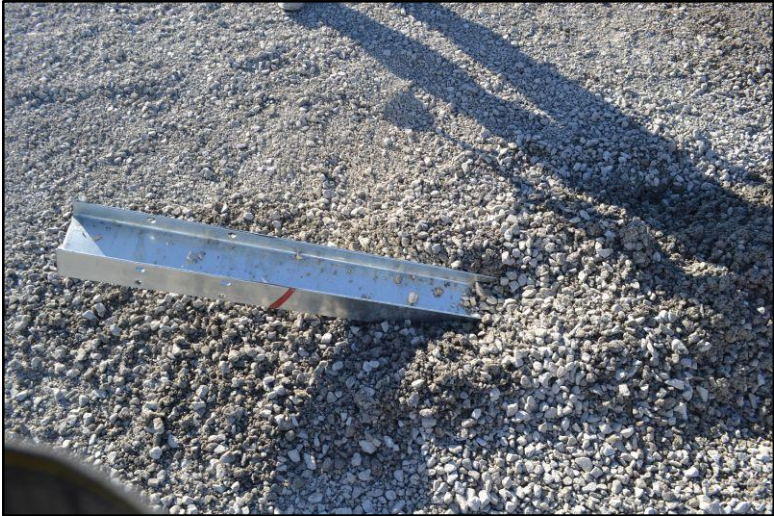
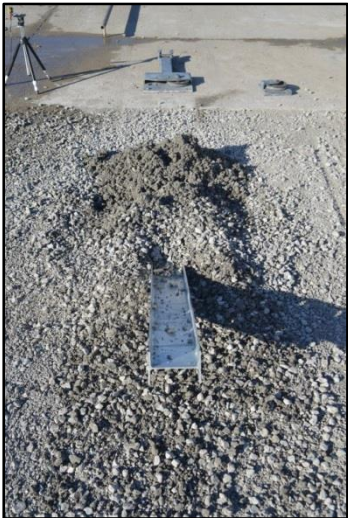
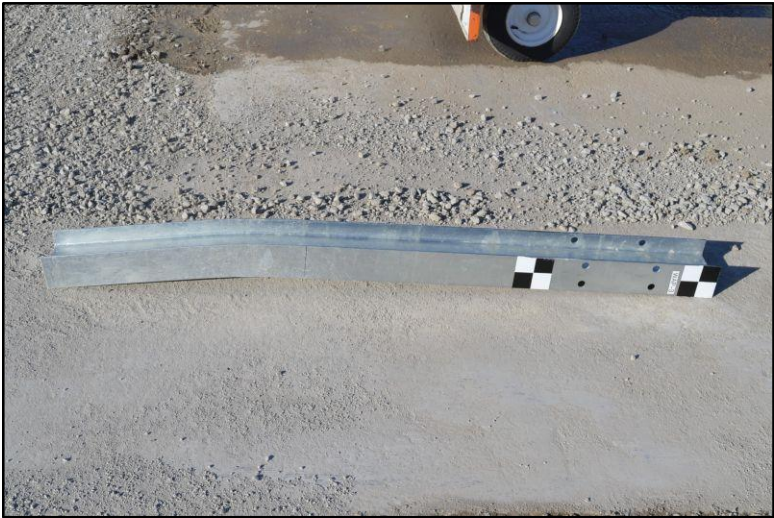
During test no. WAP-3, the bogie impacted the W6x8.5 (W150x12.6) steel post embedded 28 in. (711 mm) at a speed of 20.6 mph (33.2 km/h). Upon impact, the post began to rotate through the soil. Post rotation continued until the bogie overrode the top of the post at a displacement of 41.5 in. (1,054 mm). The post bent slightly and encountered minor yielding below the groundline.

Figure 11. Time-Sequential and Post-Impact Photographs, Test No. WAP-3

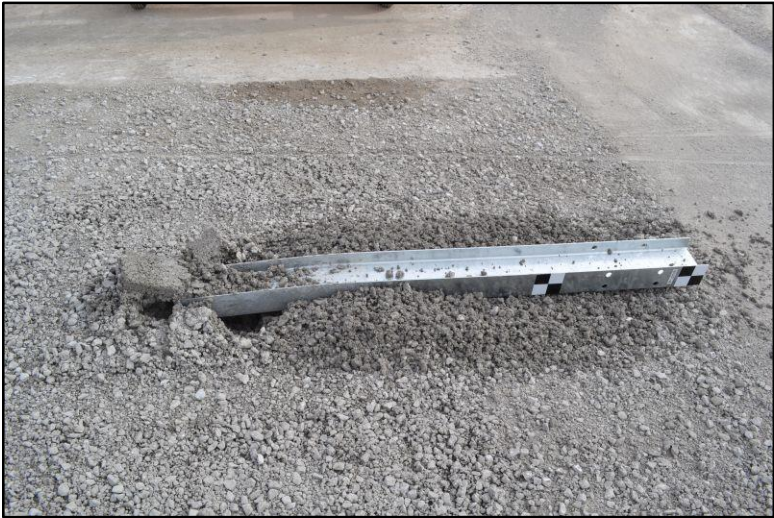
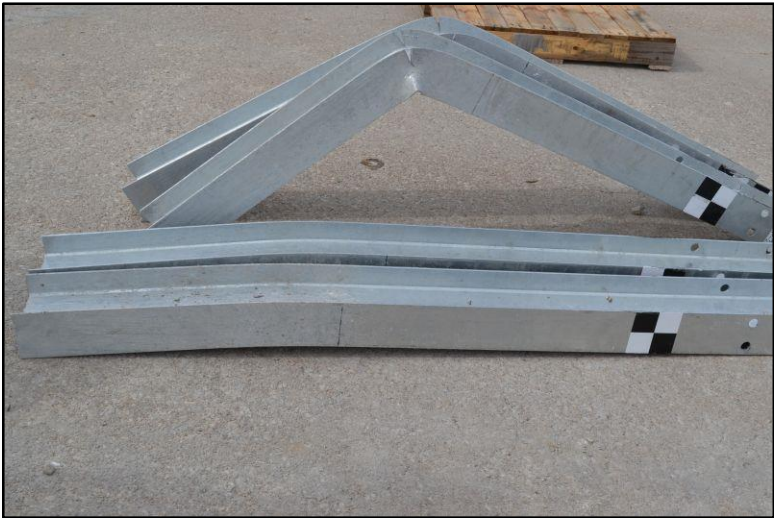
During test no. WAP-4, the bogie impacted the W6x8.5 (W150x12.6) steel post embedded 24 in. (610 mm) at a speed of 20.5 mph (33.0 km/h). Upon impact, the post began to rotate through the soil. The post continued to rotate until the bogie overrode the post at a displacement of 41.2 in. (1,046 mm). The post bent slightly and encountered minor yielding below the groundline.

Figure 13. Time-Sequential and Post-Impact Photographs, Test No. WAP-4

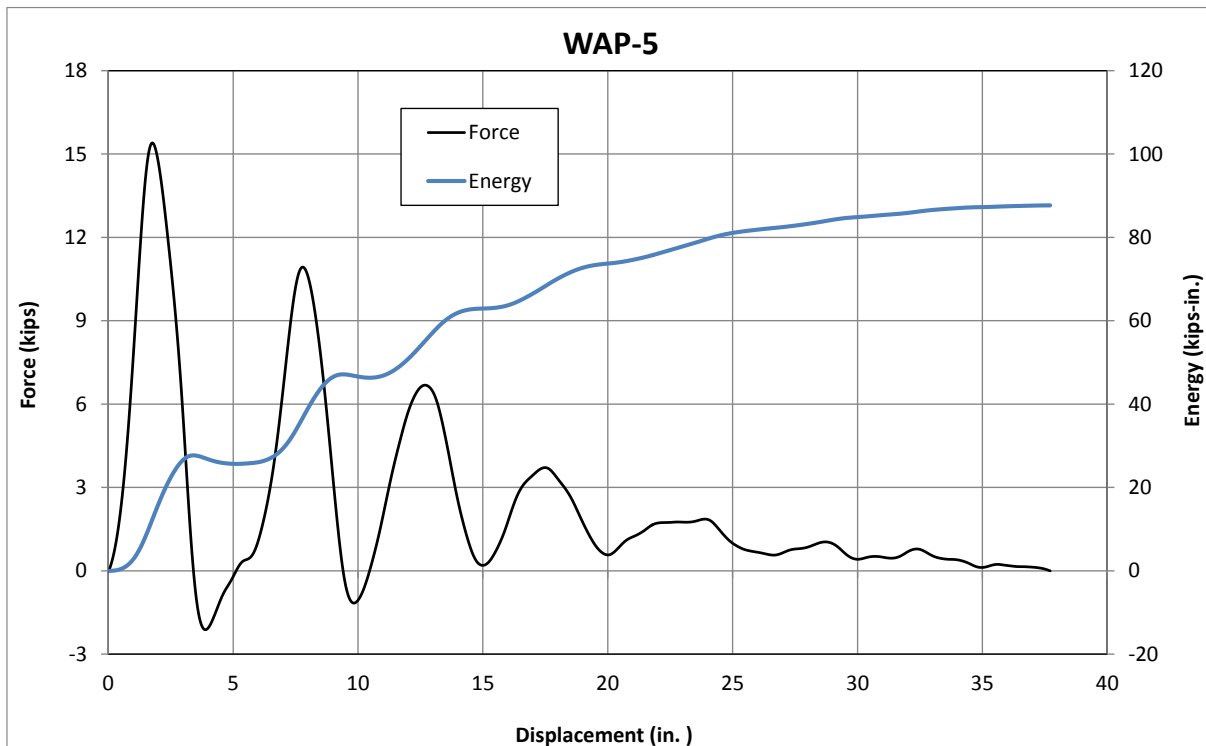
Force vs. deflection and energy vs. deflection curves created from the accelerometer data are shown in Figure 14. The force rose to a peak force of 15.4 kips (68.5 kN) at 1.7 in. (43 mm) of deflection. The post provided an average resistive force of 4.4 kips (19.6 kN) through 16 in. (406 mm) of deflection. The force then steadily decreased for the remainder of the impact event. A total of 87.7 kip-in. (9.9 kJ) of energy was absorbed by the system before the bogie overrode the post at 37.7 in (958 mm). Time-sequential and post-impact photographs are shown in Figure 15.

Figure 14. Force vs. Deflection and Energy vs. Deflection, Test No. WAP-5

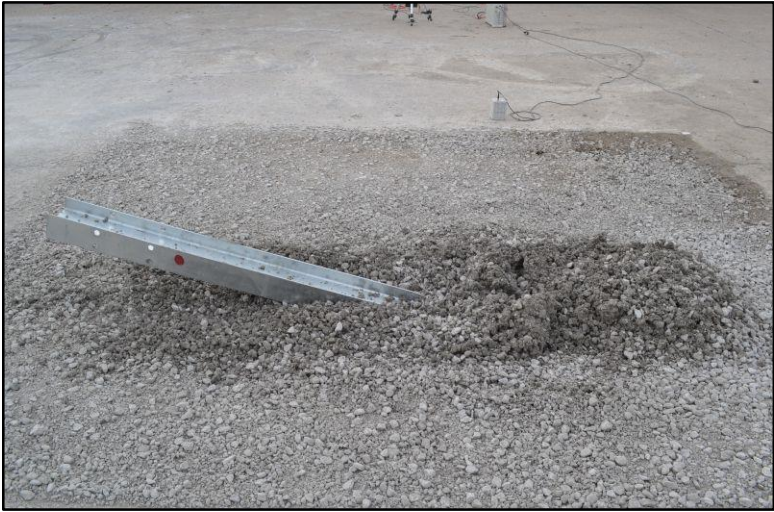
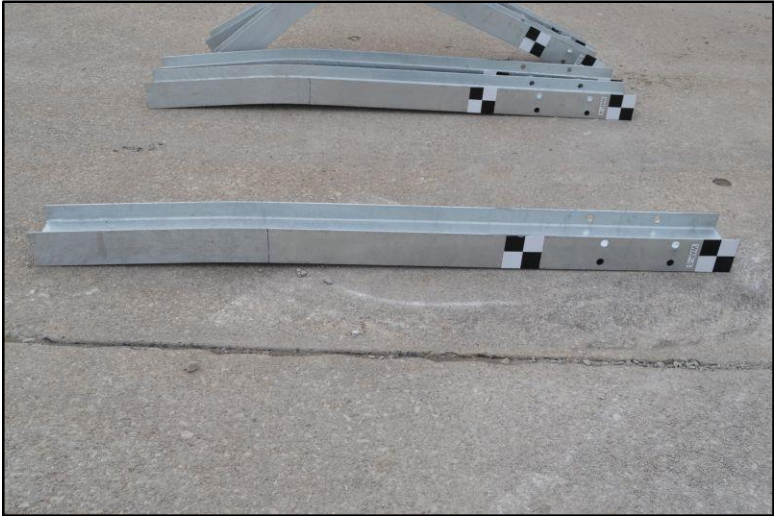
During test no. WAP-5, the bogie impacted the W6x8.5 (W150x12.6) steel post embedded 24 in. (610 mm) at a speed of 20.3 mph (32.7 km/h). Upon impact, the post began to rotate through the soil. The post continued to rotate until the bogie overrode the post at a displacement of 37.7 in. (958 mm). The post bent backwards slightly and encountered minor yielding below the groundline.

Figure 15. Time-Sequential and Post-Impact Photographs, Test No. WAP-5

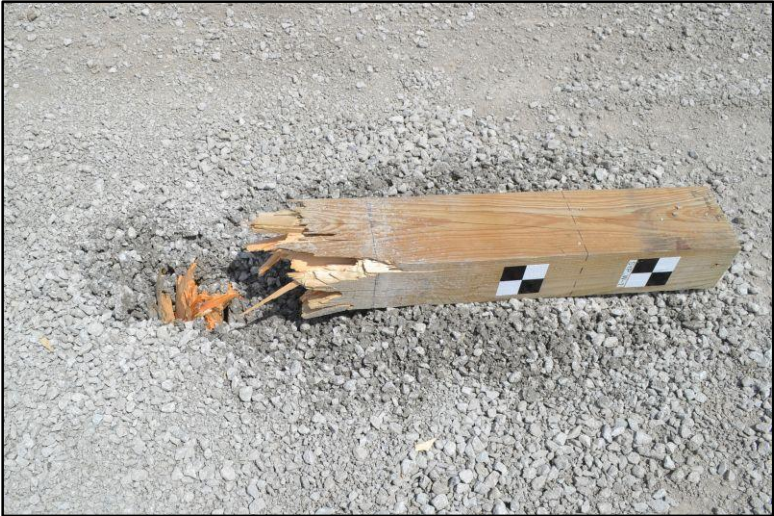
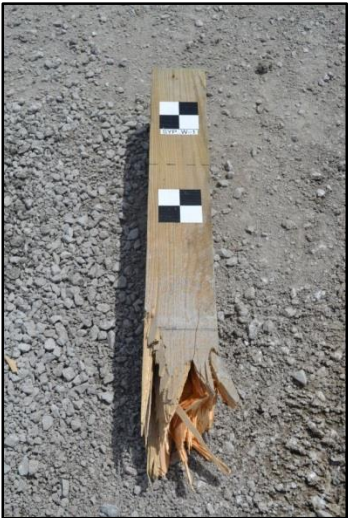
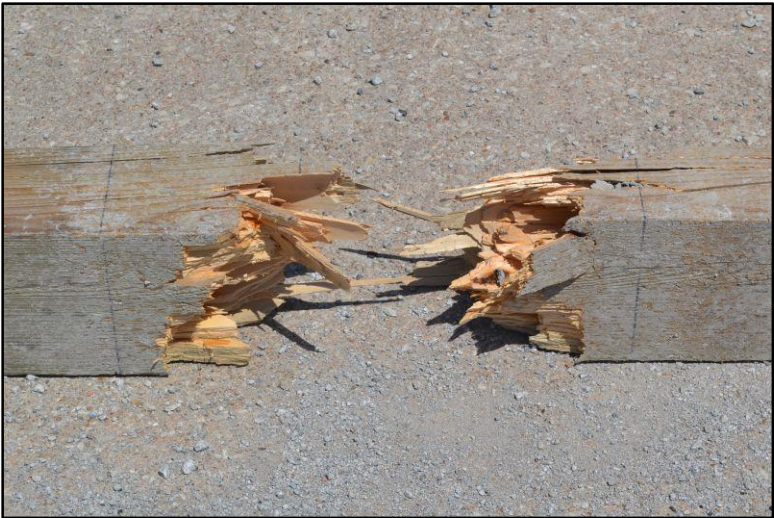
During test no. SYPW-1, the bogie impacted the 6-in. x 8-in. (152-mm x 203-mm) SYP post embedded 40 in. (1016 mm) at a speed of 20.5 mph (33.0 km/h). Upon impact, the post began to rotate through the soil. The post continued to rotate until it fractured at a displacement of 10.5 in. (267 mm). The post fractured approximately 6 in. (152 mm) below the groundline.

Figure 17. Time-Sequential and Post-Impact Photographs, Test No. SYPW-1

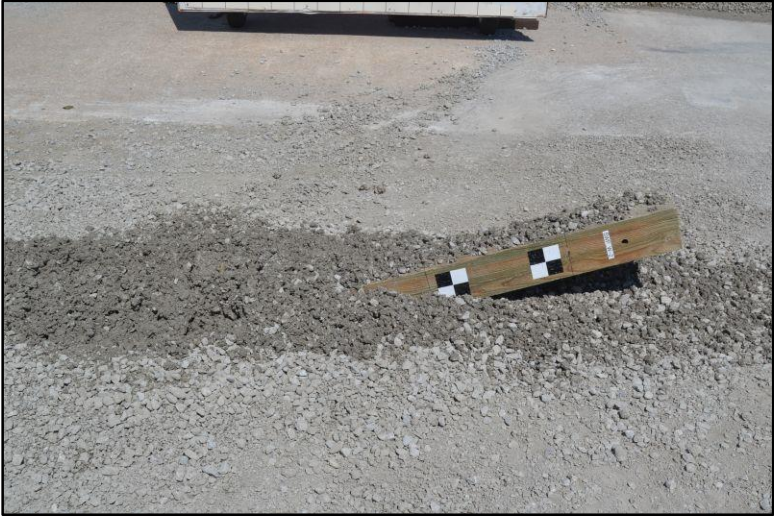
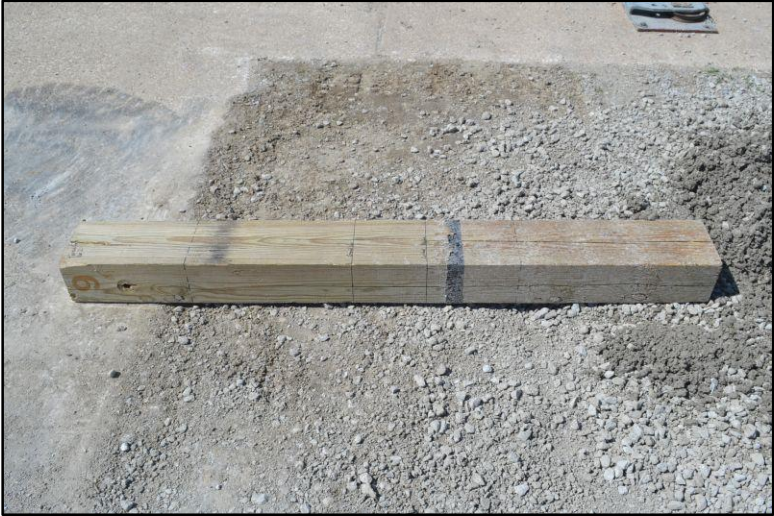
During test no. SYPW-2, the bogie impacted the 6-in. x 8-in. (152-mm x 203-mm) SYP post embedded 30 in. (762 mm) at a speed of 20.8 mph (33.5 km/h). Upon impact, the post began to rotate through the soil. The post continued to rotate until it fractured at a displacement of 36.6 in. (930 mm). The SYP post showed no signs of fracture.

Figure 19. Time-Sequential and Post-Impact Photographs, Test No. SYPW-2

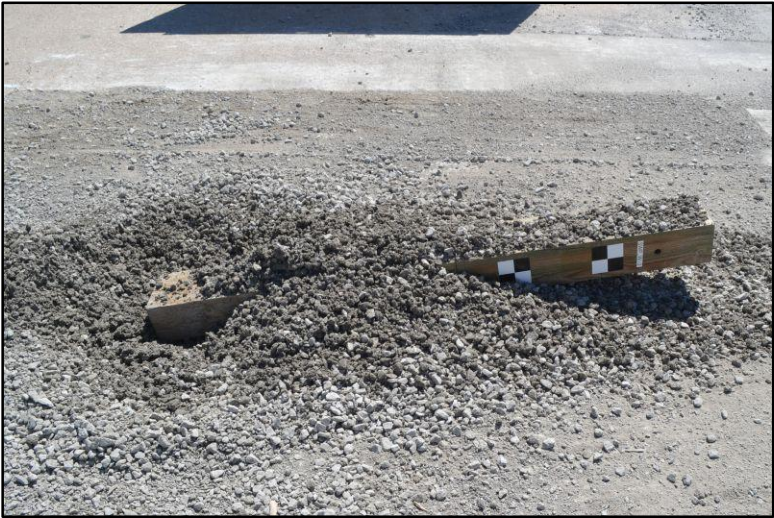
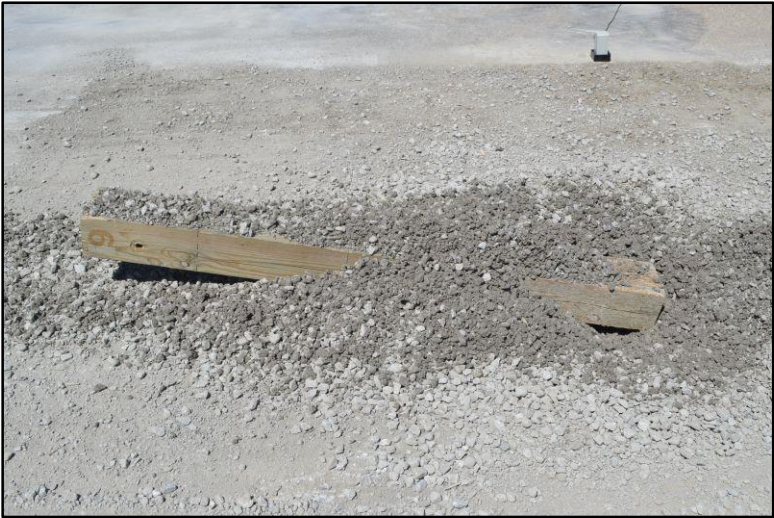
During test no. SYPW-3, the bogie impacted the 6-in. x 8-in. (152-mm x 203-mm) SYP post embedded 34 in. (864 mm) at a speed of 20.0 mph (32.2 km/h). Upon impact, the post began to rotate through the soil. Post rotation continued until the bogie overrode the post at a displacement of 40.3 in. (1,024 mm). The SYP post showed no signs of fracture.

Figure 21. Time-Sequential and Post-Impact Photographs, Test No. SYPW-3

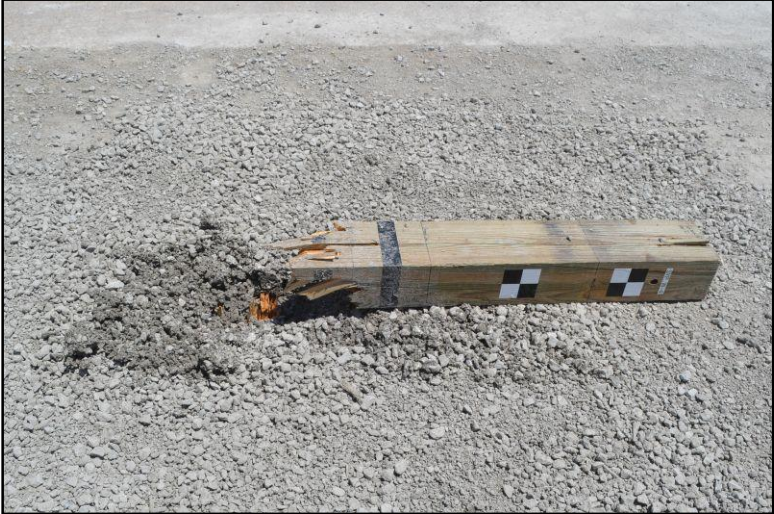
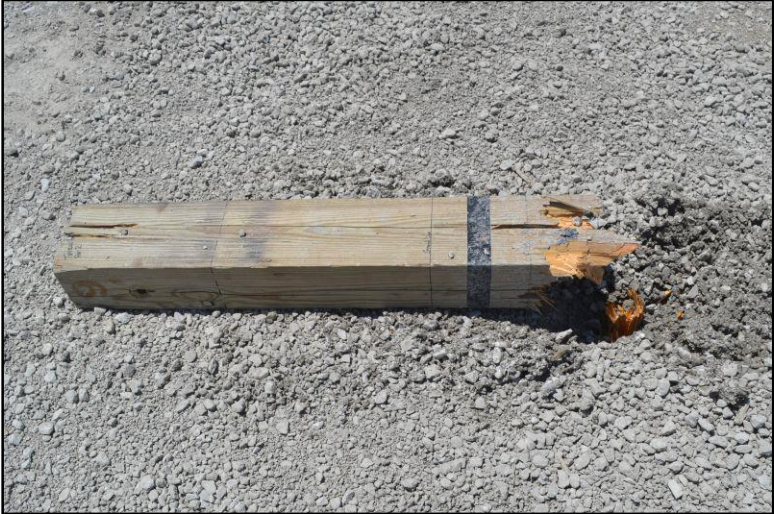
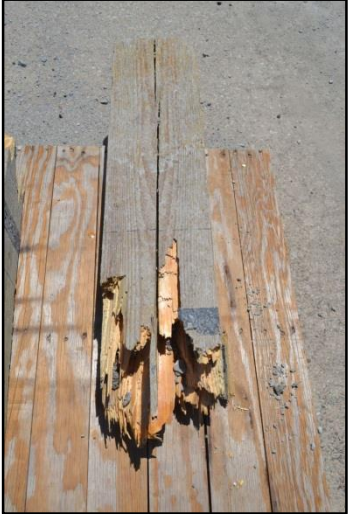
During test no. SYPW-4, the bogie impacted the 6-in. x 8-in (152-mm x 203-mm) SYP post embedded 37 in. (940 mm) at a speed of 20.3 mph (32.7 km/h). Upon impact, the post began to rotate through the soil. The post continued to rotate until it fractured at a displacement of 6.9 in. (175 mm). The post fractured approximately 8 in. (203 mm) below the groundline.

Figure 23. Time-Sequential and Post-Impact Photographs, Test No. SYPW-4

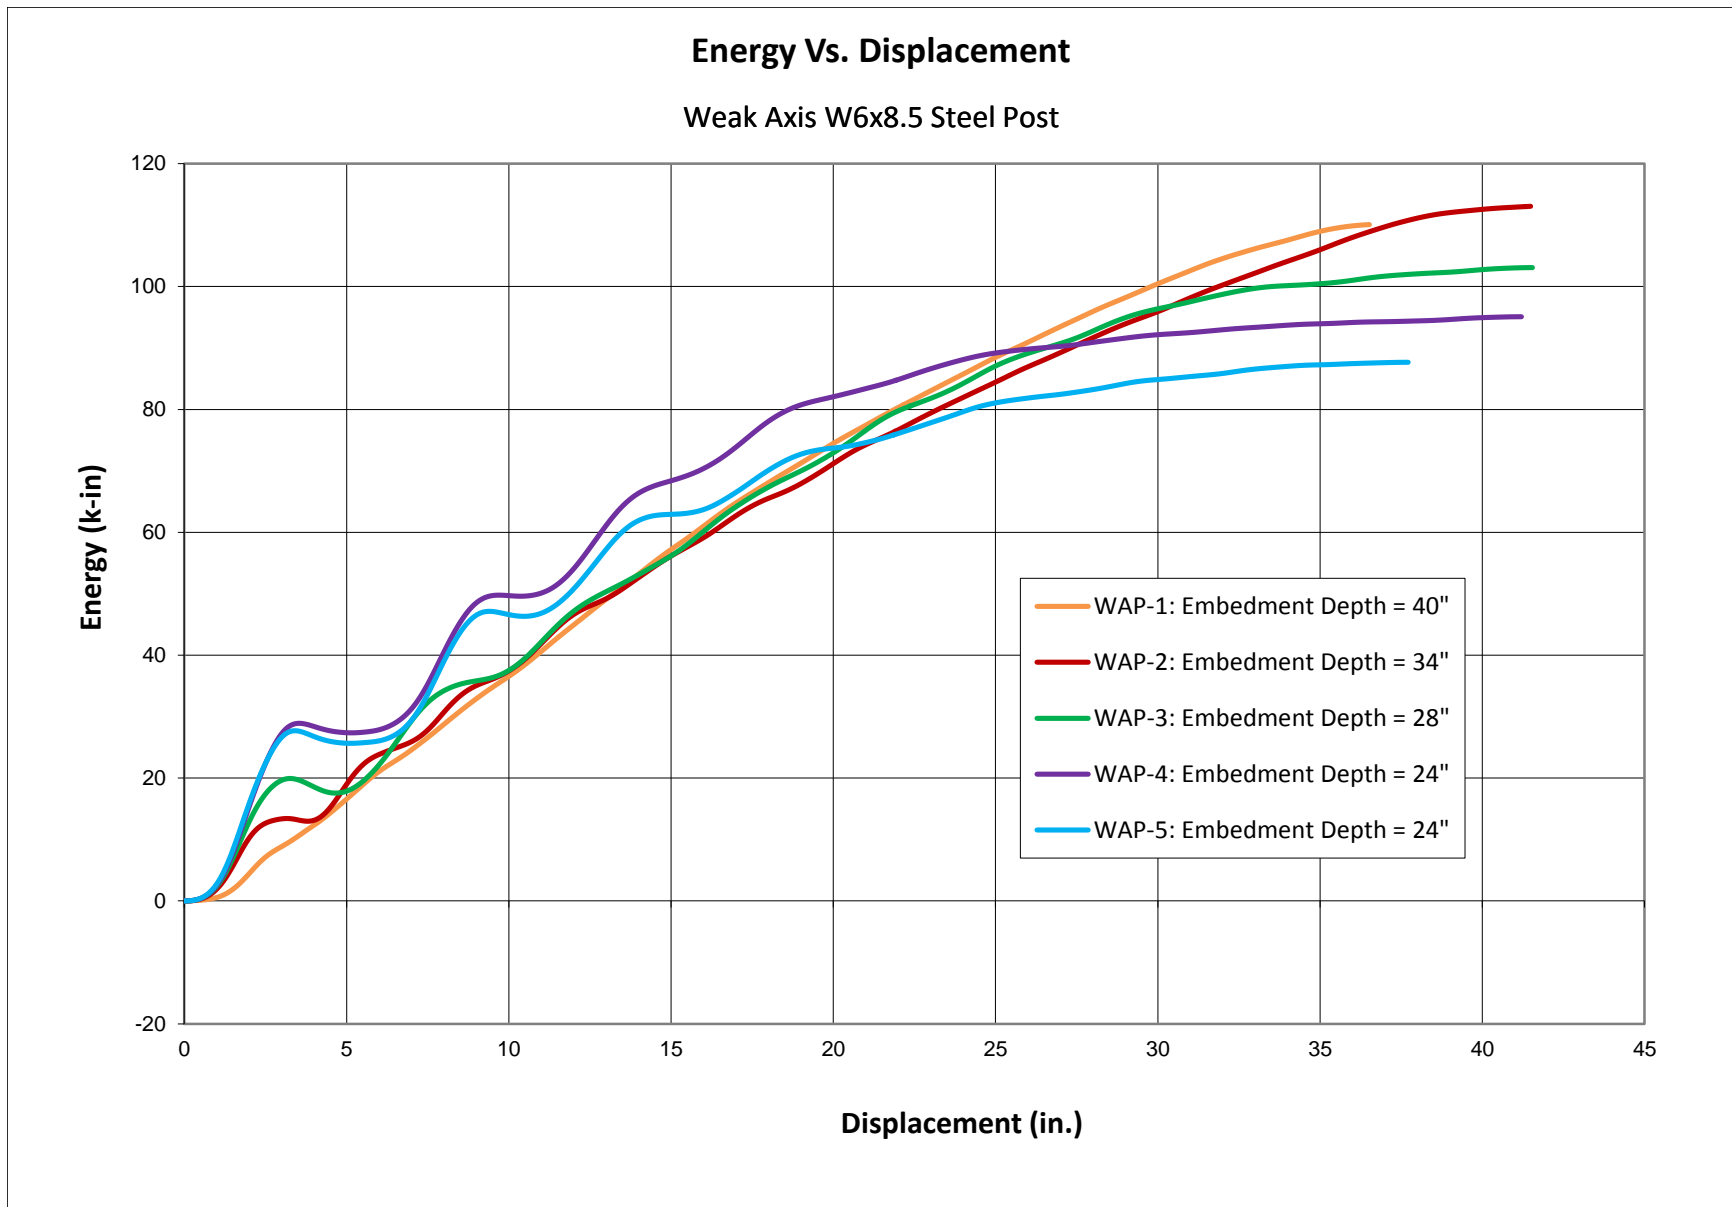
Figure 25. Energy vs. Deflection Comparison, Test Nos. WAP-1 through WAP-5

When embedment depths of 24 and 28 in. (610 and 711 mm) were used, as observed in test nos. WAP-3 through WAP-5, the posts rotated through the soil with minor post bending. The shallower embedded posts, which rotated through the soil, absorbed noticeably less energy than the posts that bent with plastic deformation, as reported in Table 2.

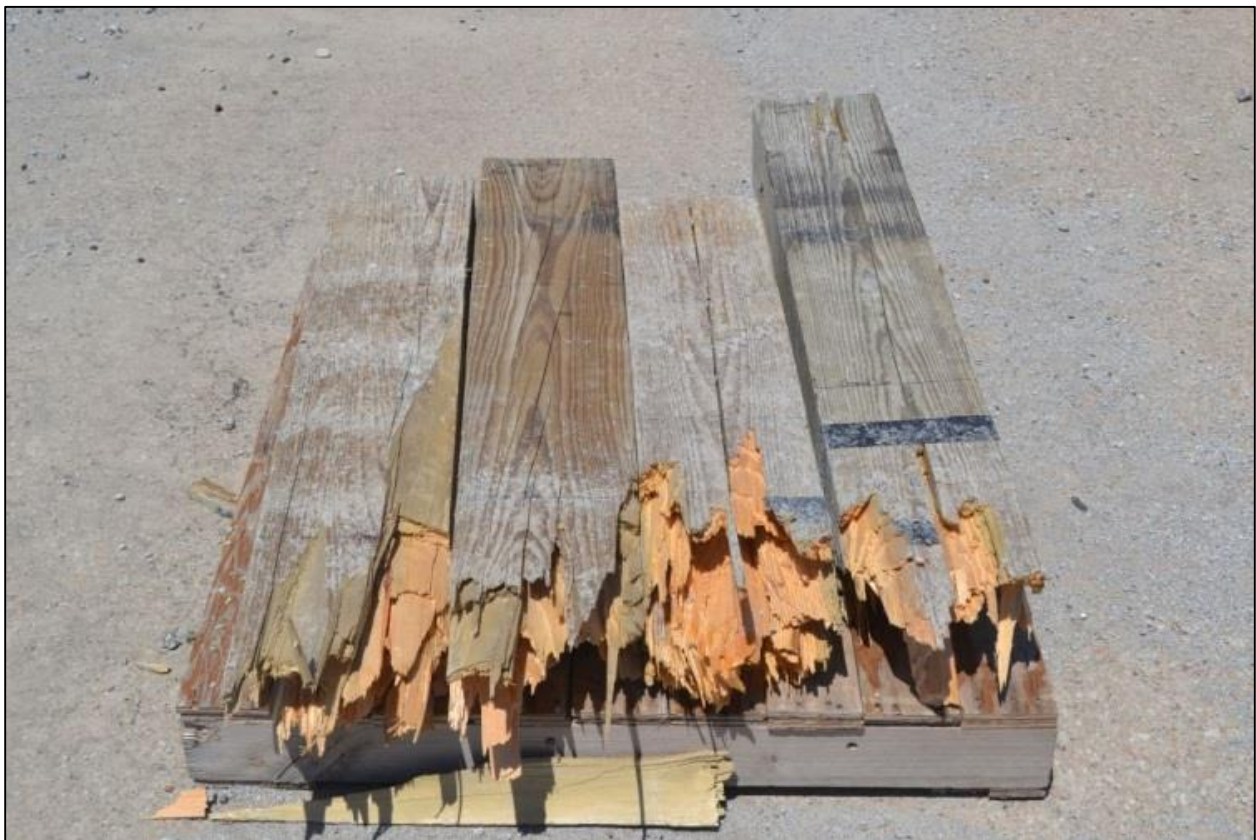
When deeper embedment depths of 37 and 40 in. (940 and 1016 mm) were used, such as in test nos. SYPW-1 and SYPW-4, the post fractured completely with little rotation through the soil. The values of the peak force were relatively similar regardless of post behavior, as reported in Table 2. However, the deeper embedded posts, which fractured, did not provide resistive forces for as long of a duration as the posts that rotated through the soil, as seen in Figure 27. As a result, the posts that fractured absorbed noticeably less energy than the posts that rotated through the soil.

Figure 26. Comparison of Post Fractures, Test Nos. SYPW-1 (Left) and SYPW-4 (Right)

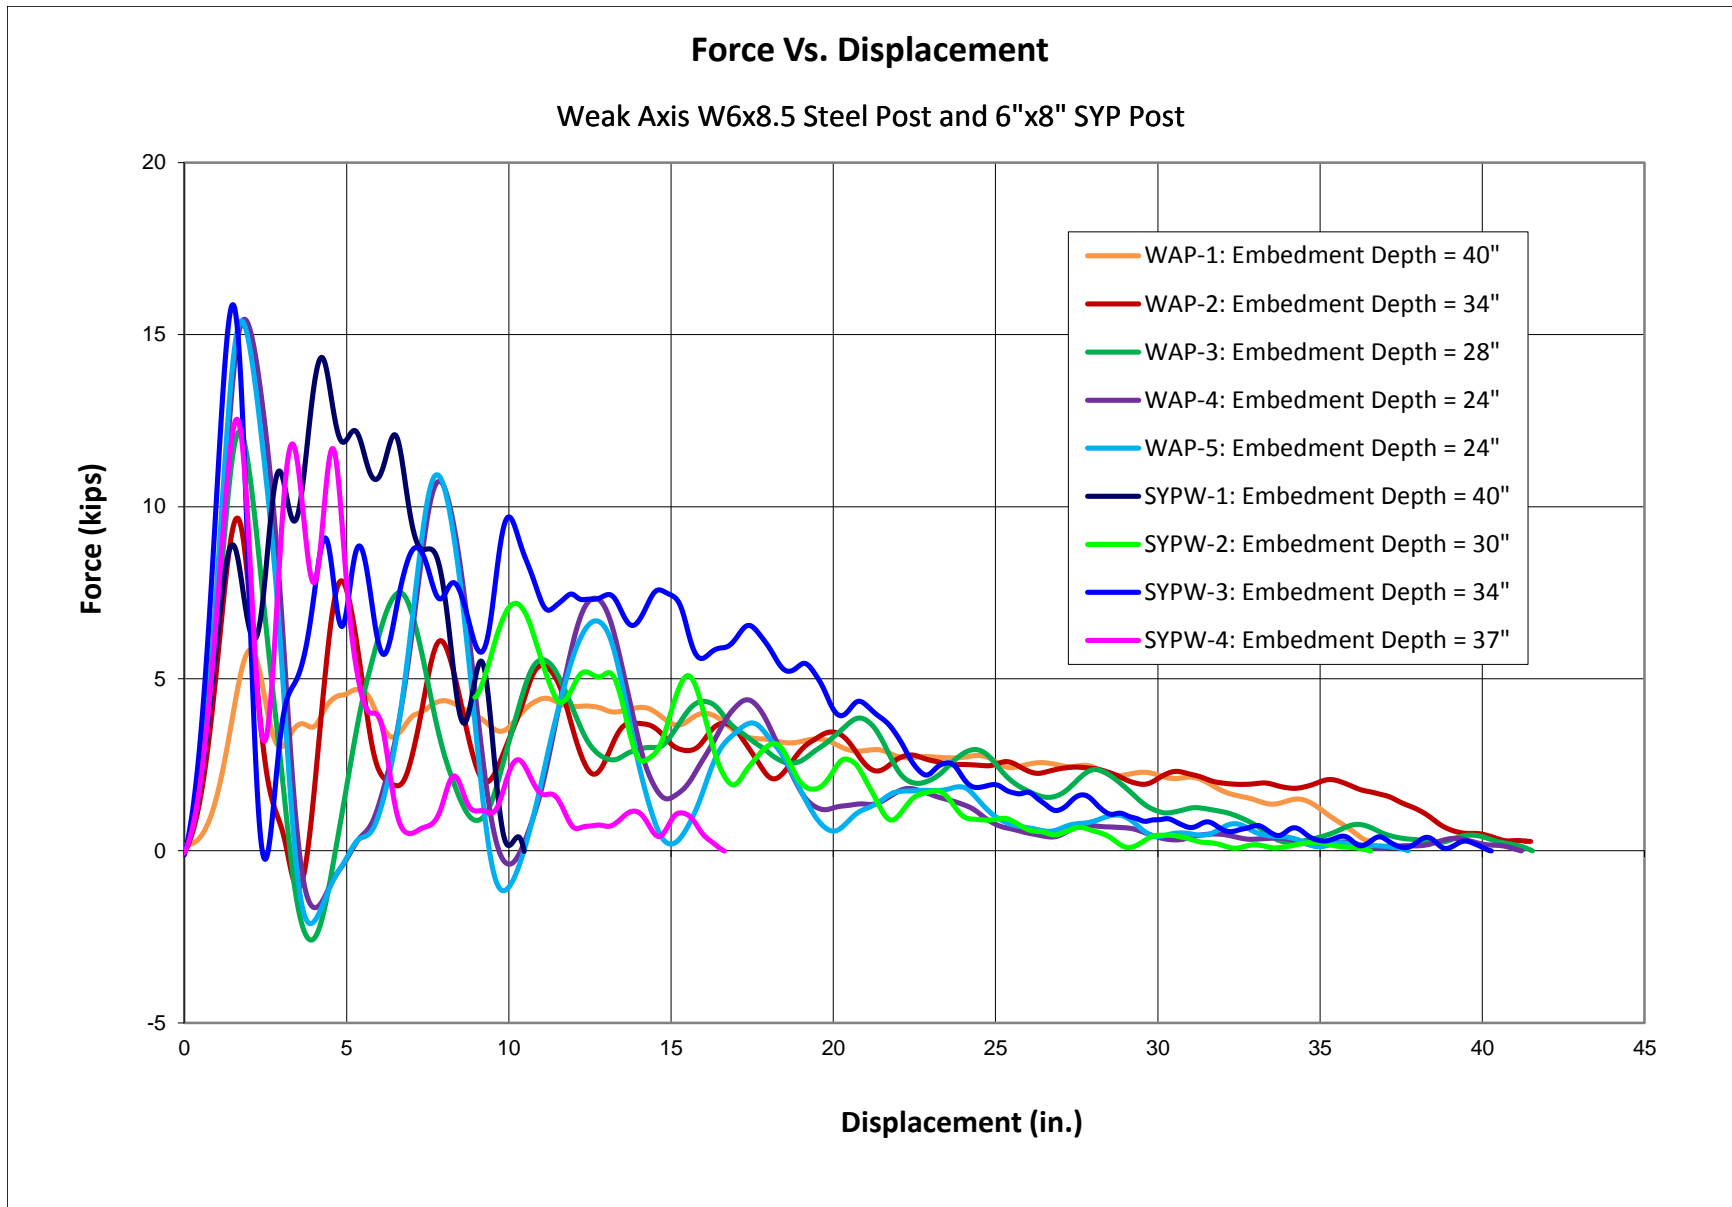
Figure 29. Combined Force vs. Deflection Comparison, All Bogie Tests

In summary, the wood post systems absorbed more energy when rotation through the soil was witnessed compared to the wood post systems that fractured. However, the steel post system absorbed more energy when the post yielded compared to when the steel post rotated through the soil.

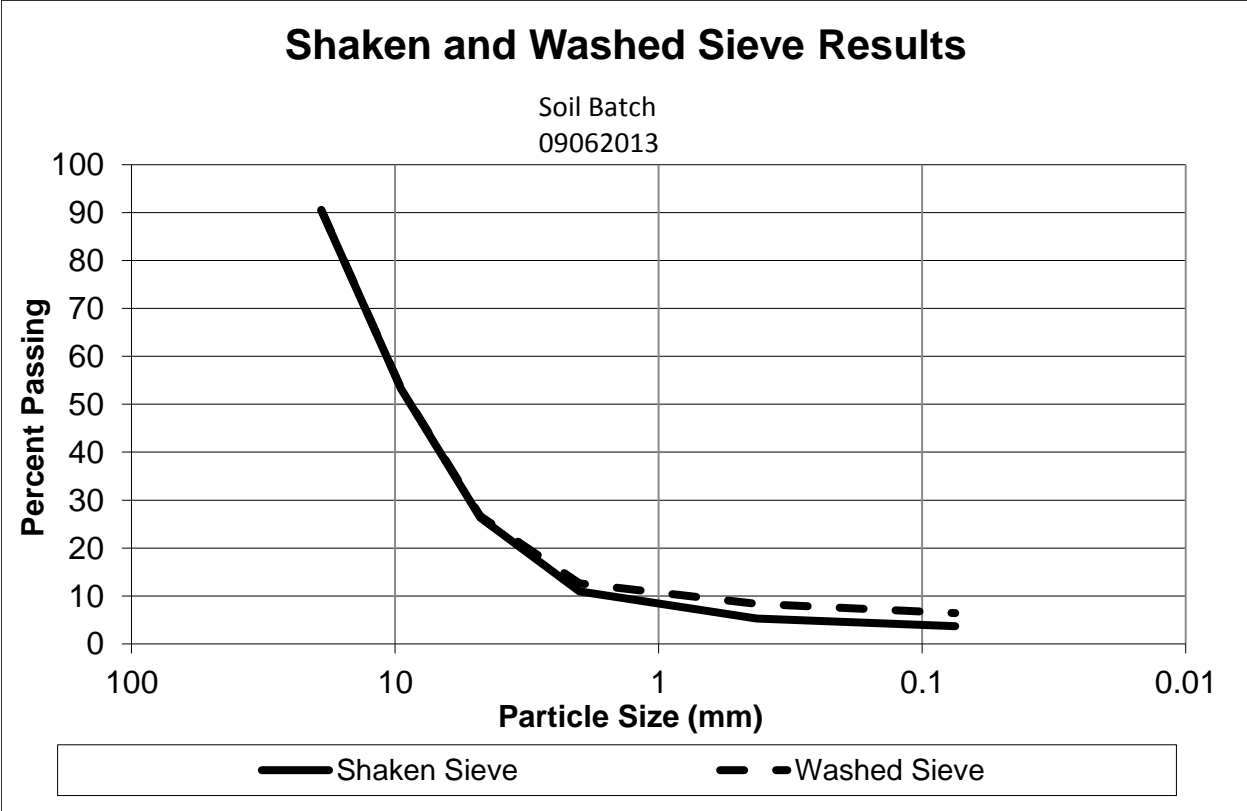
Figure A-5. Graph of Soil Sieve Data for All Bogie Tests
