Detection of Multiple Flaws in Concrete Bridge Decks Using Ultrasonic Wave Propagation

**Detection of Multiple Flaws in Concrete Bridge Decks Using
Ultrasonic Wave Propagation**

M066

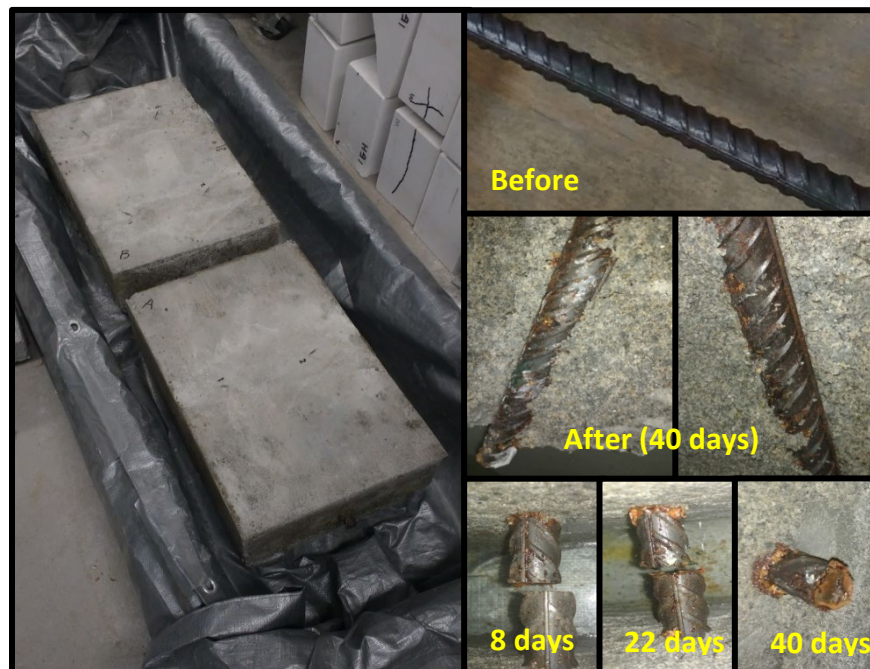
Figure 2 – Specimen Set 1A: Corrosion Specimens (left) and Corrosion product build-up over time (right)

- A. **Specimen Set 1A: Two 18inch x 12inch x 5 inch concrete slabs** with a No.5 steel reinforcing bar embedded at the center (Figure 2): The purpose of these specimens were to put them under conditions to simulate corrosion and monitor the capabilities of the proposed UGWL method to detect the onset and the progression of corrosion. As such, the specimens were cast using 5% NaCl solution to accelerate corrosion. These specimens were also placed in a covered tub with water during curing such that the water was at a level that partially submerged the specimens, i.e. just below the reinforcing bar.

Specimen Set 1A comprised of two 18inch x 12inch x 5 inch concrete slabs with a No.5 steel reinforcing bar embedded at the center level (Figure 2). The purpose of the experiment was to investigate whether the proposed method can detect the start of corrosion. Figure 8 shows the velocity measurement results (time domain) on top and the amplitude measurement results (frequency domain) on the bottom. As discussed before, velocity measurements represent the current industry standard, while amplitude measurement is part of the methodology proposed by our team. Figure 9 shows a larger view of the peak amplitudes in frequency domain that clearly shows the change in amplitude as the corrosion progressed; while it is more difficult to see this change by velocity measurements (Figure 8). These figures represent the average of five measurements each. Figure 10 shows mean and standard deviation of each data set in a plot of percent change in energy (or peak amplitude) versus days (or progression of corrosion).

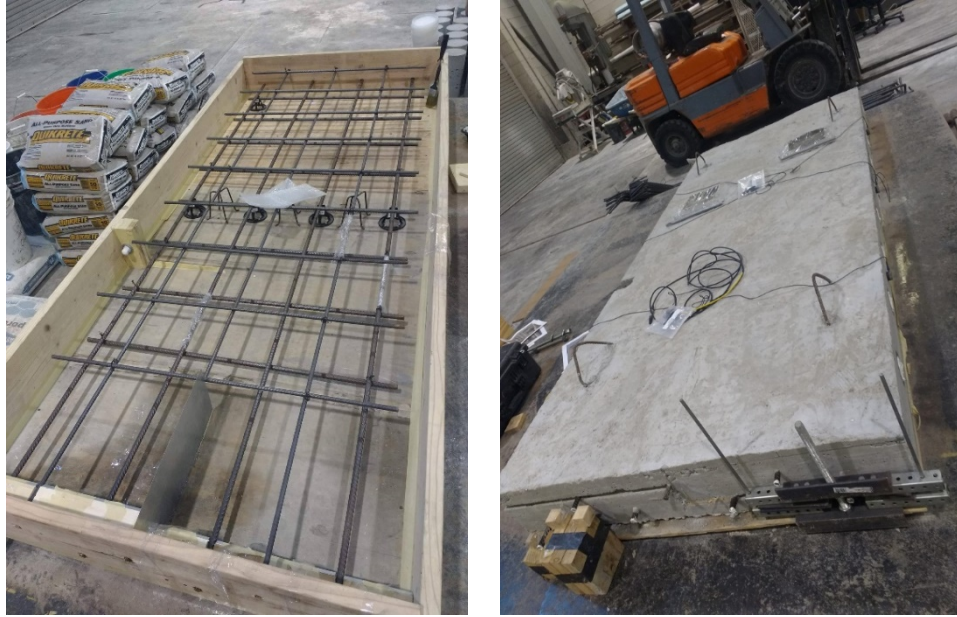
Figure 5- Specimen Set 3 formwork and bars before casting (left) and final specimen (right)

Specimen set 3 was a larger reinforced concrete slab (10 feet long, 4 feet wide, and 8 inches thick), which was cast to examine the influence of multiple layers and direction of reinforcement on the UGWL method, as well to test farther distances between the transmitter and receivers than we tested before (Figure 5). Each layer of reinforcement had a cover of 2.5 inch and, consequently, 3 inches between them. The specimen contained known areas with delamination, corrosion and cracks as shown in Figure 6. An array of sensor locations were marked on the side of the slab as shown in Figure 7.

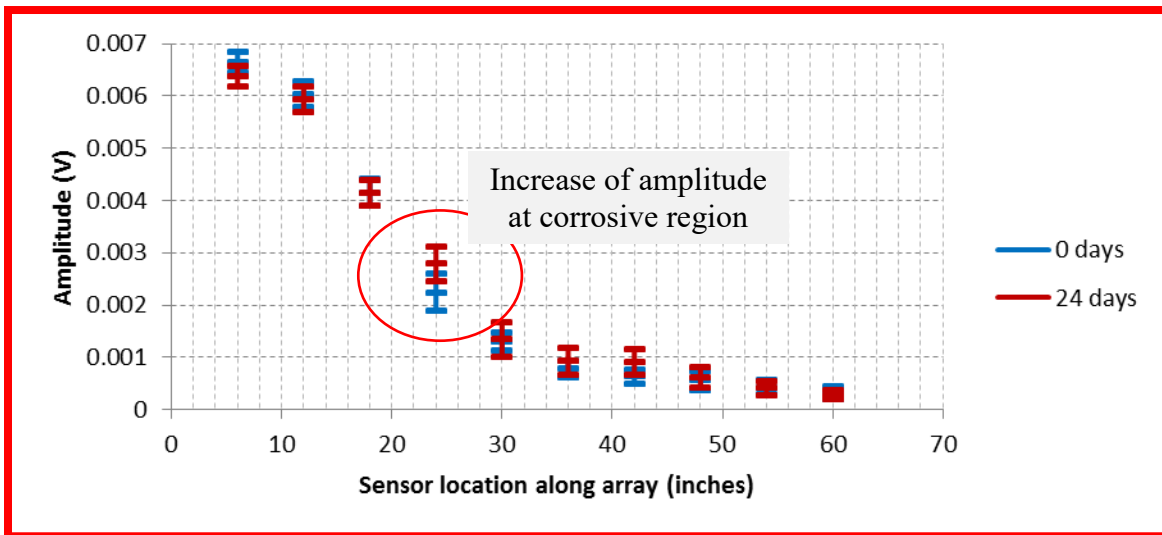
Figure 11- Amplitude of leaked waves versus sensor location plot for Specimen 1B, Transmitter on corroded bar (bar 1a) and Receivers 1 foot away from the bar

Specimen Set 1B comprised of one 60 inch x 48 inch x 5 inch concrete slab with three No.5 steel reinforcing bars spaced at 12 inches (Figure 4). Figure 11 shows the amplitude of leaked waves detected from the array of sensors located along the edge of the concrete slab at the beginning and after 24 days of corrosion progression. In this test, the transmitter is on bar 1a (shown in Figure 12), and sensors are located on the near edge of the slab, i.e. 1 foot away from the bar (denoted by the red line in Figure 12). As expected, the energy attenuates as the sensors are farther away from the transmitter location at the end of the rebar. Further, while the no-corrosion data (0 days) follows an exponential curve as expected from theoretical equations after 24 days, the sensors corresponding to the corrosion region show an increase in amplitude. Finally, based on the leakage angles demonstrated in Figure 13, it is expected to have the exponential decay of the amplitude start around 13.5 inches.

It should also be noted that the corrosion is detected as an increase in the amplitude of the leaked signals in either case (Figures 11 and 14). The initial stages of corrosion improves the bond between steel and concrete until the delamination occurs, increasing the amount of energy absorbed into concrete.

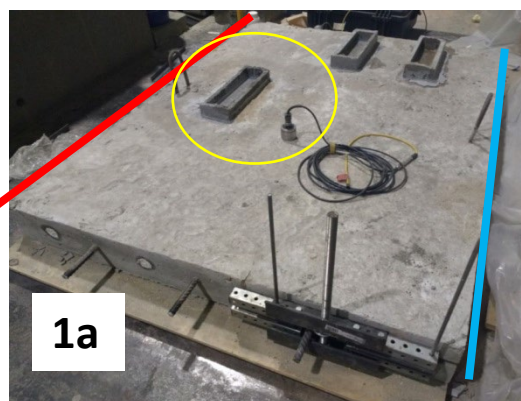
Figure 12- Red line denotes the sensor array for data displayed in Figure 11, and blue line denotes the sensor array for data displayed in Figure 14.

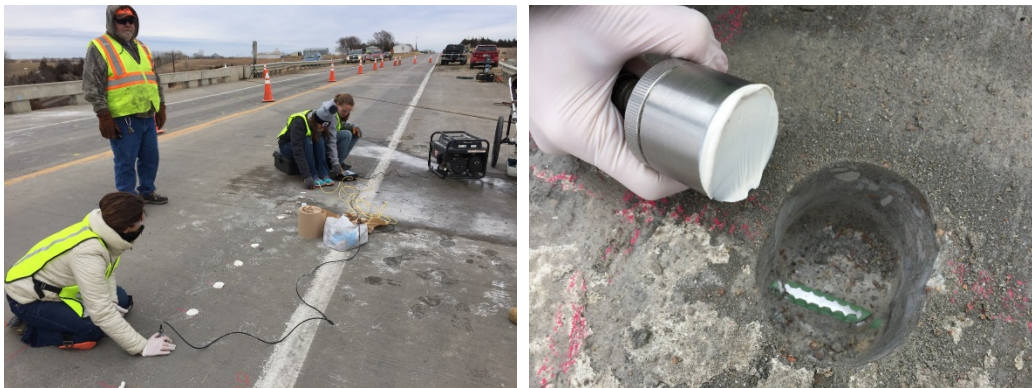
A pilot test was conducted on Bridge S006 30574 near the town of Emerald. This bridge will be henceforth referred to as the Emerald Bridge. There were two testing locations: one in north lane and one in south lane; each right on a rebar. At each location, with the help of NDOT staff, we drilled down to the top rebar and grinded the surface of the rebar to create a smooth and flat surface for better coupling. We used both a 1-inch diameter sensor and a 2-inch diameter sensor. 2-inch diameter sensor is shown in Figure 27.

Figure 27- Images from pilot field work

- 1 inch sensor was not strong enough to detect signals on the field, even though it had worked in the lab
- 2 inch sensor could collect data up to 14 feet away from the transmitter, which is greater than the largest distance we have achieved in the lab (due to specimen size).
- Placing sensors directly aligned with the bar was better than setting them up on an offset, which is another deviation from the lab setup. While signals were stronger in this case, we know that all of the transmitted energy does not go into the rebar in this layout. In the future, a mechanism that directs the signal to a direction close to parallel to the rebar needs to be invented.
