Assessment of Total Suspended Solids and Total Phosphorus Removal by Wetlands and Best Management Practices in Lincoln, Nebraska

An Undergraduate Thesis

The Environmental Studies Program at the University of Nebraska-Lincoln

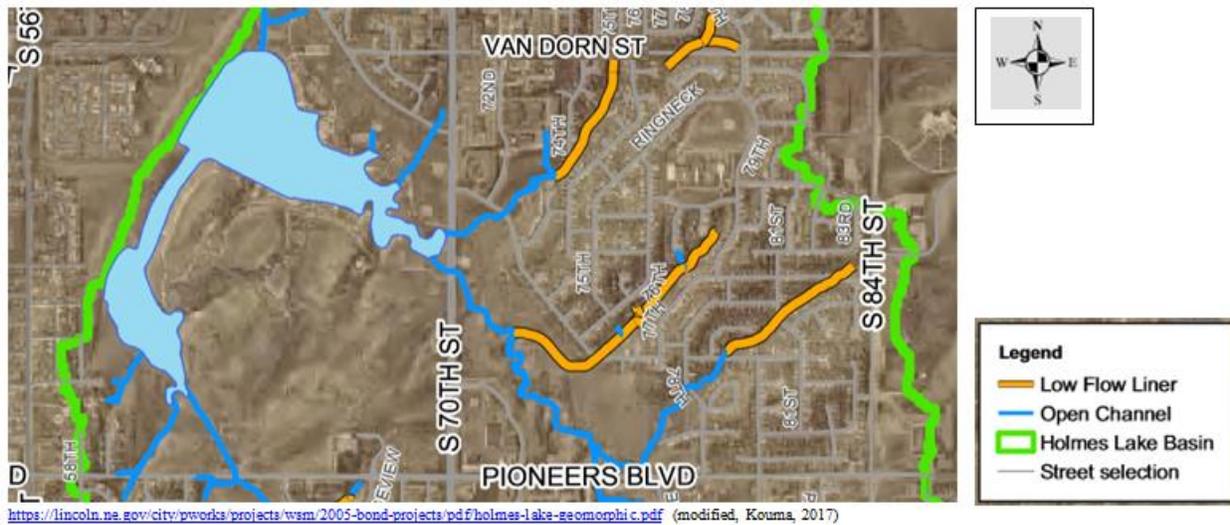
Figure 1. Holmes Lake Watershed

This study took place inside city limits of Lincoln, NE, Lancaster County, on 132.0 acres of the northwest corner of 70th and Pioneers Blvd., Holmes Park Rd., Cooper Ave., S 76th St., and Lucile Dr. (Fig 1), meeting all research requirements. The first requirement is for urban areas utilizing wetlands, and BMPs to control stormwater runoff, and remove TSS and TP. Next, be in close proximity to contributors of TSS and TP commercial areas with customer parking lots, roads with moderate traffic flow, residential areas, and green spaces (Pitt, 2011, Smith, 2016). Finally, effluent waters from these sites, entering surface waters.

An estimation for 800-850 homes was made by using data from residential roofs, lawns, and driveways measured, then applying it to the area bordered by 70th, Van Dorn St., 84th, and Pioneers Blvd. inside the Holmes Lake watershed (Fig.1). It is not possible, in the scope of this research, to account for all impermeable surfaces in residential areas as they are not public property, and are out of control of the developer to know how it was developed after purchase (Krause et al., 2006). Any changes the homeowners have made will affect the imperviousness of the area, but calculations based on data generated do show the possible imperviousness of residential properties.

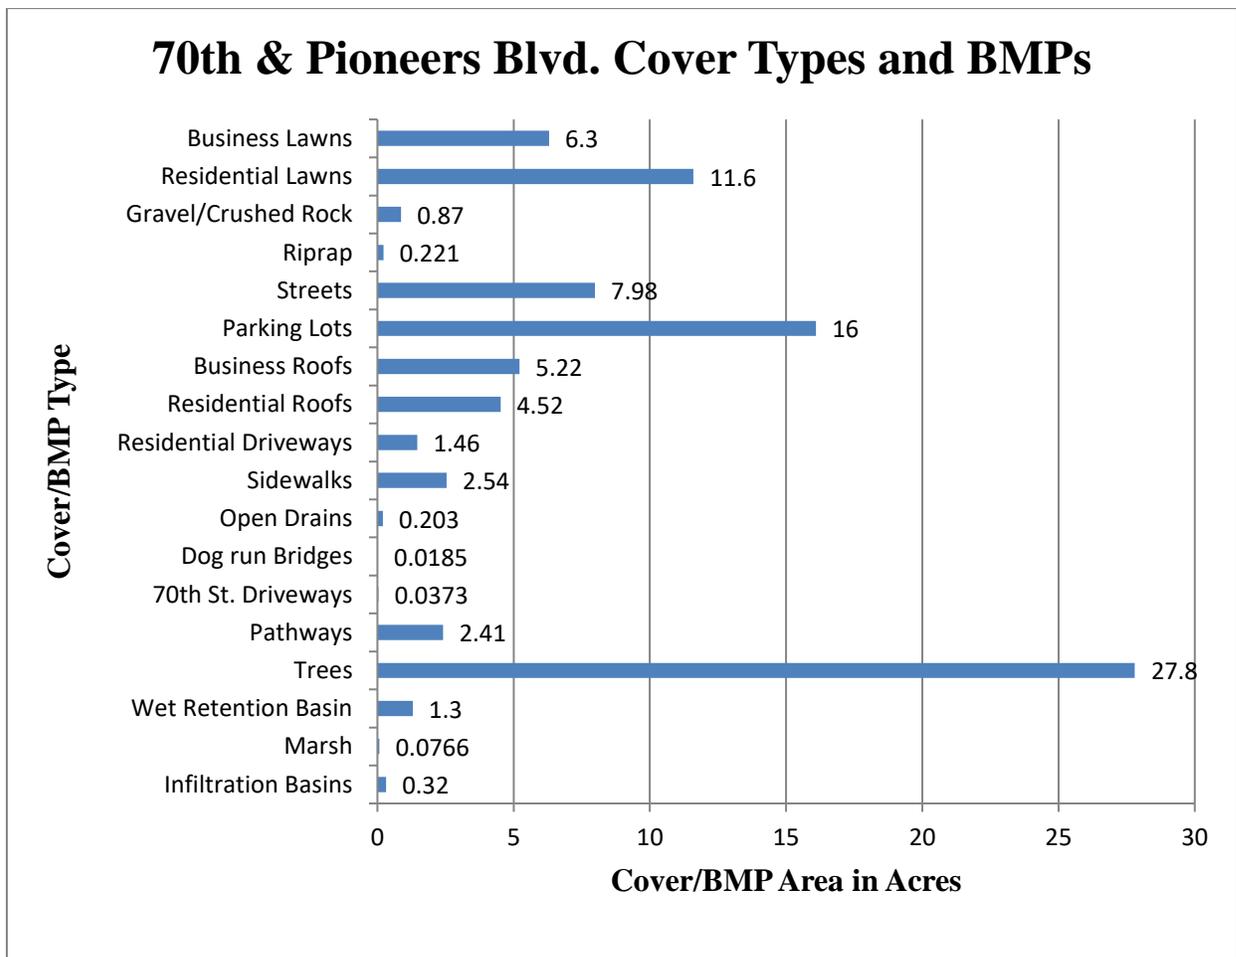
Figure 2. Breakdown of cover types, wetlands, BMPs, and the area they occupy.

- Traditional BMPs found: riprap, and conveyance structures such as open drains/low flow liners.
- Alternative BMPs found: wet retention basins, berm/swale with clover and other natural vegetation (included in total acres of green space), infiltration basin, wet retention marsh, trees, and natural vegetation.
- There is a combination of open areas covered by native grasses/plants with deeper roots providing an opportunity for infiltration of runoff, and turf grass with short root structure (COLNWM-S, 2018) unable to infiltrate rainwater like native grasses/plants, and increasing the amount of runoff (COLNWM-I, 2018).

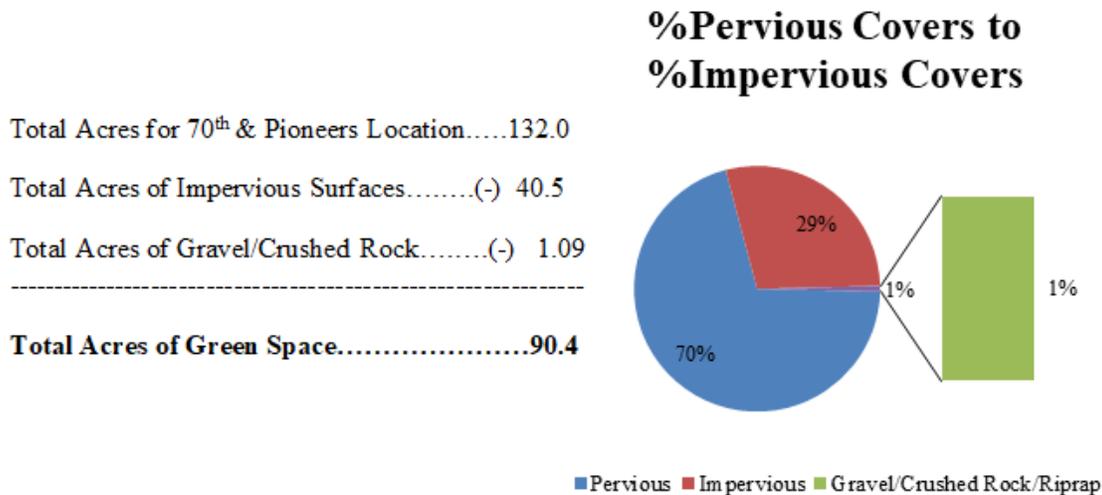
Figure 3.

In Tables 1-2, each cover type classified, and acres totaled for Impervious Cover or Pervious Cover. The acres covered by riprap, gravel, and crushed rock are grouped together to make the distinction between what is covered by a solid, constructed, impervious cover, and a collection of impervious units (Figure 3).

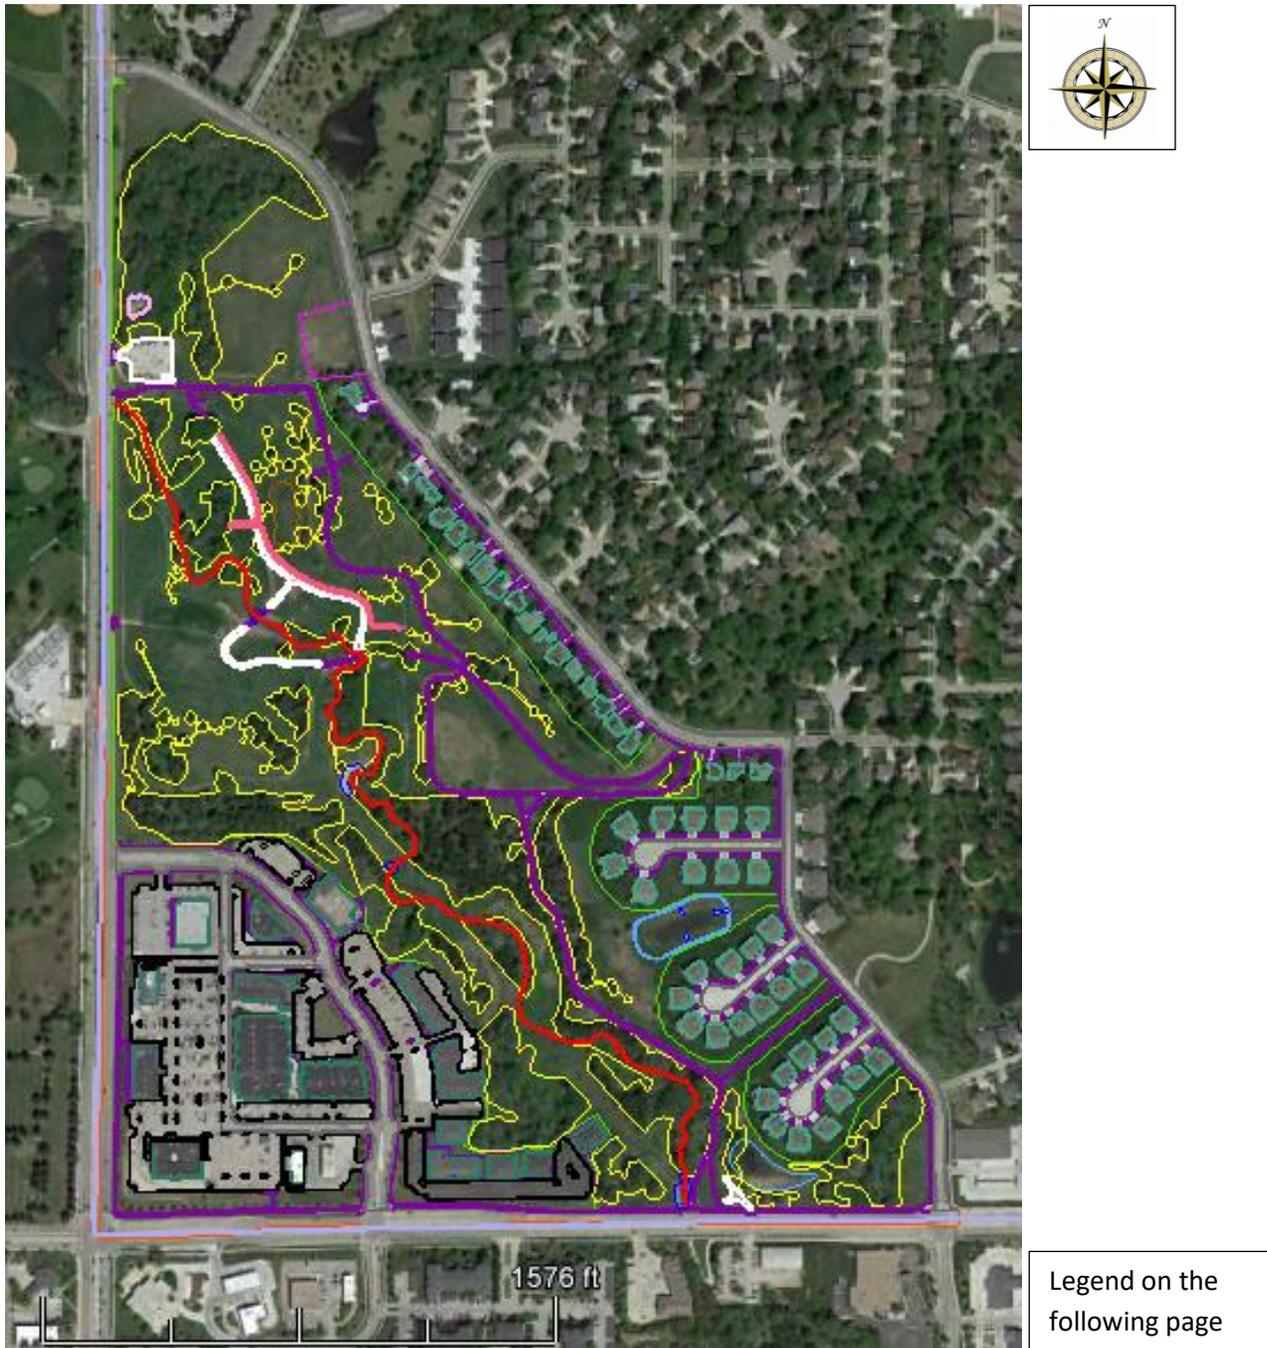
Figure 1. Image from Google Earth

70th and Pioneers Blvd. Cover Types and BMPs.

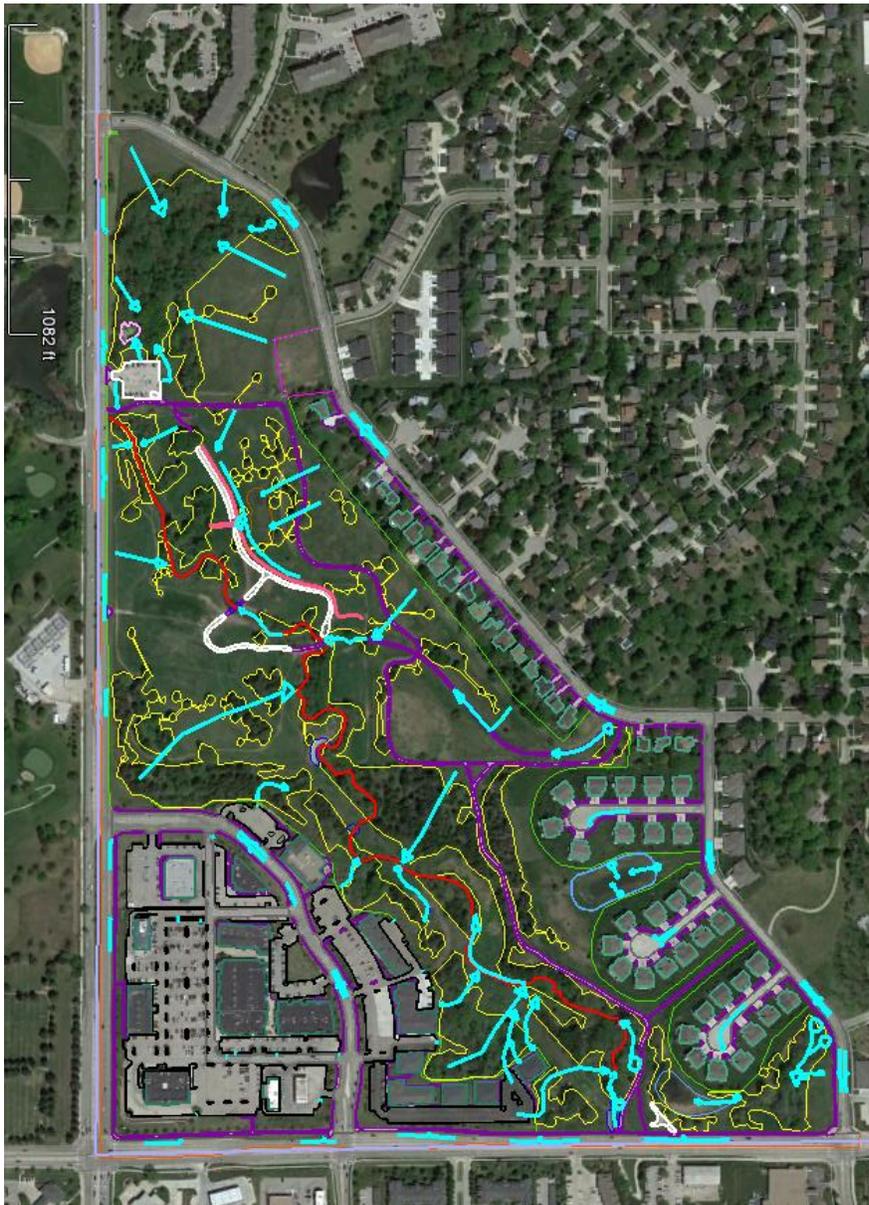
Figure 2. Image from Google Earth

70th and Pioneers Blvd. Direction of Stormwater Flow

structures are meant to control high volume flow water, and remove high percentages of TSS and TP before reaching surface waters or ground water. Structures are positioned along the east side of Antelope Creek (see appendix figure 2) intercepting point source runoff from drains at Holmes Park Rd. and Raven Cir. emptying into infiltration basins, sheet flow runoff in residential areas flow towards infiltration basins and the berm/swale, and a portion of dog run runoff flows into the infiltration basin and berm/swale. The open concrete drain near the intersection of Holmes Park Rd. and Cooper Ave. ends just inside the fenced in dog run, emptying onto riprap, and into the creek 31 meters from its end.

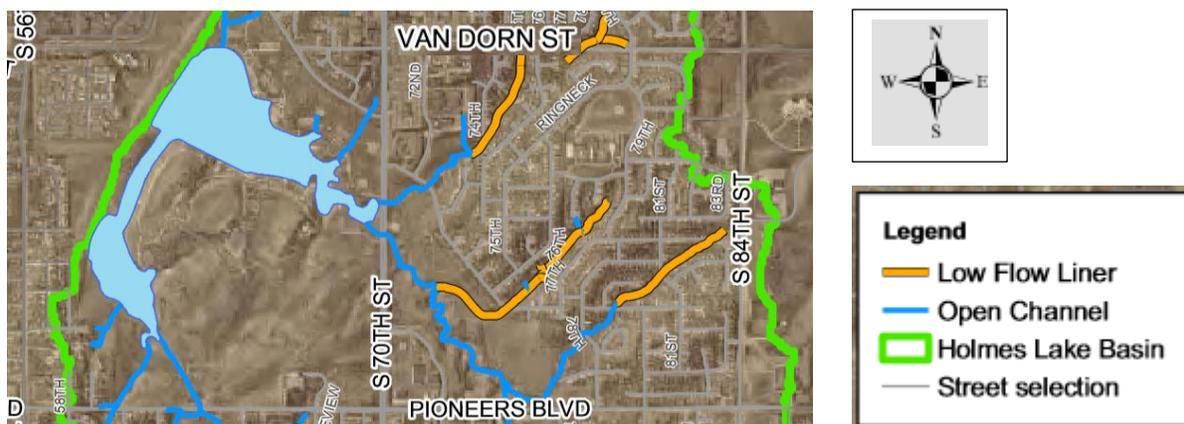
Figure 3.

Holmes Lake Watershed

Using available data from residential roofs and driveways measured, then applying it to the area bordered by 70th, Van Dorn St., 84th, and Pioneers Blvd. inside the Holmes Lake watershed (figure 3), there are estimated, 800-850 homes in this area. The estimated area covered by roofs, driveways, and lawns.
