Investigating the Interaction of NDOT Hot-Pour PCC Joint Sealant and Penetrating Concrete Sealers

Background

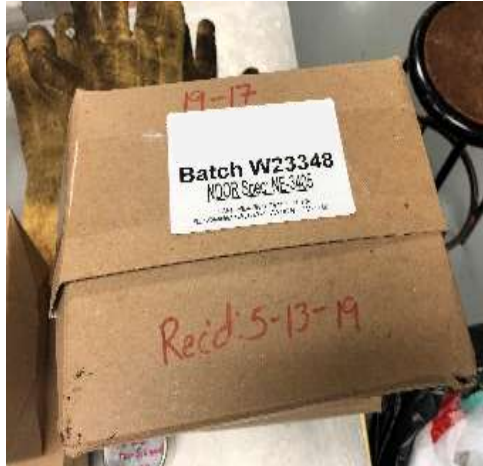
Figure 3 – NDOT designation NE-3405 from production batch W23348 was used in research.

The bituminous lab constructed six sets of three concrete blocks according to ASTM D5329. NDOT designation NE-3405 sealant from Batch W23348, shown in Figure 3, was used to construct the blocks. The batch was from an adjacent production lot to the sealant used on the NE-83 project.

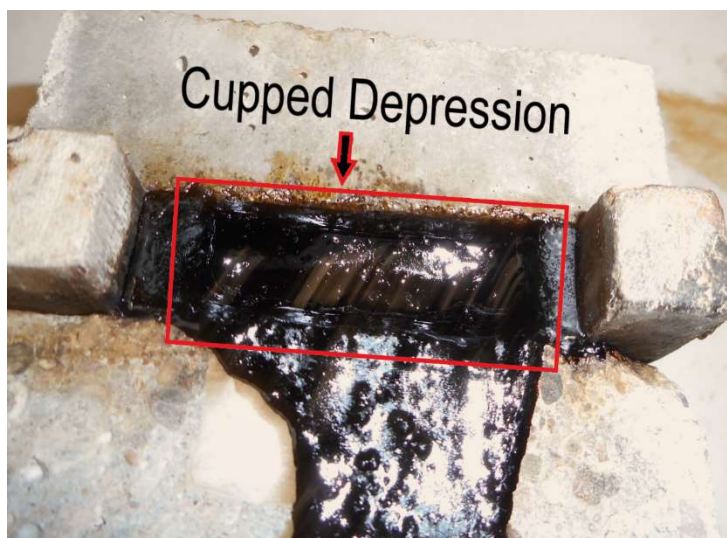
Figure 5 - A set of blocks was modified to create a cupped depression in the hot-pour sealant.

A set of three blocks was constructed with a modified mold designed to provide a cupped surface. Cupping is a depression created as hot pour sealant settles and cools in a joint and has been observed in the field. Cupping causes liquids to pond on the surface of the hot pour sealant. To create the depression, or cup, the physical testing laboratory provided the bituminous lab with a ½-round bar of 12.7 mm diameter, and 38 mm length. The bar was placed in the mold and the testing blocks were made in accordance with ASTM D5329. For this experiment, the three cupped blocks were ponded with Product 5 and allowed to evaporate and dry prior to extension testing. One of cupped blocks was photographed during the testing process. The cupped depression, boxed in red, is shown in Figure 5.

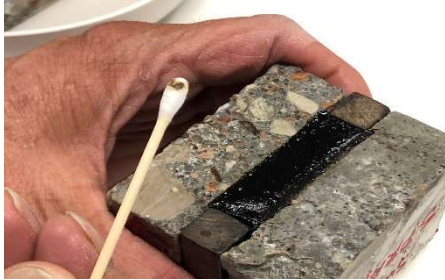
Figure 6 - The sprayed block was swabbed at the interfacial bond. The swab shows discoloration occurred after spraying.

The first set of blocks tested with Product 1 obtained from the project all showed discoloration. The sprayed block was swabbed at the interfacial bond which revealed discoloration as shown in Figure 6. The 1-minute and 5-minute soaked blocks both showed discoloration in the dishes. Expectedly, the 5-minute soak produced a darker color than the 1-minute soak, shown in Figure 7. Researchers observed a small amount of solids in the dish. The solids appeared to be small pieces of aggregate that scaled off during the soaking period. All Product 1 blocks passed all three extension tests. The results are summarized in Table 2.

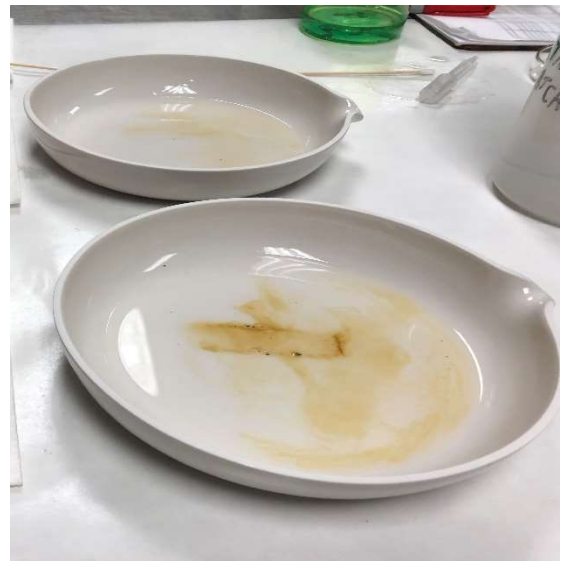
Figure 7- The Product 1 field sample 1-minute soaking dish (top) and the 5-minute soaking dish (bottom) each showed discoloration of the penetrating concrete sealer. The 5-minute soak shows more dissolution than the 1-minute soak.

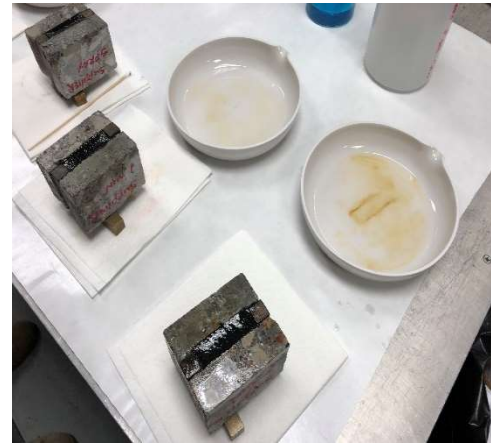
Figure 8 - Product 1 from the supplier showed similar results as the Product 1 field sample.

The second set of blocks tested with Product 1 received from the supplier exhibited similar levels of discoloration and dissolution as the field supplied sample shown in Figure 8. All blocks passed the extension test. Results are summarized in Table 3.

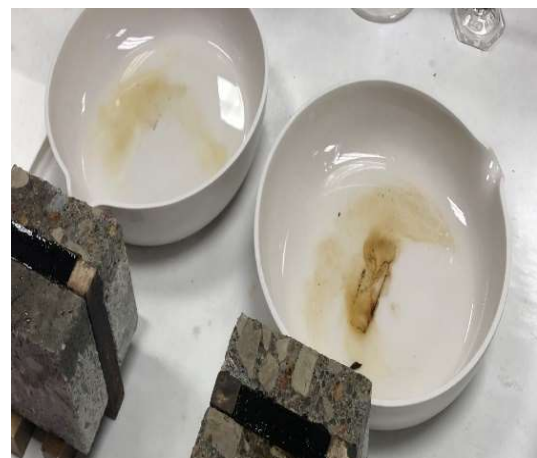
Figure 9 - The Product 2, 1-min (left) and 5-min (right) tests show dissolution.

Product 2 exhibited discoloration and dissolution, shown in Figure 9. All blocks passed the extension test. The results are summarized in Table 4.

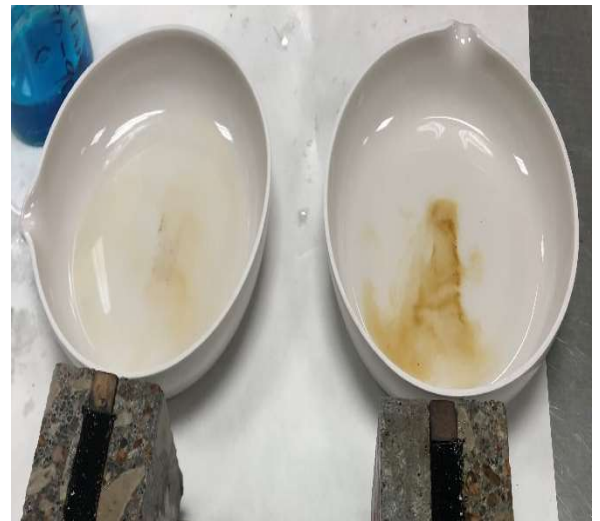
Figure 10 - Product 3, 1-min. and 5-min. post-test dishes showing discoloration.

Product 3 exhibited discoloration and dissolution, shown in Figure 10. All blocks passed the extension test. The results are summarized in Table 5. Product 3's 1-minute block showed some debonding along one side edge after the 3rd pull. The debonding is shown in Figure 11. The edge that debonded was not exposed directly to the PCS, however wicking might have drawn PCS up the side of the block. Inspection showed a pit, possibly caused by loose aggregate in the concrete block, where the debonding occurred. Researchers concluded that this damage was not caused by PCS.

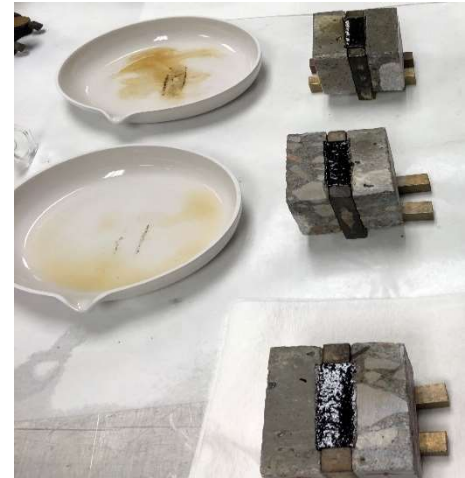
Figure 12 - Discoloration from the Product 4 testing was more intense than in Products 1, 2, and 3. The 5-min dish (top) also shows some solids falling off the block.

Product 4 showed more discoloration than Products 1, 2, and 3. The discoloration is shown in Figure 12. All blocks passed the extension test. The results are summarized in Table 6.

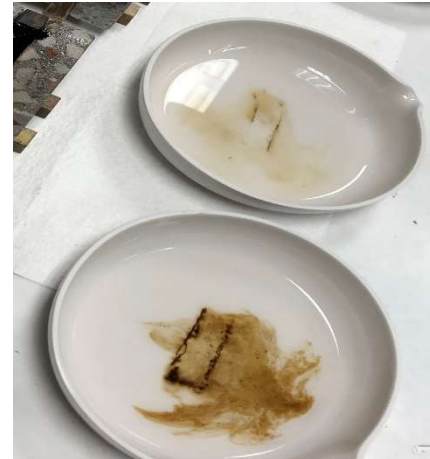
Figure 13 - Product 5; the 5-min (bottom dish) soak showed the most discoloration of any of the tests.

Product 5 showed the most discoloration of all products, shown in Figure 13. Researchers observed small particles floating in the dish, shown in Figure 14. After the third extension, researchers observed that sealant flowed down the side of the block, as shown in Figure 15. Researchers also observed that sealant treated with Product 5 was sticky. Despite these observations, all blocks passed the extension test. The results are summarized in Table 7.

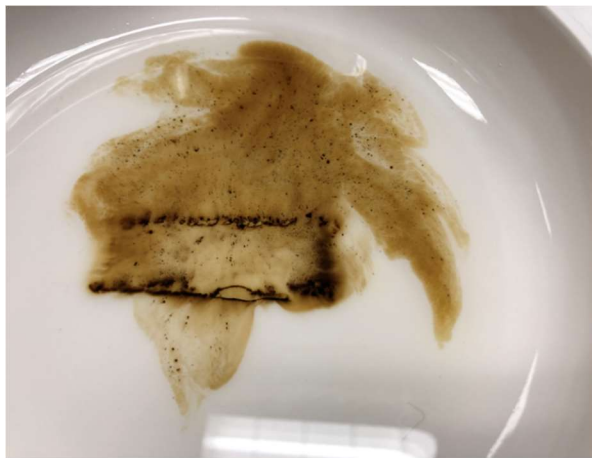
Figure 14 - The 5-min soak of Product 5 left solids in solution.

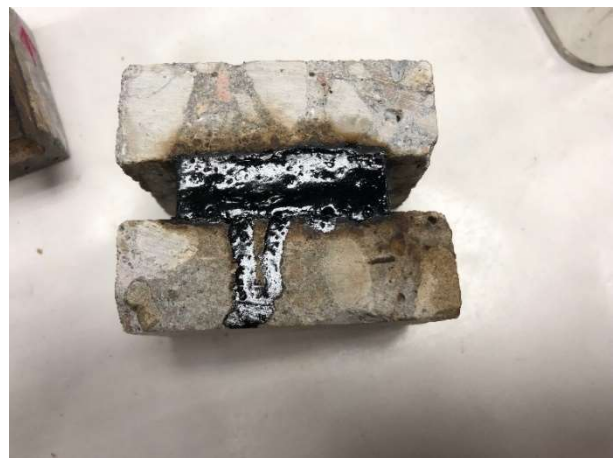
Figure 15 – NE-3405 sealant ran down the face of Product 5's 5-minute block.

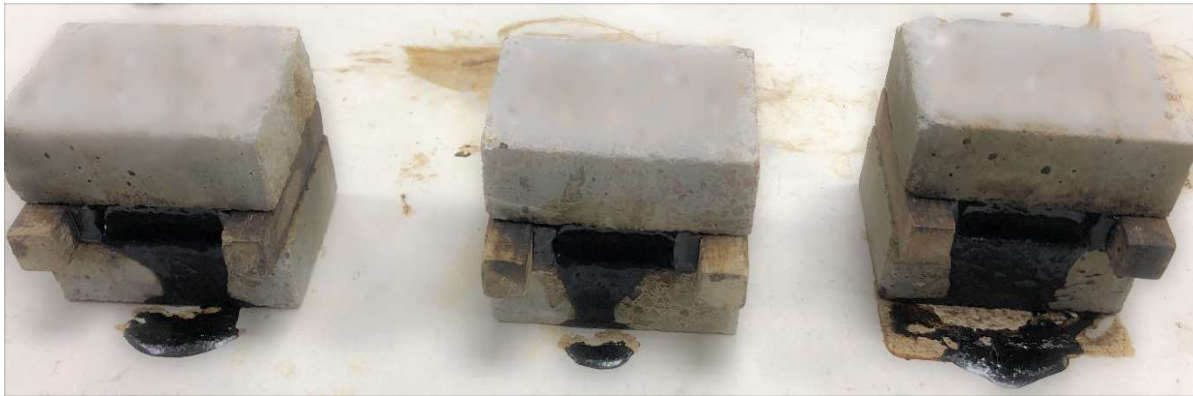
Figure 16 - Hot pour sealant flowed out of the cupped blocks after being ponded with Product 5.

Product 5 was poured into the cupped depression in the modified cupped blocks. The blocks were left in the ponded state at room temperature in the Bituminous Lab until the PCS had dried or evaporated after approximately 5-7 days. The blocks were turned on their sides in preparation for the pull testing and during that time, the hot pour sealant flowed onto the table surface as shown in Figure 16. All of three blocks passed the extension test. The results are summarized in Table 8.
