Science for Stewardship: Multidisciplinary Research on USS *Arizona*

The National Park Service's Submerged Resources Center and USS *Arizona* Memorial are conducting and coordinating research directed at understanding the nature and rate of natural processes affecting the deterioration of the USS *Arizona* in Pearl Harbor, Hawaii. The USS *Arizona* Preservation Project is designed to be multi-year, interdisciplinary and cumulative, with each element contributing to developing an overall management strategy designed to minimize environmental hazard from fuel oil release and provide the basic research required to make informed management decisions for long-term preservation. The primary project focus is toward acquiring requisite data for understanding the complex corrosion and deterioration processes affecting *Arizona's* hull, both internally and externally, and modeling and predicting the nature and rate of structural changes. This research program is designed to be a cumulative progression of multi-disciplinary investigative steps. Multiple lines of evidence are being pursued simultaneously, each directly or indirectly linked to the others and to the overall project objectives.

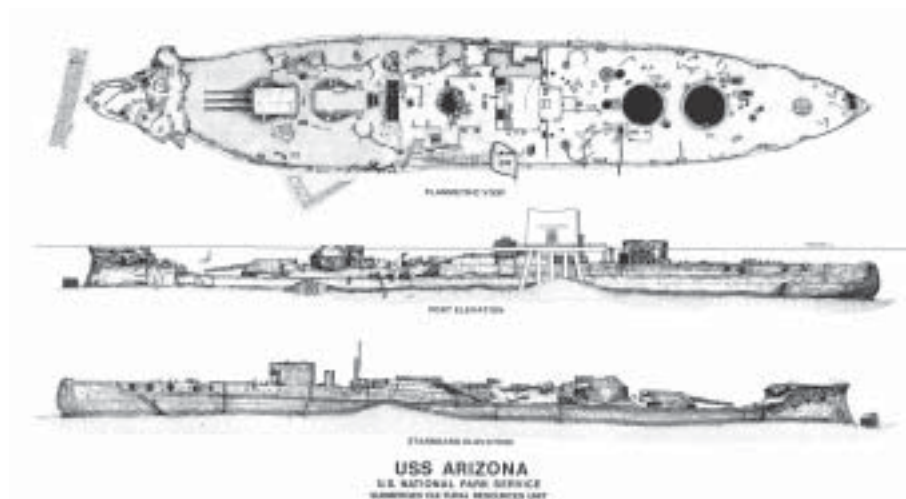
FIGURE 2

A map of USS *Arizona's* remains was completed by the National Park Service in the mid-1980s.

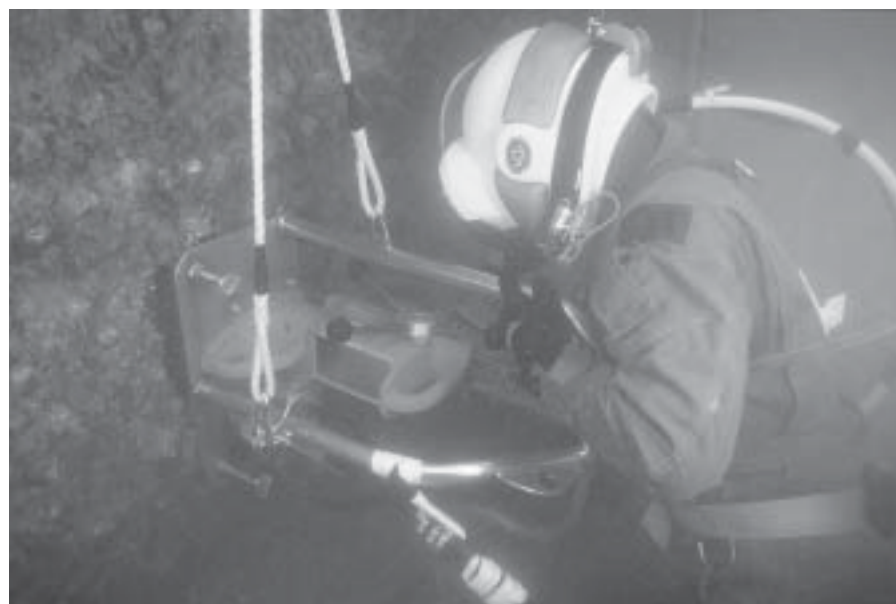
FIGURE 3

A Navy diver from Mobile Diving and Salvage Unit One collecting a coupon from USS *Arizona*’s hull. Credit: Brett Seymour/NPS.

Additional metallurgical and metallographic analyses are being performed on hull coupons collected *in situ* from *Arizona*’s hull. Four-inch diameter hull samples, including intact exterior and interior concretion, were removed using a hydraulic-powered hole saw (Figure 3). A total of eight coupons were removed from external, vertical hull locations on both port and starboard sides (Figure 4). On each side, one sample was taken at the Upper Deck level, near the water line; from the Second Deck level, above the torpedo blister; from the Third Deck level, in the torpedo blister; and from the First Platform level, in the torpedo blister and below the mud line. After removal, each location was plugged using a standard plumber’s pipe plug and sealed with marine epoxy to prevent formation of a localized corrosion cell. UNL researchers used metallographic methods to examine the hull coupons to measure metal thickness at Rail Sciences laboratories in Omaha, Nebraska (Johnson et al., 2003). Additional metallurgical and metallographic analyses on the same samples are being performed by researchers from NIST.

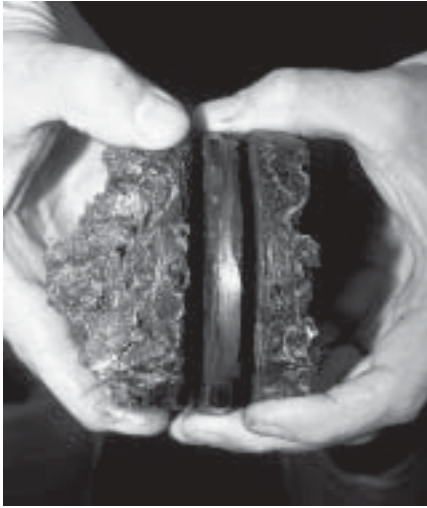
FIGURE 4

Hull coupon with interior and exterior concretion. Credit: Brett Seymour/NPS.

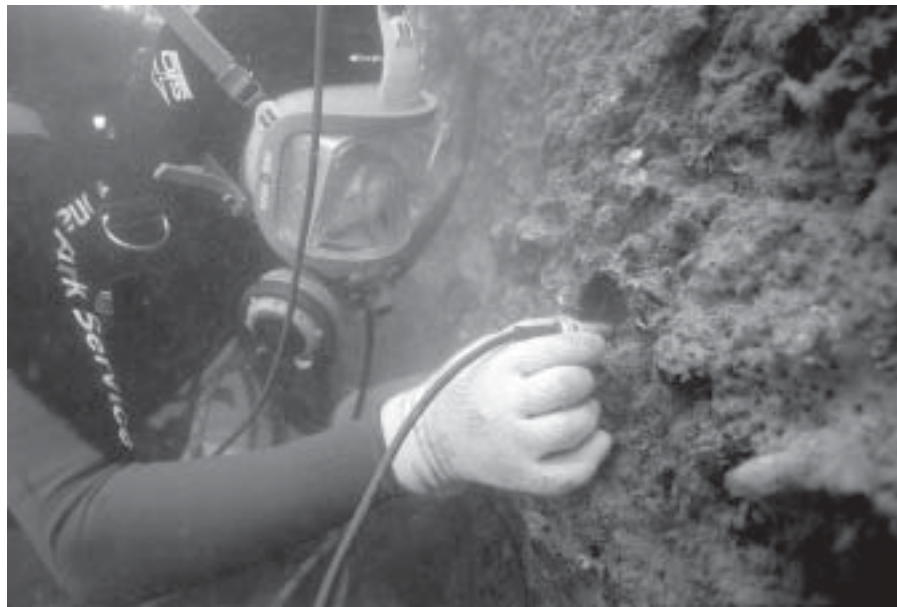
FIGURE 5

NPS archeologist Matt Russell taking ultrasonic thickness measurements on *Arizona's* hull.

Another critical *in situ* measurement of USS *Arizona's* hull includes ultrasonic thickness measurements. The eight hull coupons collected in two vertical transects on *Arizona's* hull provide an empirical measure of corrosion rate at each of these locations when compared to as-built hull thicknesses. Because of the invasive nature of collecting hull coupons, however, it is necessary to develop a more non-invasive technique to expand hull thickness data. Since hull thickness measurements give a direct measure of corrosion rate, this data is essential to developing an accurate FEM. Because the specific metal thickness has been precisely measured at the eight coupons locations, they are a control for ongoing testing of ultrasonic thickness techniques and instruments (Figure 5).

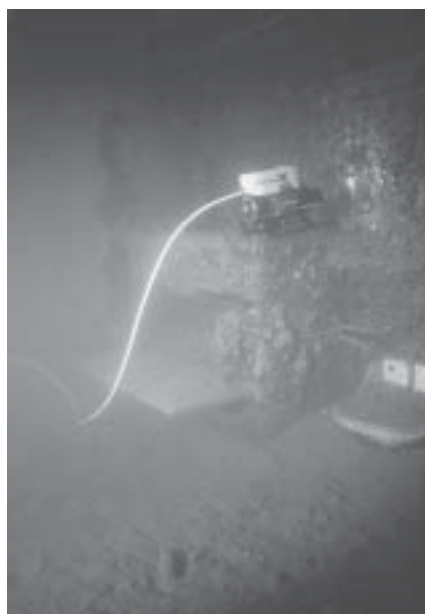
FIGURE 6

A VideoRay ROV examines the marine encrustation on a mirror above the sink in the sediment filled Division Marine Office. Credit: Brett Seymour/NPS.

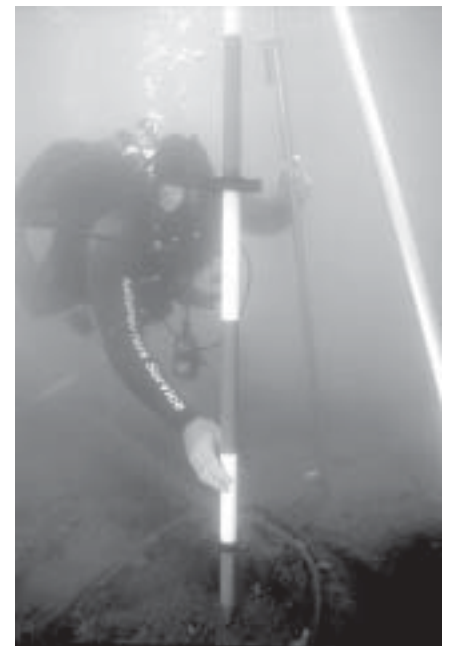
FIGURE 7

NPS archaeologist Larry Murphy setting up an underwater tripod on USS *Arizona* used to collect high-resolution GPS positions.
Credit: Brett Seymour/NPS.

The primary method used to monitor physical changes to USS *Arizona's* hull is a series of very high-resolution Global Positioning System (GPS) points. Using dual-frequency GPS receivers, researchers have set a series of monitoring points across *Arizona's* exposed decks. Initially using stainless steel studs, later changed to PVC disks, in selected locations, NPS surveyors leveled a large, purpose-built underwater tripod over each point (Figure 7). Extension poles set on top of the tripod extending above the water's surface allowed the GPS antenna to be placed precisely over the desired point. Using advanced survey techniques, each point was collected with sub-centimeter accuracy in three dimensions. These points will be re-surveyed every two years to

determine if, and how, the ship is moving, shifting, or settling. Although the accuracy of each point was mathematically calculated to about 0.5 cm (Circle of Error Probable), it will be necessary to apply a more conservative threshold of change to future monitoring re-occupations. Because of environmental conditions and differences in equipment and stadia variations, a more realistic threshold is 10 cm. Instrument error, set-up error, or most likely, nearly imperceptible antenna movement caused by water movement can create cumulative errors of up to 10 cm. Consequently, we cannot reliably attribute any observed change that is less than 10 cm vessel movement; however, corroborative evidence would be sought for any level of change.

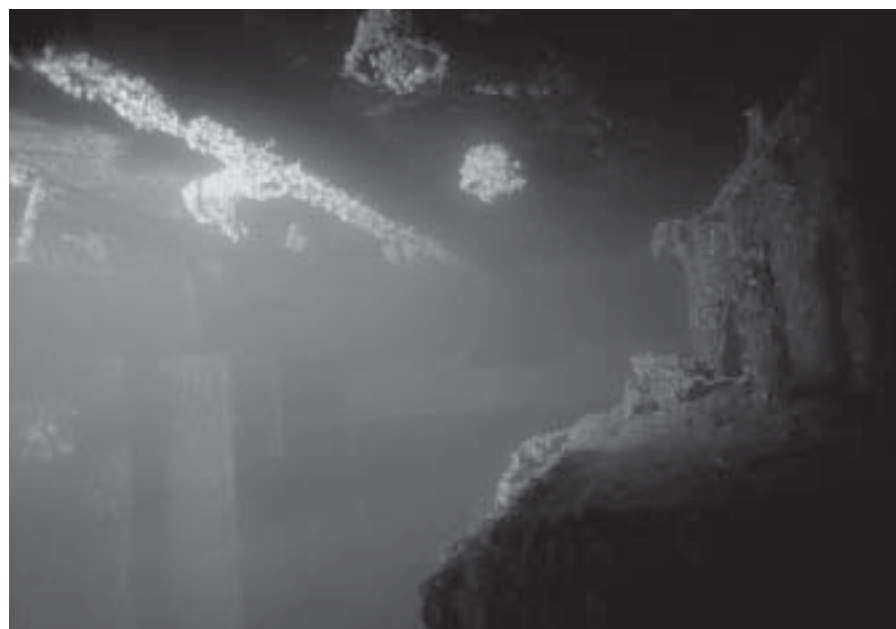
FIGURE 8

Illumination inside a Junior Officer's Stateroom reveals oil pooling between deck beams of the ceiling overhead. A white microbial community is visible growing on the oil surface at the left of the photograph. Credit: Brett Seymour/NPS.
