# Cattle guards reduce white-tailed deer crossings through fence openings

J. L. BELANT†, T. W. SEAMANS and C. P. DWYER‡

United States Department of Agriculture, National Wildlife Research Center, 6100 Columbus Avenue, Sandusky, OH 44870, USA

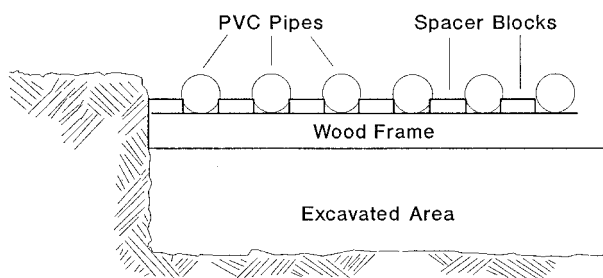
Figure 1. Profile of simulated cattle guard showing 7.6 cm diameter PVC pipes placed parallel between spacer blocks on wood frame over excavation.

Simulated cattle guards were constructed following United States Department of Agriculture (1960) guidelines by building 4.6×3 m wooden frames using 5×15 cm lumber (figure 1). Twenty-two 7.6 cm diameter×3 m PVC pipes were spaced evenly at 12.7 cm intervals across each wood frame, parallel to the fence opening and level with the ground surface. To prevent entanglement and potential injuries to deer while attempting to cross cattle guards, pipes were not secured to the wood frame. The existing 2.4 m high chain-link fence was extended along each side of the cattle guard to prevent deer from crossing along the side. Track plots of soil were established in excavated and approach areas as a second means to monitor deer use of cattle guards.
