# Nondestructive Method to Detect Corrosion of Steel Elements in Concrete

FINAL  
REPORT

Sponsored By  
**The Nebraska Department of Roads**

April, 2009

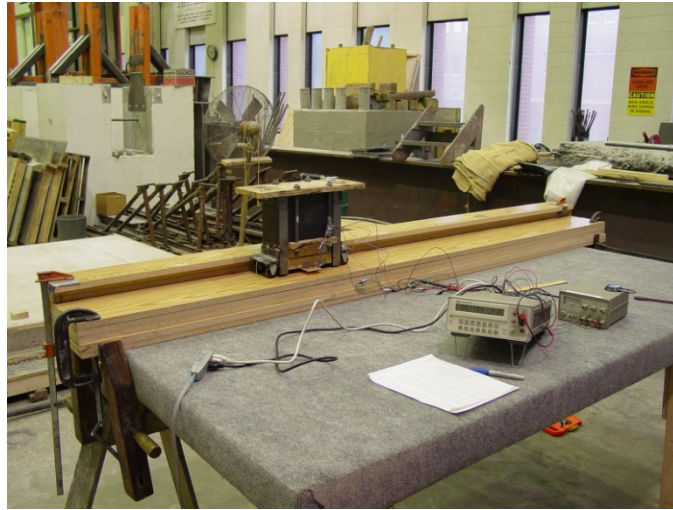
Figure 2-8: Typical plywood specimen test setup

chart, to identify the location of induced damages. Some plywood specimens were tested using different magnet configurations. A typical setup can be seen in Figure 2-8.

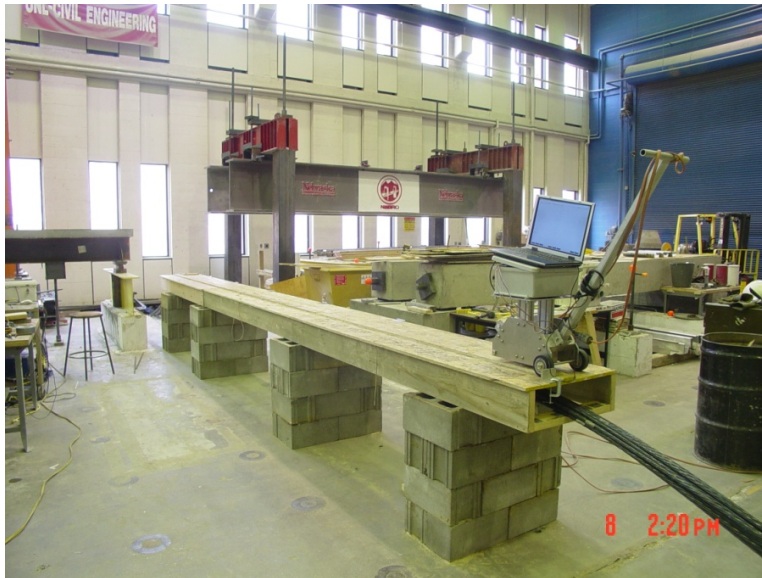
**Figure 4-4: Test setup before running**

Figure 4-4 shows the wooden frame that was built to hold all elements involved in the test. Plywood sheets were used to create a flat surface on the top of concrete bricks, so the cart could travel during testing.

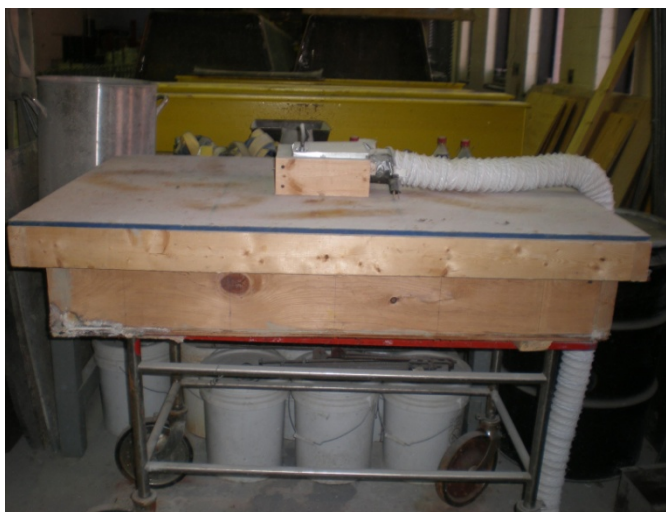
**Figure 6-12: Timber box used for the electrolysis experiment**

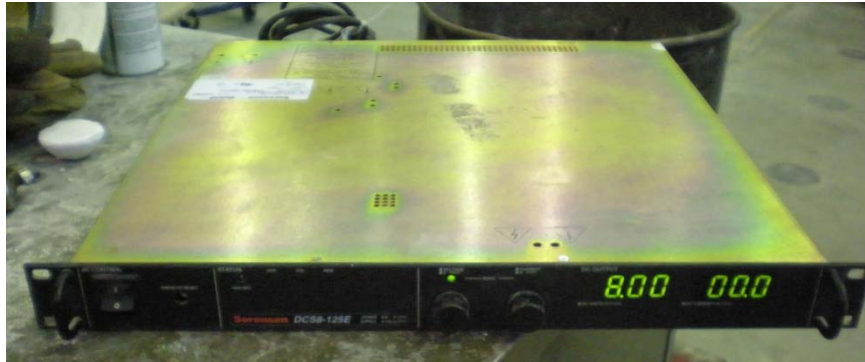
**Figure 6-13: Sorensen® DCS8-125E power supply**

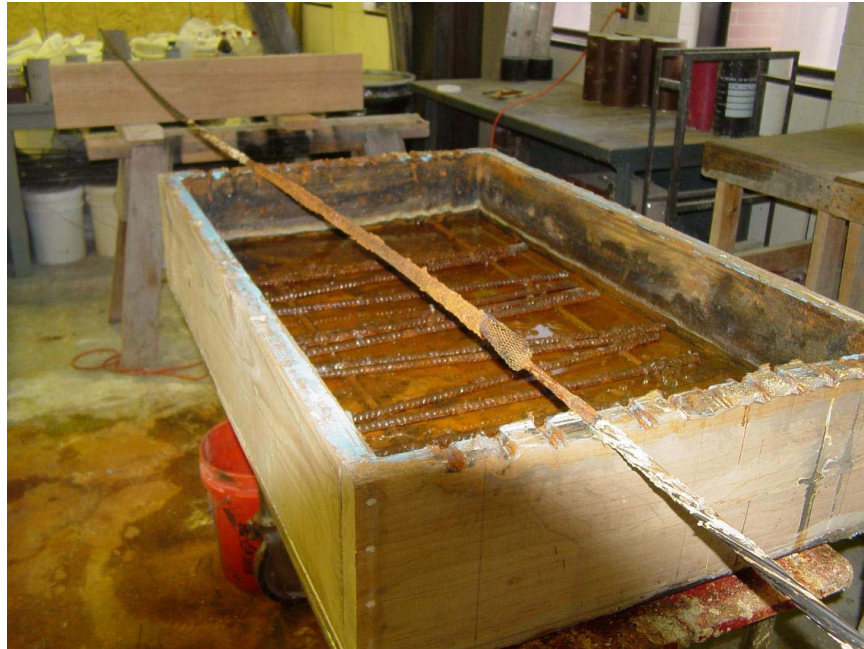
**Figure 6-14: Final result after four days of electrolysis**

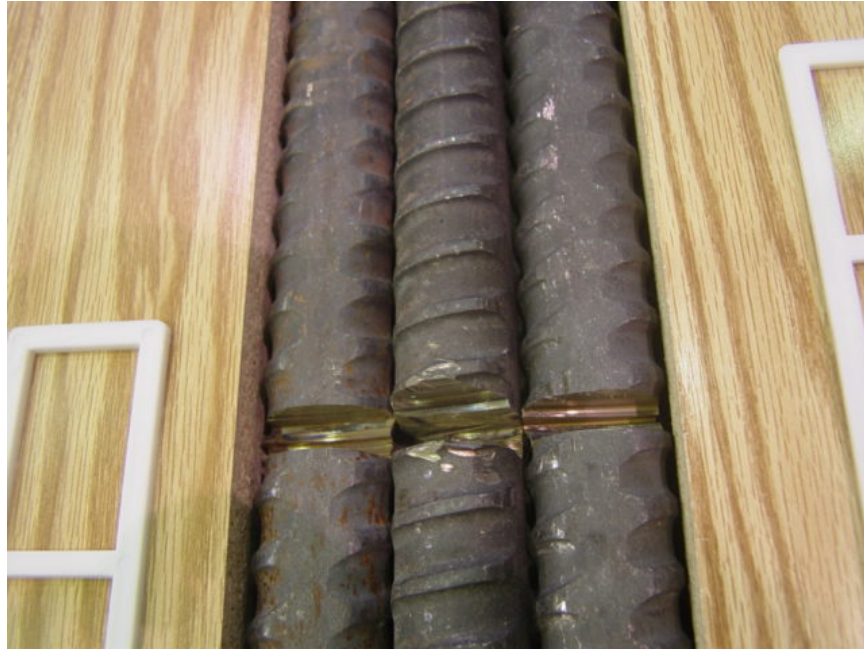
**Figure A.31: Close-up view of the alignment of damage at PS2**
