Infrared Thermography-Driven Flaw Detection and Evaluation of Hot Mix Asphalt Pavements

Report #: SPR-PI (08) P309

Final Report

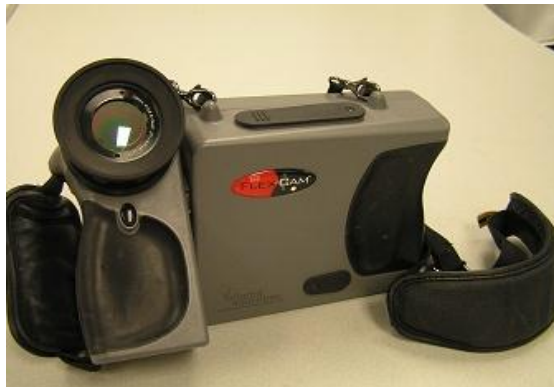
Figure 3.1 Infrared Camera

For verification of the use of thermal image data in HMA applications, temperature readings were initially taken on the surface of the HMA as well as internally using a temperature probe. The internal and external temperature readings were compared to those obtained by the infrared camera. This was also done to ensure the specific infrared camera used in this study provided an accurate representation of temperature differentials. The accuracy of infrared cameras in general has already been proven in HMA applications by the University of Washington study, which notes that both temperature probes and infrared cameras are adequate tools for proving temperature differentials (Willoughby 2001). Figure 3.1 shows a Flex Cam XR2, the infrared camera used in this research. Figure 3.2 shows infrared images taken from Nebraska paving sites.

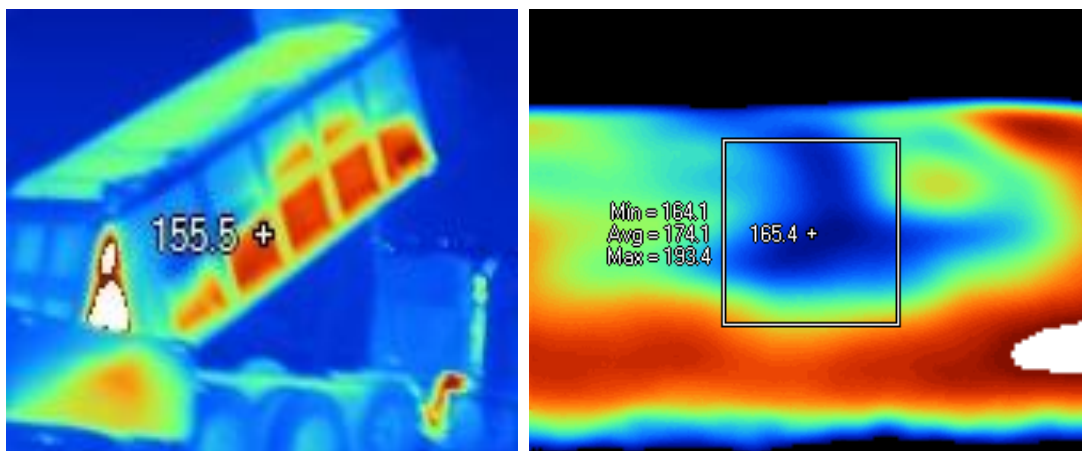
Figure 3.2 Heat Loss from a Truck (left) and Temperature Differential from an HMA Mat (right) with Temperatures Shown in °F

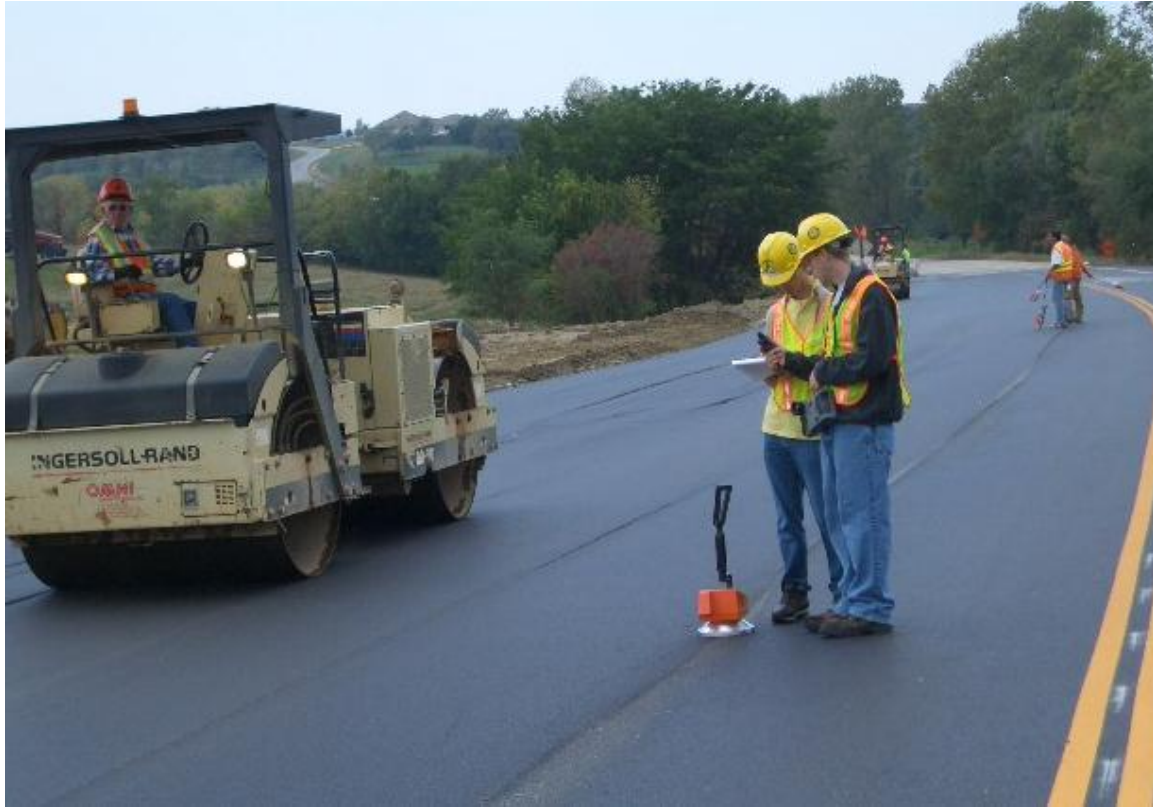
Figure 3.3 Taking PQI Density Readings Onsite

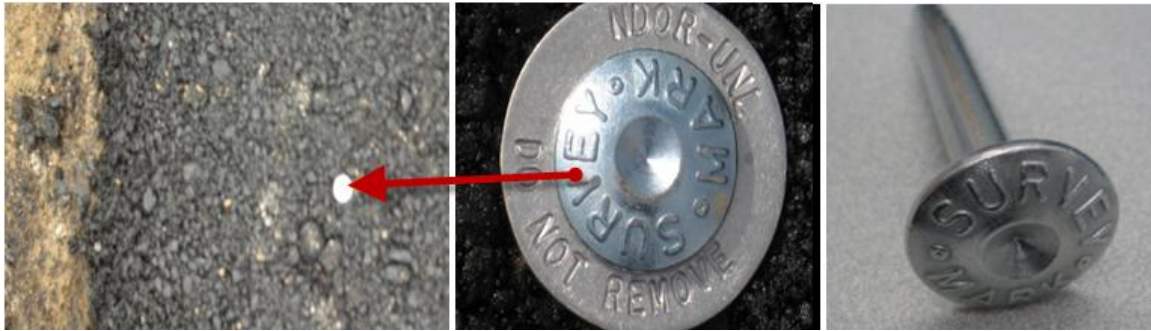
Figure 3.6 Physical Location Markers

physical markers were driven into the shoulder pavement while still malleable and the distance directly across from the marker to the location was recorded.

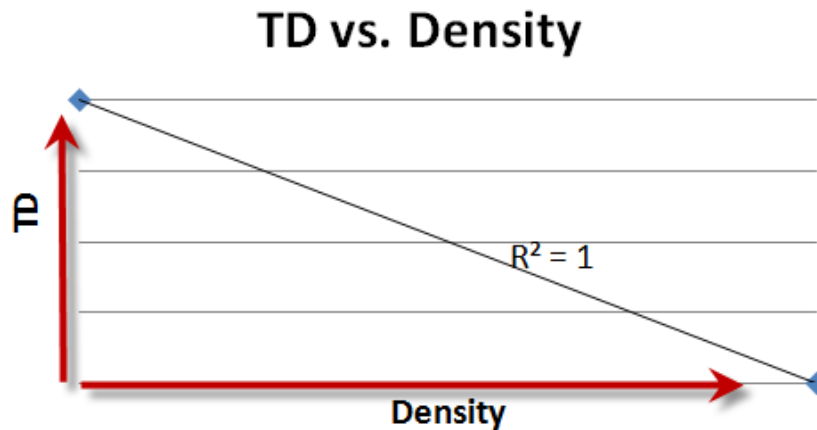
Figure 4.1 Theoretical Relationship between Temperature Differential (TD) and Pavement Density

Throughout this project, 304 unique locations have been evaluated with the primary intention of investigating the effect that temperature differentials (TD) have within the HMA paving process. As found within earlier studies, the areas possessing increased temperature differentials after final compaction are expected to yield lower densities (Figure 4.1).

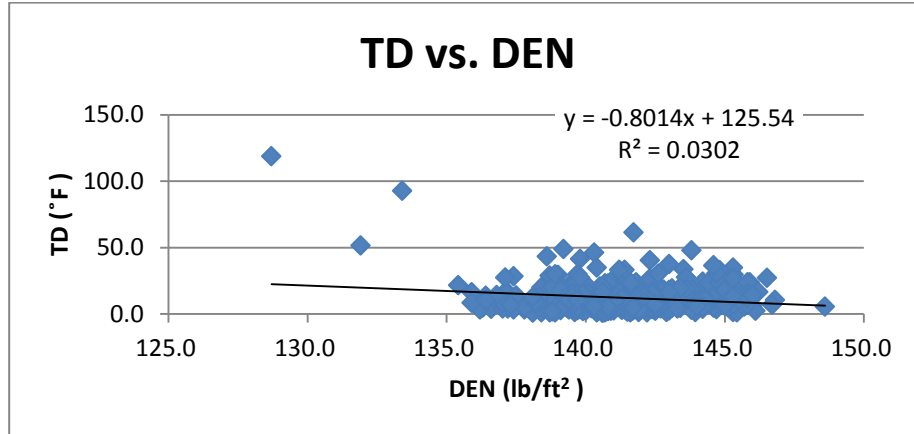
Figure 4.2 Relationship for All Collected Data between Temperature Differential (TD) and Density (DEN)

Although a negative relationship was found, the general analysis between temperature differentials (TD) after compaction and pavement density (DEN) showed the relationship between the two variables not to be significant (Figure 4.2). This analysis included all 304 density readings obtained throughout the project and charted them against their corresponding temperature differential.

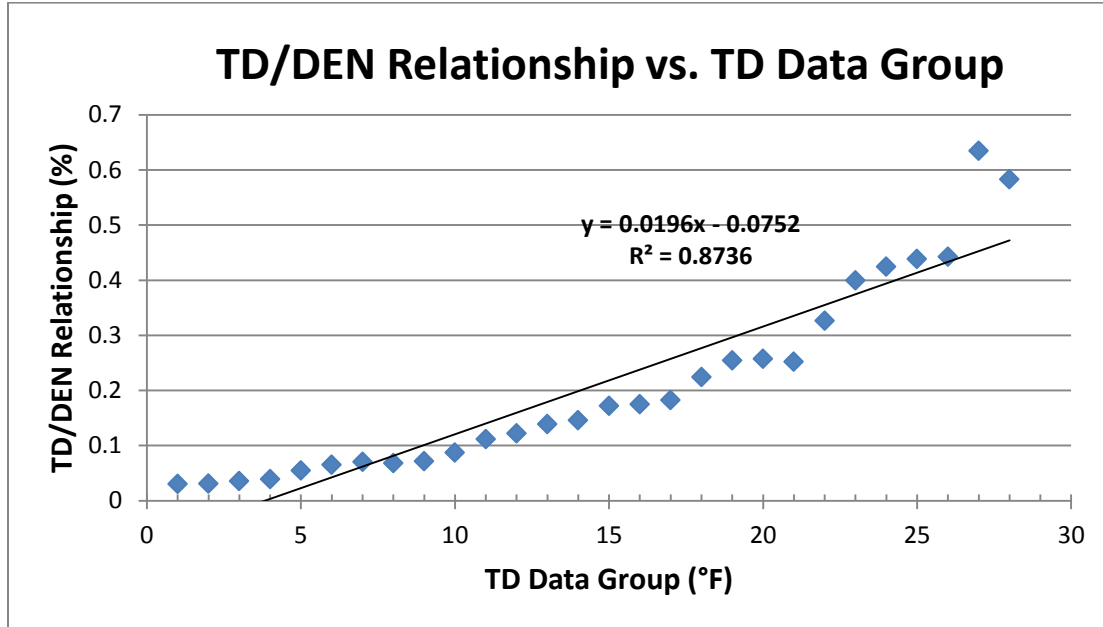
Figure 4.3 A Graphical Representation of the Relationship between Individual Temperature Groups and TD and DEN

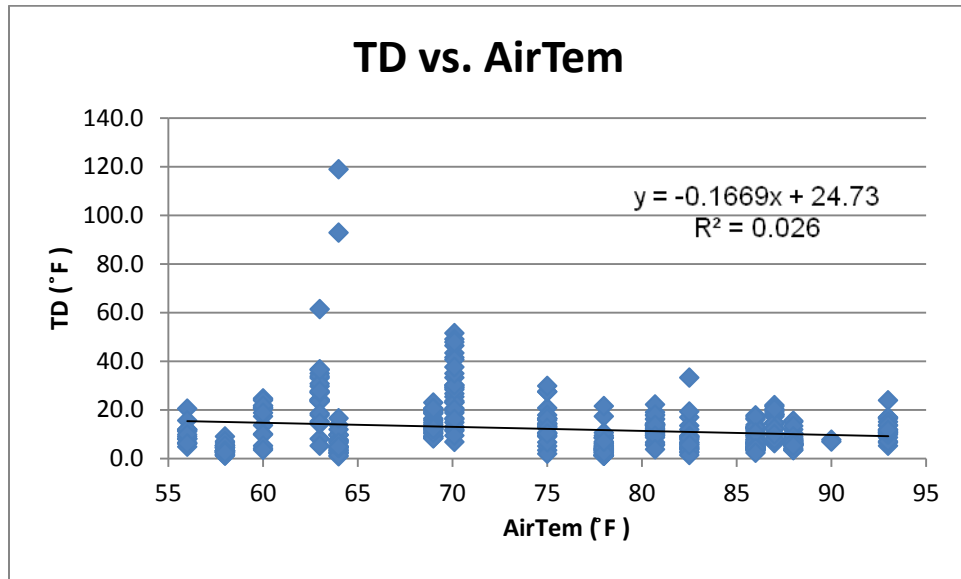
Figure 4.4 Relationship between Ambient Jobsite Air Temperature and Temperature Differential

temperature segregation. As can be seen in Figure 4.4, there was no statistically significant relationship ($r^2 = 0.026$) between the outside air temperature (AirTem) and the occurrence of temperature differentials (TD) during the typical paving seasons in Nebraska: between 50°F and 95°F.

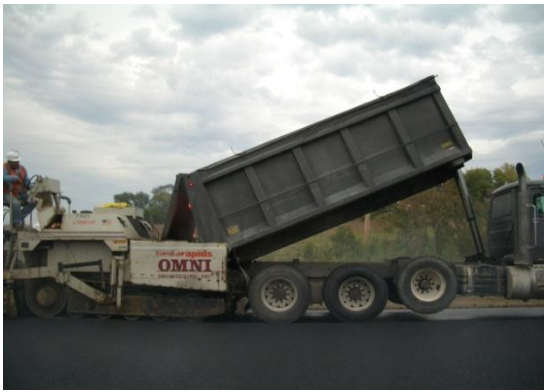
Figure 4.6 Direct Dump between Truck
and Paver

There are two types of material feeding processes from a delivery truck to a paver in Nebraska. Either HMA trucks directly dump delivered HMA into the hopper of a paver (Figure 4.6), or belly dump trucks and live belly dump trucks deposit the material ahead of a pick-up machine that scoops up the HMA and transfers it into the hopper of a paving machine (Figure 4.7). Unlike a material transfer vehicle (MTV), such as Roadtec, Inc.'s, Shuttle Buggy MTV, the pick-up machine does not have a special remixing auger or chute.

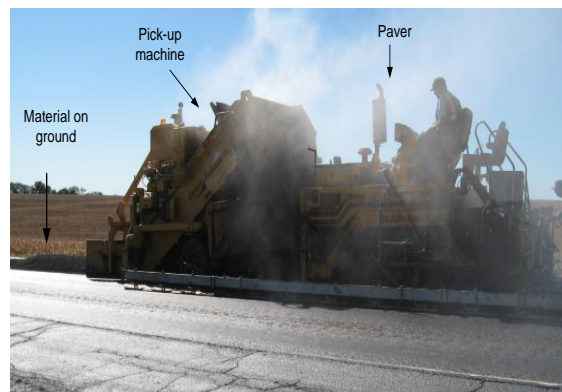
Figure 4.7 Pick-up Machine with Paver

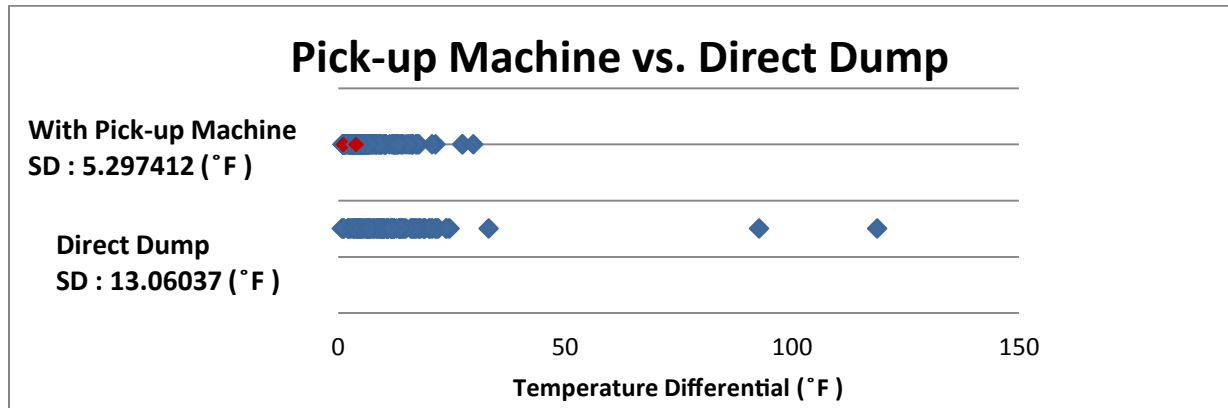
Figure 4.8 Temperature Differential Based on Feeding Types

demonstrates how a pick-up machine is a very cost-effective solution to reduce temperature differential of delivered HMA without using expensive MTVs.

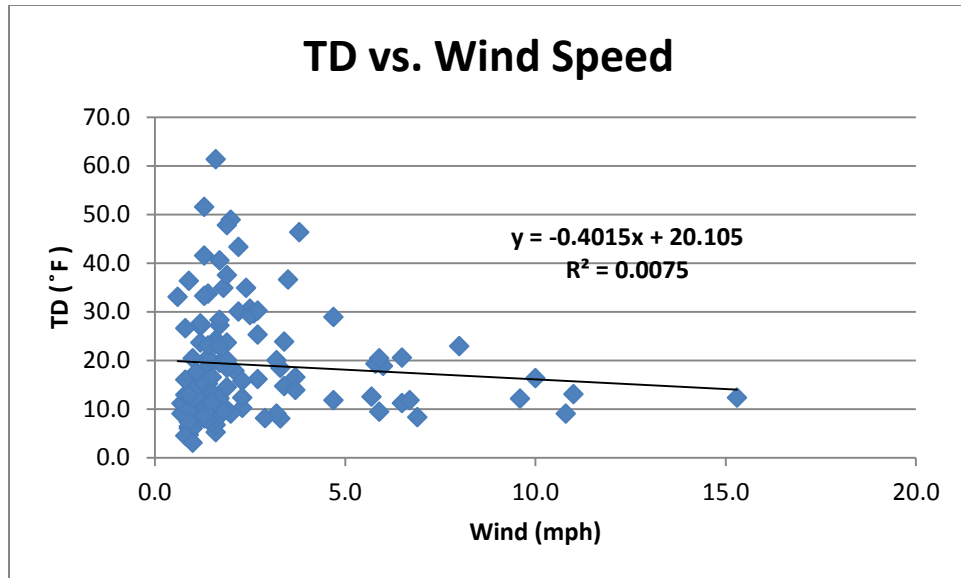
Figure 4.9 Relationship between Wind Speed and Temperature Differentials (TD)

Wind speed was collected at each location for Sites 11-15 with a hypothesis that its effects could lead to HMA temperature segregation (Figure 4.9). The data suggests that wind speed has a negligible effect on temperature segregation, showing less than a 1% relationship. This is because the wind is likely affecting the pavement overall, rather than focalized areas.

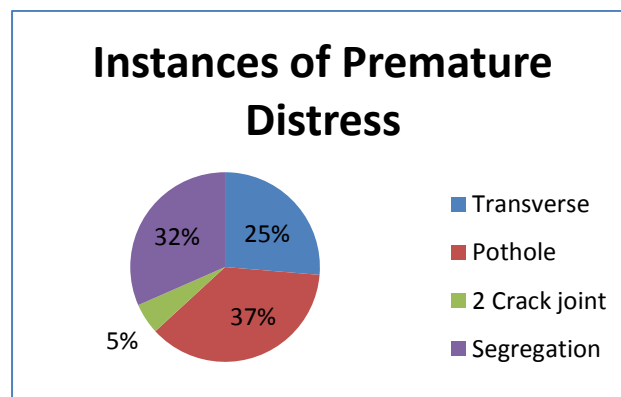
Figure 5.1 Instances of Premature Distress

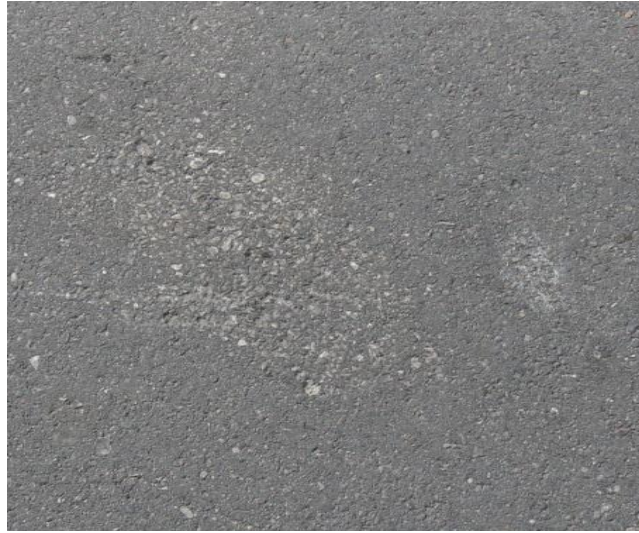
Figure 5.4 Observed Material Segregation

compared to fine aggregate as well as low asphalt content (Williams et. al 1996). Aggregate segregation in HMA can be caused by improper mixing. Aggregate segregation leads to flaws like accelerated rutting, fatigue failure, and potholes (Williams et. al 1996; Walker 2009).

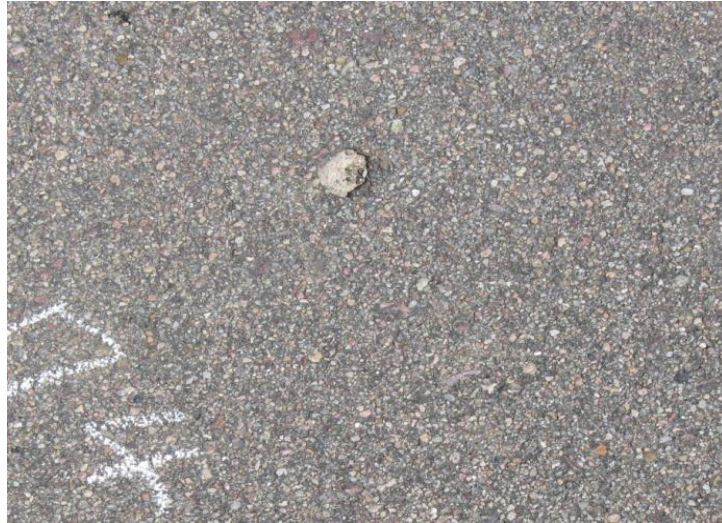
Figure 5.5 Observed Surface Void

freeze-thaw cycle. Because these potholes have not degenerated pavement qualities to date, later data analysis deals with their inclusion at certain times.

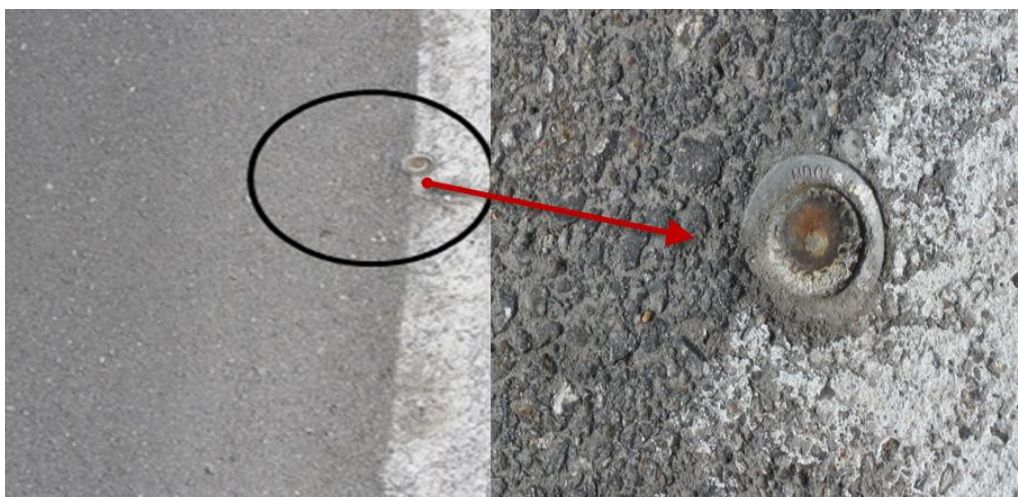
Figure 5.6 Observed Marker after One Freeze-Thaw Cycle

The site revisits for all fourteen sites were conducted between eight and 18 months after the initial site visit. At each site, a handheld GPS unit was used to find each location that was investigated at the time of paving. Additionally, some exact locations were found based on survey markers placed along the shoulder of the road. Figure 5.6 shows what these markers looked like after one freeze thaw cycle.

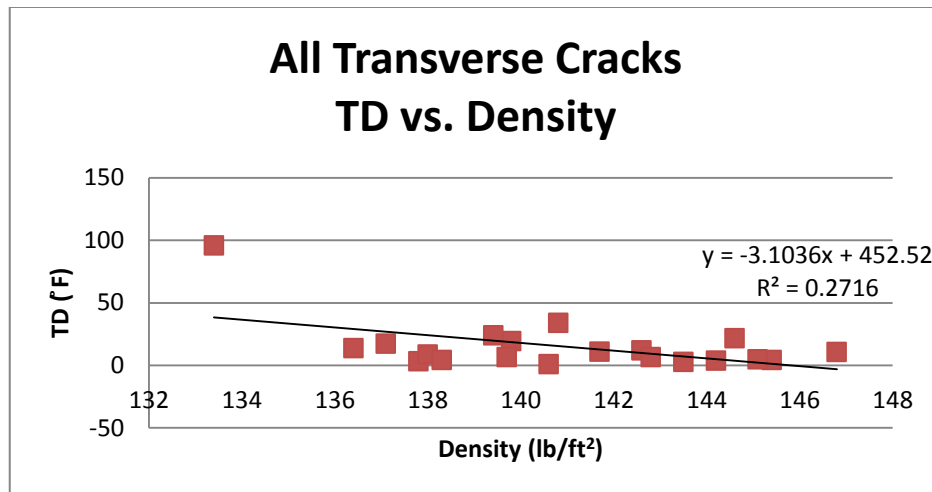
Figure 5.7 Relationship of TD and Density among Transverse Cracks

temperature differentials and density, all 20 locations were evaluated based on that criteria. After calculating this relationship, a correlation of just greater than 27% was obtained (Figure 5.7). This correlation was lower than expected because the collected data included reflective cracks which were not affected by temperature differential.

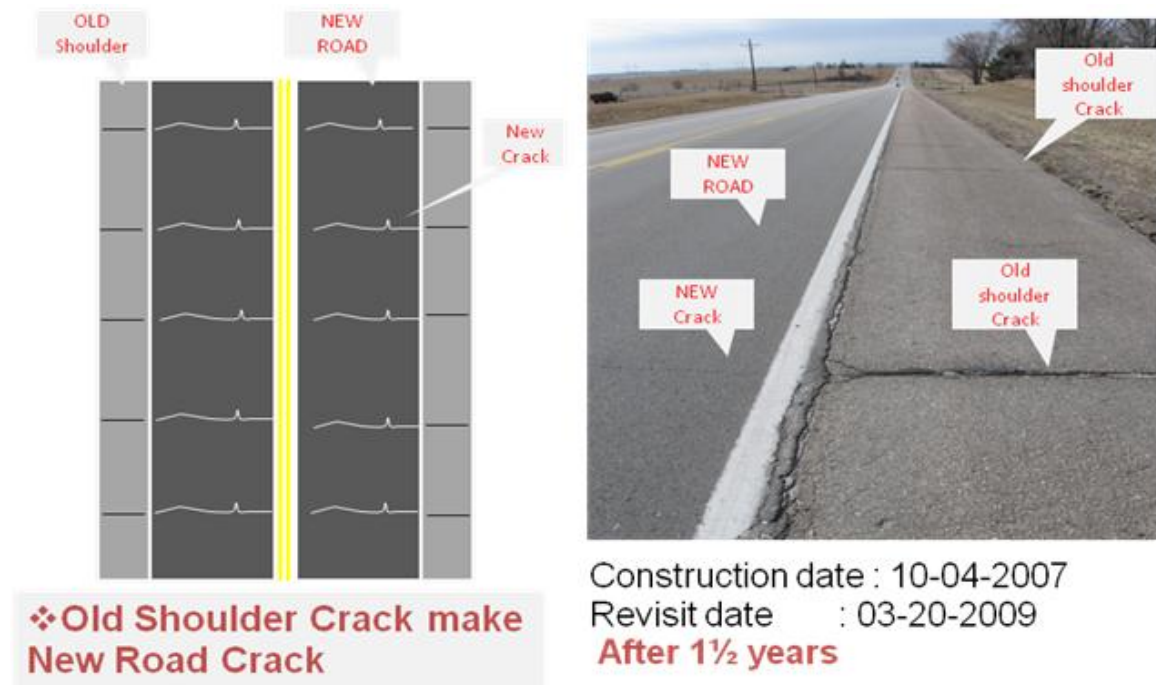
Figure 5.8 Plan View of Roadway Exhibiting Reflective Cracks (left) and Observed Reflective Cracking (right)

After collecting individual location data and conducting preliminary analyses, each site was considered as a whole. It was during this second phase of data analysis that the research team decided it was important to take a closer look at the instances of repetitive transverse cracks. Some were suspected of being reflective. Reflective cracks occur when cracks in older asphalt or concrete joints are reflected upon the new asphalt overlay. A series of graphics depicts what reflective cracking looks like in Figure 5.8.

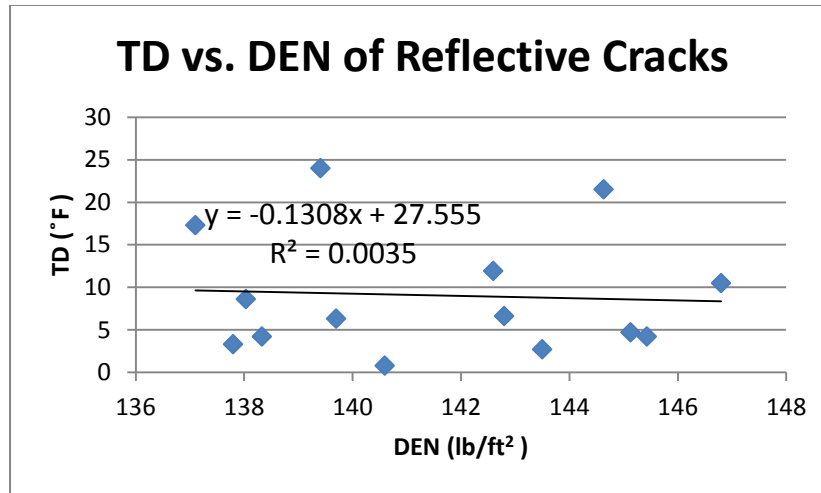
Figure 5.9 Temperature Differentials and Density Relationship among Reflective Cracks

From the 20 observed instances of transverse cracking, 14 were found to exhibit signs of reflective cracking. When analyzing the 14 locations alone, a relationship of less than 1% was found between temperature segregation and density. This analysis further solidifies the researcher's assumption that these locations were caused by cracks permeating up through old layers of material (Figure 5.9).

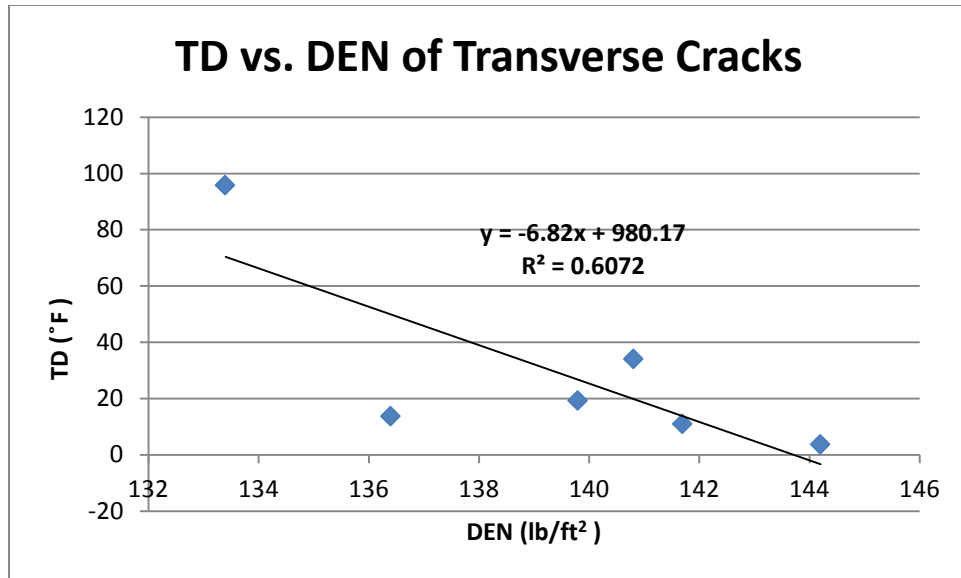
Figure 5.10 Relationship between Temperature Differentials (TD) and Density (DEN),
 Excluding Reflective Cracks

The 14 locations were not further included in data analysis as these locations were almost certainly influenced primarily by the previous pavement underlayments. After excluding the suspected reflective cracks, the remaining six transverse cracks that had developed were found to possess an increased relationship (60.7%) between temperature differentials and density (Figure 5.10).

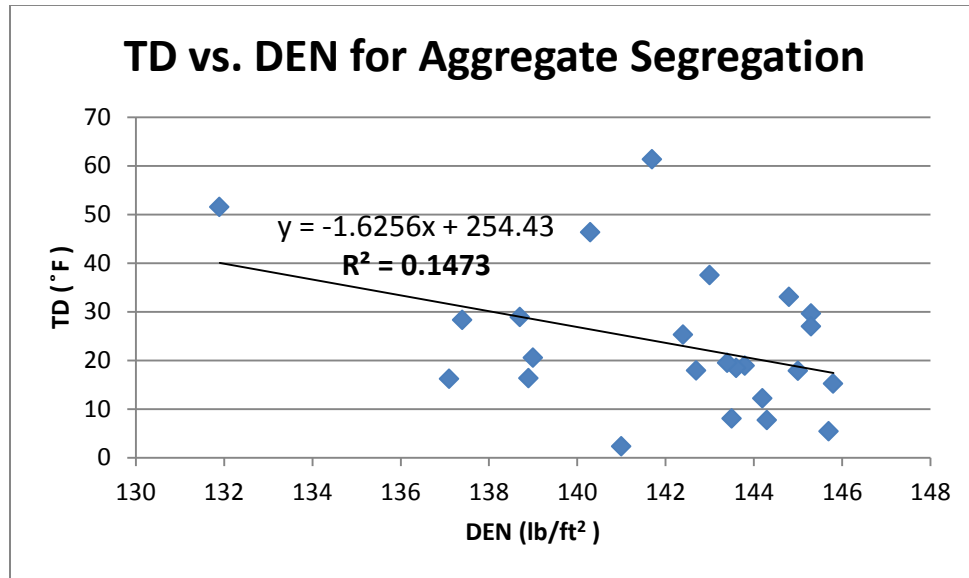
Figure 5.12 Relationship between Temperature Differentials (TD) among Aggregate Segregation

Of the 24 locations with visible material segregation, a 15% negative relationship was found between temperature differential (TD) and density (DEN).

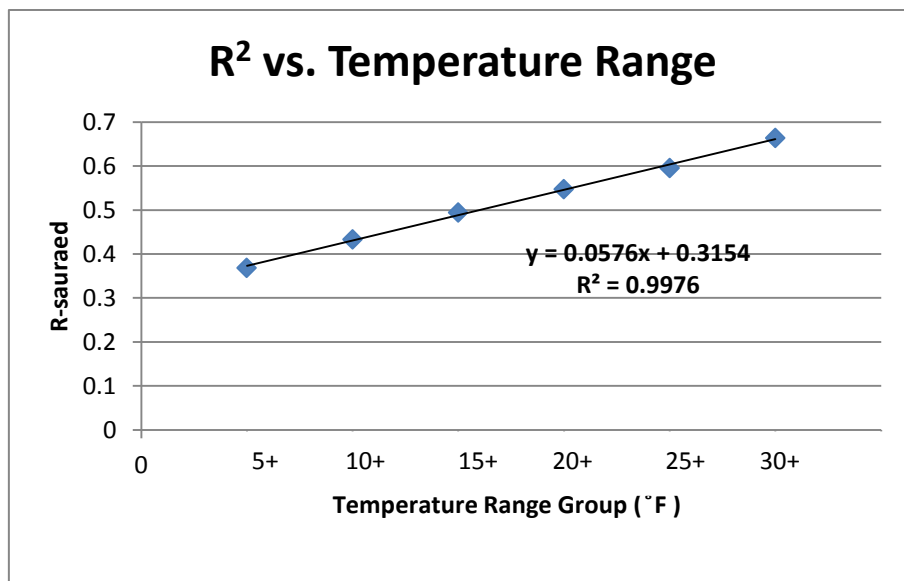
Figure 5.15 Relationship between the Correlation of TD and DEN for a Given Temperature Range and the Temperature Range Group

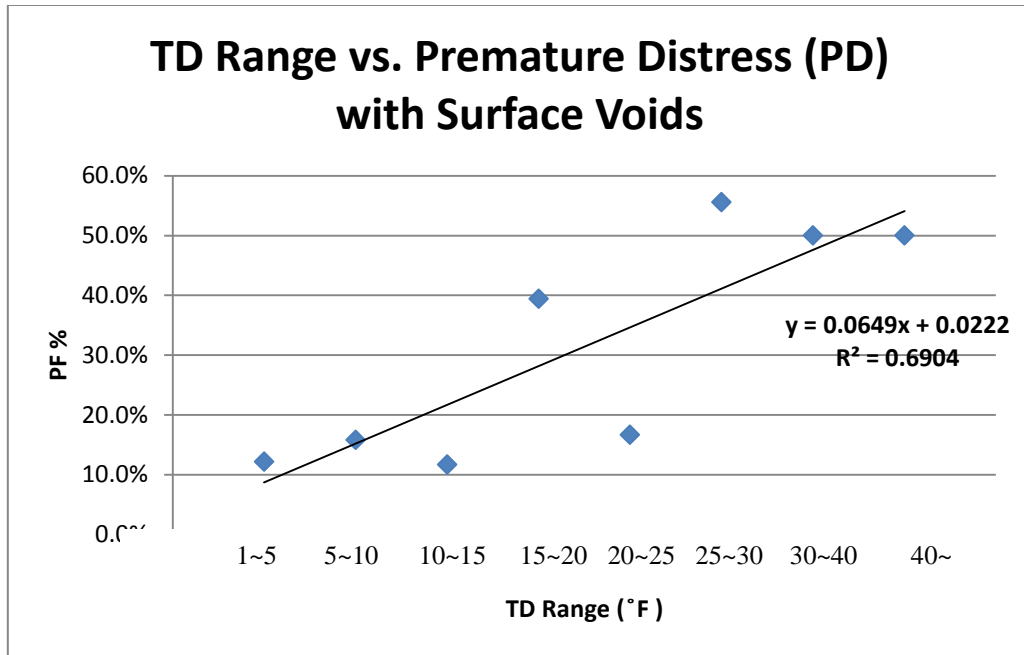
Figure 5.16 Correlation between the Percentages of Premature Distresses, Including Surface Voids, Found within a Specified Temperature Range

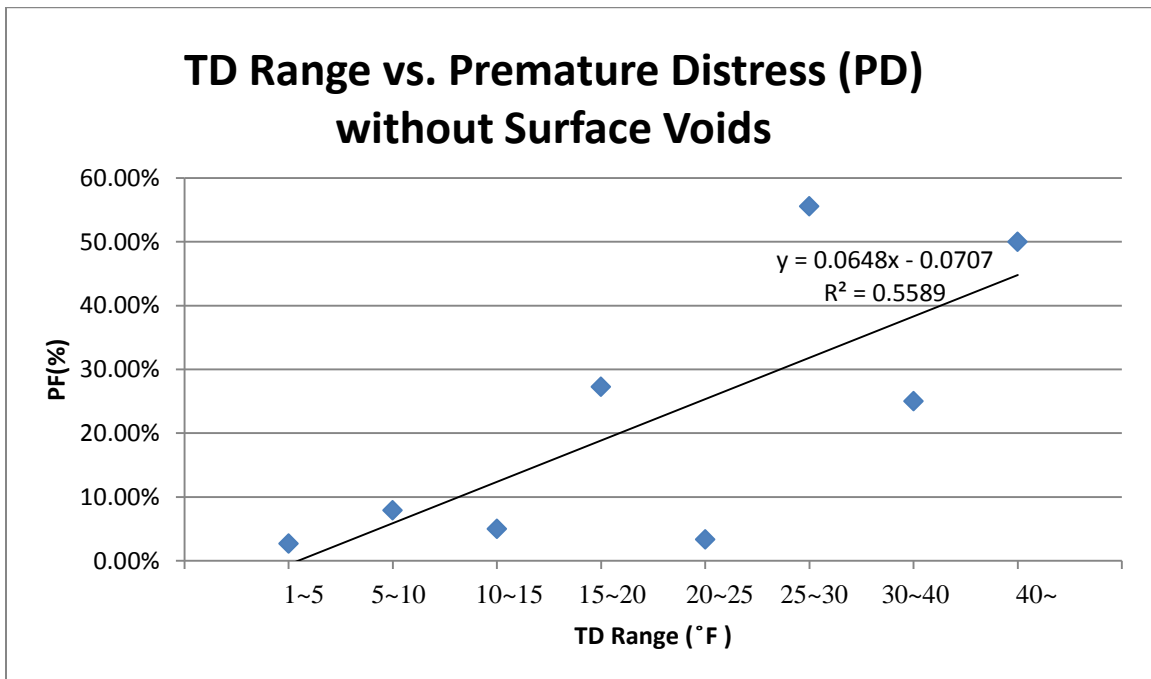
Figure 5.17 Correlation between the Percentages of Premature Flaws, Excluding Surface Voids, Found within a Specified Temperature Range

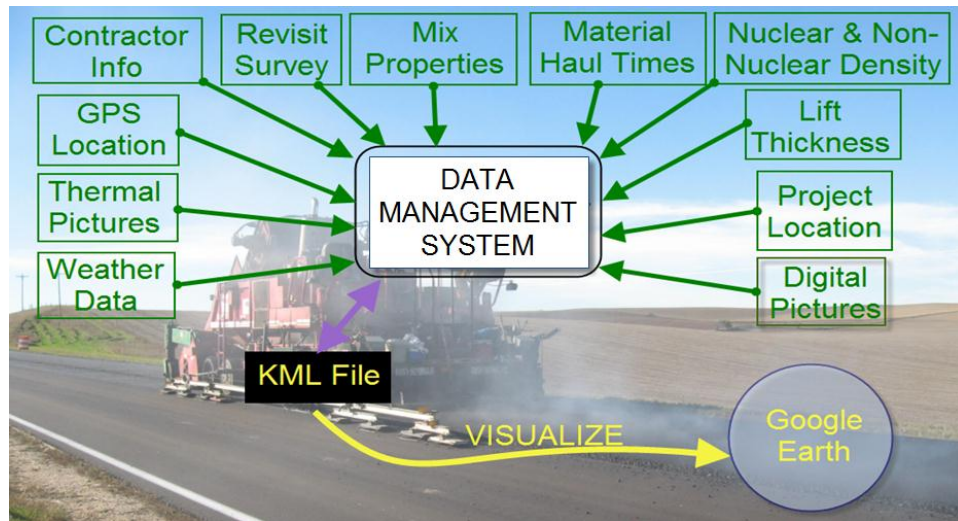
Figure 6.1 Developed Data Management System

In order to perform this investigation, a number of devices were utilized. Those devices included (1) a portable anemometer to record current weather conditions, (2) portable GPS unit to digitally mark areas of interest for later revisit, (3) a thermal imaging camera to locate areas of HMA temperature segregation, (4) a penetrating thermometer to validate the thermal camera, (5) a digital camera to record site conditions and procedures, and (6) nuclear and non-nuclear pavement density devices to measure the compacted density of the material. In addition to data collected via portable devices, site-specific information was collected, including (1) pavement or mix type, (2) lift thickness, (3) haul time, (4) equipment used, and (5) location.

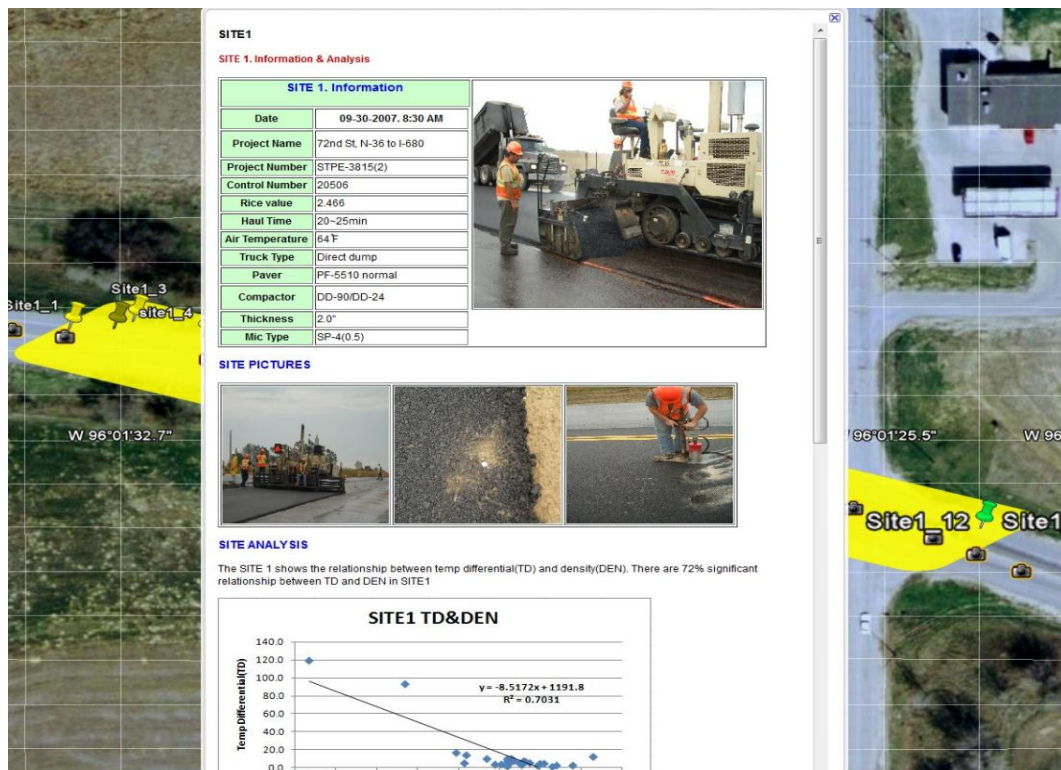
Figure 6.2 Google Earth Based Database

The system was constructed during the paving offseason and ready for use at the start of the 2009 paving season in Nebraska. That spring, all previous sites were revisited in an effort to measure or identify a change in overall pavement quality. Any changes in quality were documented and imported into the Google Earth (KML) format database system that was created. After all information from the revisit had been uploaded, users were able to simply “fly” around the Google Earth program and select individual sites to find site properties like the contractor, mix properties, or even site data analyses (Figure 6.2). Once a particular site had been selected, users were able to further focus on a site-specific data point (Figure 6.3). For example, when a flaw was noted at a specific location during site revisitation, users were able to immediately call up that exact location to view relevant information that was logged at the time of construction that might explain the pavement’s premature distress. Information that might explain the pavement’s distress could have included decreased density readings or thermal images showing drastic temperature segregation.

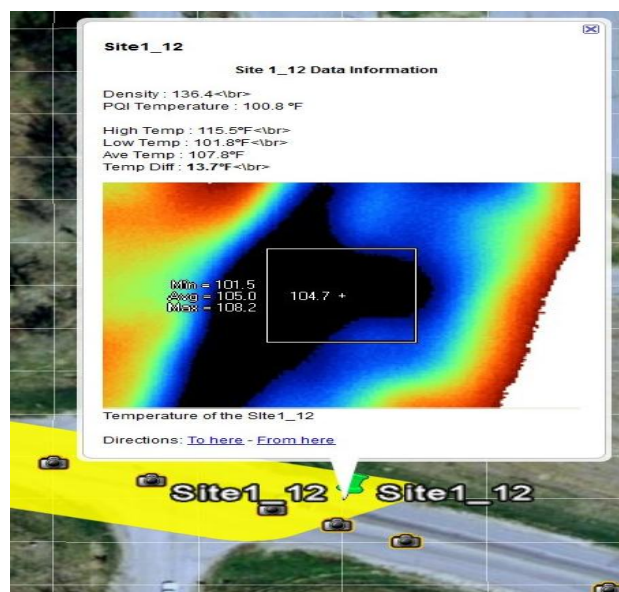
Figure 6.3 Location-Specific Data via Google Earth

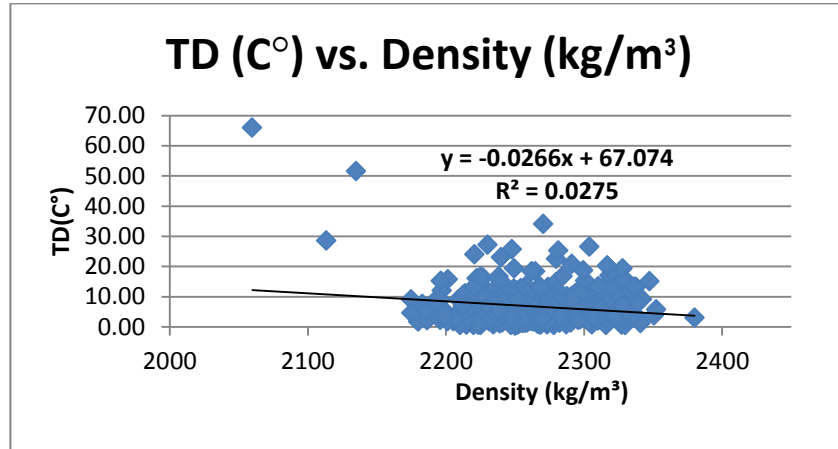
Figure 4.2 Relationship for All Collected Data between Temperature Differential (TD) and Density (DEN)

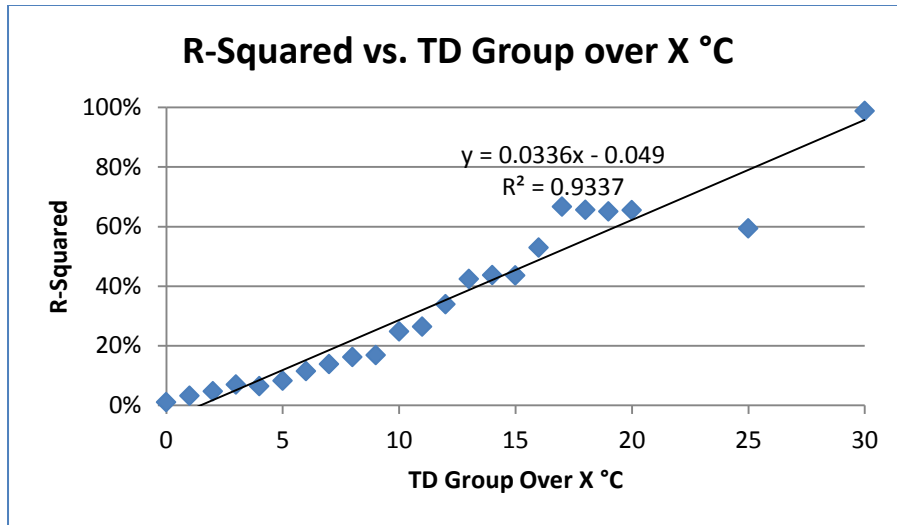
Figure 4.3 A Graphical Representation of the Relationship between Individual Temperature Groups and TD and DEN

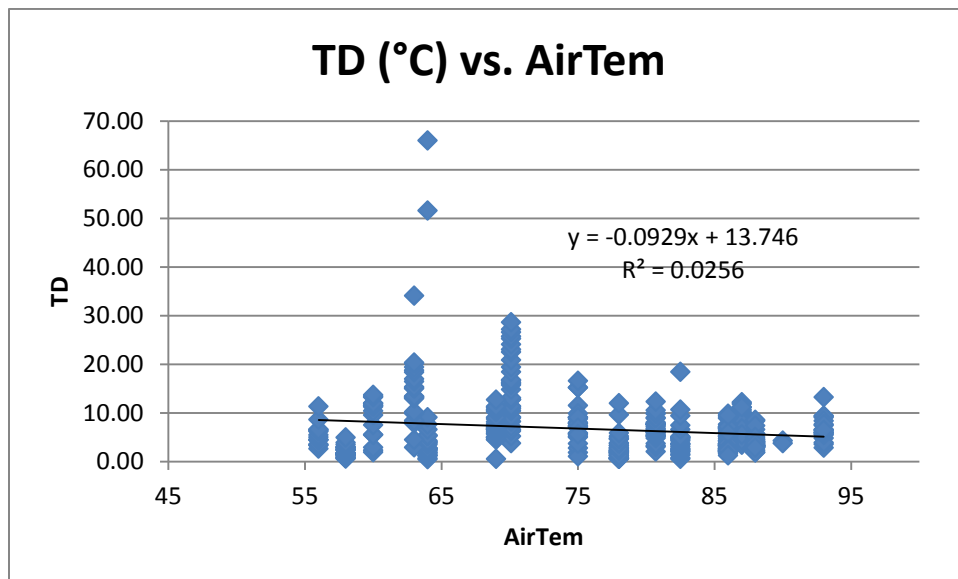
Figure 4.4 Relationship between Ambient Jobsite Air Temperature and Temperature Differential

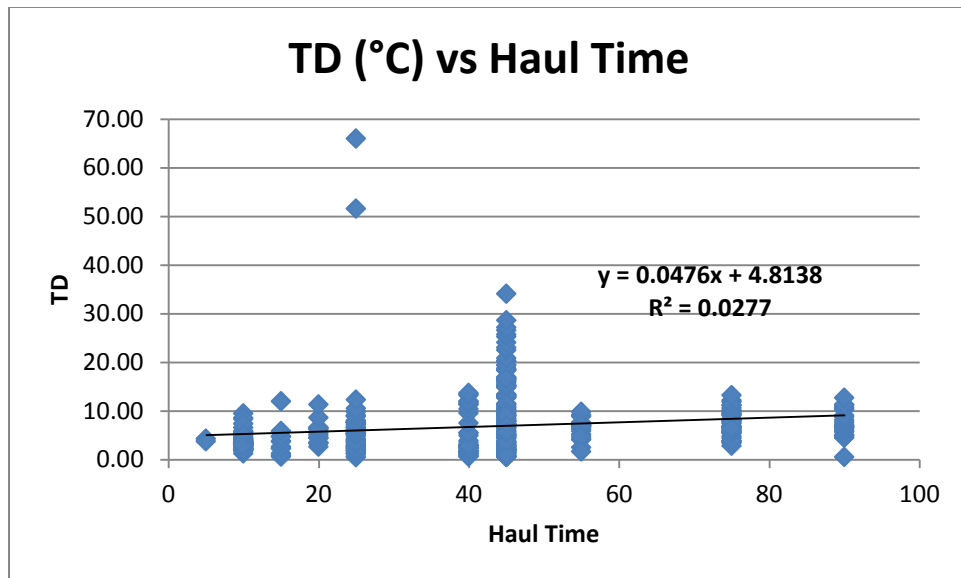
Figure 4.5 Relationship between Haul Time and Temperature Differentials

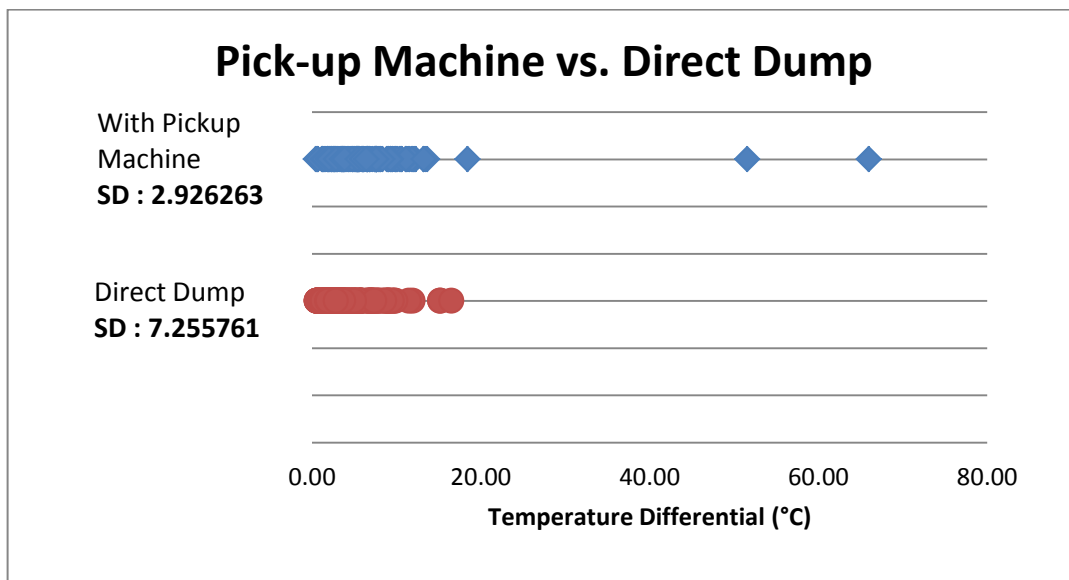
Figure 4.8 Temperature Differential Based on Feeding Types

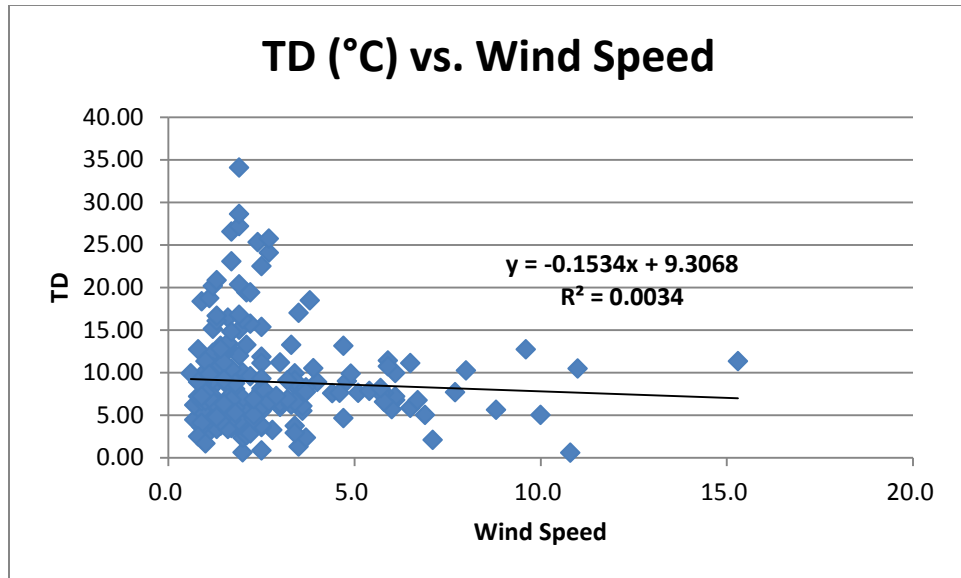
Figure 4.9 Relationship between Wind Speed and Temperature Differentials (TD)

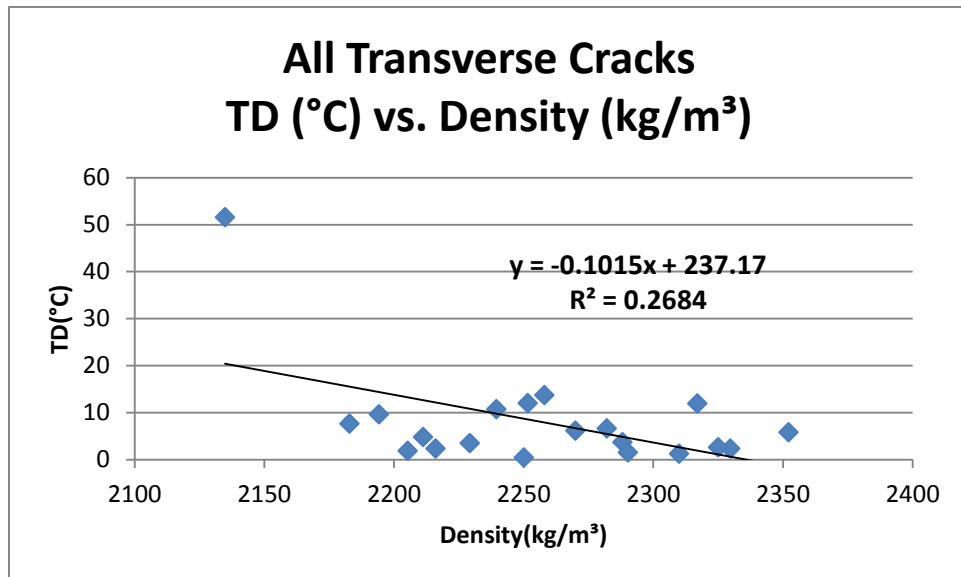
Figure 5.7 Relationship of TD and Density among Transverse Cracks

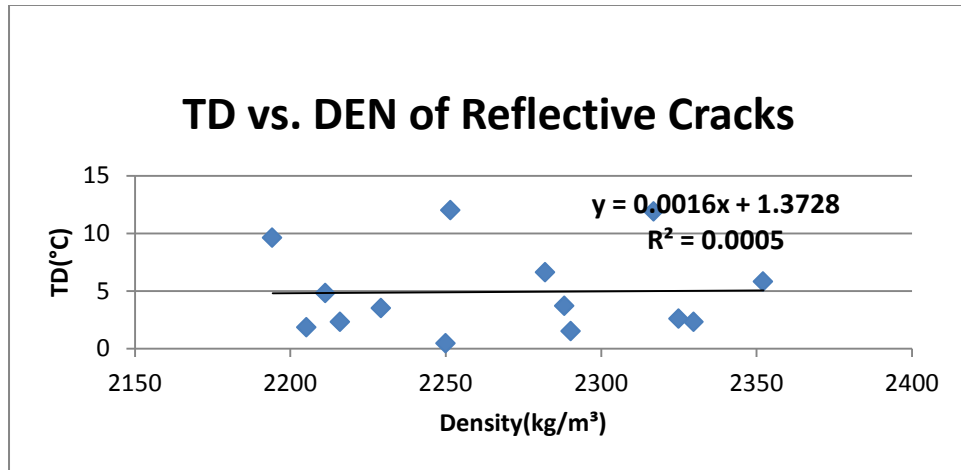
Figure 5.9 Temperature Differentials and Density Relationship among Reflective Cracks

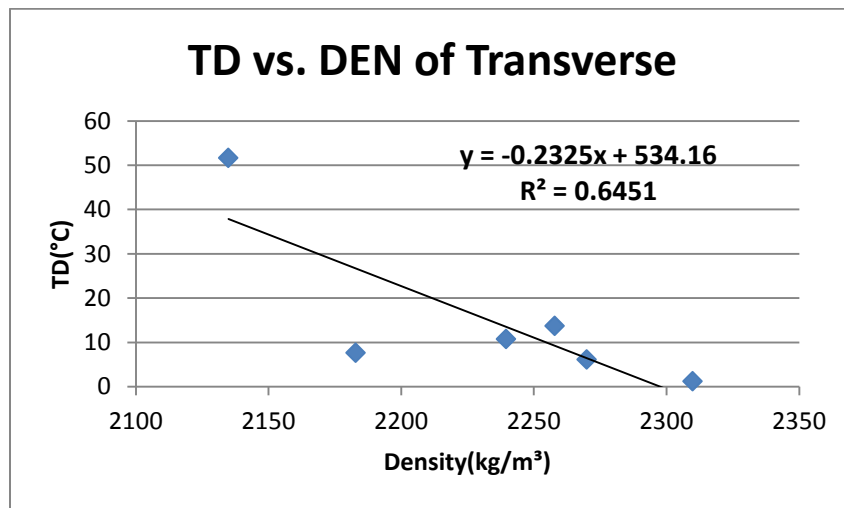
Figure 5.10 Relationship between Temperature Differentials (TD) and Density (DEN), Excluding Reflective Cracks

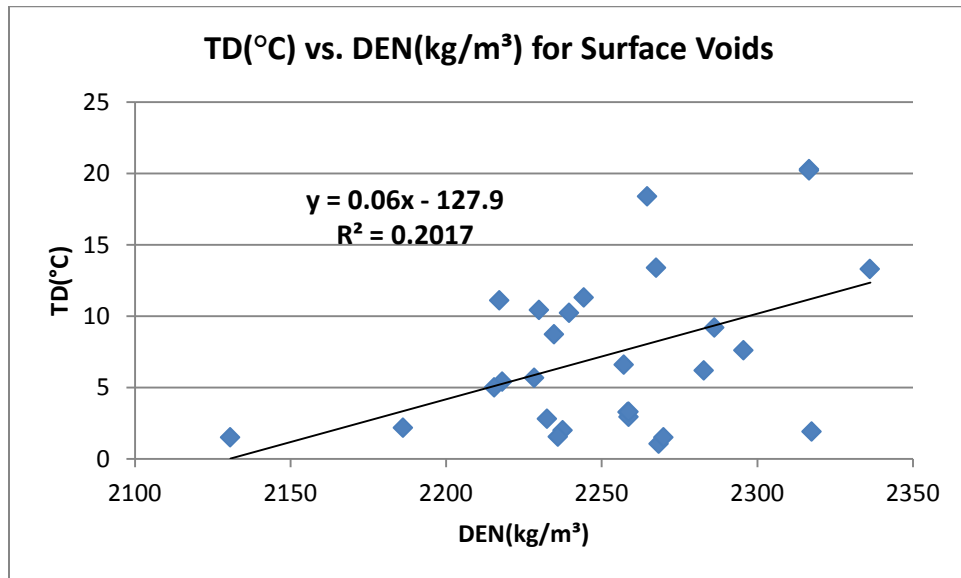
**Figure 5.11** Relationship between Temperature Differentials (TD) and Density (DEN) among Surface Voids

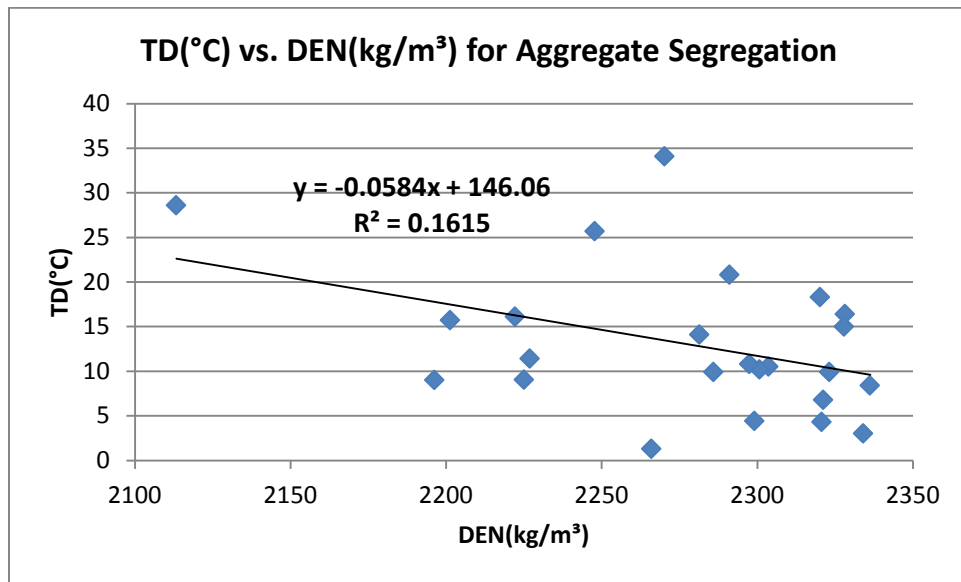
Figure 5.12 Relationship between Temperature Differentials (TD) among Aggregate Segregation

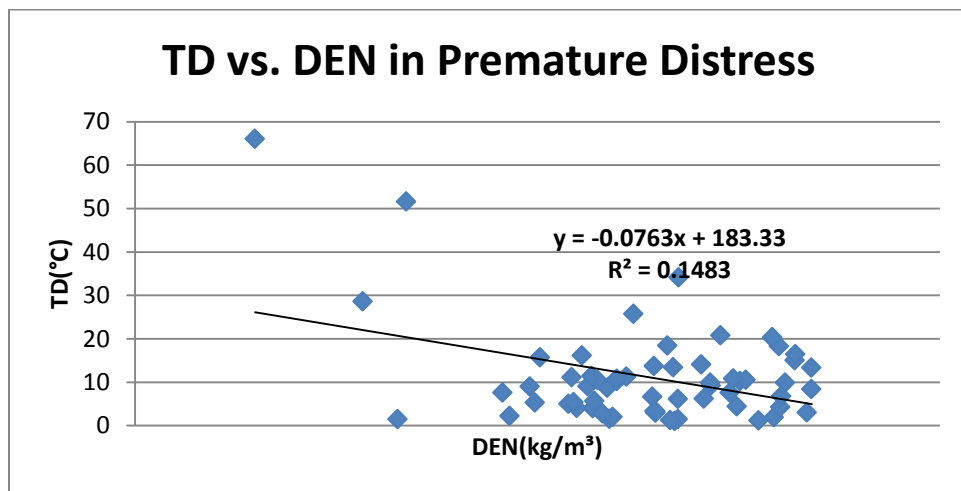
Figure 5.13 Relationships between Temperature Differentials and Density among Total Instances of Observed Premature Distresses
