Infrared Thermography-Driven Flaw Detection and Evaluation of Hot Mix Asphalt Pavements

Report #: SPR-PI (08) P309

Final Report

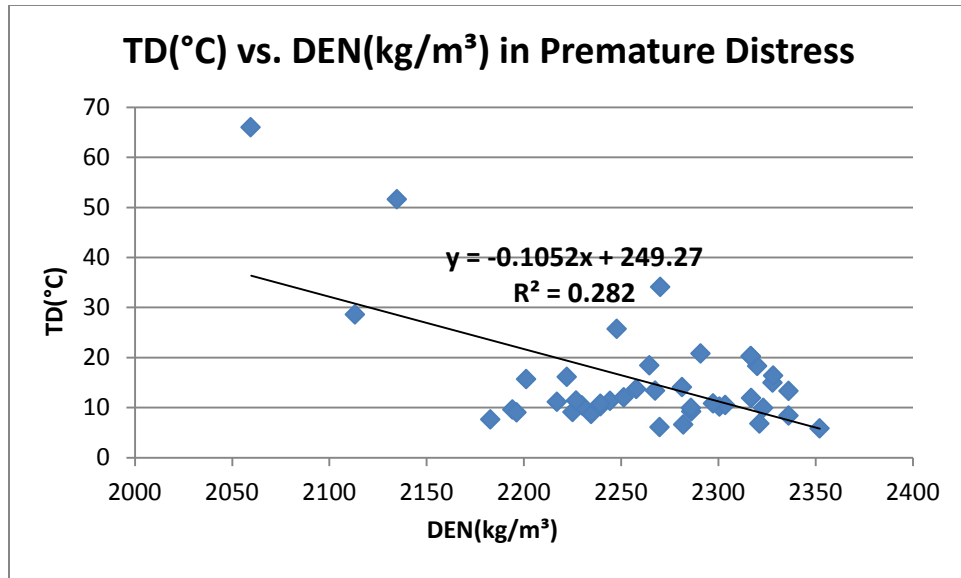
Figure 5.14 Relationship between Temperature Differentials and Premature Distresses, Excluding Small Surface Voids

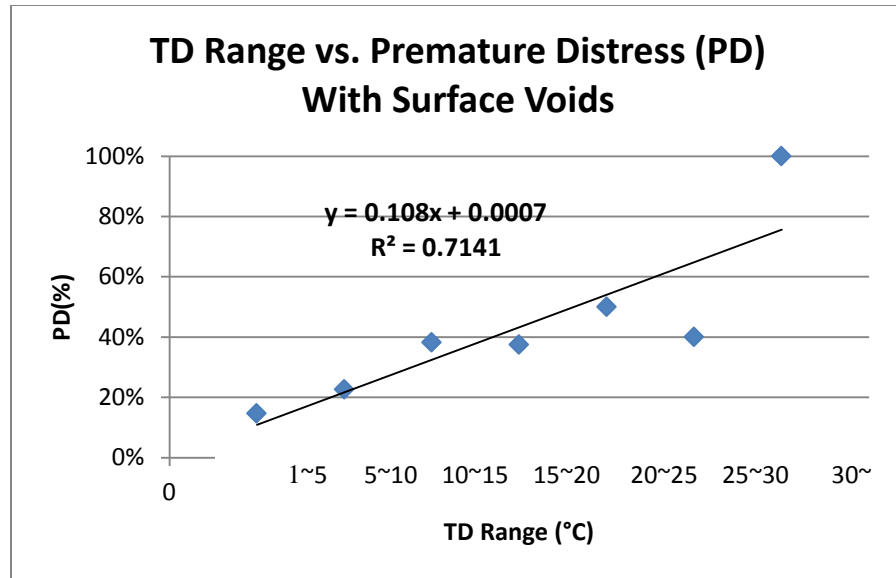
Figure 5.16 Correlation between the Percentages of Premature Distresses, Including Surface Voids, Found within a Specified Temperature Range

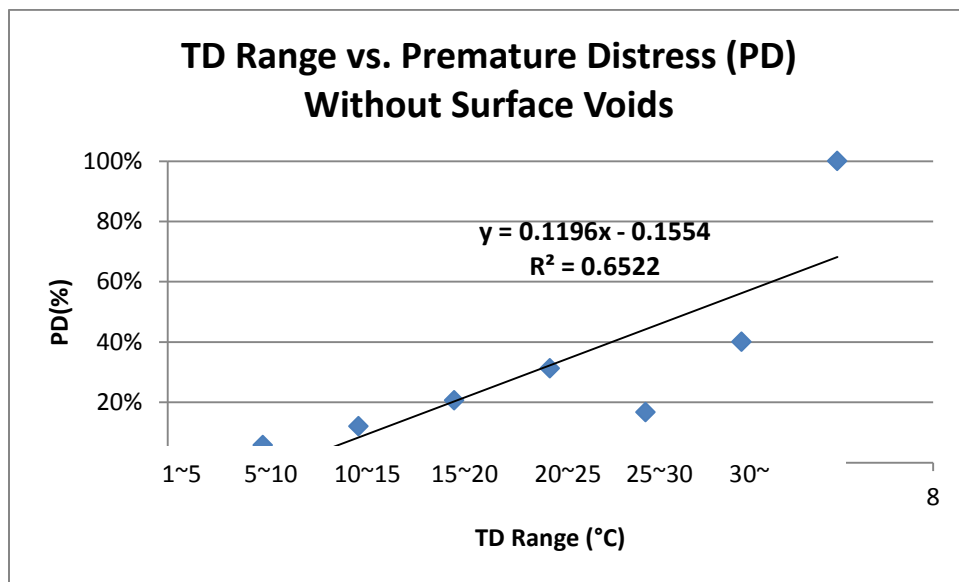
Figure 5.17 Correlation between the Percentages of Premature Flaws, Excluding Surface Voids, Found within a Specified Temperature Range
