SAFETY PERFORMANCE EVALUATION OF THE NEBRASKA OPEN BRIDGE RAIL ON AN INVERTED TEE BRIDGE DECK

MIDWEST ROADSIDE SAFETY FACILITY

NEBRASKA DEPARTMENT OF ROADS

MwRSF Research Report No. TRP-03-133-04

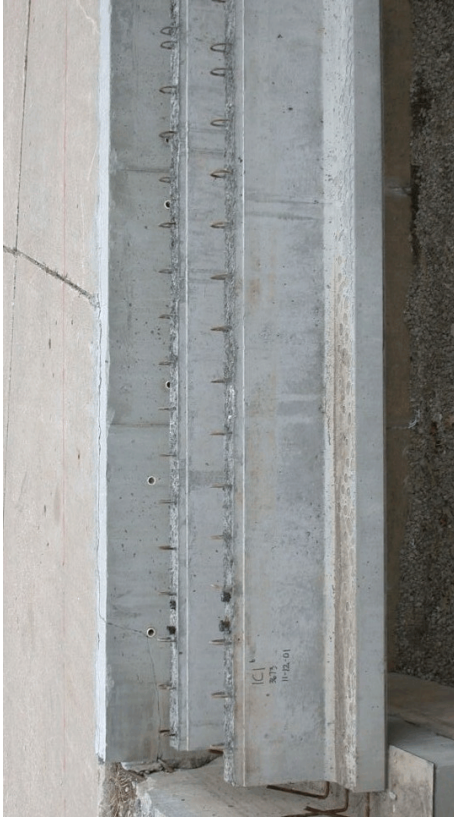
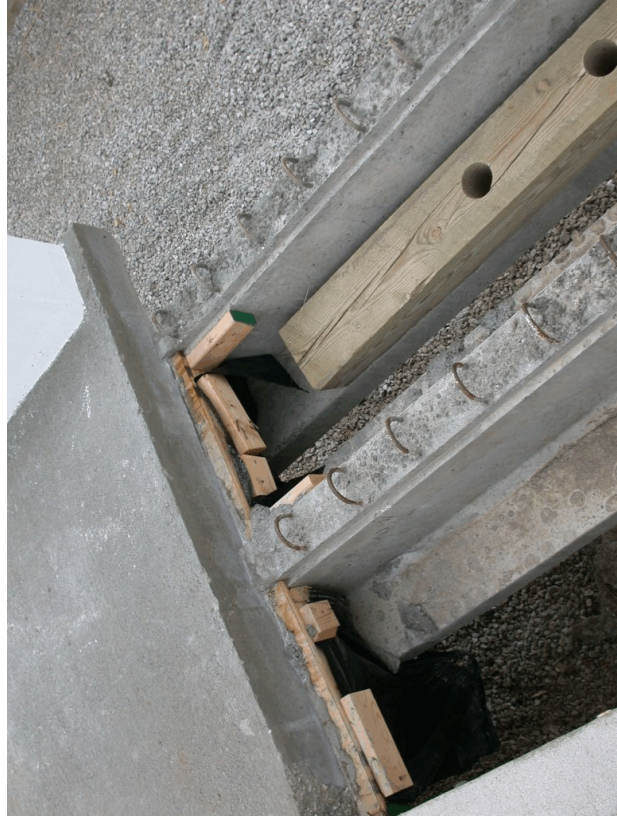
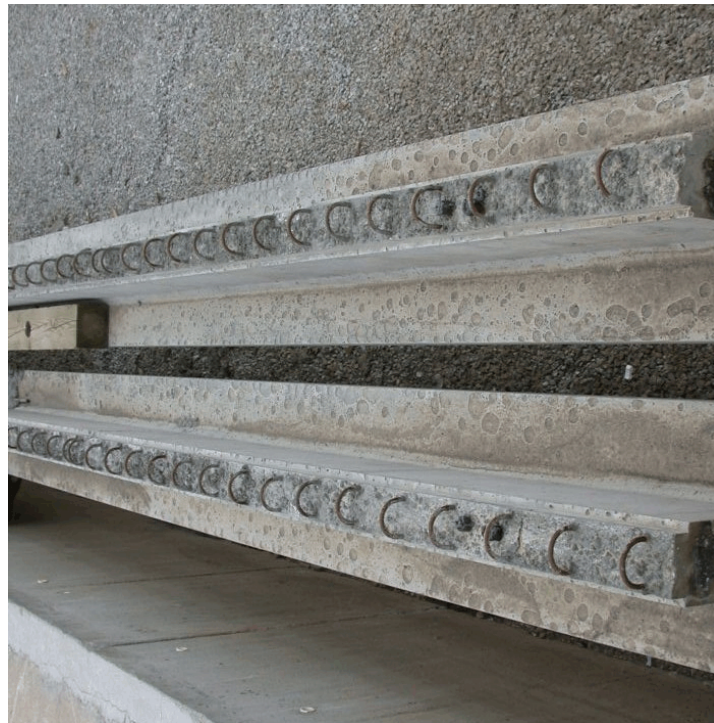
Figure 9. Concrete Girders

Two IT-500 prestressed concrete girders, spanning between any two concrete bridge supports, were placed on top of the concrete bridge abutments and bents. Each concrete girder measured 600-mm (23 ⅝-in.) wide by 140-mm (5 ½-in.) high at the base and 160-mm (6 5/16-in.) wide by 398-mm (14 3/16-in.) high along the stem and were 11.89-m (39-ft) long, as shown in Figure 9. NDOR's design and reinforcement details for the girders are shown in Appendix A . Neoprene bearing pads, measuring 6-mm (¼-in.) thick, were placed between the concrete girders and the concrete bearing pads. Lateral stiffener caps were then cast-in-place between the ends of concrete girders along the bents and the downstream abutment. The reinforcement details for the caps are shown in Figures 5, 7, 10, and 11.

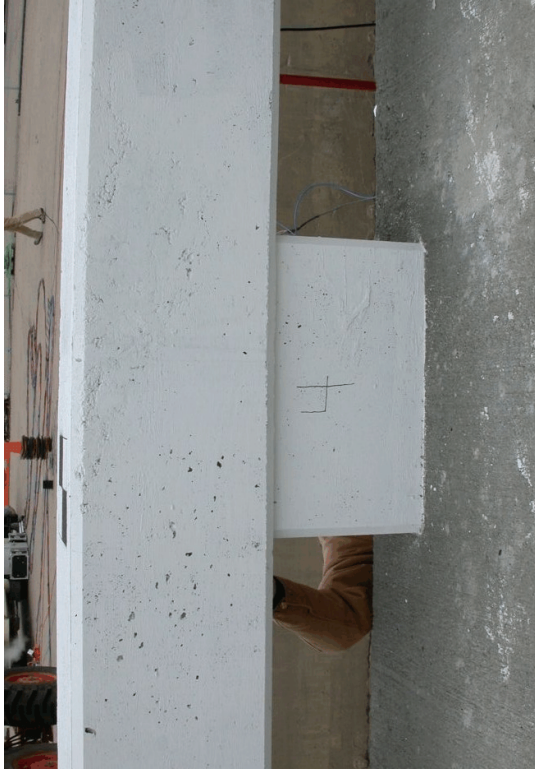
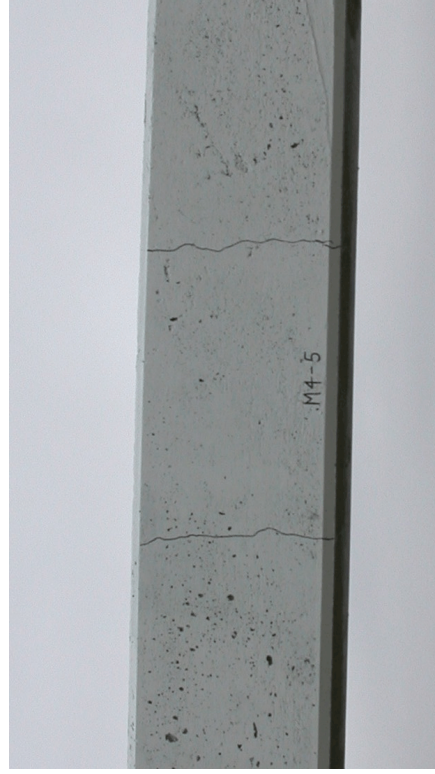
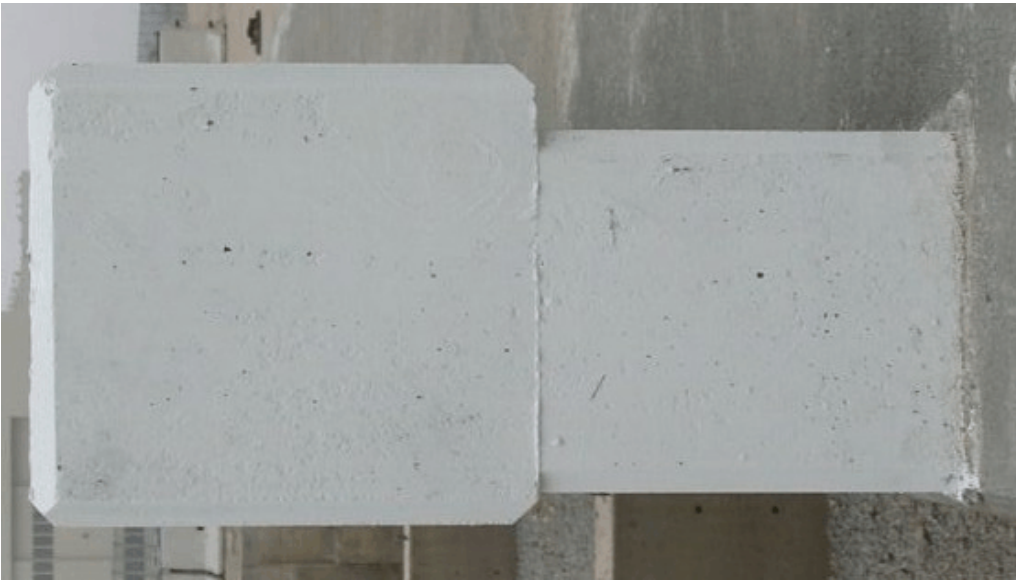
Figure 15. Bridge Rail and Posts

The concrete used for the bridge rail and posts consisted of Nebraska 47-BD Mix Type 3, with a minimum compressive strength of 31.03 MPa (4,500 psi). The 28-day concrete compressive strength for the bridge rail and posts, as determined from concrete cylinder testing, was found to be approximately 46.28 MPa (6,712 psi). A minimum concrete cover of 51 mm (2 in.) was used for all of the rebar placed within the bridge rail and posts. All steel reinforcement in the bridge rail and posts was Grade 60 epoxy-coated rebar. The bridge rail and post reinforcement details are shown in Appendix A.

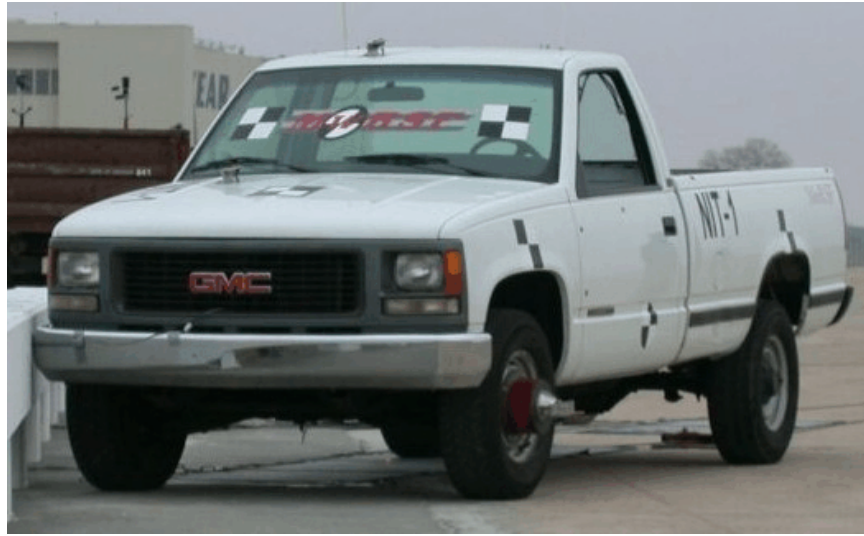
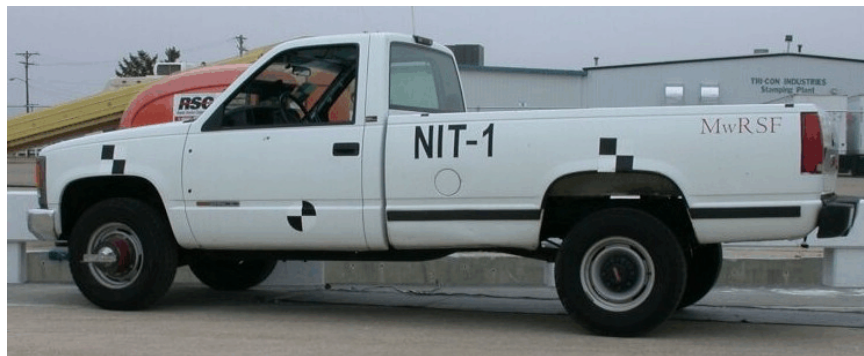
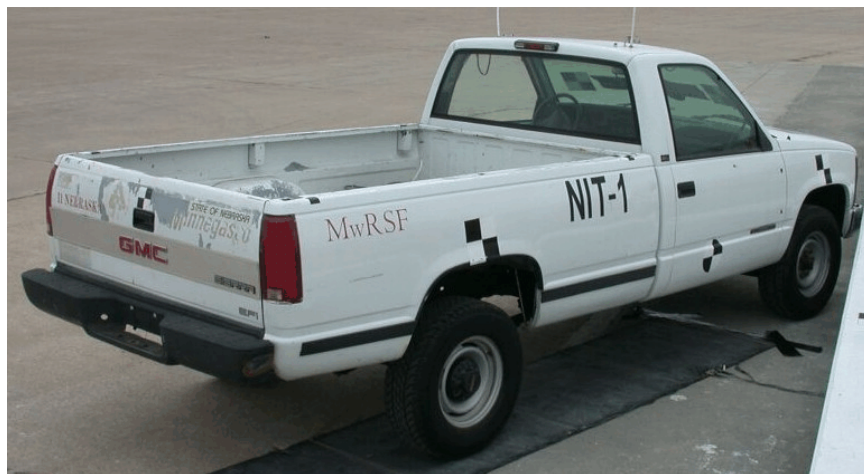
Figure 16. Test Vehicle, Test NIT-1

For test NIT-1, a 1995 GMC 2500 ¾-ton pickup truck was used as the test vehicle. The test inertial and gross static weights were 2,016 kg (4,445 lbs). The test vehicle is shown in Figure 16, and vehicle dimensions are shown in Figure 17.

Date: 3/20/02 Test Number: NIT-1 Model: 2000P
 Make: GMC Vehicle I.D.#: 1GDGC24K4SE500791
 Tire Size: 245/75 R16 Year: 1995 Odometer: 246437

The longitudinal component of the center of gravity was determined using the measured axle weights. The location of the final centers of gravity are shown in Figures 16 and 17.

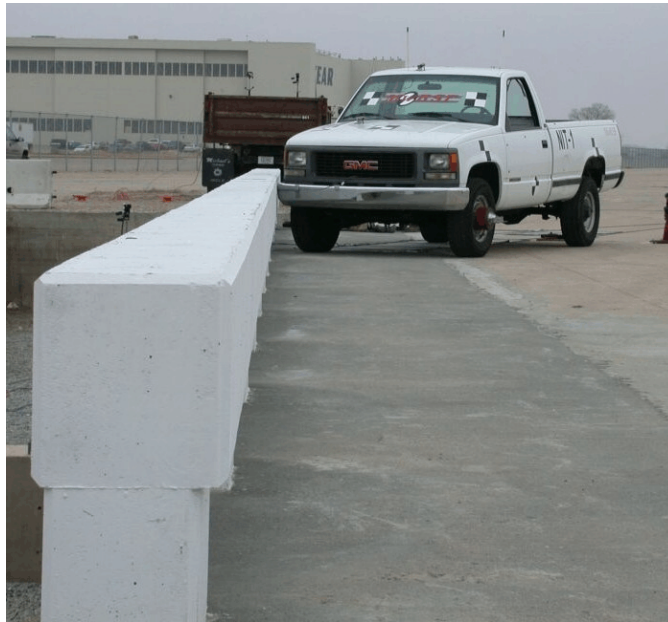
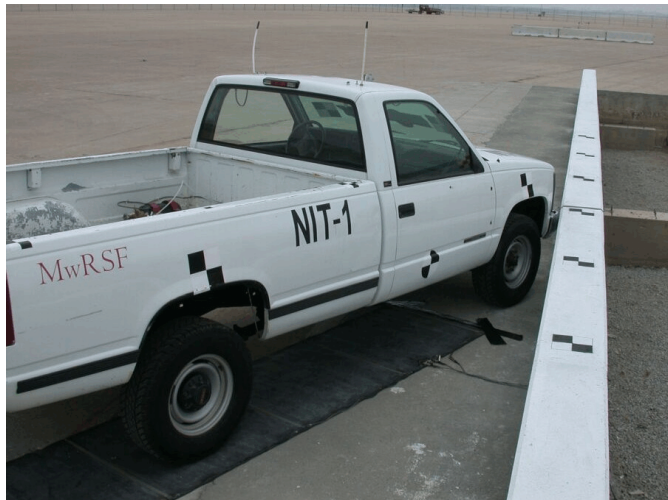
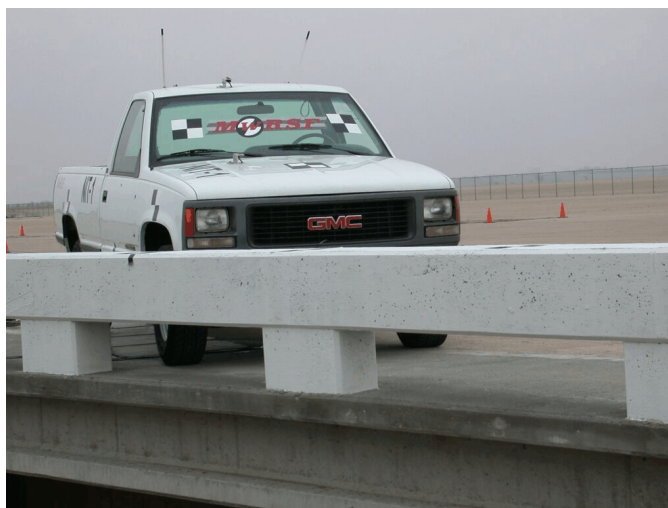
Figure 27. Impact Location, Test NIT-1

Initial impact occurred between bridge post nos. 5 and 6 or 10.56 m (34 ft-8 in.) downstream from the upstream end of the system, as shown in Figure 27. At 0.020 sec after impact, the front bumper shifted toward the left side of the vehicle as the right side crushed inward. Shortly after this time, minor dynamic rail deflections occurred. At 0.034 sec, the right-front tire contacted the bridge rail and began to rotate parallel to the rail. At 0.047 sec, the right-front corner of the vehicle protruded over the top of the rail. At this same time, the bumper continued to deform inward. At 0.079 sec, the truck began to redirect as the top of the right-side door became ajar. At 0.08 sec, the right-front corner of the vehicle reached its maximum intrusion of 587 mm (23 in.) over the rail. At 0.096 sec, the area between the vehicle's cab and box began to rise into the air. At 0.121 sec, the left-front tire became airborne. At 0.126 sec, the entire right-side of the vehicle's cab was in contact with the rail. At 0.167 sec, the left-rear tire became airborne. At 0.192 sec, the right-rear corner of the vehicle contacted the rail. The vehicle became parallel to the bridge rail at 0.221 sec after impact with a resultant velocity of 79.6 km/hr (49.4 mph). At this same time, the vehicle began to roll

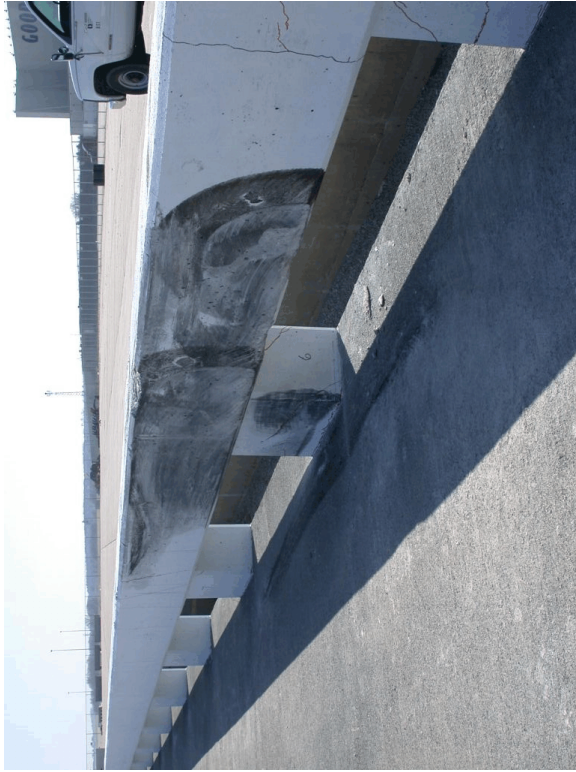
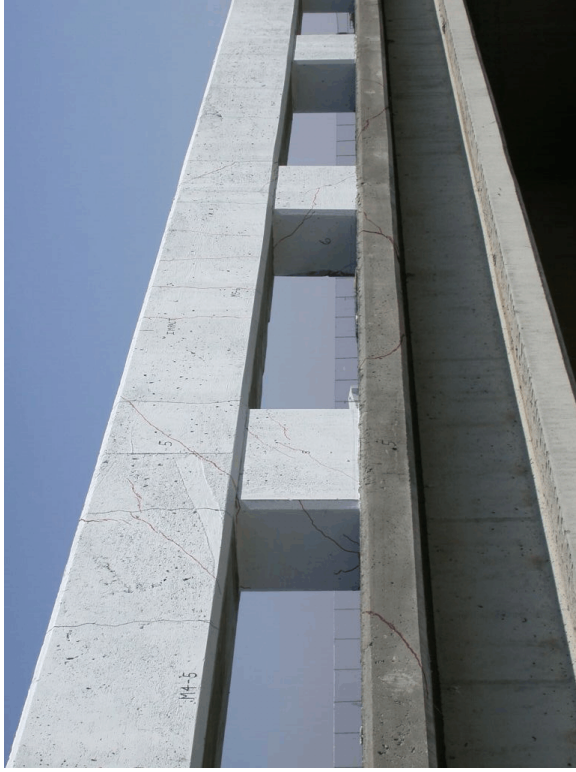
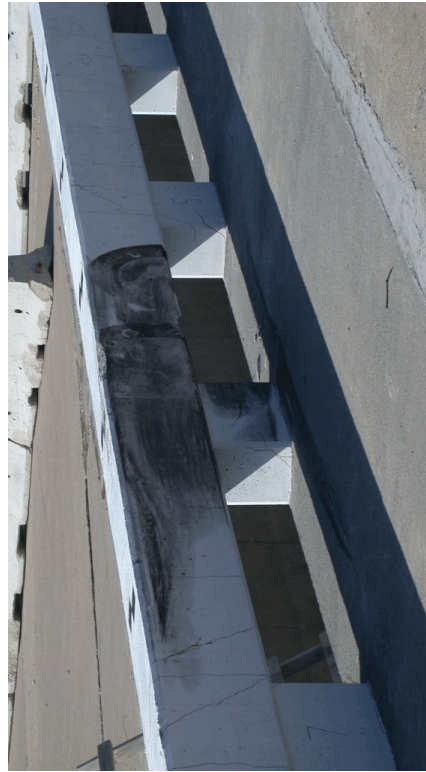
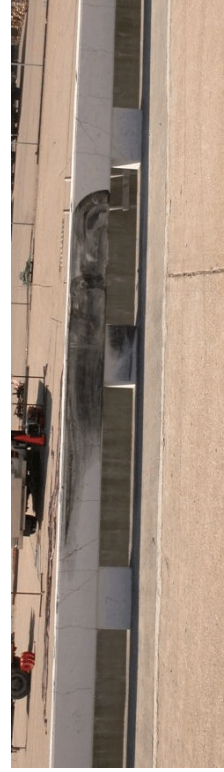
Figure 29. Open Concrete Bridge Rail System Damage, Test NIT-1

Damage to the barrier was moderate, as shown in Figures 29 through 36. Barrier damage consisted of deck, post, and rail cracking along with contact and gouge marks. The length of vehicle contact along the concrete bridge rail was approximately 4 m (13 ft).

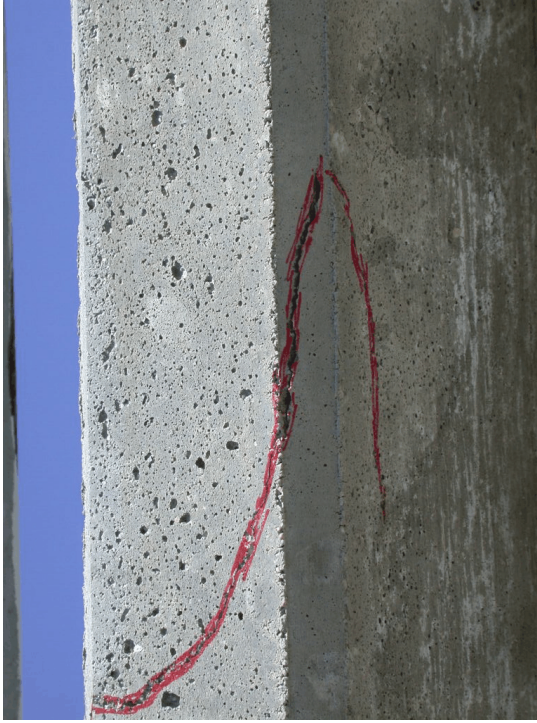
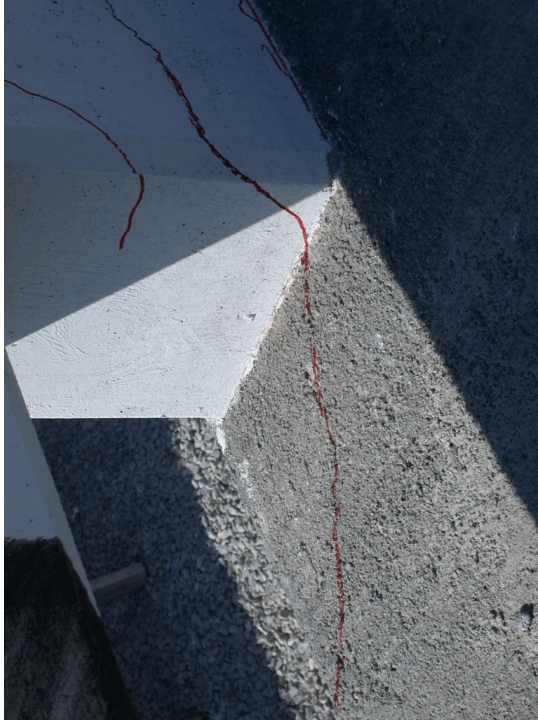
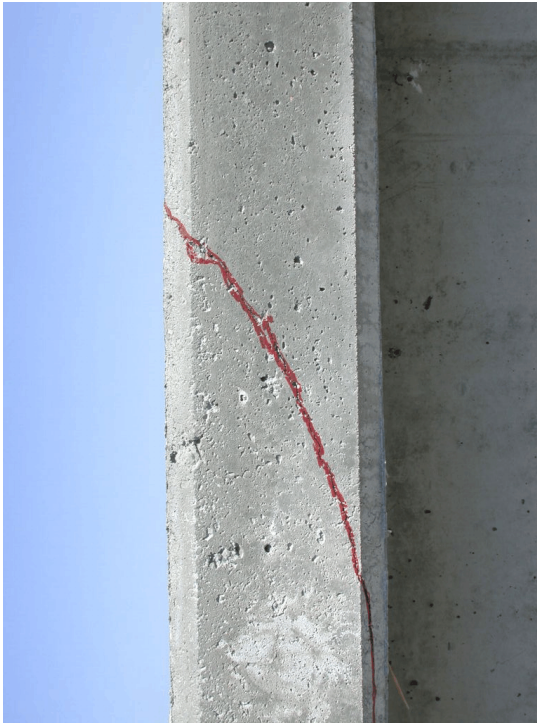
Figure 34. Bridge Deck Damage Around Post No. 5, Test NIT-1

Damage to the deck consisted of minor hairline cracks and black contact marks. One crack originated at the front-upstream corner of post no. 5 and continued diagonally back 559 mm (22 in.) then down the back of the deck for 203 mm (8 in.) for a total length of 762 mm (30 in.) upstream from the upstream face of post no. 5. Another crack originated at the downstream face of post no. 5, continued diagonally for about 254 mm (10 in.) where it reached the back edge of the deck and then continued for 152 mm (6 in.) diagonally along the back face of the deck. A third crack originated at the upstream face of post no. 6 and continued diagonally upstream for 279 mm (11 in.) then 178 mm (7 in.) diagonally along the back face of the deck. Another crack originated at the back face of post no. 6 and propagated diagonally downstream 305 mm (12 in.) and then 305 mm (12 in.) along the back face of the deck. A final crack originated at the back face of post no. 6 and continued 610 mm (24 in.) diagonally downstream and then 305 mm (12 in.) diagonally across the back face of the deck. Black tire contact marks, measuring 229-mm (9-in.) wide by 2.24-m (88-in.) long, were found on the concrete deck in front of post no. 6.

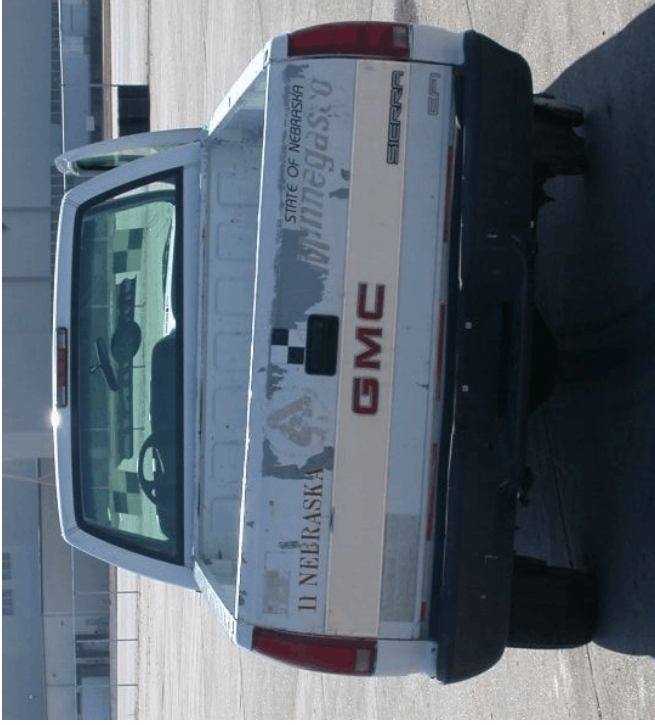
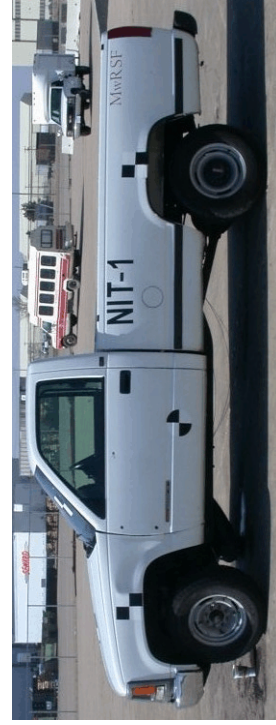
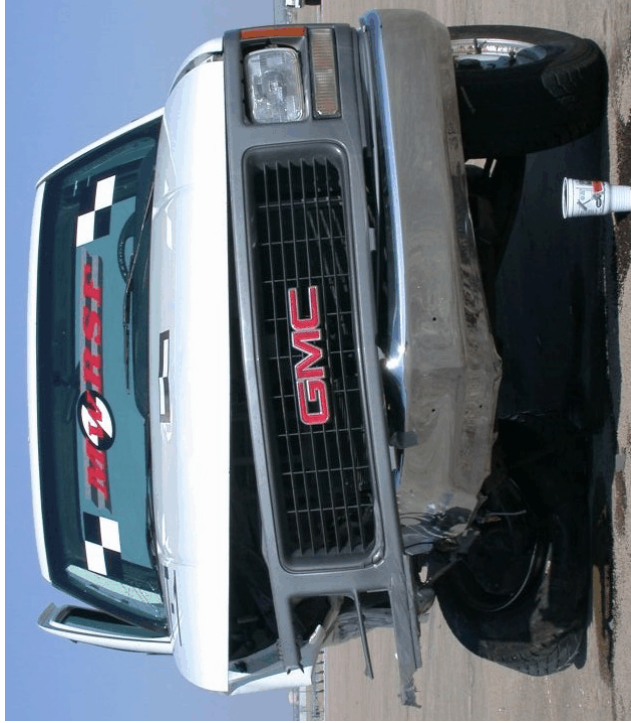
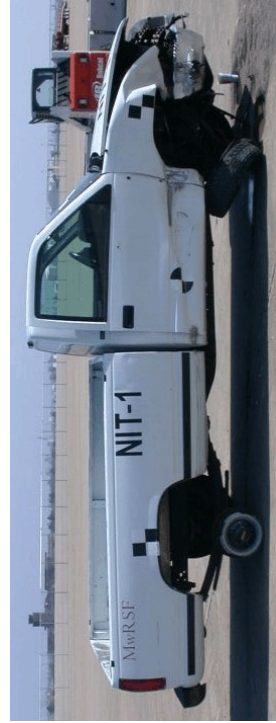
Figure 37. Vehicle Damage, Test NIT-1

Exterior vehicle damage was moderate, as shown in Figures 37 through 41. Moderate occupant compartment deformations occurred with deformations to the right-side floor pan and firewall, as shown in Figure 41. Occupant compartment deformations and the corresponding locations are provided in Appendix C.

Damage was concentrated on the right-front corner and right side of the vehicle. The right-front corner of the vehicle was crushed inward and back, including the fender, bumper, and frame rail. A buckling point was found at the center of the front bumper. A major crease was found in the frame just behind the right-front control arm. The right-front upper control arm and tie-rod disengaged completely. The right-front lower control arm joint was fractured and still attached. The right-front brake line was severed, and the exhaust manifold was cracked above the control arm assembly. Scuff marks were found on the right-rear wheel well, and the tire was ripped away from the hub rivets. The back of the right-front steel rim was damaged from the lower control arm, and the tire was separated from the rim. Deformation of the right-side door and the right side of the truck bed were also observed, and heavy contact marks were found along the entire right side of the vehicle. The top of the right-side door and the hood were jarred open. The grill was broken and deformed around the right-side headlight assembly. The right side of the radiator housing was deformed. The truck's cab shifted toward the left approximately 51 mm (2 in.) offset from the truck box. A small crease was observed on the left-front fender. The lower-right corner of the windshield encountered a minor crack and starring. The left-rear tire remained inflated. The roof and the right-side, left-side, and rear window glass remained undamaged.

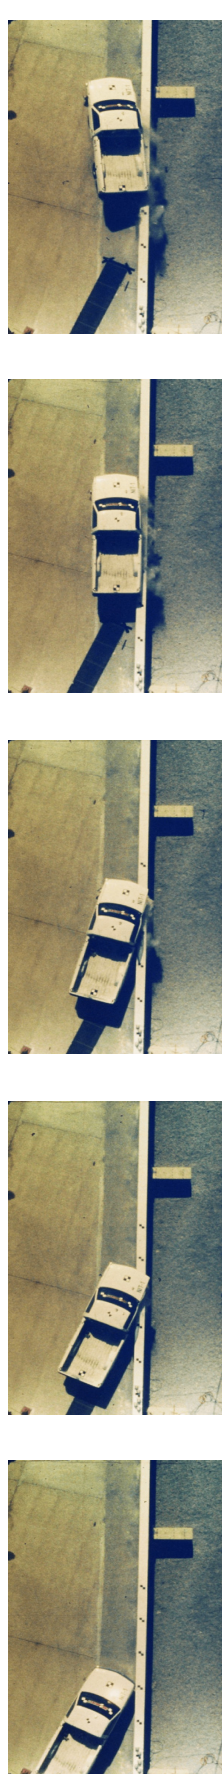
Figure B-1. Summary of Test Results and Sequential Photographs (English), Test NIT-1

| ● Test Number | NIT-1 | ● Vehicle Speed | 62.0 mph |
| ● Date | 3/20/02 | ● Impact | 49.7 mph |
