# Safety Performance Evaluation of Weak-Post, W-Beam Guardrail Attached to Culvert

*Midwest States Regional Pooled Fund Research Program*

*Research Project Number TPF-5(193) Supplement #32*

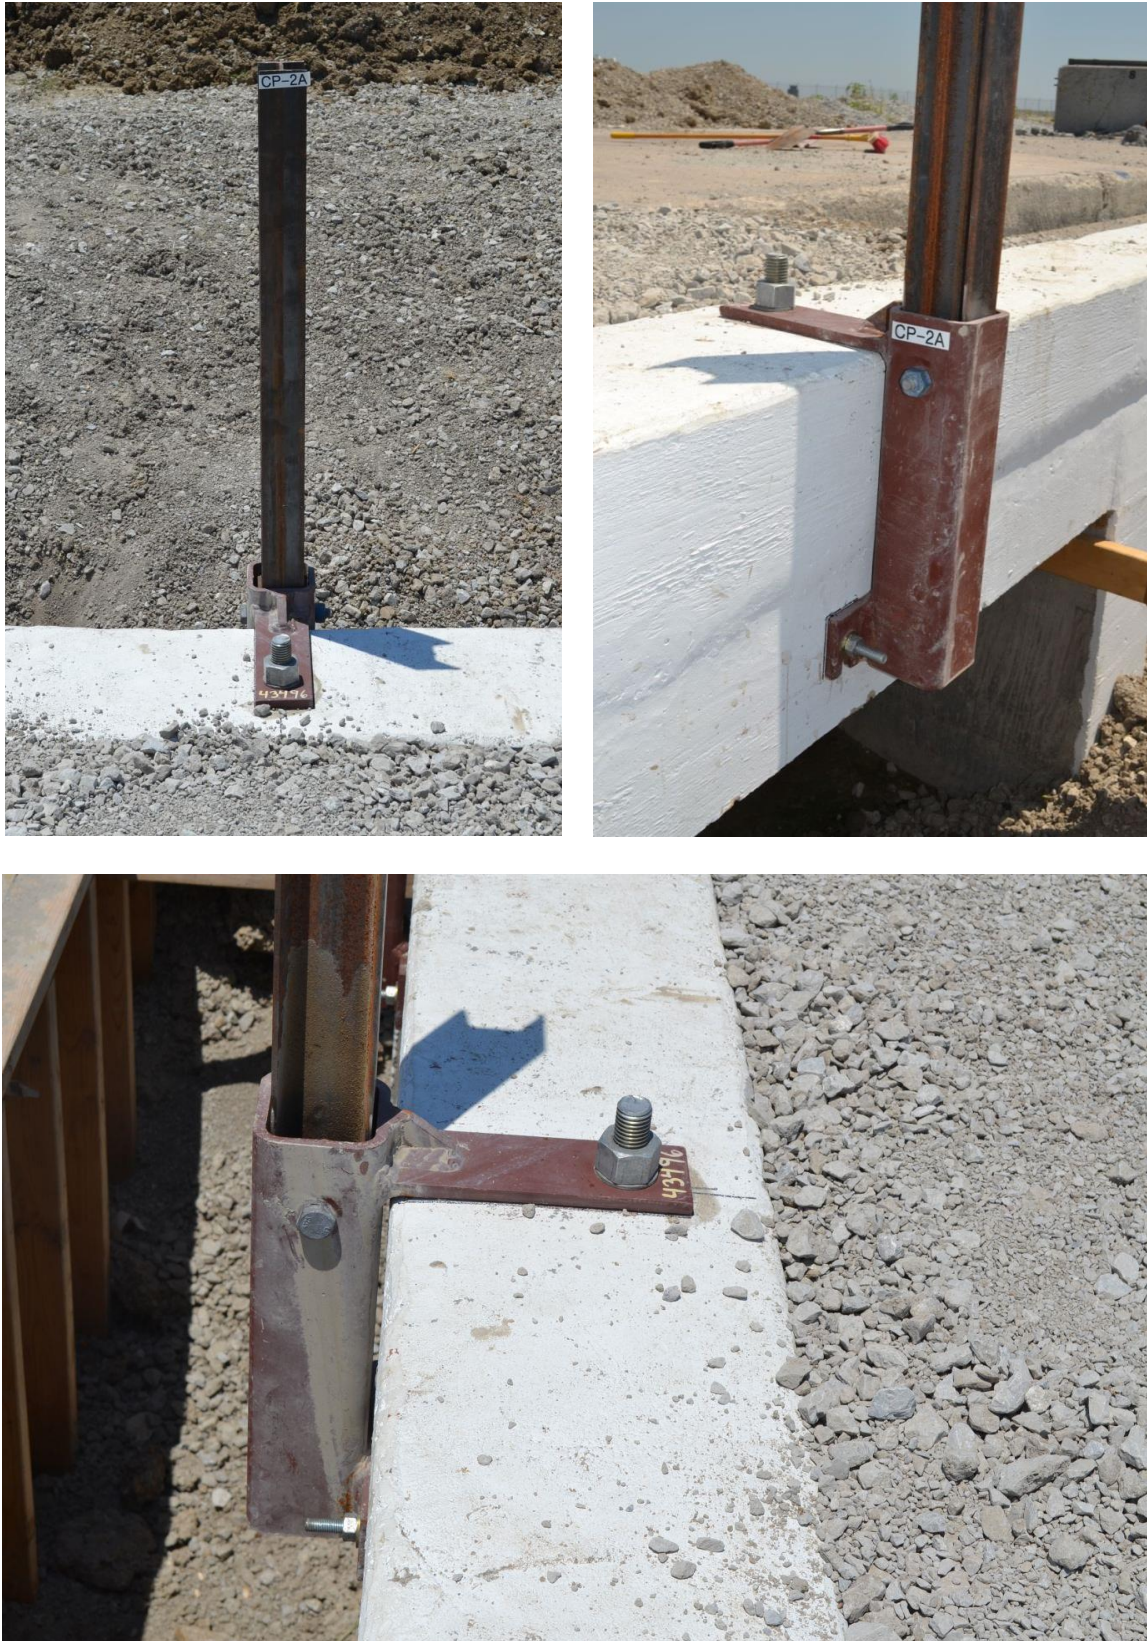
Figure 18. Design Concept A, Installation Photographs

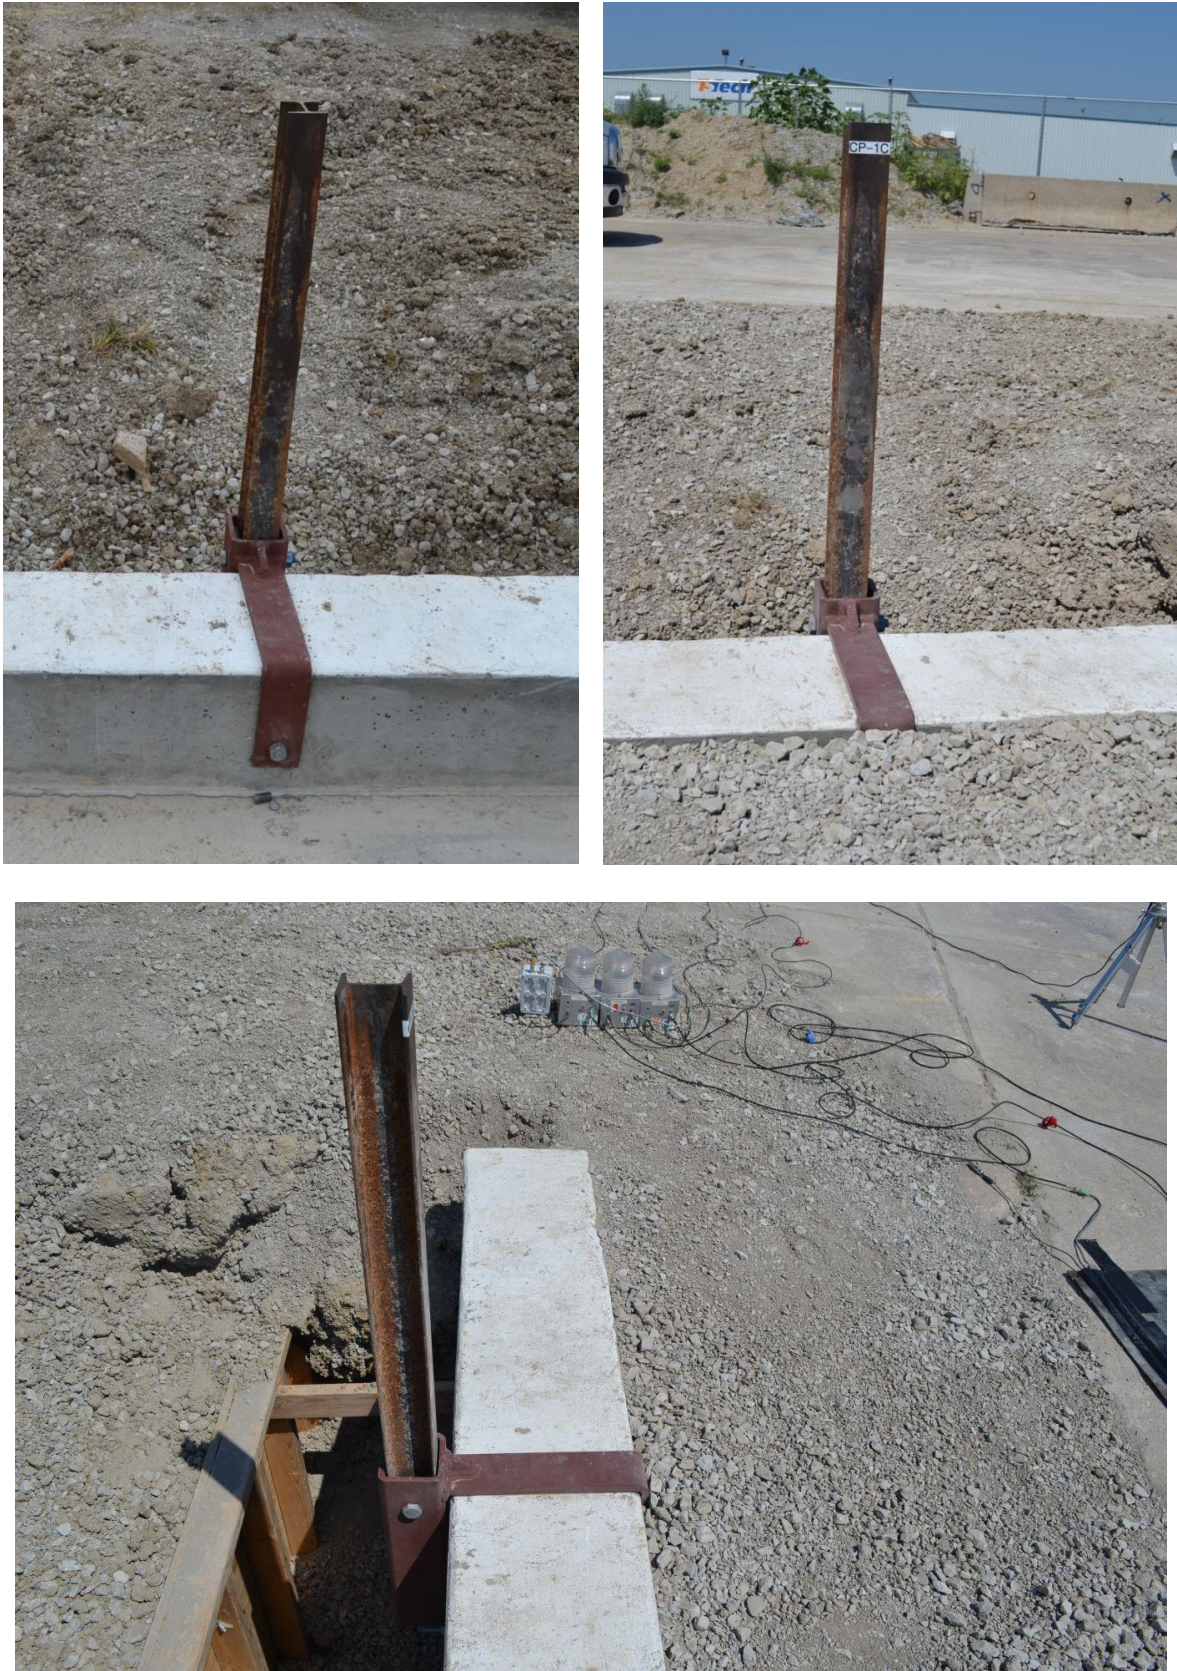
Figure 32. Design Concept C, Installation Photographs
