Universal Breakaway Steel Post for Other Applications

Midwest States' Regional Pooled Fund Research Program

Research Project Number TPF-5 (193), Suppl. 55

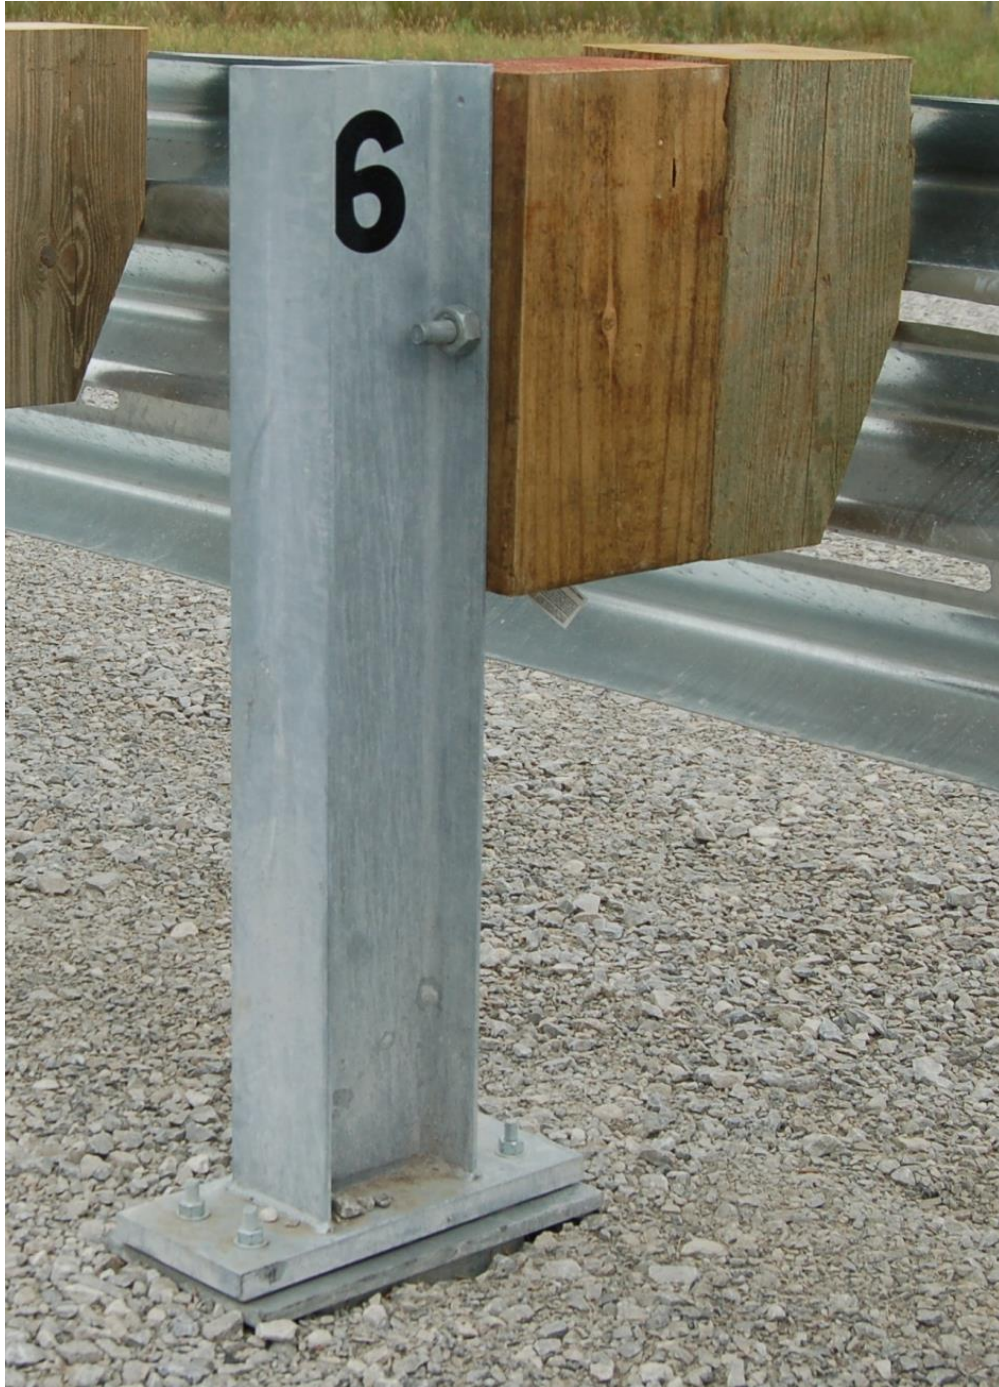
Figure 1. UBSP Installed in the Thrie Beam Bullnose

In order to address this need, MwRSF developed the Universal Breakaway Steel Post (UBSP) to replace the CRT wood posts in the three beam bullnose system [6-9]. The design goal of the new, non-proprietary, UBSP was to mimic the strength and behavior of the wooden CRT post. The UBSP, as shown in Figure 1, consisted of a W6x9 (W152x13.4) steel post top section, which was the standard steel section used in strong-post guardrail, and a 6-in. x 8-in. x $\frac{3}{16}$ -in.

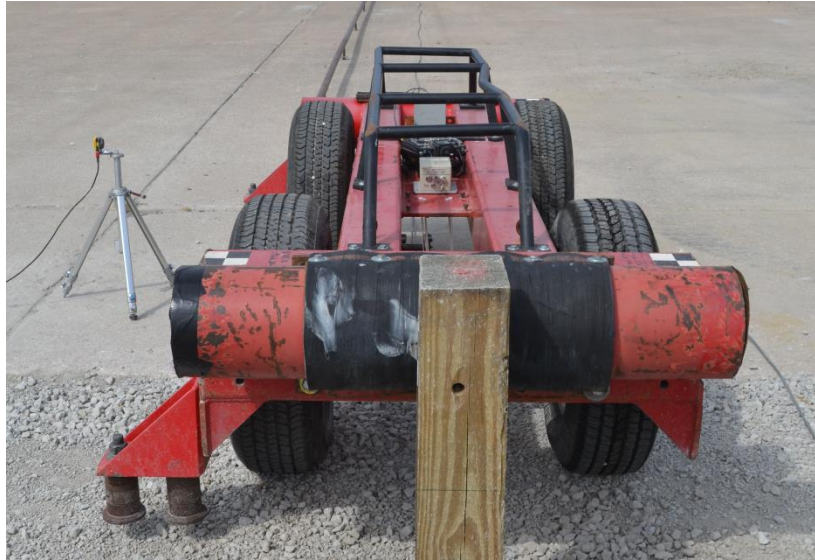
Figure 2. Rigid Frame Bogie and Guidance Track

A rigid-frame bogie was used to impact the posts. A variable-height, detachable impact head was used in the testing. The bogie head was constructed of 8-in. (203-mm) diameter, 1/2-in. (13-mm) thick standard steel pipe, with 3/4-in. (19-mm) neoprene belting wrapped around the pipe to prevent local damage to the post from the impact. The impact head was bolted to the bogie vehicle, creating a rigid frame with an impact height of 24 7/8 in. (632 mm). The bogie with the impact head is shown in Figure 2. The weight of the bogie with the addition of the mountable impact head and accelerometers was 1,875 lb (850 kg).

A pickup truck with a reverse cable tow system was used to propel the bogie to a target impact speed of 20 mph (32 km/h). When the bogie approached the end of the guidance system, it was released from the tow cable, allowing it to be free rolling when it impacted the post. A remote braking system was installed on the bogie allowing it to be brought safely to rest after the test.

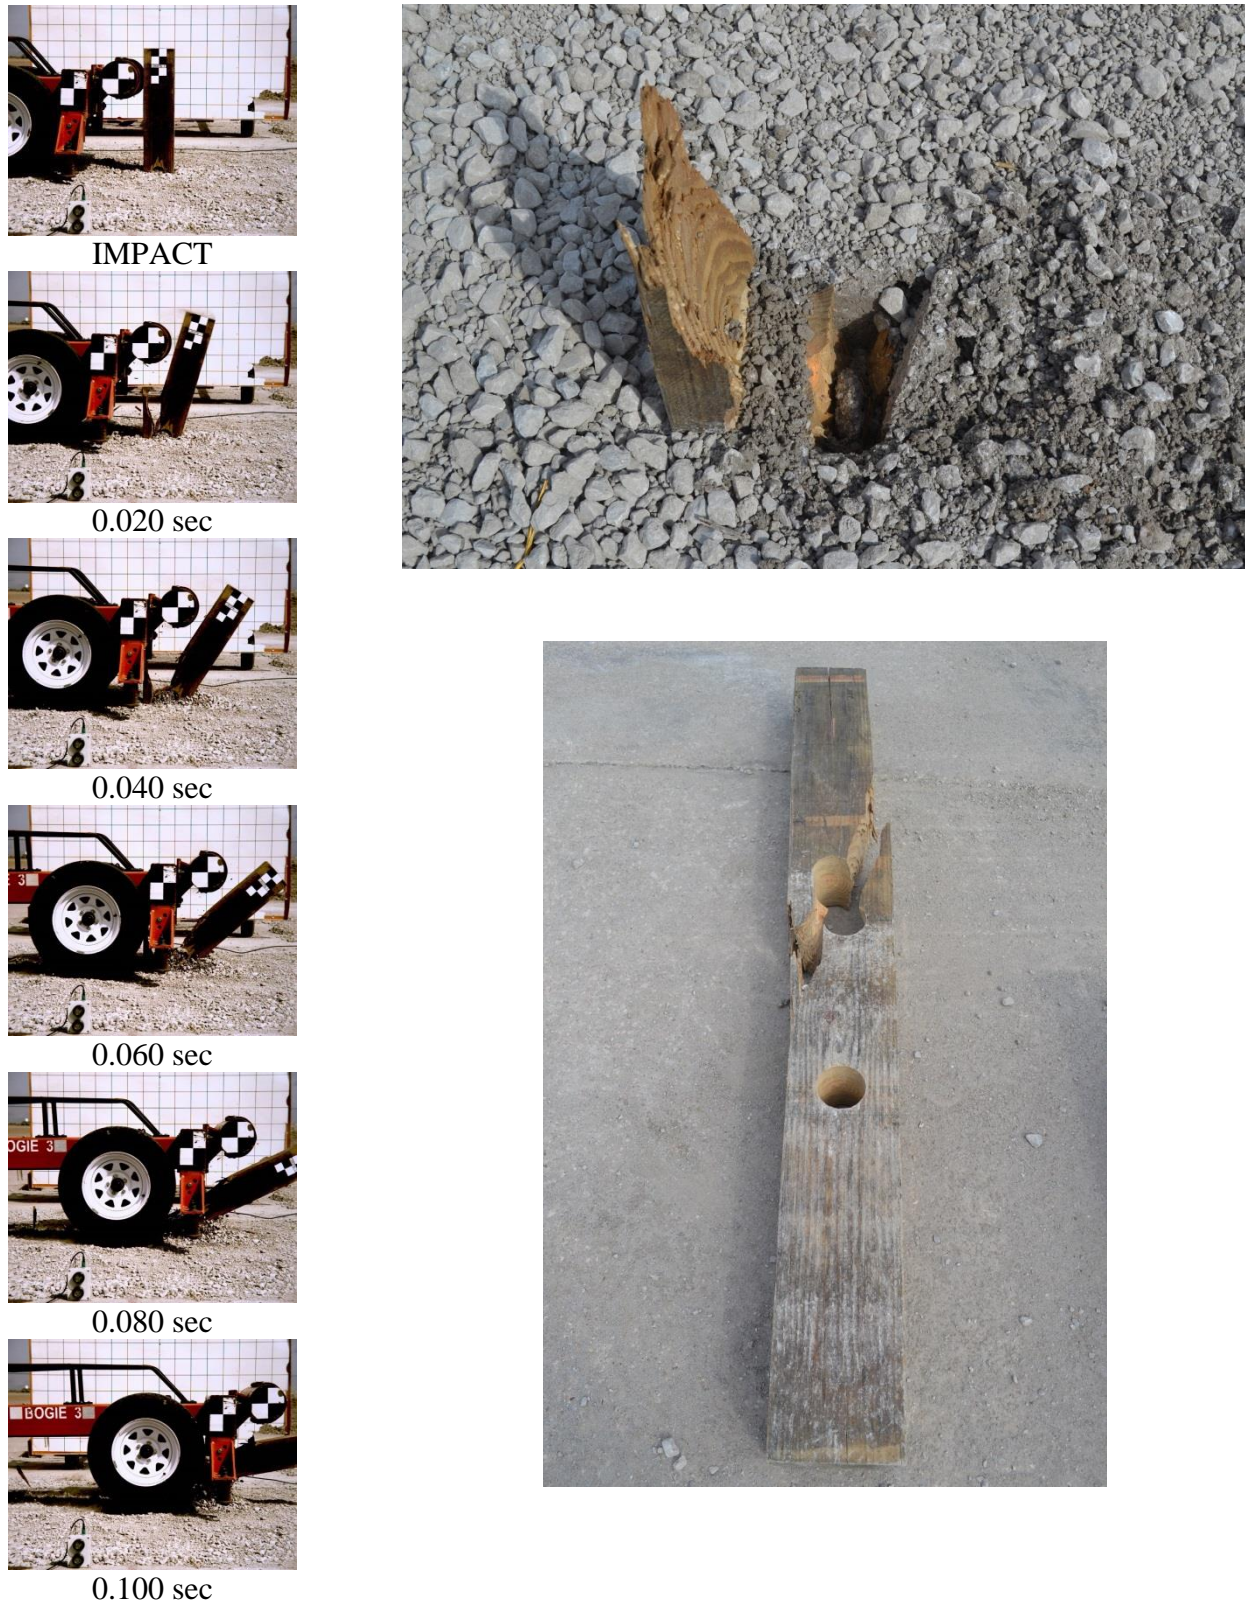
Figure 13. Time-Sequential and Post-Impact Photographs, Test No. UBSPB-1

During test no. UBSPB-1, the bogie impacted the CRT wood post, which created strong-axis bending a speed of 21.1 mph (34.0 km/h). Initially, the post began to rotate backward. However, by 8 ms, the post began to fracture. The top of the post continued to rotate backward until the bogie overrode it. Upon post-test examination, the post was found to have fractured through the hole at ground level.

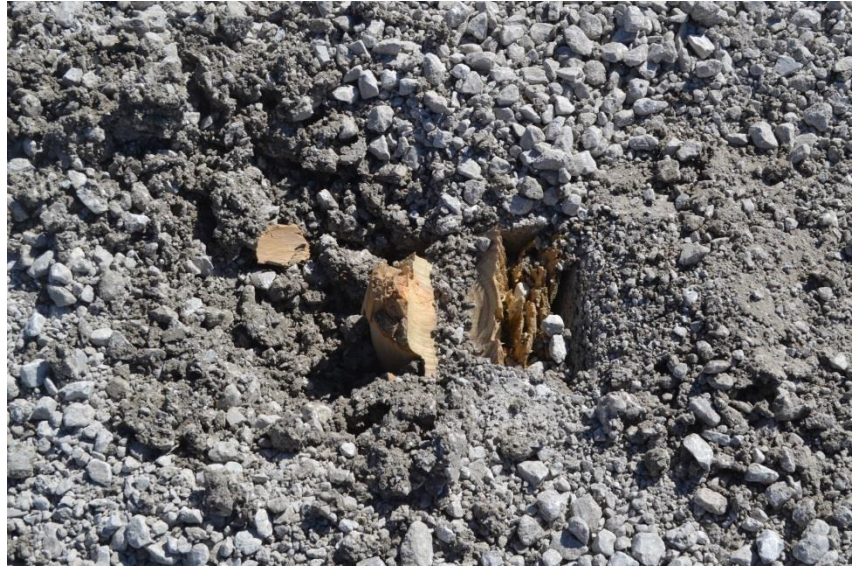
Figure 16. Time-Sequential and Post-Impact Photographs, Test No. UBSPB-2

During test no. UBSPB-2, the bogie impacted the CRT wood post, which created strong-axis bending at a speed of 21.2 mph (34.1 km/h). Initially, the post began to rotate backward. However, by 13 ms, the post began to fracture. The top of the post continued to rotate backward until the bogie lost contact with it and overrode it. Upon post-test examination, the post fractured through the hole at ground level.

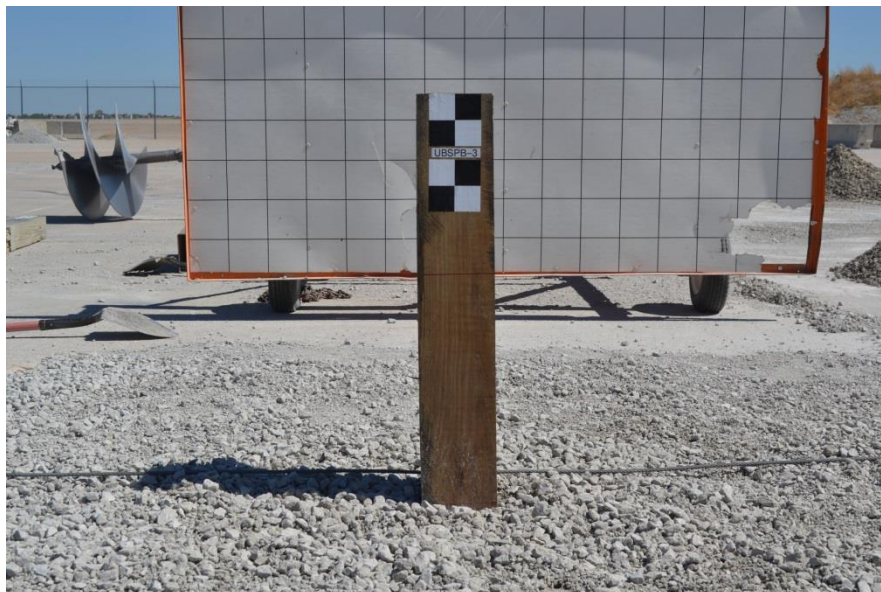
Figure 18. Pre-Test Photograph, Test No. UBSPB-3

Force vs. deflection and energy vs. deflection curves created from the SLICE accelerometer data are shown in Figure 17. The post reached a peak force of 11.1 kips (49.4 kN) at 1.7 in. (43 mm) of deflection. Around 7 in. (178 mm) of deflection, the force quickly dropped and then gradually decreased to zero. At a deflection of 36.4 in. (925 mm), the post absorbed 101.8 kip-in. (11.5 kJ) of energy. A pre-test photograph is shown in Figure 18. Time-sequential and post-impact photographs are shown in Figure 19.

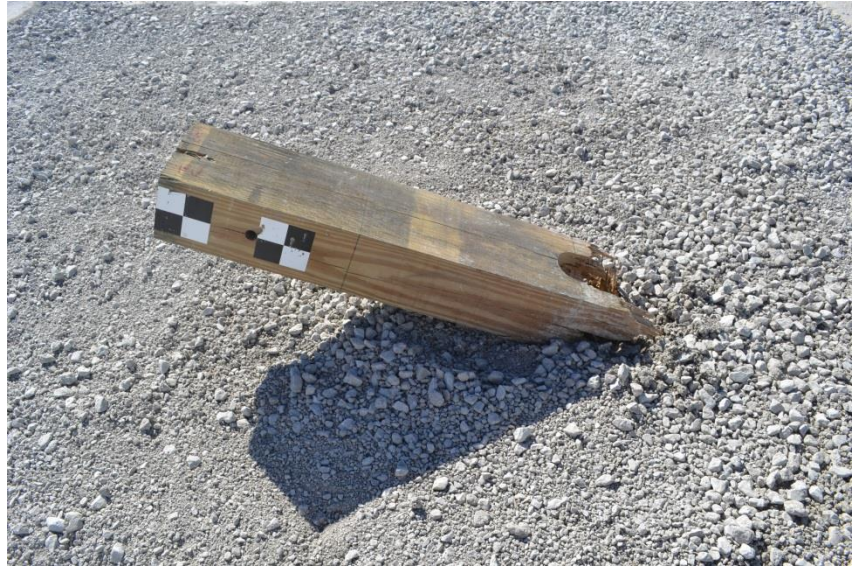
Figure 22. Time-Sequential and Post-Impact Photographs, Test No. UBSPB-4

During test no. UBSPB-4, the bogie impacted the CRT wood post, which created weak-axis bending at a speed of 20.9 mph (33.6 km/h). Initially, the post began to rotate backward. However, by 13 ms, the post began to fracture. The top of the post continued to rotate backward until the bogie lost contact with it at 54 ms. Upon post-test examination, the post fractured on the front face through the hole at ground level, but it did not fracture completely through the post and remained attached on the backside.

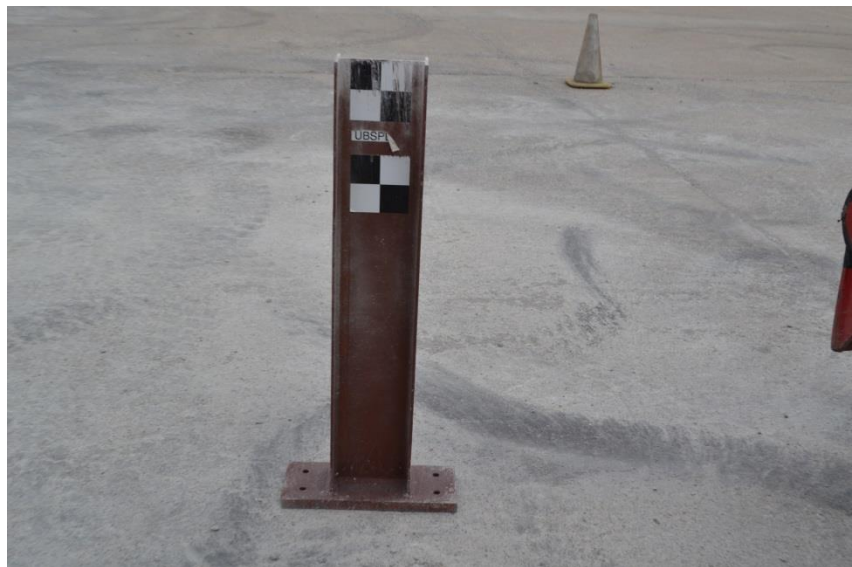
Figure 25. Time-Sequential and Post-Impact Photographs, Test No. UBSPB-5

Test no. UBSPB-5 was a strong-axis impact on the UBSP. The bogie impacted the UBSP at a speed of 21.3 mph (34.3 km/h). Upon impact, the UBSP began to rotate in the soil until the impact-side bolts released in tension at approximately 12 ms. The bogie continued to rotate the top section of the UBSP until the non-impact-side bolts fractured at approximately 66 ms, which corresponded to a deflection of approximately 23.9 in. (607 mm). Following the release of the post, the bogie continued downstream and overrode the post.

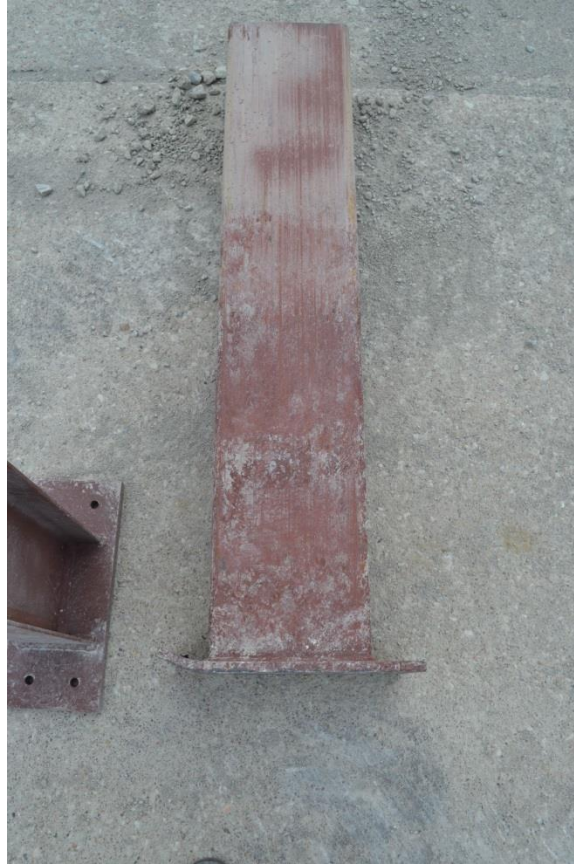
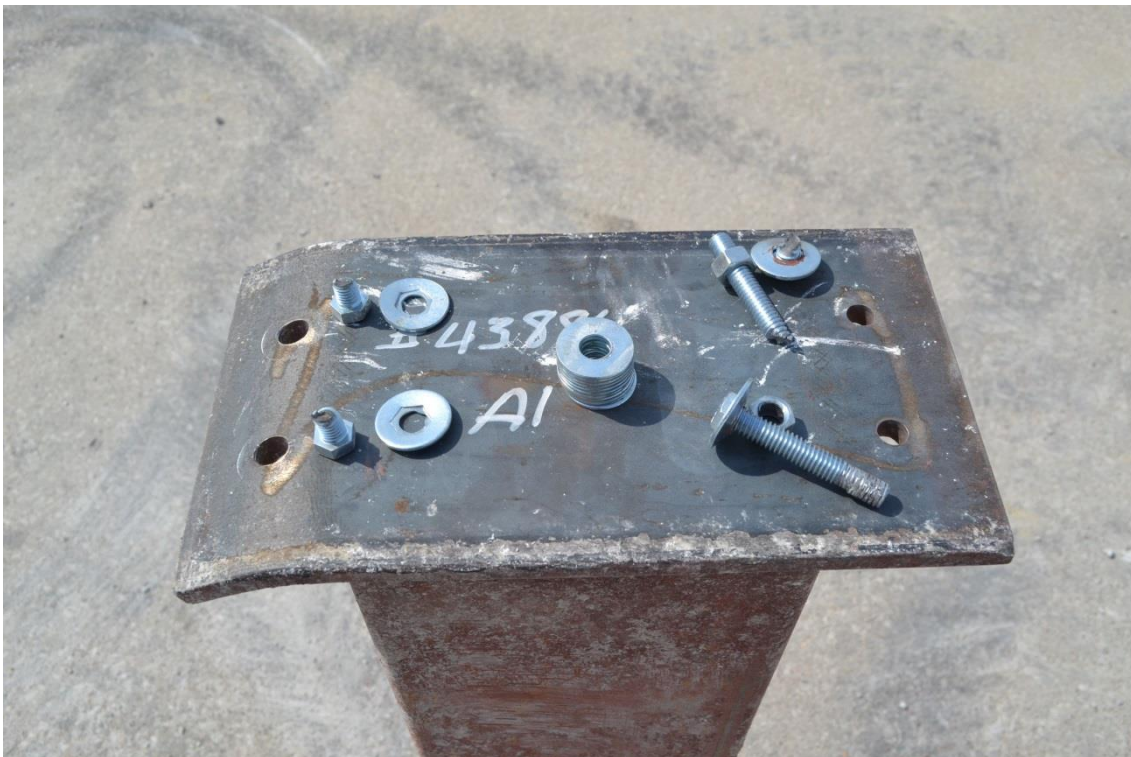
Figure 26. Bolts and Lower Base Plate, Test No. UBSPB-5

Damage to the UBSP is shown in Figure 26. Upon post-test examination, it was found that three of the four bolts had fractured in tension. The remaining bolt, which was located on the impact-side, was stripped of its threads as the nut slid off. The non-impact side of the bottom post plate was bent downward. The upper section and lower tube section did not experience noticeable deformation.

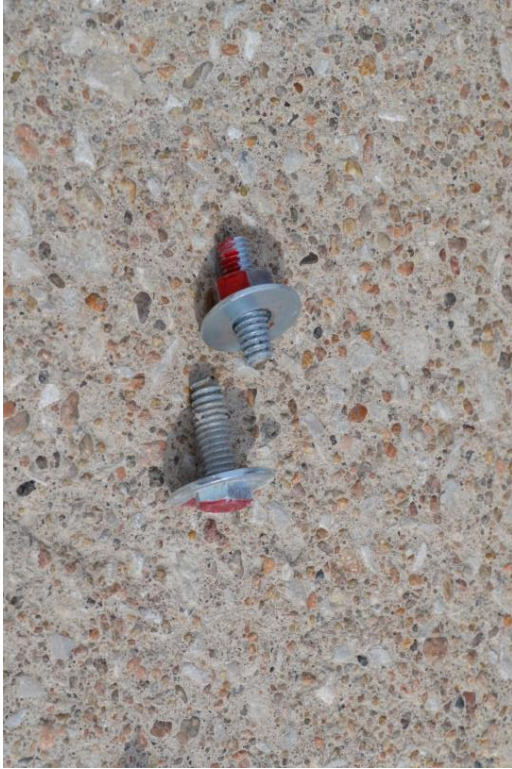
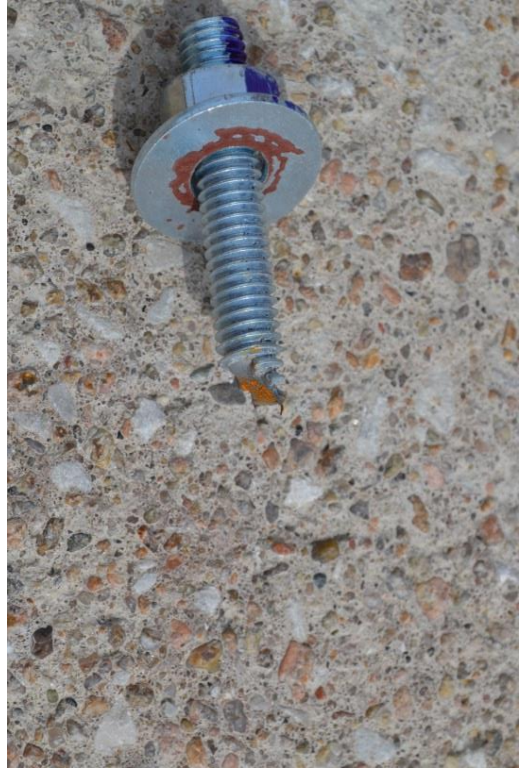
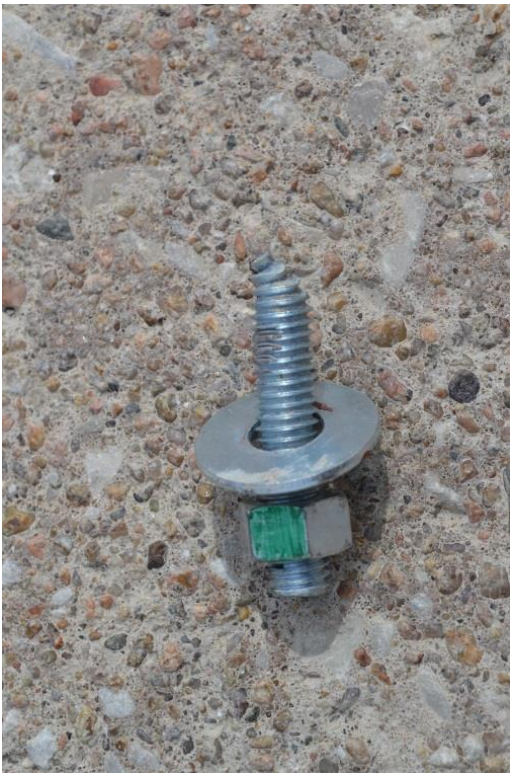
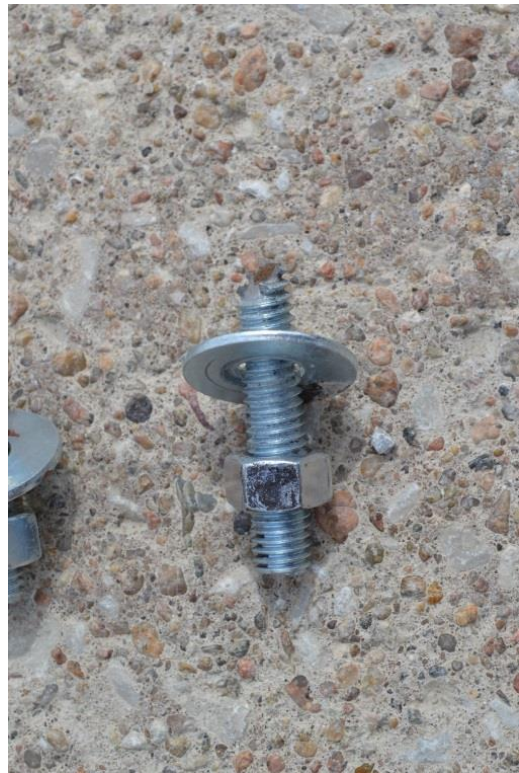
Figure 30. Fractured Bolts, Test No. UBSPB-6

Damage to the UBSP is shown in Figure 29, and the fractured bolts are shown in Figure 30. Upon post-test examination, all four bolts had fractured in tension. The non-impact side of the bottom post plate was bent downward. The top post plate and lower tube did not experience noticeable deformation.

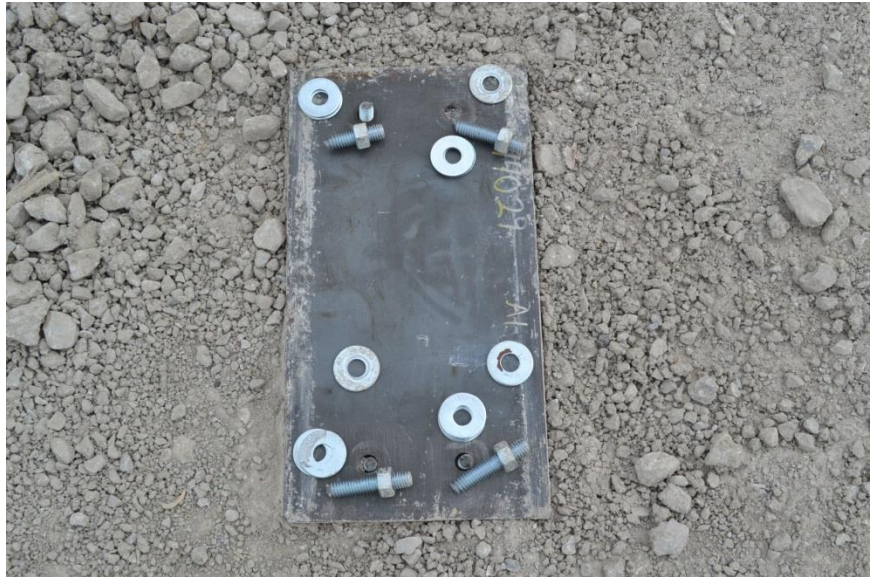
Figure 33. Time-Sequential and Post-Impact Photographs, Test No. UBSPB-7

Test no. UBSPB-7 was a weak-axis impact of the UBSP. The bogie impacted the UBSP at a speed of 20.2 mph (32.5 km/h). Upon impact, the UBSP began to rotate in the soil until the impact-side bolts fractured in tension at approximately 14 ms. The bogie continued to rotate the top section of the UBSP until the non-impact-side bolts fractured at approximately 26 ms, which corresponded to a deflection of approximately 12.7 in. (323 mm).

Fractured bolts are shown in Figure 33. Upon post-test examination, all four bolts had fractured in tension, and the top of the post was bent slightly. The top post plate did not experience noticeable deformation. The lower section of the post was undamaged and displaced very little in the soil. The previous research with the UBSP in the three beam bullnose had noted similar behavior in the full-scale testing [9]. At that time, the researchers noted that if the lower section was undamaged and had displaced less than ½ in. (13 mm), then the bottom section could be reset without removing the post by tamping around the base. In order to further investigate this recommendation, test no. UBSPB-8 was conducted with the same base as UBSPB-7 after re-compacting the soil around the post.

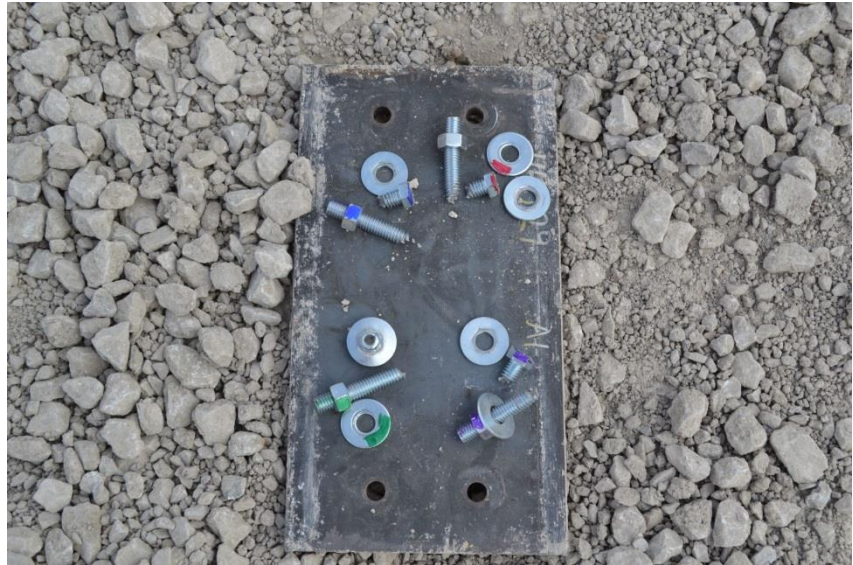
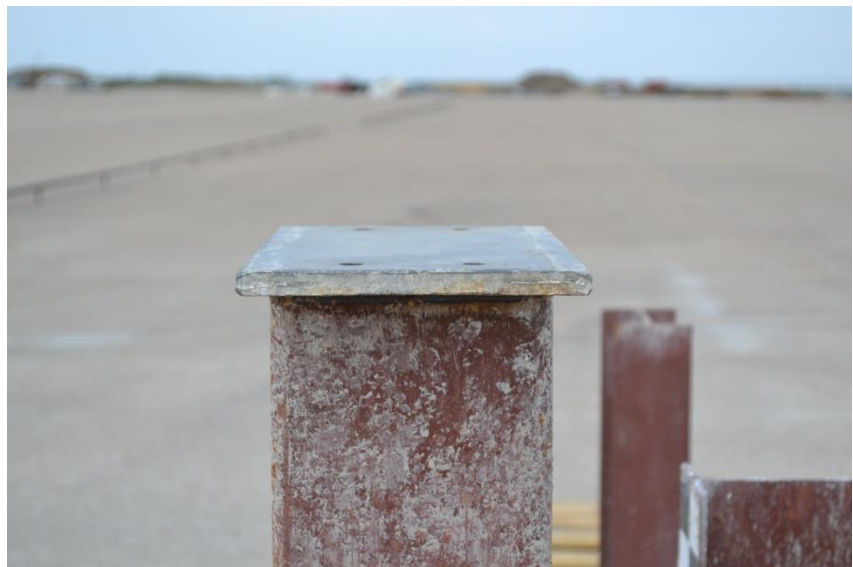
Figure 36. Time-Sequential and Post-Impact Photographs, Test No. UBSPB-8

Test no. UBSPB-8 was a weak-axis impact on the UBSP after re-compacting the soil around the lower section of the post from test no. UBSPB-7. The bogie impacted the UBSP at a speed of 19.4 mph (31.2 km/h). Upon impact, the UBSP began to rotate in the soil until the impact-side bolts fractured in tension at approximately 12 ms. The bogie continued to rotate the top section of the UBSP until the non-impact-side bolts fractured at approximately 24 ms, which corresponded to a deflection of approximately 13.9 in. (353 mm).

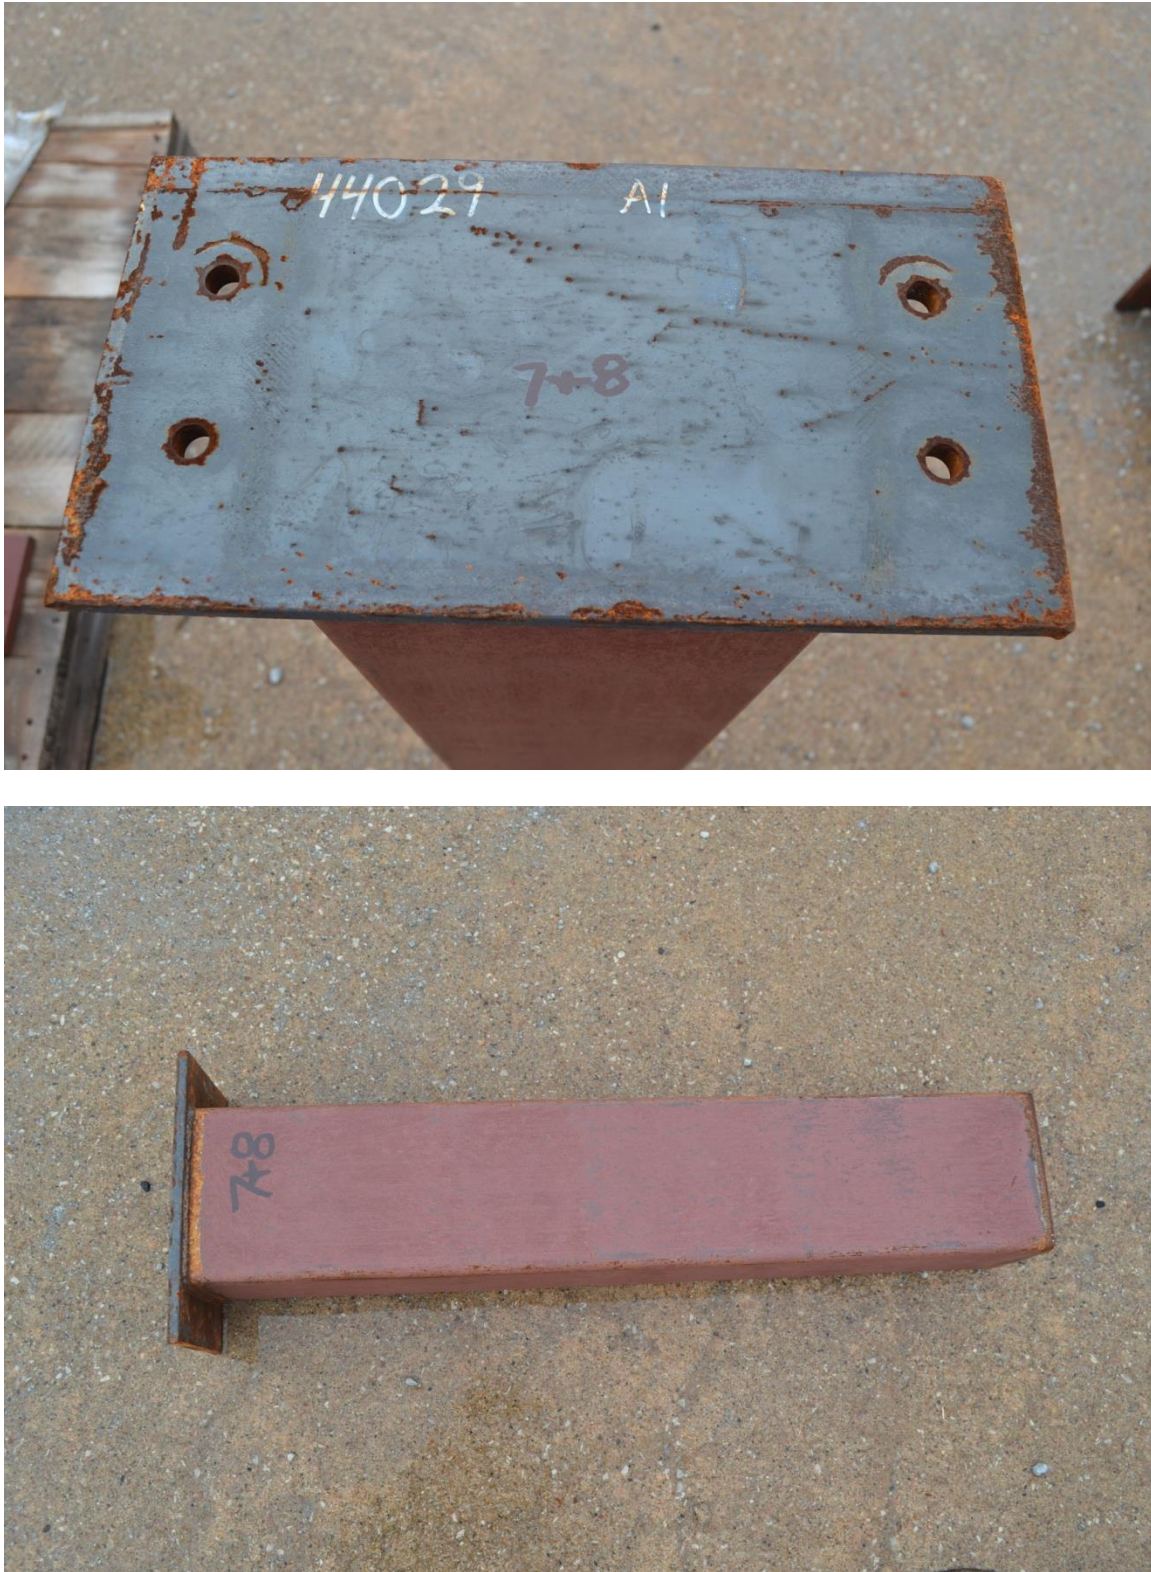
Figure 37. Lower Section and Base Plate, Test No. UBSPB-8

Damage to the UBSP is shown in Figures 37 and 38. Upon post-test examination, it was found that all four bolts had fractured in tension. The top of the post and bottom of the post did not experience noticeable deformation.

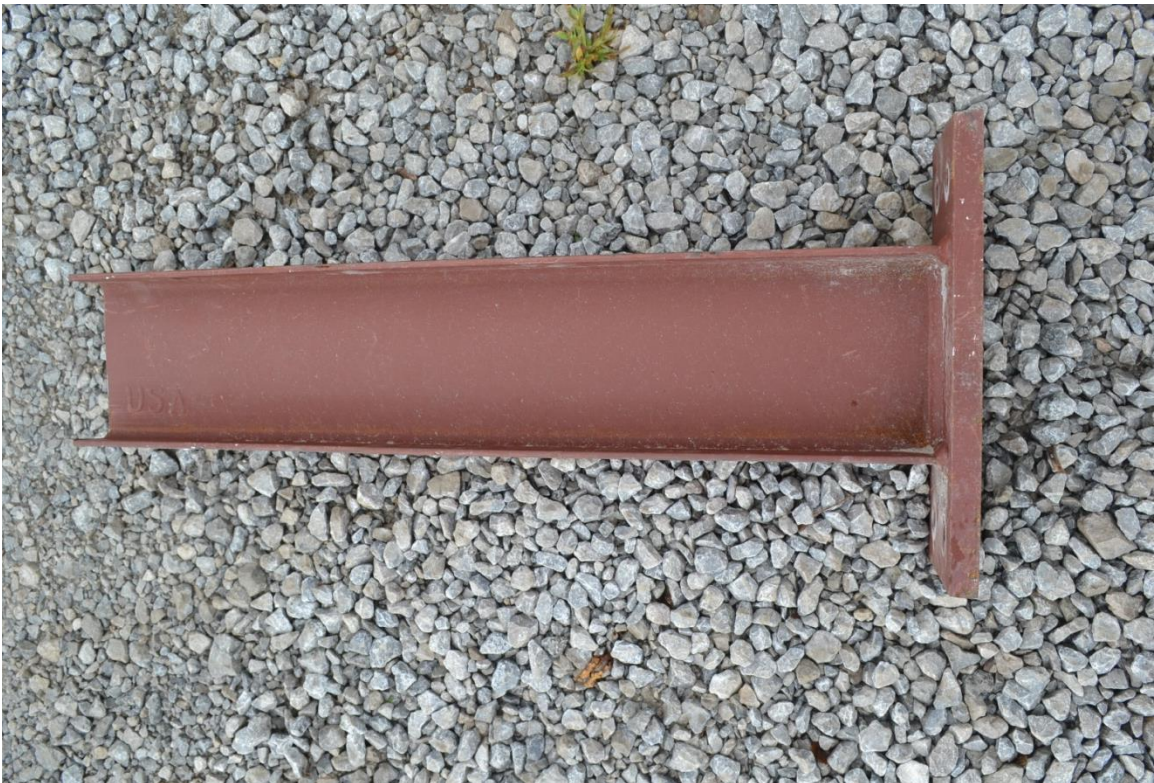
Figure 38. Top Section, Test No. UBSPB-8

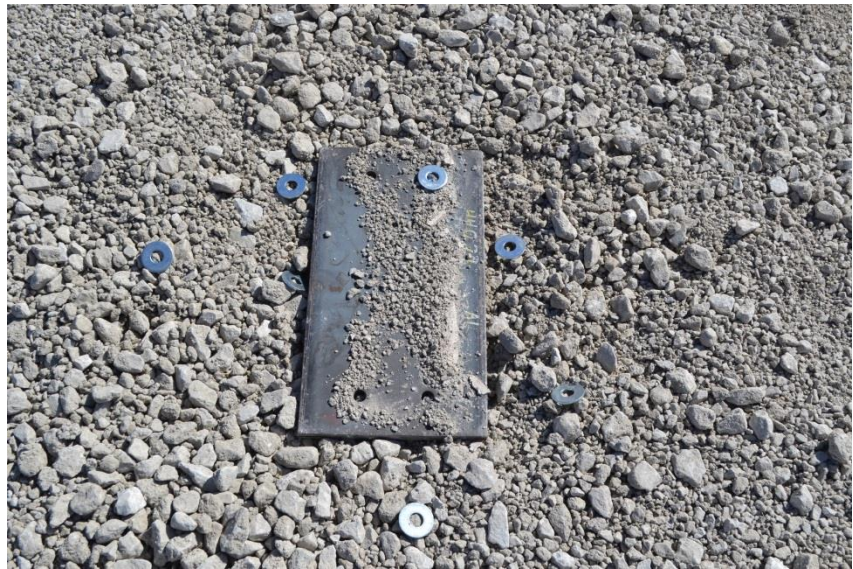
Figure 41. Time-Sequential and Post-Impact Photographs, Test No. UBSPB-8B

Test no. UBSPB-8B was a weak-axis impact on the UBSP. The bogie impacted the UBSP at a speed of 21.3 mph (34.3 km/h). Upon impact, the UBSP began to rotate in the soil until the impact-side bolts fractured in tension at approximately 12 ms. The bogie continued to rotate the top section of the UBSP until the non-impact-side bolts fractured at approximately 22 ms, which corresponded to a deflection of approximately 17.3 in. (439 mm).

Upon post-test examination, all four bolts had fractured in tension. The top of the post and bottom of the post did not experience noticeable deformation.
