Cable Median Barrier Failure Analysis and Prevention

Report # TRP-03-275-12

Final Report
25-1121-0001-428

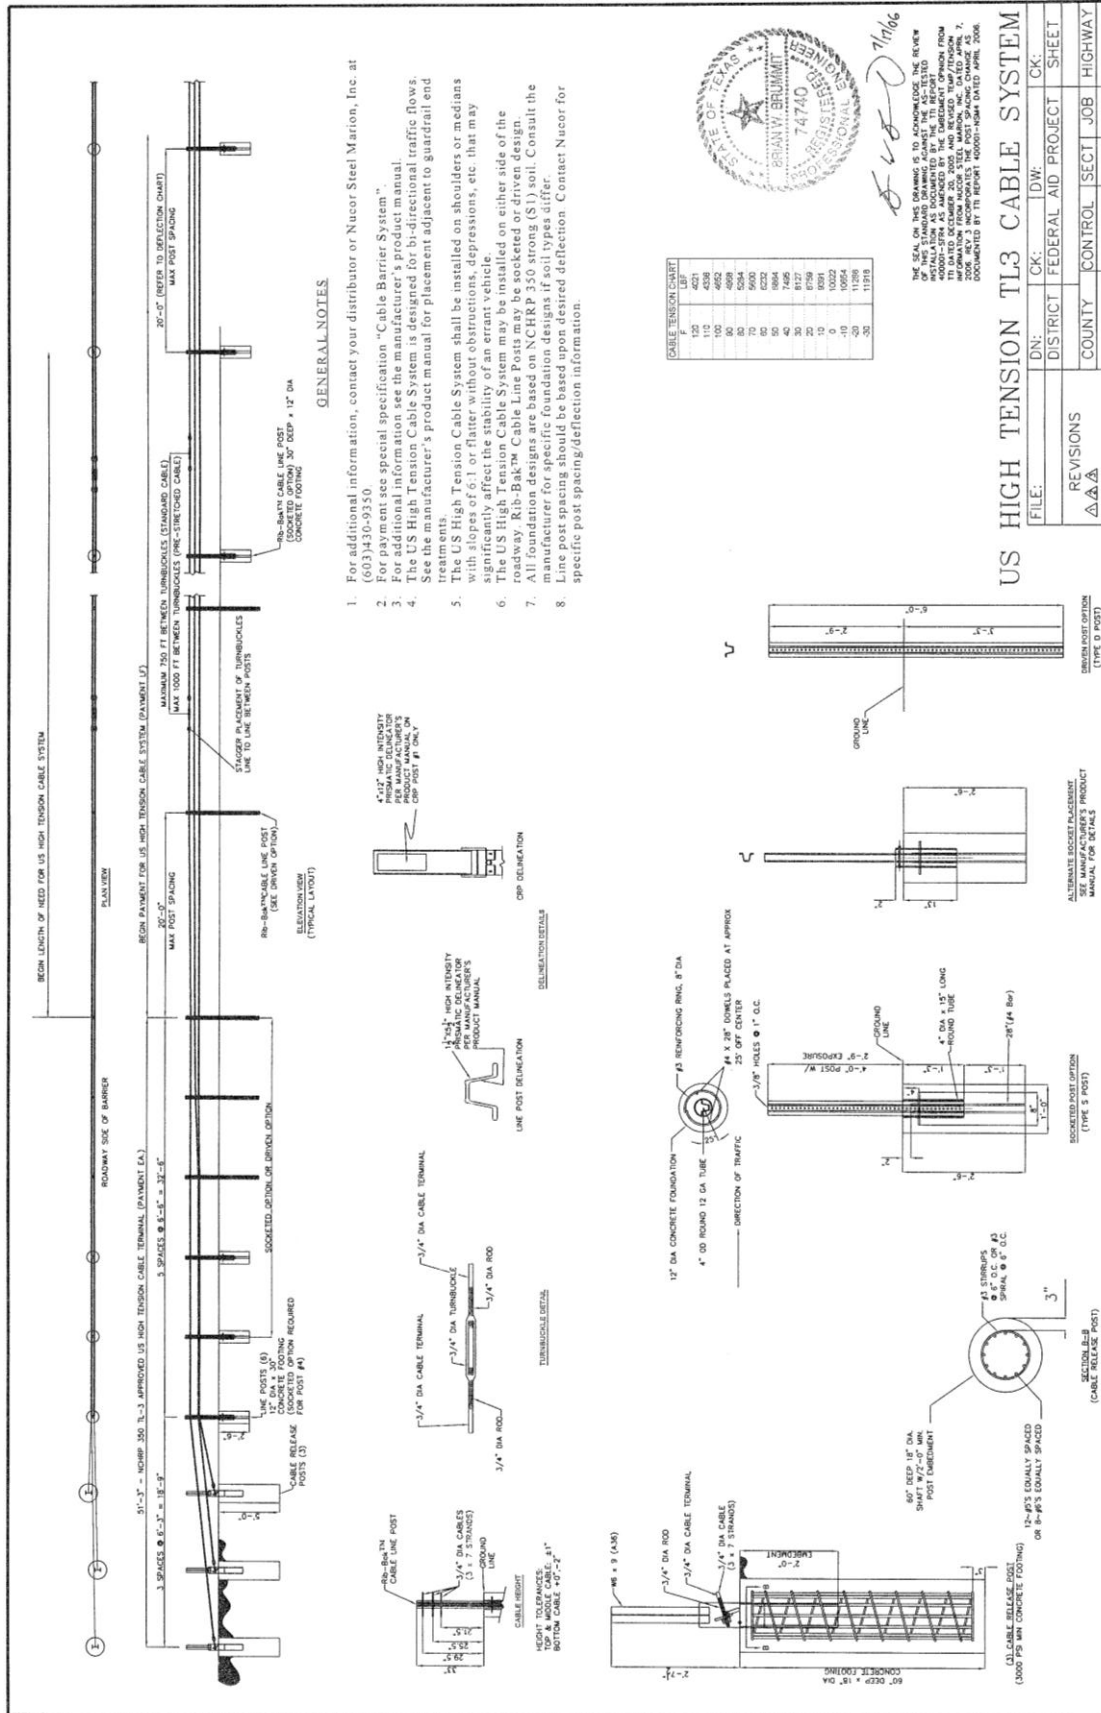
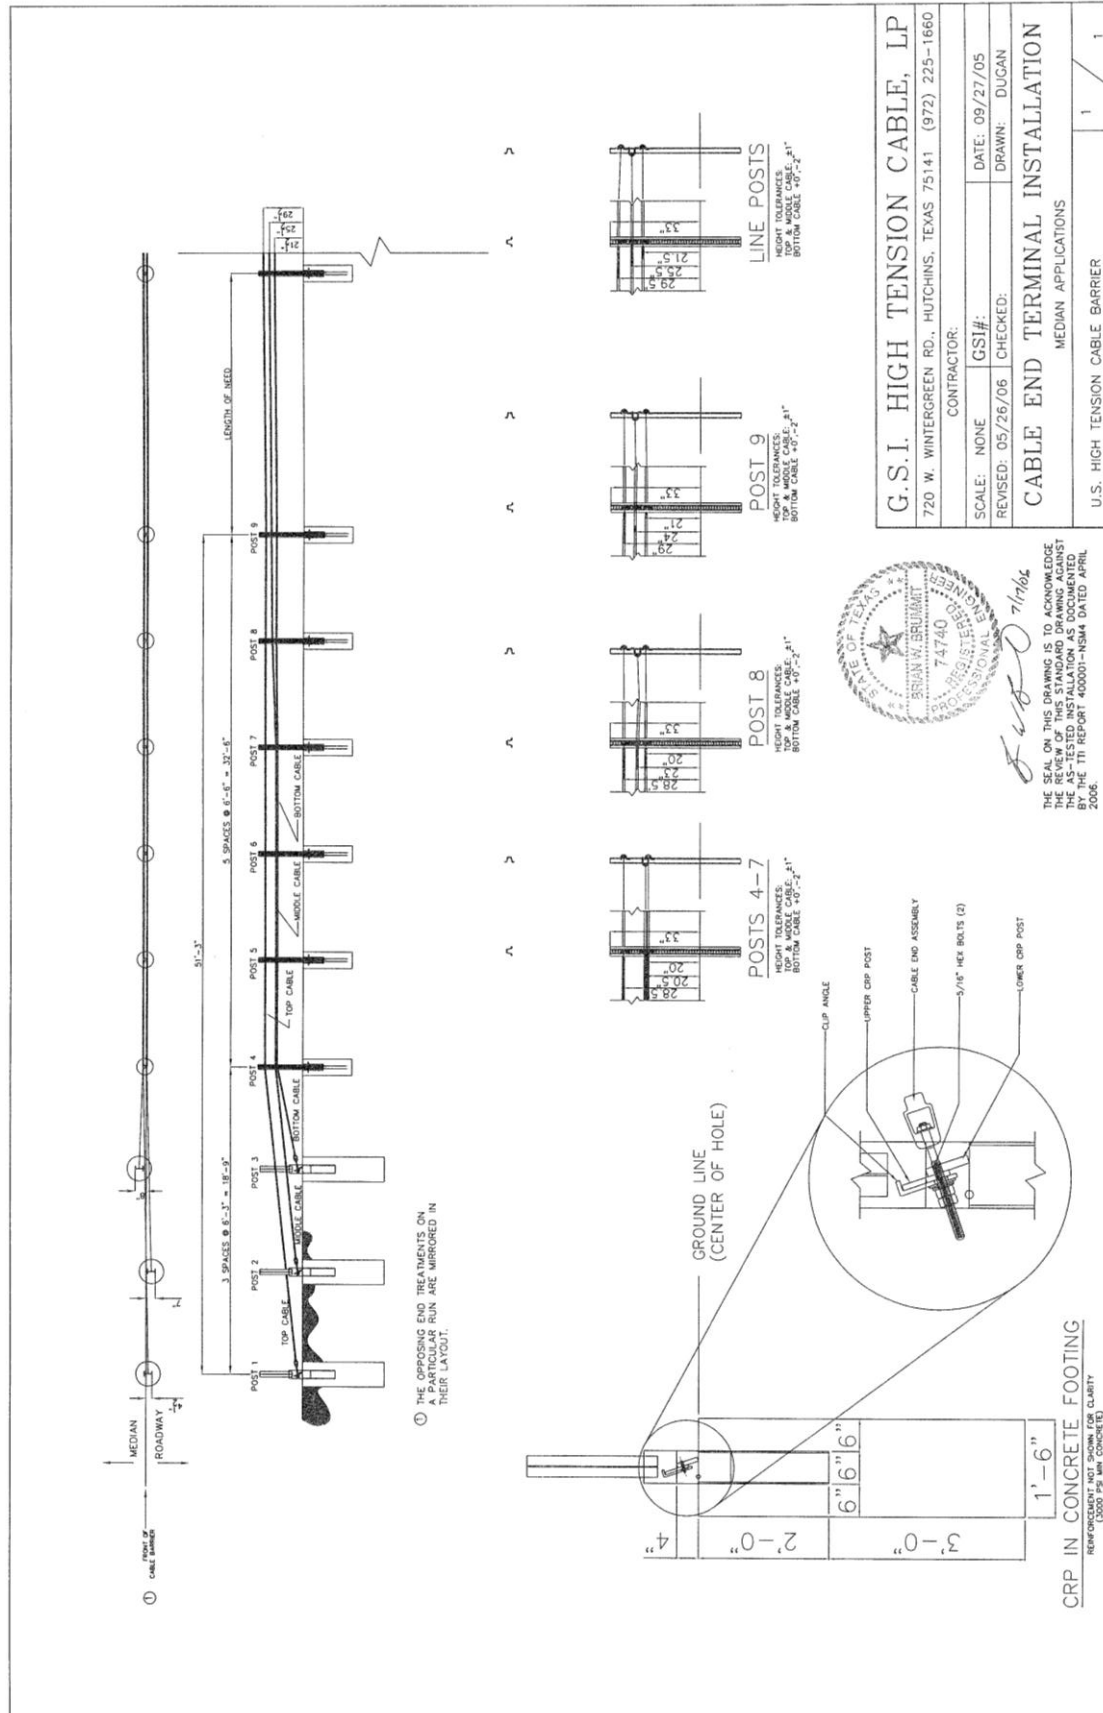
The cable-to-post attachment used by Nucor was very strong compared to all other barrier systems, and is shown in Figures 26 through 29. This cable-to-post attachment is also used in the Trinity CASS barrier, near the end anchorages and terminations.

The clips were fastened to the post by inserting the bent upper leg into the appropriate hole on the flanged U-channel, and then were locked in place with a nut threaded onto the bottom clip threads. Holes in the flanges were spaced approximately 1 in. (25 mm) on center vertically through the centerline of the flange. Many posts were 4 lb/ft (6 kg/m) flanged U-channel with Rib-Bak construction, though some installations utilized the 5 lb/ft (7 kg/m) posts. The median barrier configuration for this post utilized two short clips, shown in Figure 29, for the top and bottom cables, and one long clip, shown in Figure 28, to support the middle cable.

Since the attachment had a 60 ksi (414 MPa) minimum ultimate strength requirement, the resulting minimum tensile load required to cause rupture of the shank was 4.6 kip (20.5 kN) through a single leg. The clip appeared to be designed to dissipate energy through the bending deformation of the upper leg of the clip. During vertical pullout loading conditions, the curved

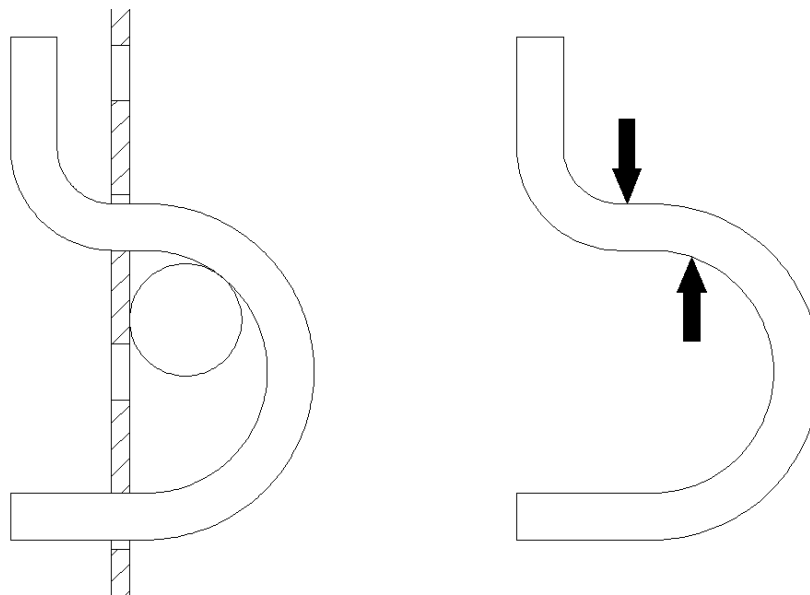
clip construction contributed to friction wedge locking of the bent leg in the top hole. Due to vertical forces, the moment couple applied to the clip tended to aggravate the locking tendency. A schematic of the vertical release problems identified is shown in Figure 30. The friction lock prevented the upper leg from bending and releasing from the post, frequently resulting in large applied tensile loads carried by both legs of the clip until the clip fractured, the post was pulled vertically out of the ground or post socket, or the post fractured. The vertical loading resulted in post pullout in most crashes.

Figure 30. Vertical Pullout Moment Couple on Nucor Cable-To-Post Attachment

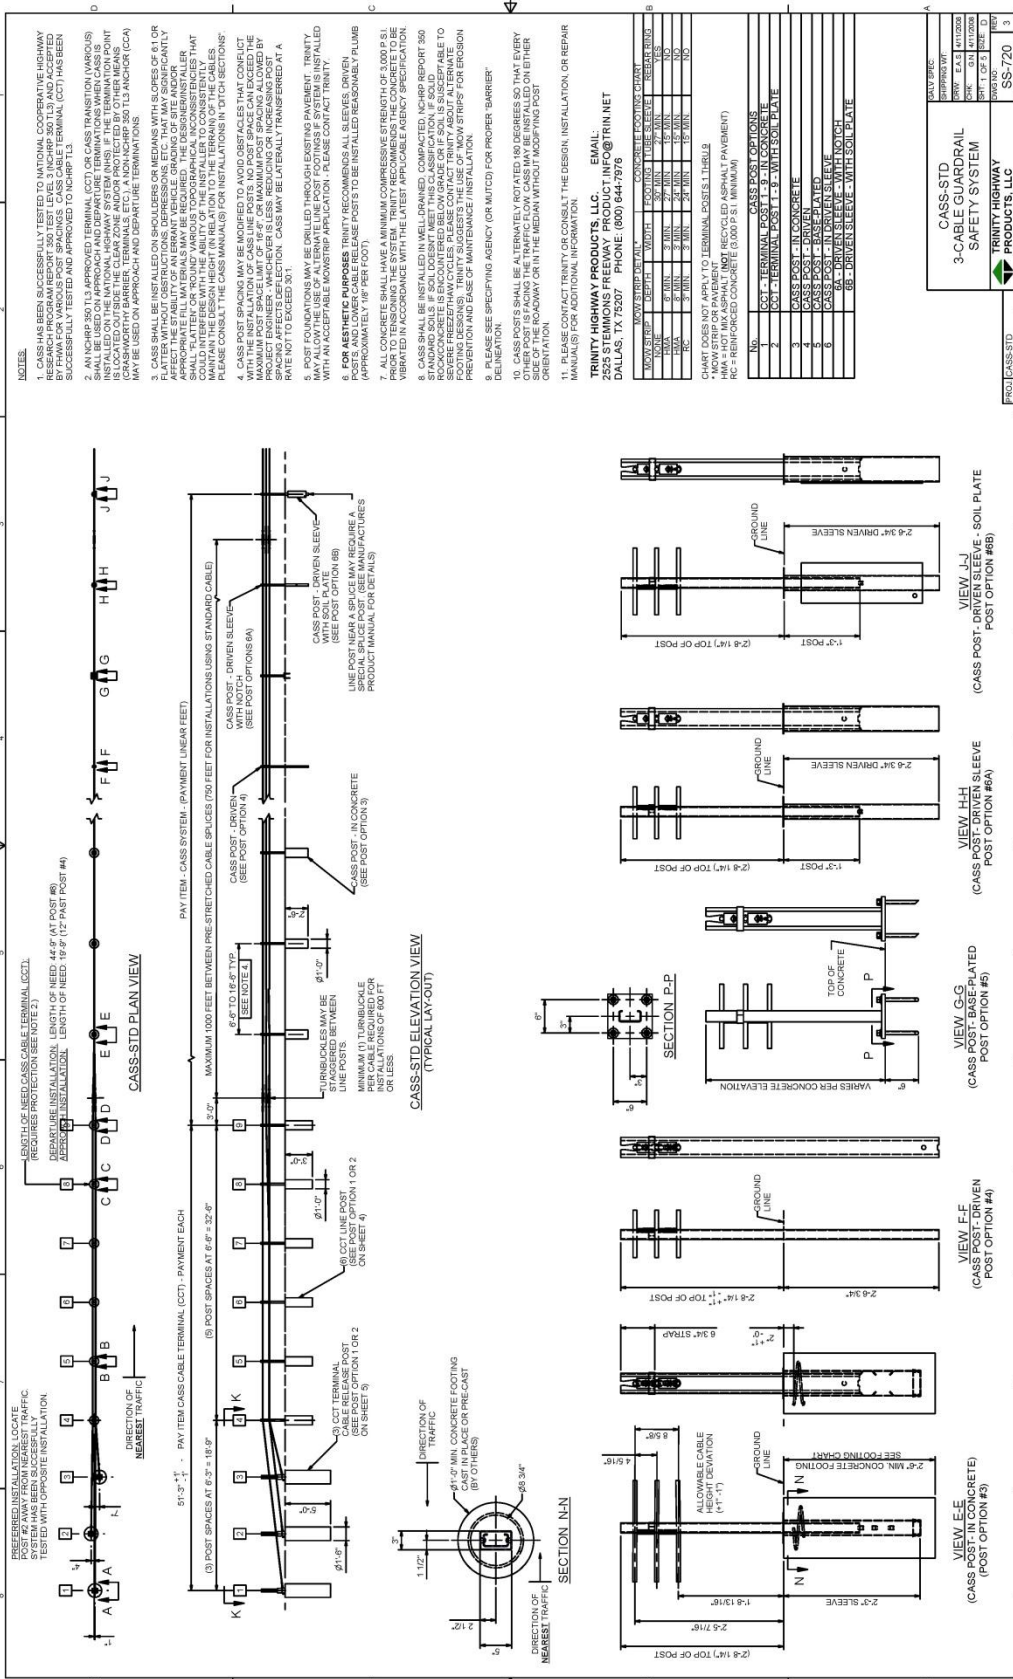
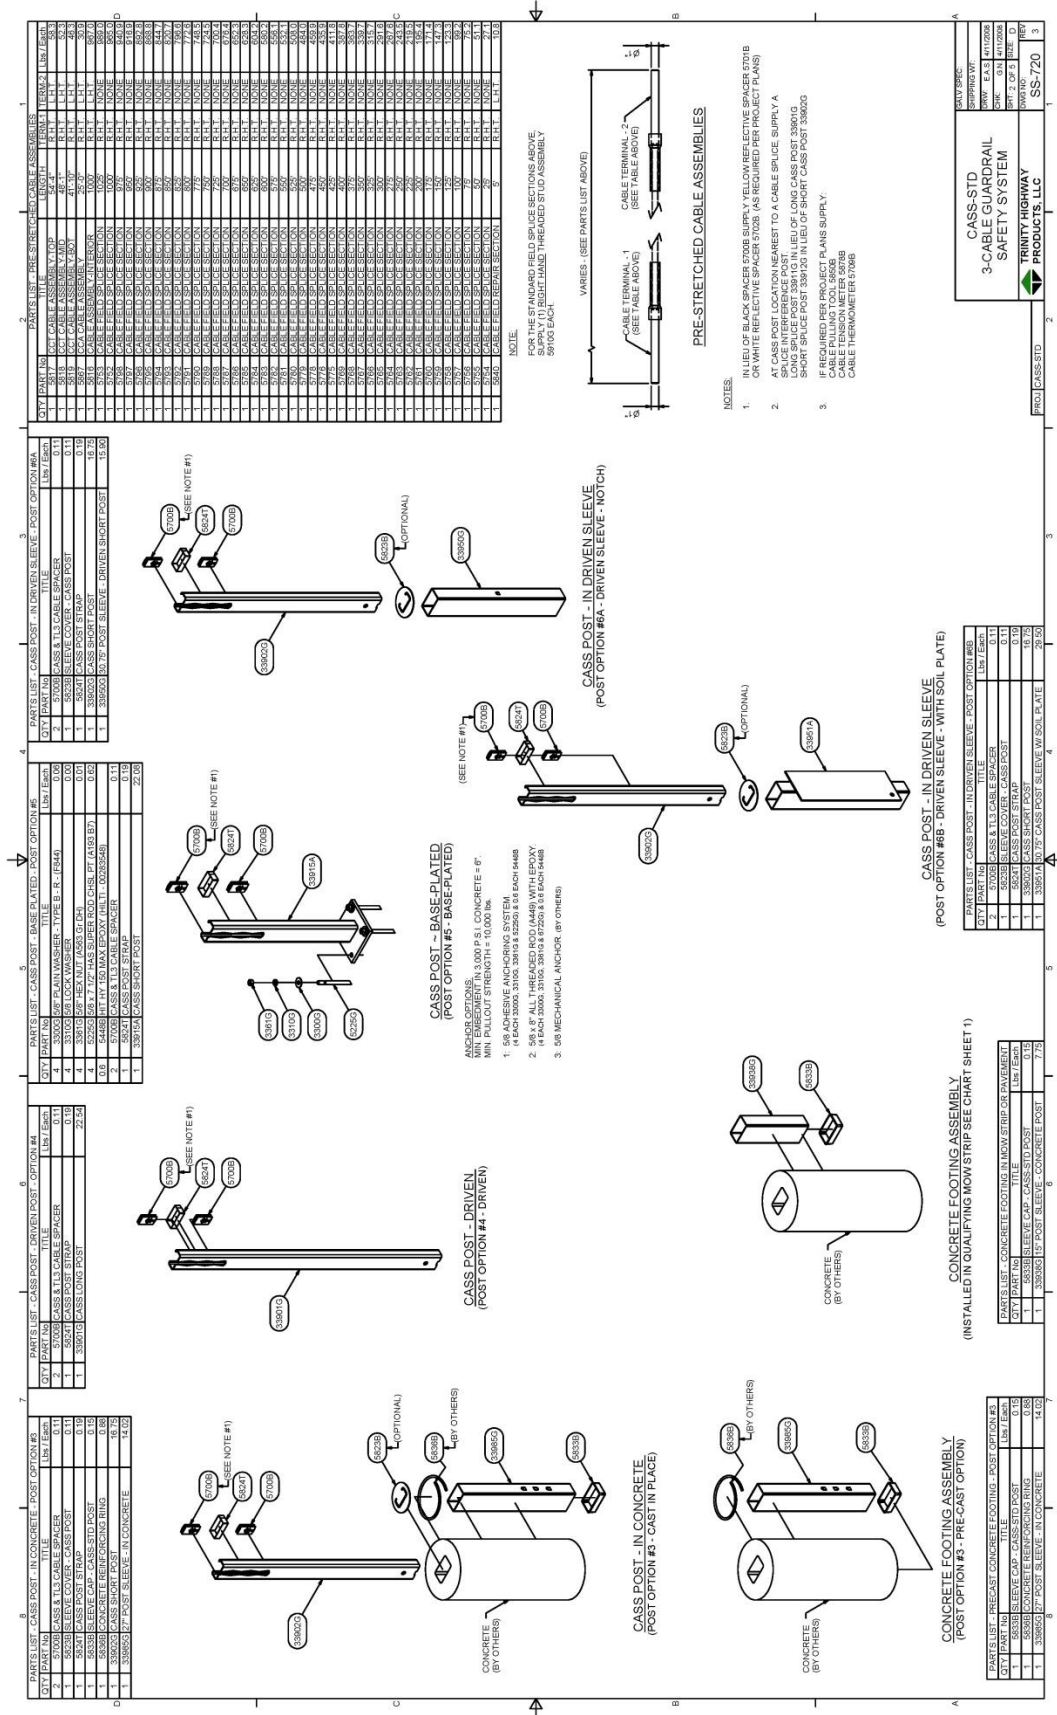
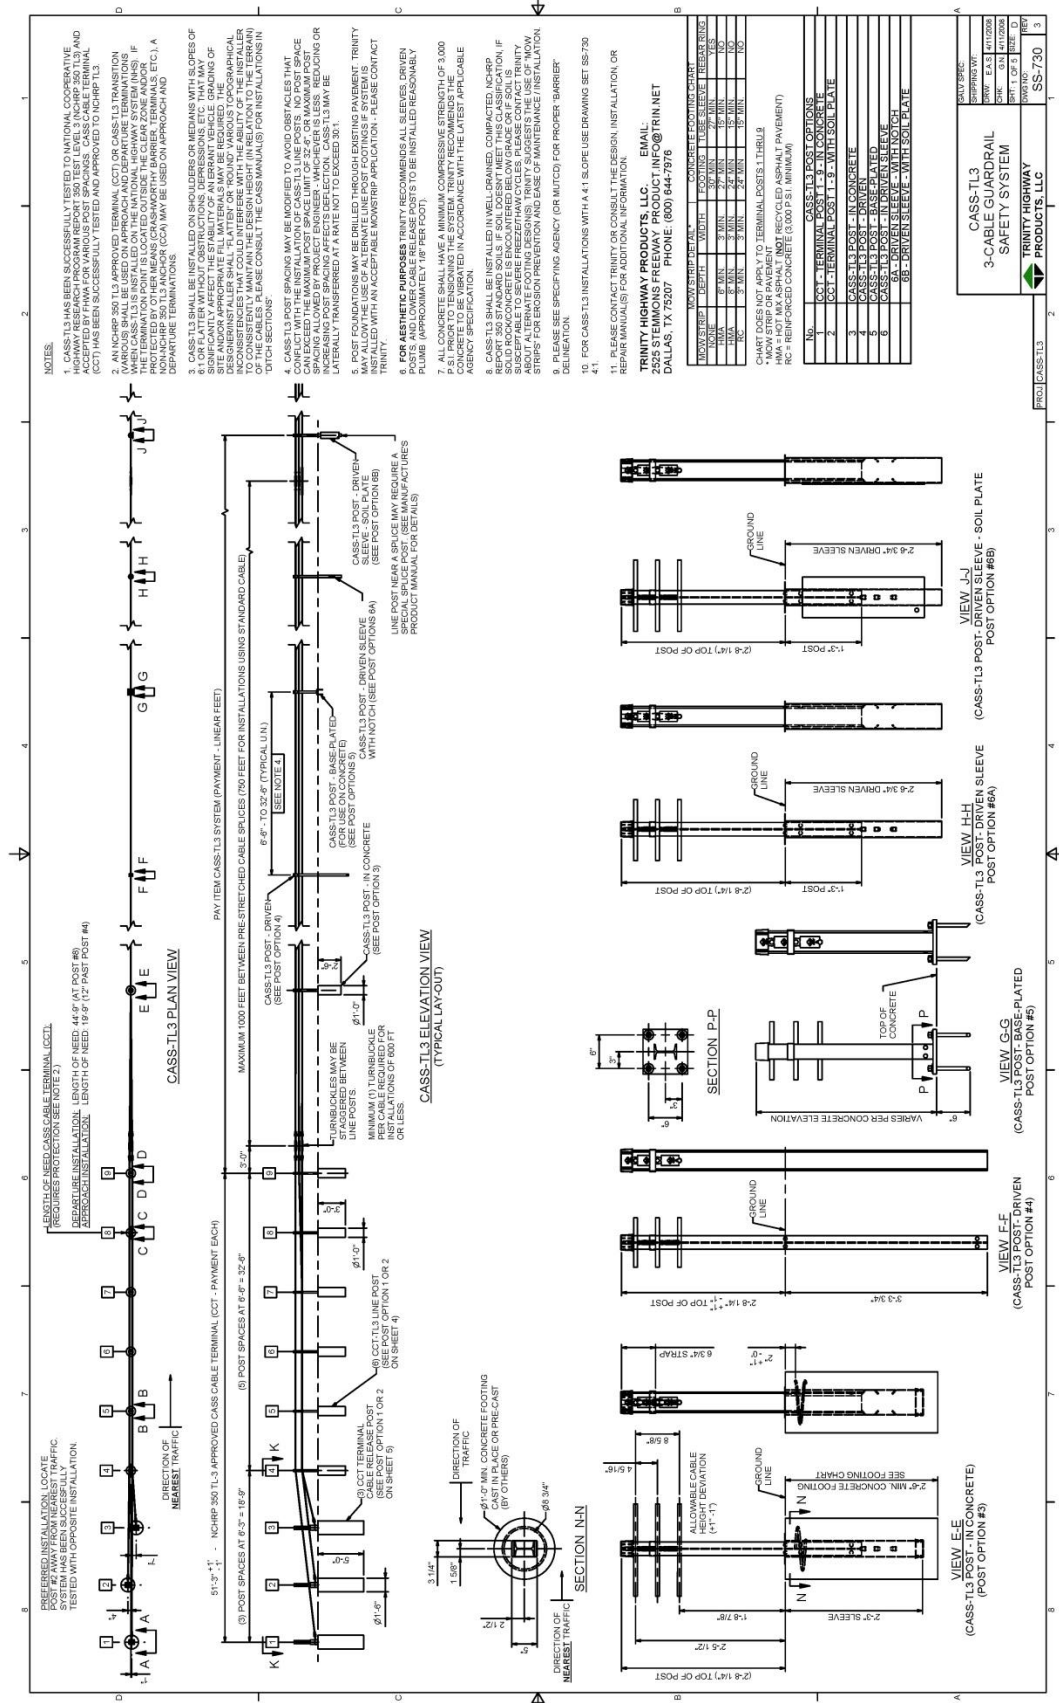
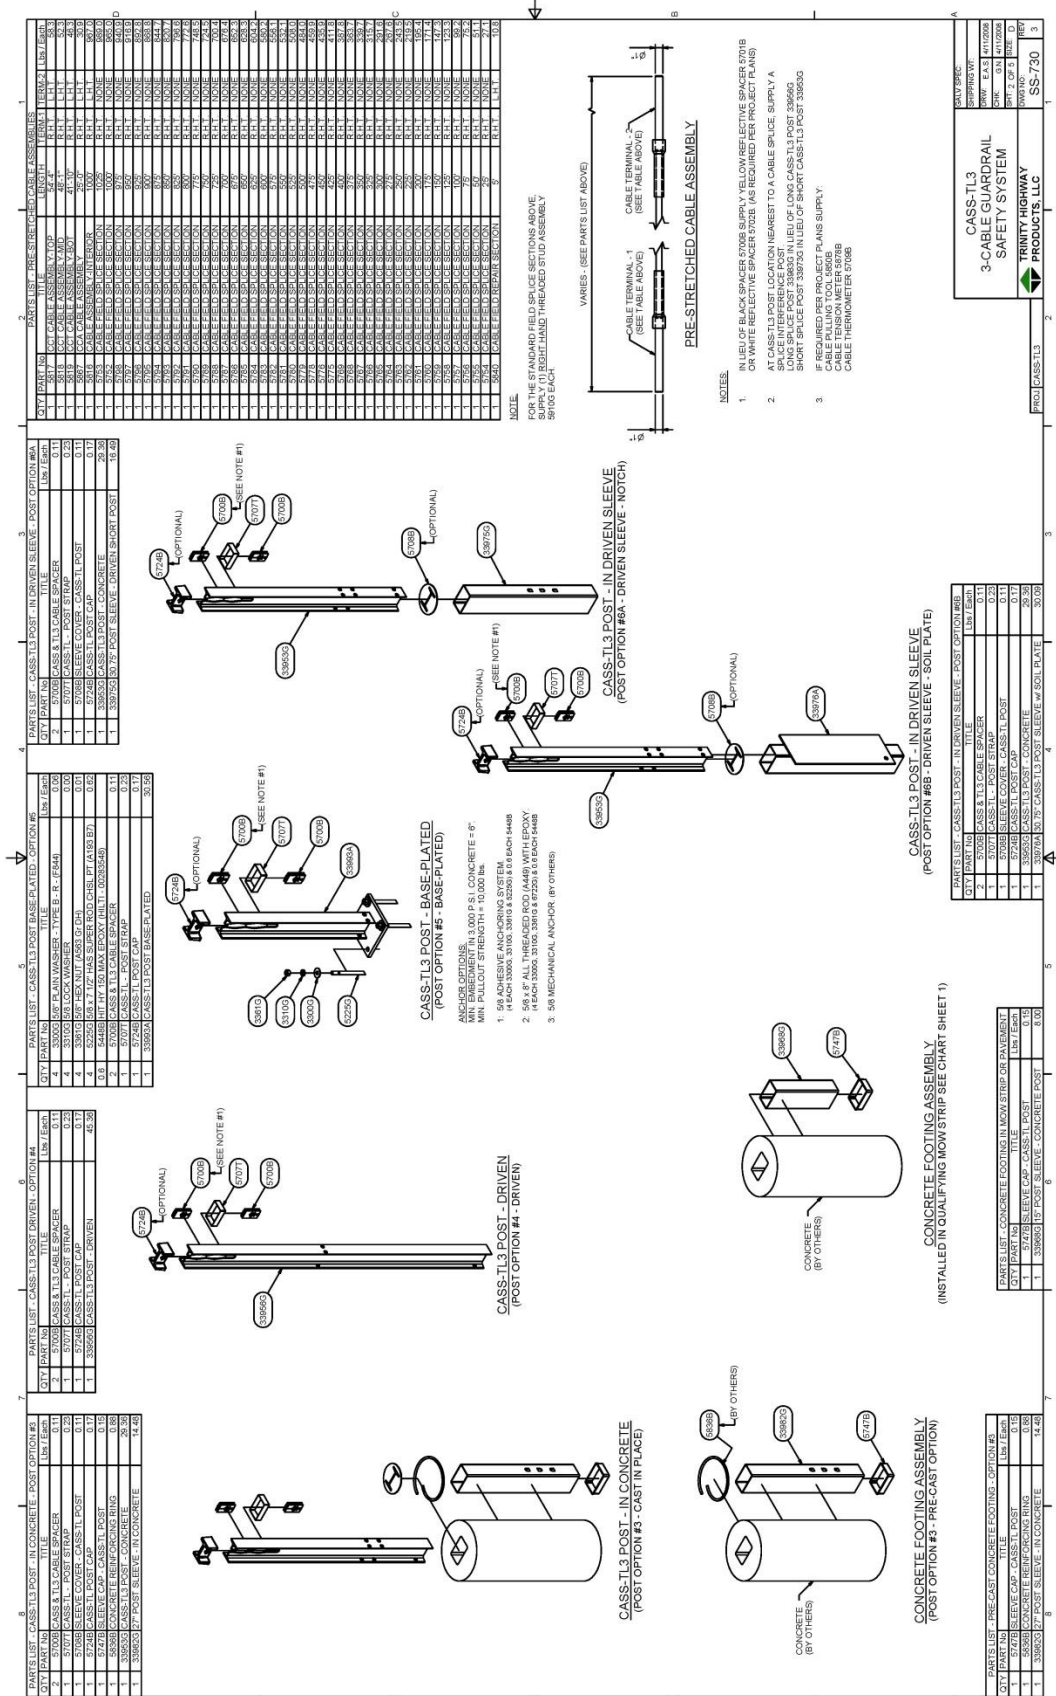
In addition to the Nucor TL-3 3-cable barrier on flange-channel posts, the Trinity CASS 3-cable barrier installed on C-shaped posts had a large installed base in the United States. CASS installations were present in such states as Iowa, Ohio, Oklahoma, Utah, and Washington, as well as many others. Details of the C-channel and S-post versions of the TL-3 CASS system are shown in Figures 31 through 34.

All of the cables in the Trinity CASS systems were located in a slot in the top of the post. Cable spacers and retainers were used to prevent the cables from slipping out of the posts in nuisance impacts. A sleeve tie was also used to retain the lower cable with a higher vertical release load and to stiffen the flanges where the web was cut. Driven and socketed options were available. The S-post TL-3 system had cables mounted at 29½, 25³/₁₆, and 20⁷/₈ in. (749, 640, and 530 mm) and are shown in Figure 33. Cables in the TL-3 C-shape post system were $\frac{1}{16}$ in.

A common cause of penetration in the CASS database occurred when the vehicle struck a post before striking the cable barrier system. Since the vehicle applied no loads to the cable at the time of impact, the only lateral load on the cables was caused by the posts; however, due to post deflection, the cables were forced down in the slot and could not release from the post and engage the vehicle, contributing to many override containment failures of even passenger cars. This type of cable entrapment will always occur when cables are located within a post slot. This form of cable entrapment was referred to as a “ramp formation” override penetration. As a result, this system may be intrinsically susceptible to cable entrapment and ramp formation override penetrations unless barrier modifications to prevent cable entrapment can be made.

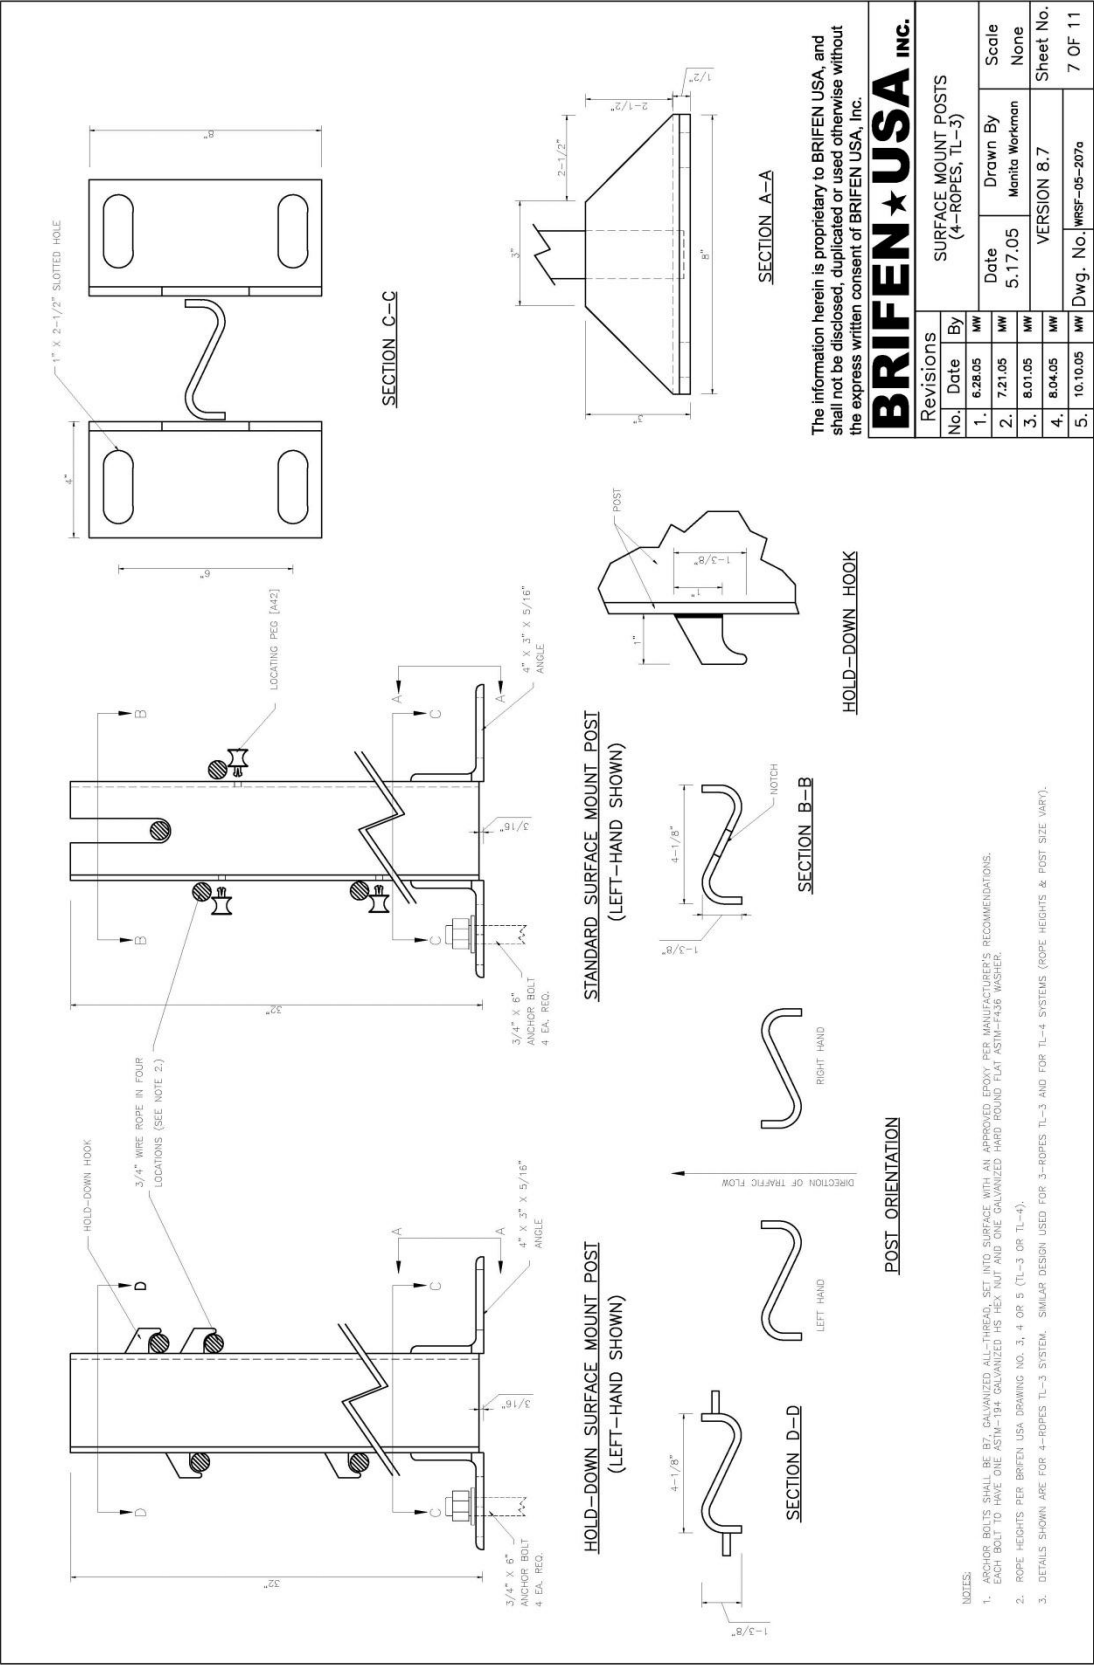
Figure 37. Typical TL-3 Brifen WRSF Surface-Mounted Post Design Details [34]

The TL-3 Brifen WRSF is typically comprised of proprietary Z-posts with rollers supporting the cables vertically, as shown in Figures 35 through 37. Virtually all Brifen systems utilize ground sockets for easy post replacement, though a post with soil plate option was also available. Four cables are used in the system, with one cable woven around the posts and mounted at $19\frac{1}{2}$ in. (495 mm), two cables cross-woven and mounted at 26 in. (660 mm), and an additional cable in a slot cut in the top of the post, mounted at $28\frac{3}{8}$ in. (720 mm).

Typically, plastic retainer caps were used to retain the top cable in the Brifen WRSF. Other cables were constrained by the interaction with adjacent posts. For each of the middle and lower cables, vertical rise was only resisted by friction, whereas the lower roller supported the cable from being pushed down by the impacting vehicle. Because of the cable weave, the Brifen cables often sagged after a moderate-speed crash into the system in which more than two posts were disengaged from the cables. The weave significantly reduced average dynamic deflections

and provided a smooth ridedown deceleration, but the system was susceptible to both rollovers and underride penetrations. Rollovers were frequently associated with wheel entrapment by the lower woven cable. Underride penetrations were frequently caused by vehicles prying the bottom cable upward, which had low vertical resistance. These factors will be discussed in greater depth in Chapters 7 and 8.

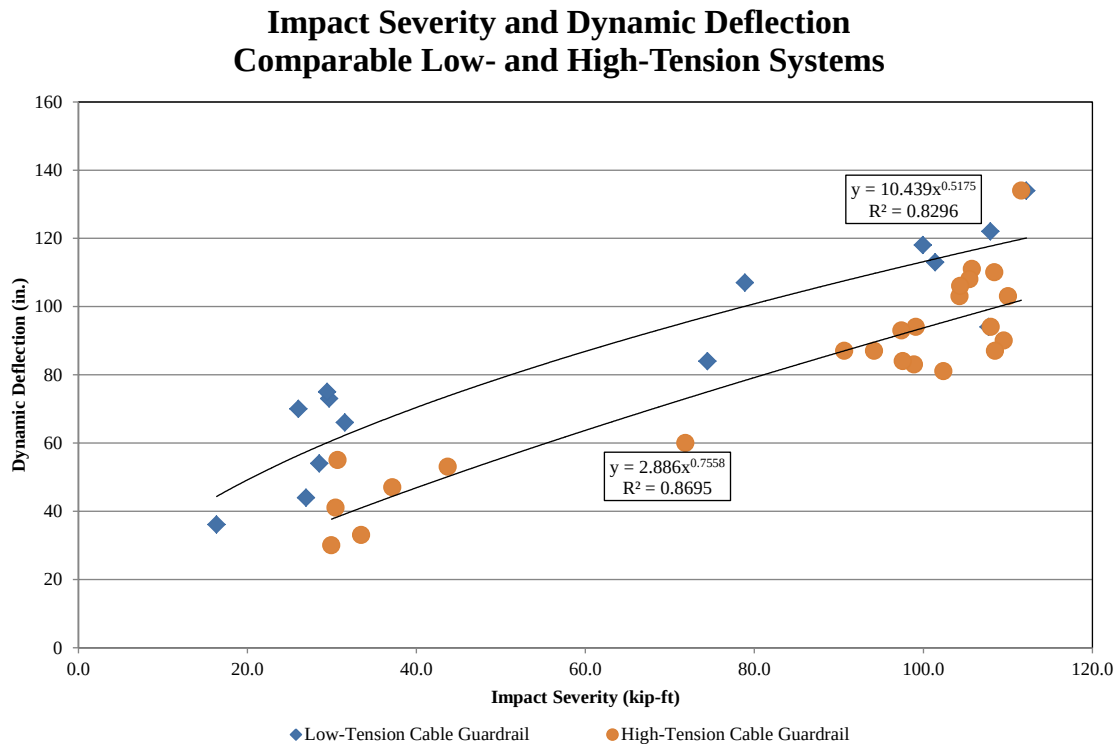
Figure 45. Dynamic Deflection Comparison, Low- and High-Tension Cable Barriers

As discussed in Chapter 4, there was an increased risk to occupants of errant vehicles in any high-tension cable median barrier crash that appeared to be associated with the higher tension in the cables. Although higher cable tensions do tend to reduce dynamic deflections, the effect was not as pronounced as many engineers have assumed previously. Dynamic deflections in tests conducted on cable barrier systems, including roadside systems, were plotted by impact severity. Impact severities were derived from crash test results submitted to FHWA for eligibility

As shown in Figure 45, at low IS-values below 40 kip-ft (54 kJ), high-tension barriers exhibit up to a 33% reduction in dynamic deflection compared to low-tension cable barriers. However, the difference in dynamic deflection between low- and high-tension cable barrier systems was approximately 15% with an IS value of 102 kip-ft (138 kJ). This IS value is typical of the standard impact condition for TL-3 impacts using a 2000P test vehicle according to NCHRP Report 350. Reported rates of dynamic deflections were always higher than the 15% average determined from full-scale crash testing. It should be noted that the high-IS value crashes with high-tension cable median barriers very closely correspond to, and occasionally intersect, data from low-tension crashes; the primary “benefit” of high-tension dynamic deflection reduction occurs at low IS-value crashes. However, the low-IS value crashes would

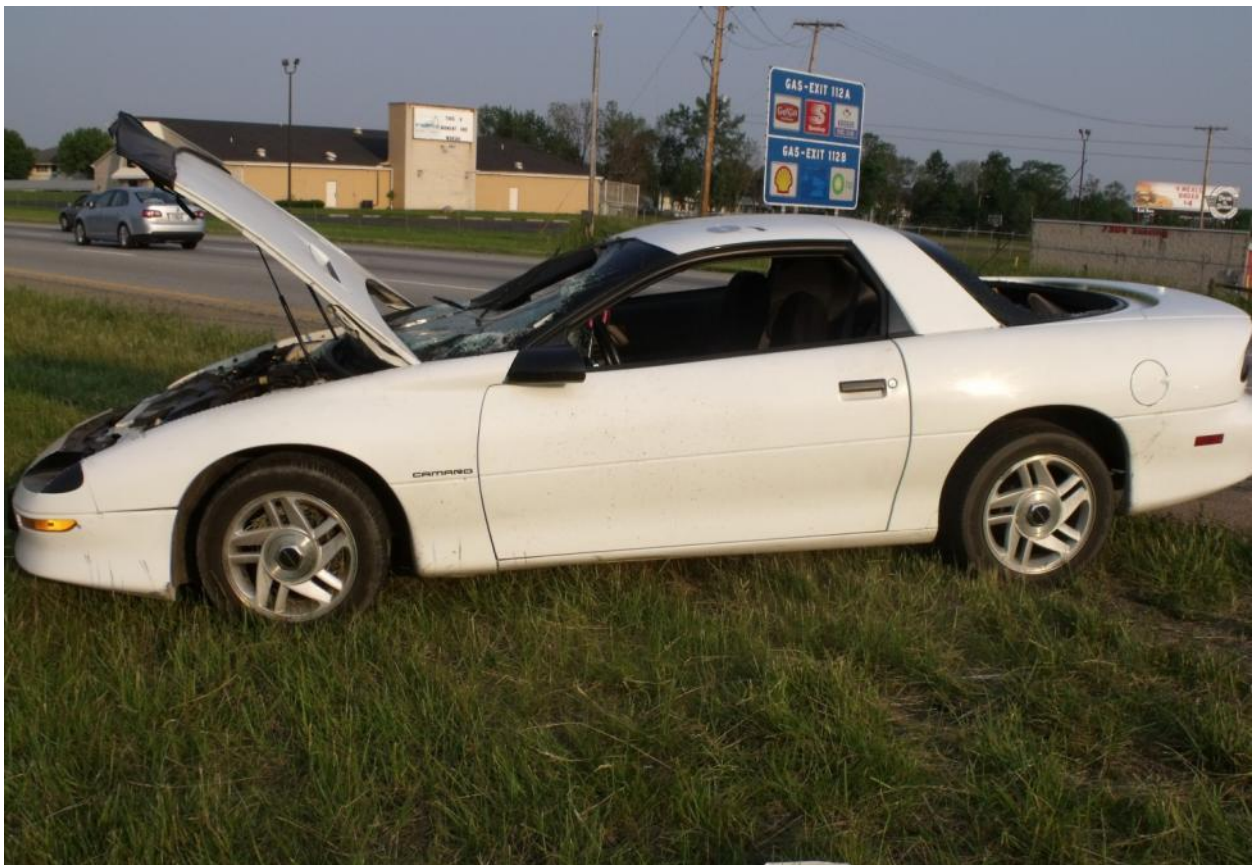
Figure 51. Prying Penetration Failure on Nucor NU-CABLE Barrier

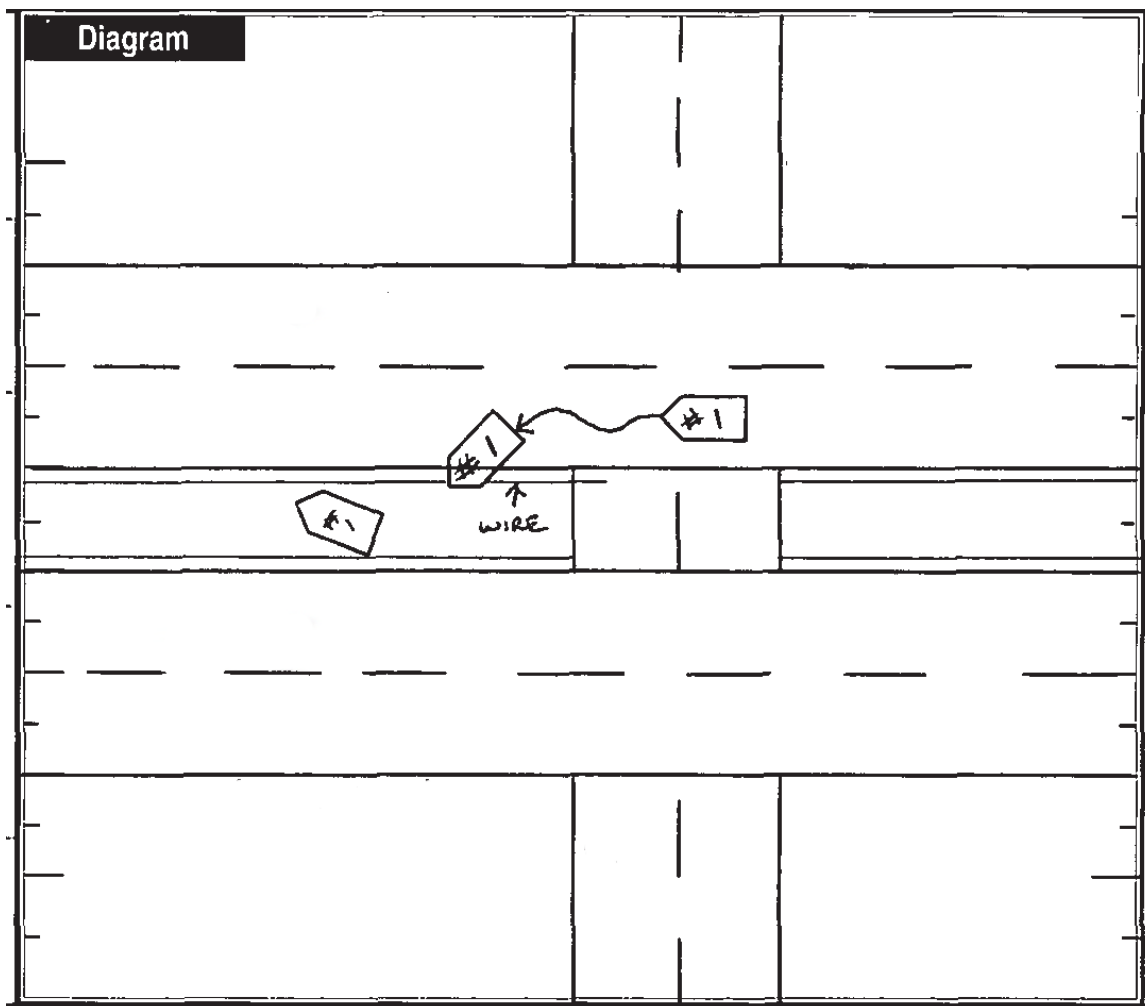
Figure 55. Scene Diagram of High-Orientation Angle Crash

Most light to mid-size SUVs and some full-size cars were not typically involved in penetration crashes, since the broad front end combined with large bumper protrusions typically resulted in capture or rollover. One vehicle, which was involved in 21 cable median barrier crashes, but only one penetration crash, was a Dodge Stratus. The scene diagram from the penetration crash involving the 2002 Dodge Stratus is shown in Figure 55. Photographs of a 2002 Dodge Stratus, which was similar to the vehicle involved in the impact, are shown in Figure 56.

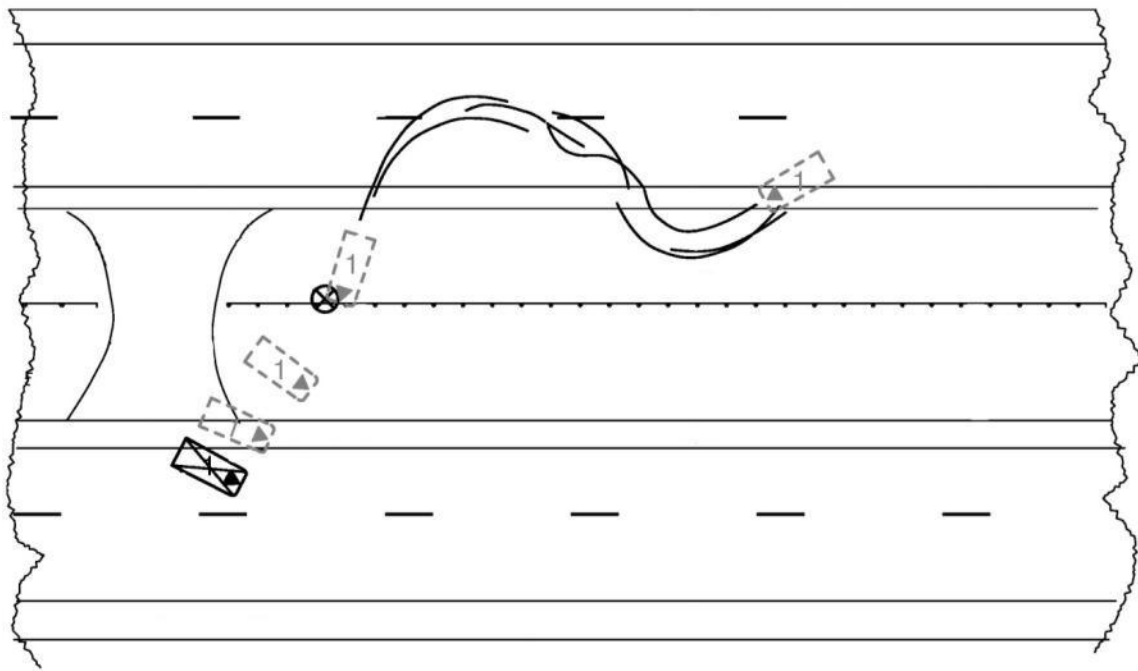
downstream, then overrode the cables. The override was likely due to the following two factors: (1) the low tension in the cables was insufficient to prevent sagging when multiple support posts were removed from the system, and (2) the large vehicles with stiff exterior body panels were less conducive to energetically-favorable cable engagement. This engagement was frequently caused by crushing the vehicle exterior and retaining the cables against the sides of the vehicle. As a result, any sag in the cables lowered the height of the cables with respect to the impacting vehicle. As the vehicle bent the support posts, it was likely that the vehicles bounced or rode up the post, thereby further increasing the vehicle's CG height with respect to the cables, and potentially drove the cables downward beneath the wheels.

Figure 58. High-Angle Override Penetration Crash Example

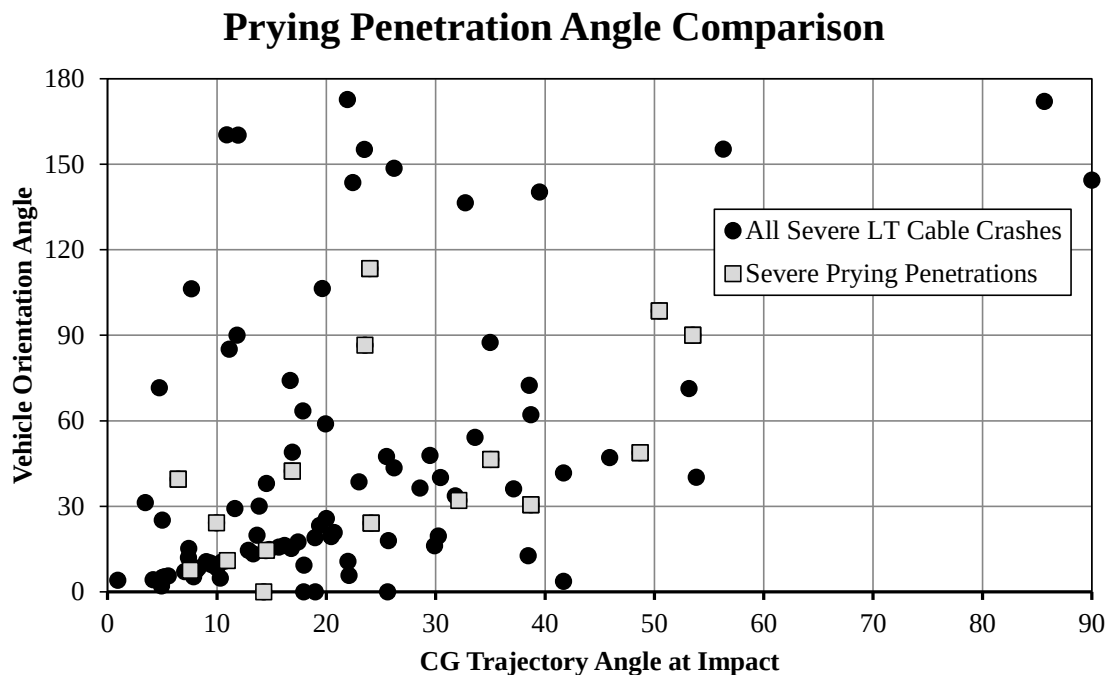
Figure 62. Comparison of Prying Penetration CG Trajectory and Orientation Angles

Frequently, at least two prying risk factors were present in prying penetration crashes. Prying penetrations occurred when cables were lifted or separated and failed to engage the vehicle. As with the high-tension cable median barrier systems, prying penetrations were sensitive to the impacting vehicle orientation angles. These angles were cross-plotted against all severe cable median barrier crashes in Missouri, as shown in Figure 62. No clear distinction could be made between the two crash distribution data sets. Oversteering impacts, in which the vehicle orientation angle was greater than the CG trajectory angle, were 5 times more common for prying penetration crashes.

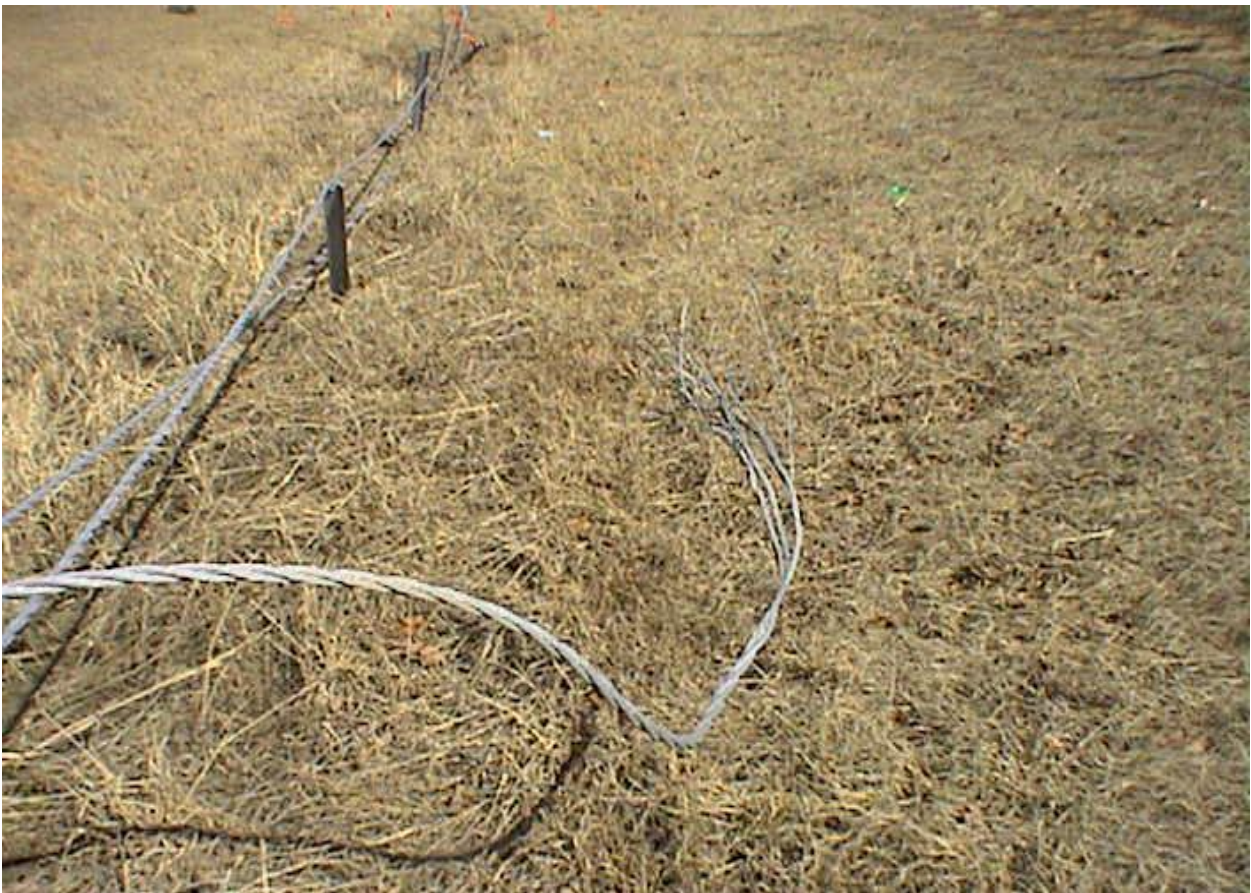
Figure 67. High-Tension Splice Tearout Penetration

Figure 68. High-Tension Splice Tearout Penetration

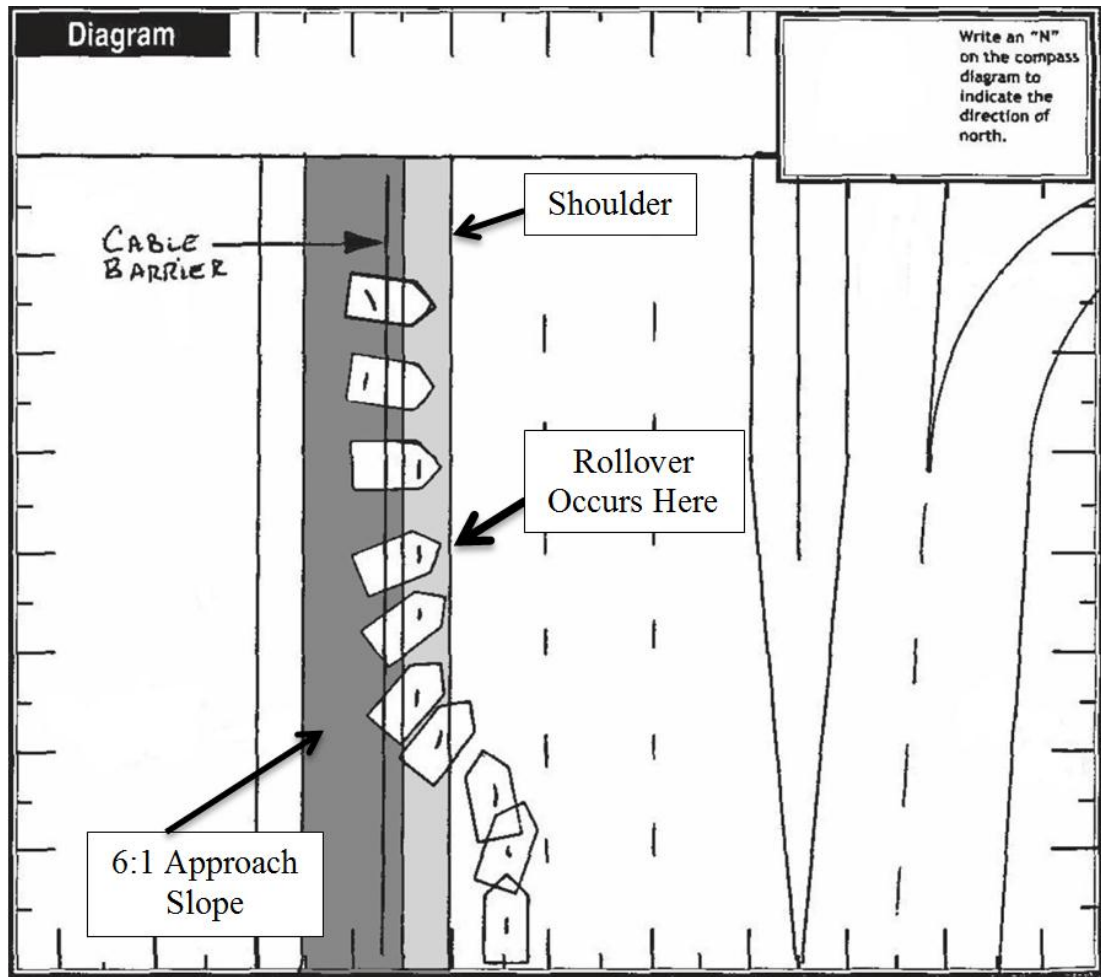
The second slope-related rollover failure type was due to vehicle orientation near the center of a steep V-ditch. Vehicles were also captured during this type of rollover, but redirection frequently resulted in yaw displacement of the vehicle around the impacting end. Wheels on the other end of the vehicle were forced to climb the median approach slope which had been traversed during yaw rotation, which generated large, dynamic vertical and sideslip forces. Due to a combination of large trip forces, vehicle instability, digging in to the slope, post impact, or rough median terrain, the vehicle then tripped and rolled.

Figure 69. Entrapment Rollover Crash in which Vehicle Extends Over SBP of 6:1 Slope
