Cable Median Barrier Failure Analysis and Prevention

Report # TRP-03-275-12

Final Report
25-1121-0001-428

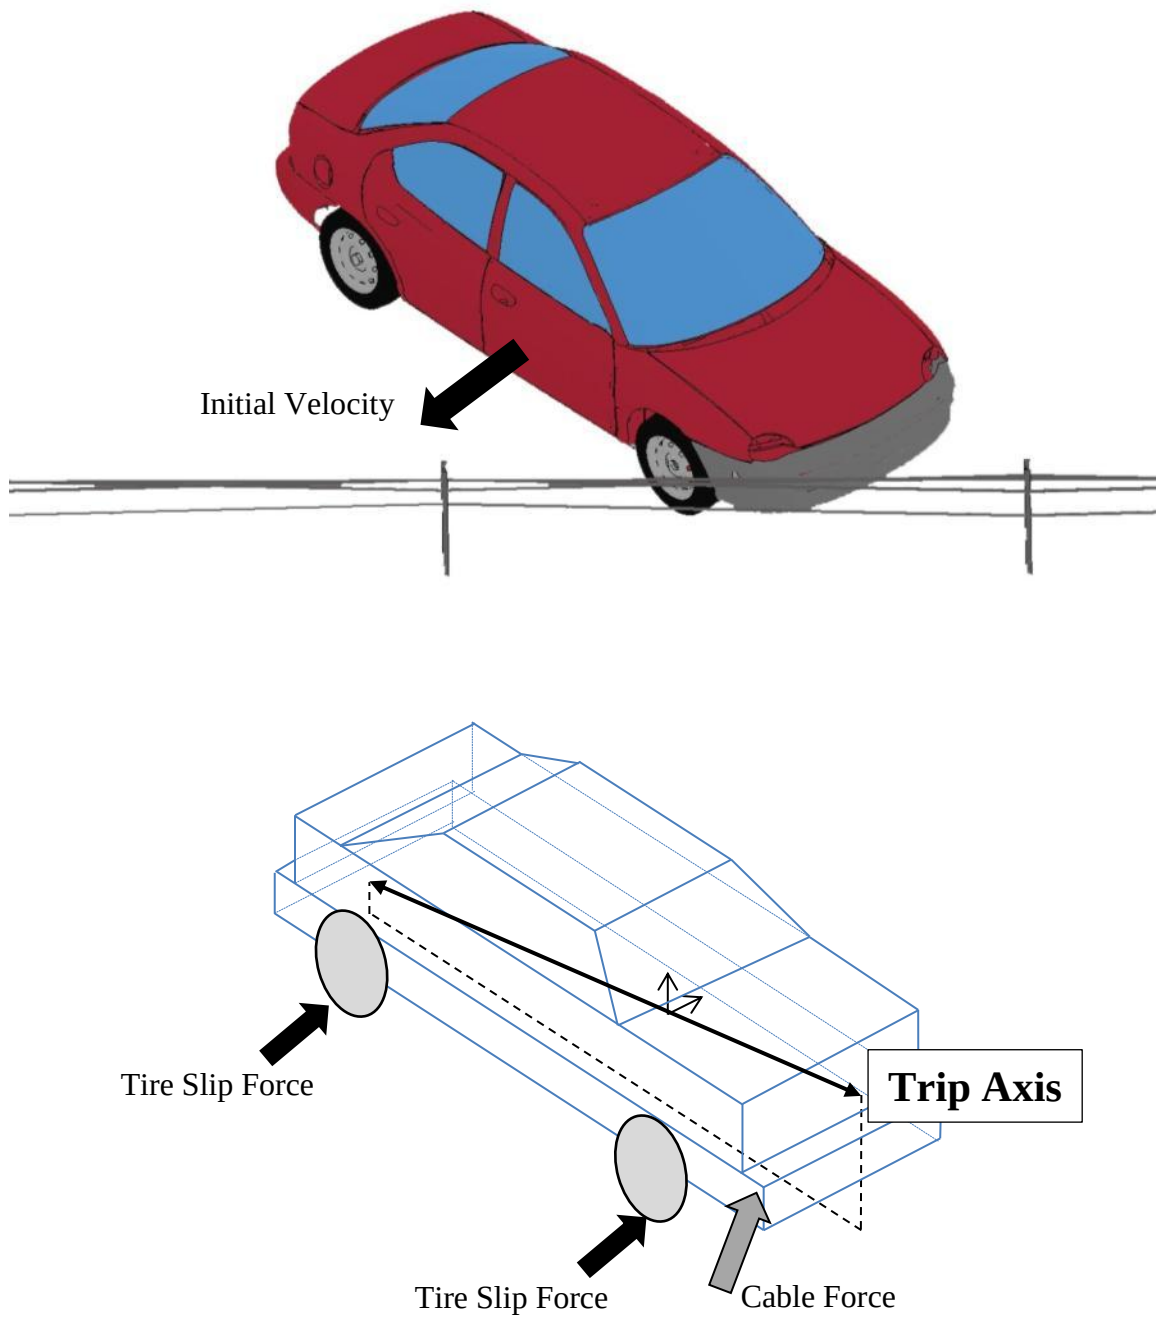
Figure 72. Impact at High Orientation Angle with Unbalanced Force Diagram

Vehicle impacts at high orientation angles contributed to vehicle instability by increasing the overturning moment applied to the vehicle frame. A model and schematic diagram of the force interaction in a high-orientation angle crash is shown in Figure 72. During rollover crashes,

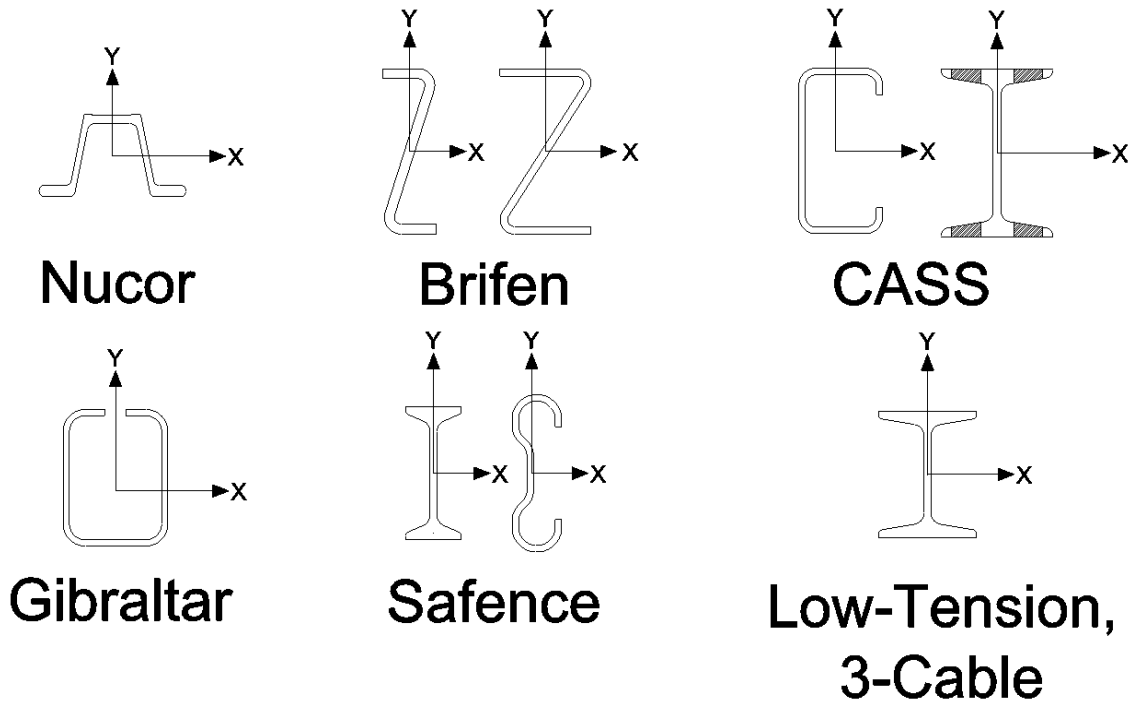
Figure 78. High-Tension Post Section Shapes

Contact-with-post rollovers were the most sensitive to the make of cable barrier struck, since post strengths were critical to facilitating rollover. Post shapes and cable tensions are shown in Tables 26 and 27, and several post section shapes are shown in Figure 78.

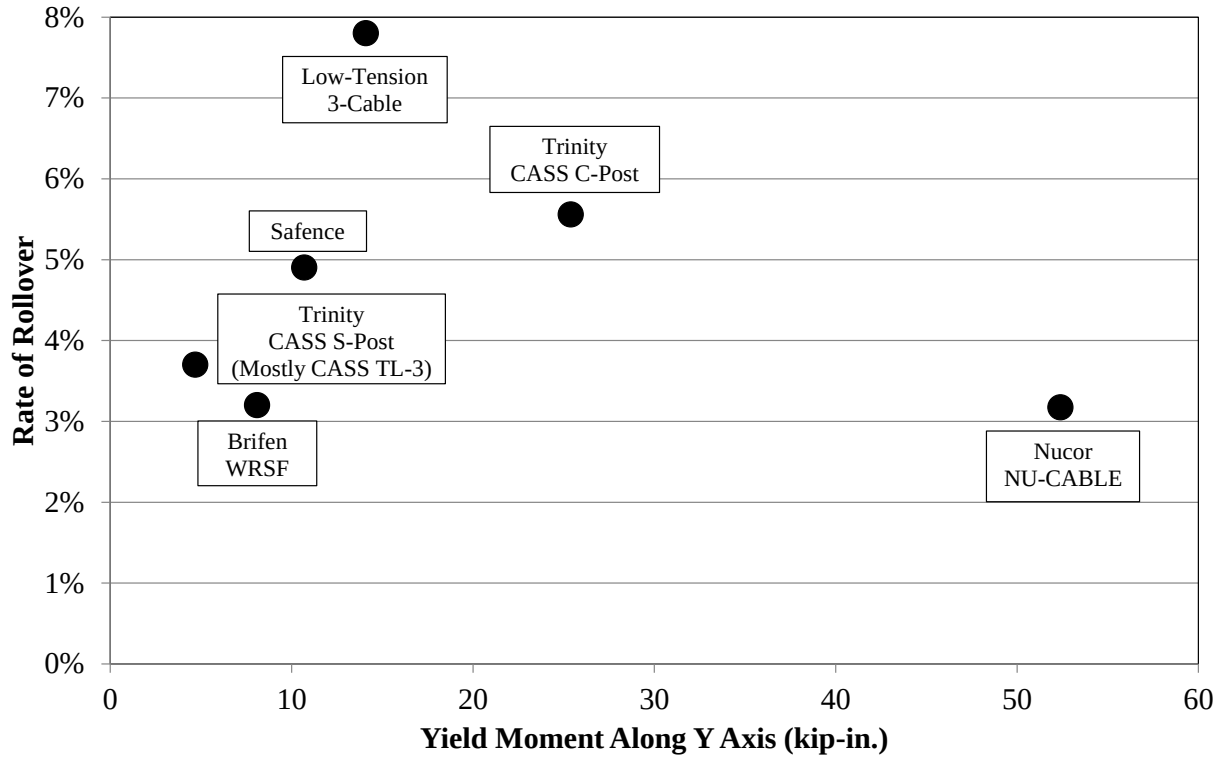
Figure 79. Y-Axis (Typ. Weak Axis) Yield Moment Relationship with Rollover Frequency

The cumulative rate of vehicle rollover on each system was plotted against calculated yield moments about the X and Y axes. Bending moments were calculated based on the assumption that no torsional warping occurred and that all loading occurred through each post section shear center. Scatter in the weak-axis bending moment direction appeared to be randomly distributed, as shown in Figure 79. However, a possible correlation was observed when rollover frequency was plotted against yield moments about the X direction, as shown in Figure 80.

Considering the large number of factors contributing to rollover events, these results suggested that there may be a strong relationship between post strength in bending along an axis parallel with the roadway and the frequency of rollover crashes. These results also indicate that post bending strengths along axes perpendicular to the roadway (i.e., the Y-axes) do not have a strong correlation with rollover frequency, as has often been assumed.

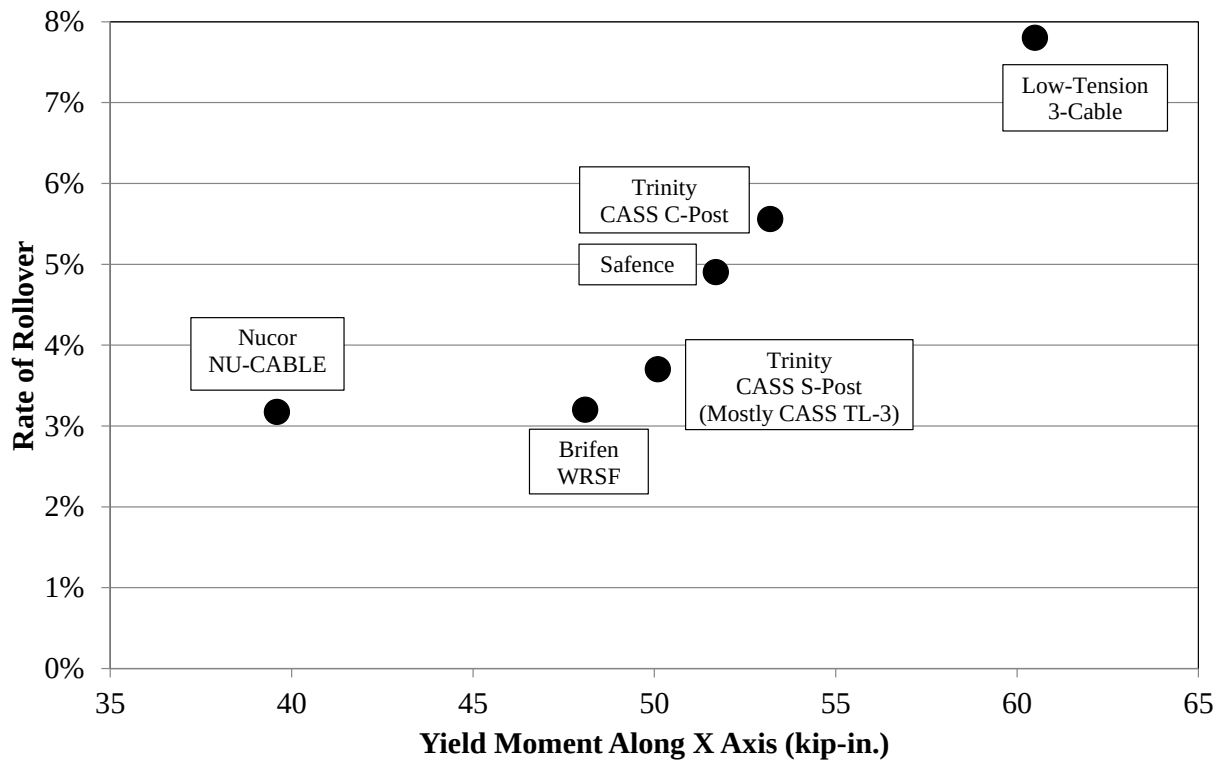
Figure 80. X-Axis (Typ. Strong Axis) Yield Moment Relationship with Rollover Frequency

Insufficient information was present to make definitive conclusions about the Gibraltar or Safence systems. The limited data available for the Gibraltar systems suggested a high rate of rollover crashes, which was consistent with the rollover model shown in Figure 80.

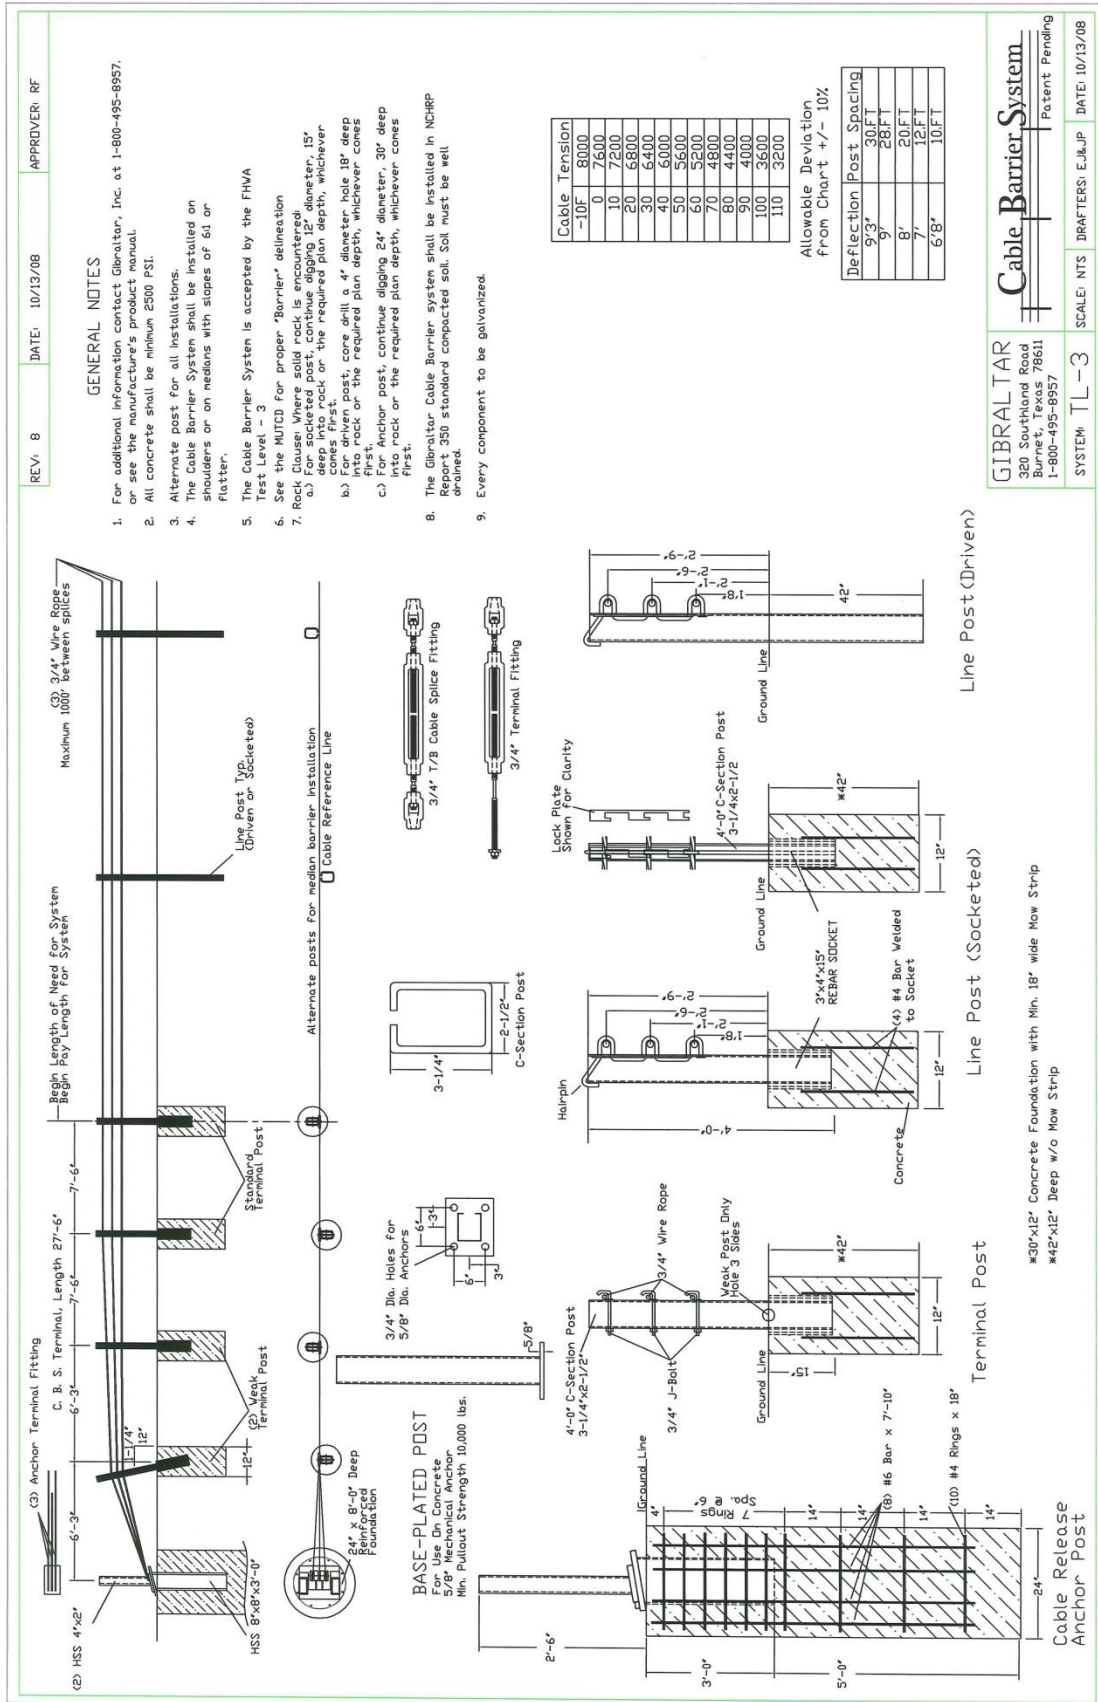
Figure 81. Gibraltar System Details, TL-3 System [44]

The Gibraltar cable barrier system, with wide post spacings up to 30 ft (9.1 m) and installed on alternating sides of the cables, may exhibit a higher susceptibility to underride penetration crashes. Vehicles impacting at the location of a post on the opposite side of the cables can cause complete post disengagement. Although the hairpin cable-to-post attachment was relatively strong, as shown in Figure 81, upward vertical bracket release could occur during impacts with low-height, sharp-nosed and narrow front-profile vehicles, as shown in Figure 77.

For posts installed at the approved 20- to 30-ft (6.1- to 9.1-m) spacing, any cable-to-post disengagement of a given post would result in a 40- to 60-ft (12.2- to 18.3-m) unsupported cable length upstream or downstream of the vehicle. With such large unsupported lengths, the barrier may experience an increased penetration frequency due to median slopes, low-profile vehicles, or vehicle crashes under non-tracking and high-orientation angle impact conditions.

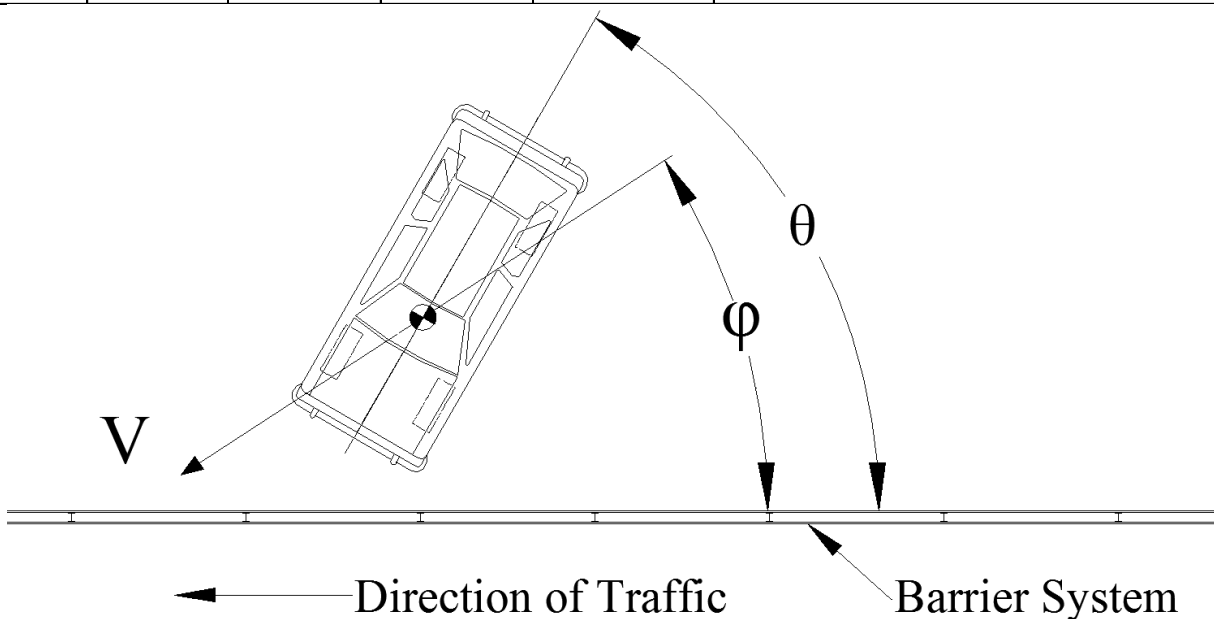
Figure 83. Representative Crash Testing Impact Diagram

The recommended impact conditions for future full-scale crash testing of cable median barriers are shown in Table 30. A diagram of the crash testing impact conditions is shown in Figure 83.

These crash tests are recommended to replace the current TL-3 MASH crash test nos. 3-10 and 3-11 which are required for cable barrier systems and should be conducted on level, flat terrain unless otherwise specified. These tests are intended to supplement V-ditch testing of cable median barriers [20].
