# Evaluating the Impact of Bridge Deck Removal Method on the Performance of Precast/Prestressed Concrete I-Girders

EVALUATING THE IMPACT OF BRIDGE DECK REMOVAL METHOD ON  
THE PERFORMANCE OF PRECAST/PRESTRESSED CONCRETE I-GIRDERS

Shaddi A. Assad

A THESIS

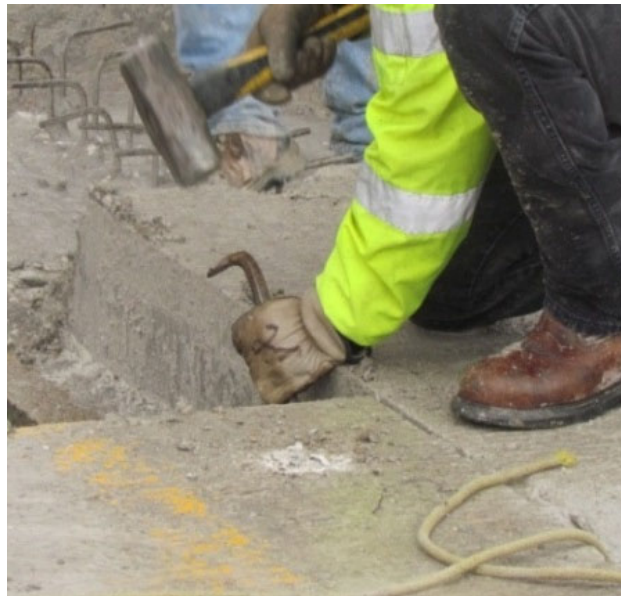
FIGURE 3-8: BREAKING PANEL FROM DECK USING A HAMMER AND A CHISEL

The second 6 in. overlap panel caused difficulties when the crew was performing the first lift to break the bond between the panel and the remaining part of the deck. The haunch being deeper at that part of the bridge was the reason for the difficulty. The lifted edge was hammered extensively on both sides; however, it could not separate the panel from the deck. A hammer and a chisel were used to break the haunch from the rest of the deck (Figure 3-8). Since the chisel could not go deep enough in the concrete due to the thicker haunch, a 60 lb jack hammer was used to break the deck attached to the haunch (Figure 3-9). As the crane was lifting the edge of the panel and the workers at the same time jack hammering on the panel, the bolts holding the bracket to the concrete slipped out of the panel and the location of the bracket had to be changed. The panel required a lot of wiggling until it was completely lifted. Despite the rough actions the deck has seen, the flange did not show any signs of cracks or damage.

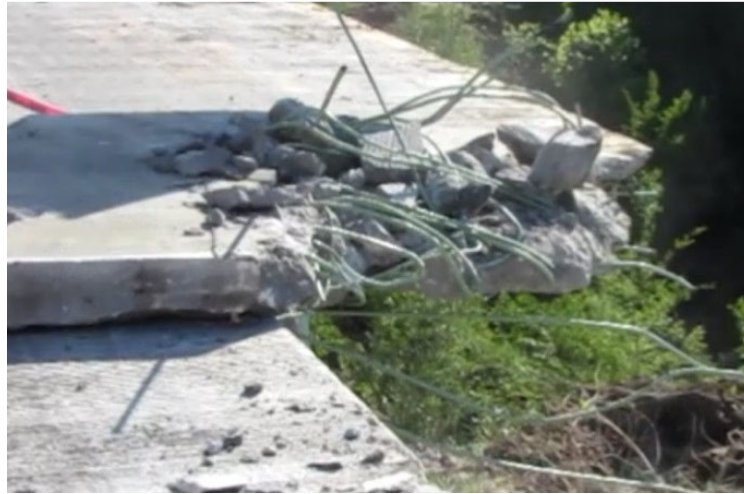
FIGURE 3-13: PART OF THE DECK THAT WAS PEELED OFF

The overhang deck in Figure 3-12 was peeled from the supporting girder making use of the 8-in wide debonded strip at the edges of the top flange. A CAT 330DL excavator with a 40 kip capacity was used to lift the edge of the overhang deck. Despite the powerful shaking of the deck, the girder and the deck stayed connected. It was then suggested to push down on the edge of the deck so as to cause tension at the top of the deck and crack it. The deck cracked when it was pushed down, however the crack did not go deeper than the location of the top reinforcement mat. Unlike the rest of the overhang, the west edge of the overhang was saw cut longitudinally; as a result, the deck was broken off the flange at the saw cut line when it was pulled up. The side of the deck was broken; however, the steel reinforcement did not break (Figure 3-13).

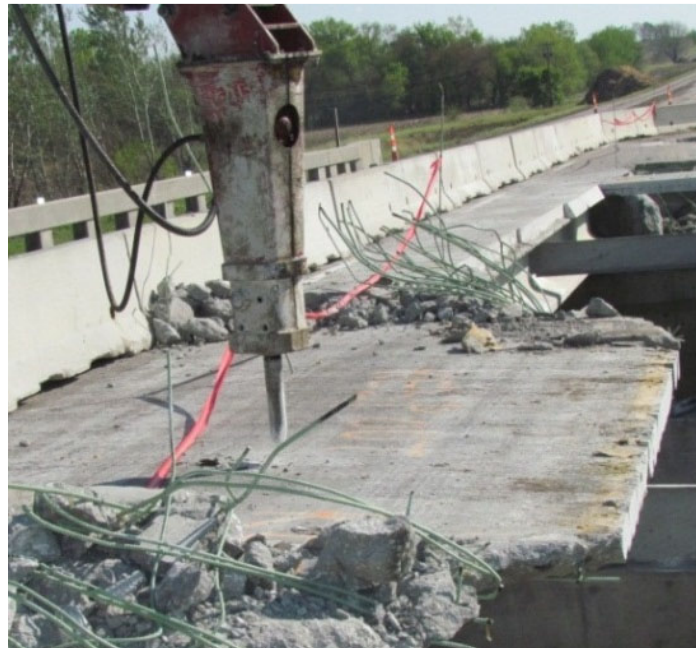
FIGURE 3-14: JACK HAMMERING THE DECK USING BACKHOE

The deck was then jack hammered transversely to form 6 ft long panels to make it easier to get the deck peeled (Figure 3-14). However, the edge of the flange broke when the deck was jack hammered on top of. When the panel was then lifted by the excavator, the edge of the flange broke more and the process was stopped. Deck peeling proved to be a vigorous, inefficient, and damaging method.

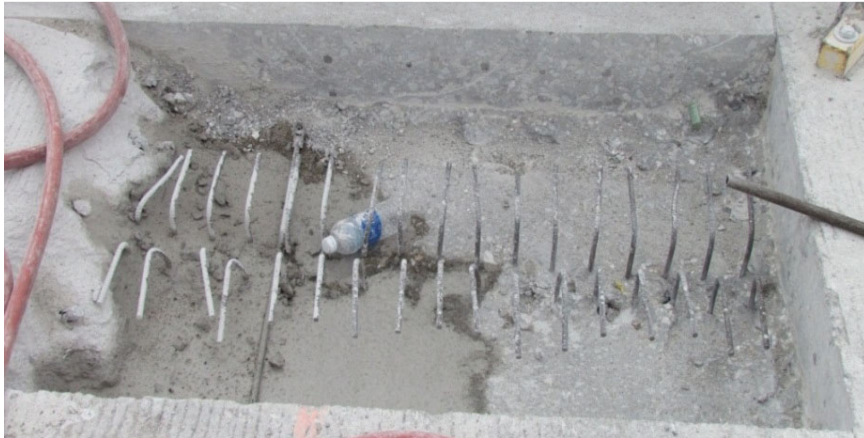
FIGURE 3-17: THE 4'10" X 3'2" JACK HAMMERED STRIP

In the second method, a 4 ft - 10 in. long by 3 ft - 2 in. wide rectangle was saw cut then jack hammered (Figure 3-17). Jack hammering was performed using 60 lb and 30 lb jack hammers, which is heavier than the specified 30 lb and 15 lb jack hammers for deck removal on top of the girders. The 60 lb jack hammer was used down to the bottom reinforcing steel mat, then the 30 lb one was used down to the top flange of the girder. It took 4 hours for the two man crew to finish the jack hammering process. The girder was slightly damaged when the 30 lb jack hammer slipped off and hit the top of the girder. The rate of deck removal for this method is 0.2613 mhr/ft<sup>2</sup>.

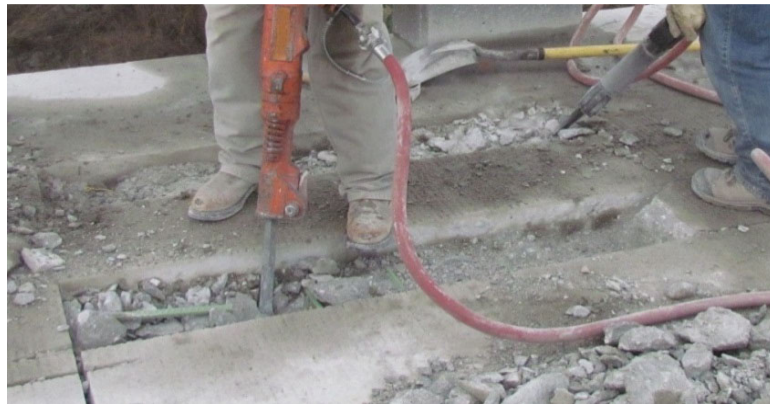
FIGURE 3-18: THE 4'10" X 3'1/2" JACK HAMMERED STRIP

The third method was to cut 4 ft - 10 in. long and 3 ft - ½ in. wide rectangle and remove concrete using 30 lb and 60 lb jack hammers. This method had additional saw cuts. Saw cuts were made directly outside the shear connectors and away from the shear connectors (Figure 3-18). This method was significantly more efficient as the broken deck came out in bigger chunks, hence, took less time and effort. The two man crew needed 1 hour and 38 minutes to finish. The girder had only one location where the jack hammer hit the top surface and caused a 5-½ in. x 2-½ in. piece that was about ½ in. deep to be chipped off the girder. The rate of deck removal for this method is 0.111 mhr/ft<sup>2</sup>.

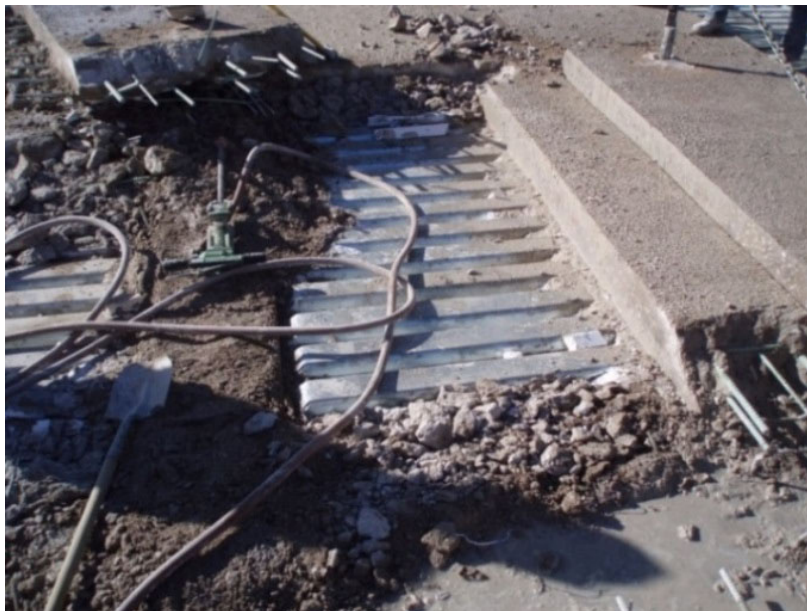
Transverse saw cuts through the epoxy coated rebar were made starting above the middle bridge pier, the deck panels between the girders were lifted off the stay-in-place forms. The deck panels easily lifted away from the stay-in-place forms (Figure 3-21). For the deck on top of the girder, a large jack hammer mounted on an excavator was used to get the majority of concrete broken up and then finished with smaller jack hammers to minimize damaging the girders and shear connectors (Figure 3-22).

FIGURE 3-21: DECK PANEL LIFTED FROM STAY-IN-PLACE FORMS BETWEEN GIRDERS

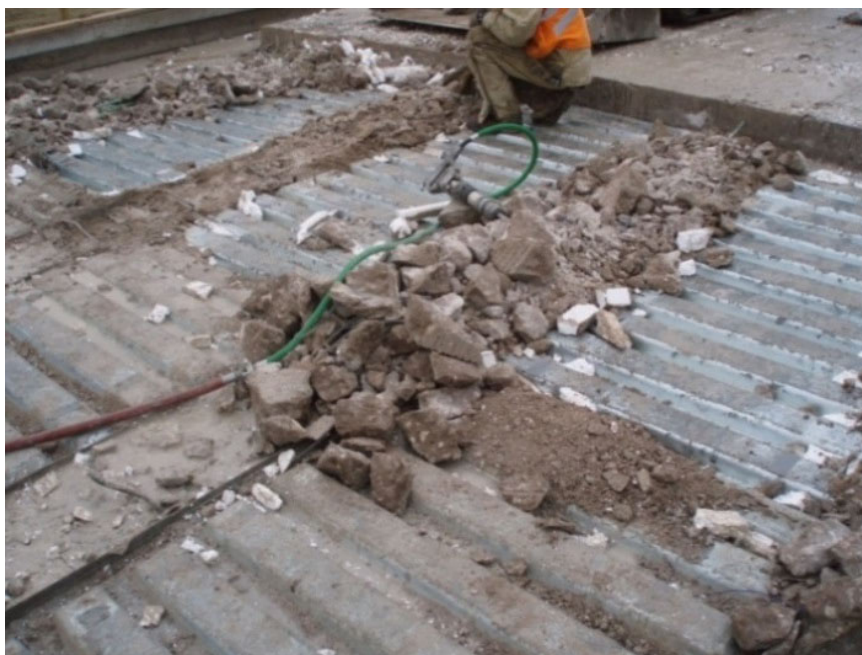
Damage occurred with the use of the large jack hammer mounted to the excavator. Figure 3-23 shows the minor damage that occurred to the top flange of the girders, as well as a half dozen shear connectors. The broken straps between the stay-in-place forms will be replaced before casting the new deck. This operation totaled 1300

FIGURE 3-22: JACK HAMMERING ABOVE THE GIRDERS

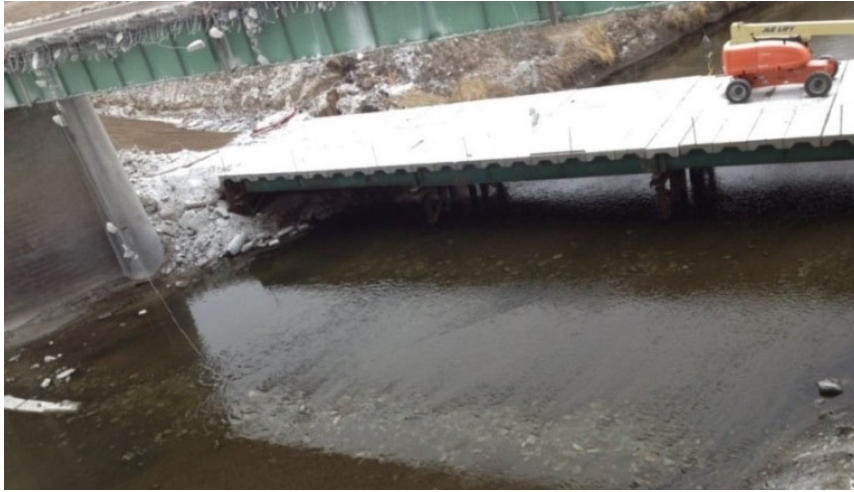
The location of transverse and longitudinal saw cuts made can be shown as the red dashed lines in Figure 3-24 and Figure 3-25. The 5 ft by 15 ft concrete slabs were lifted with the slab crab, seen in Figure 3-26. Small concrete chunks fell to the ground from jack hammering the guard rail (Figure 3-27).

FIGURE 3-27: CONCRETE PIECES FELL TO THE WATERWAY UNDERNEATH

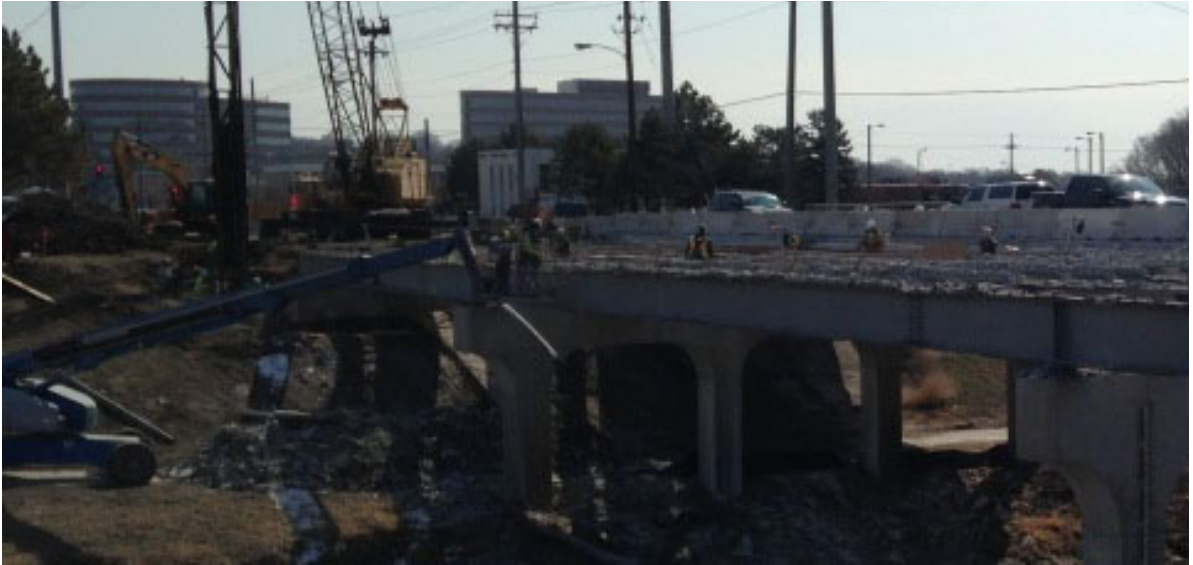
FIGURE 3-30: WORKERS USING HAND CHIPPERS TO REMOVE CONCRETE AROUND SHEAR STUDS

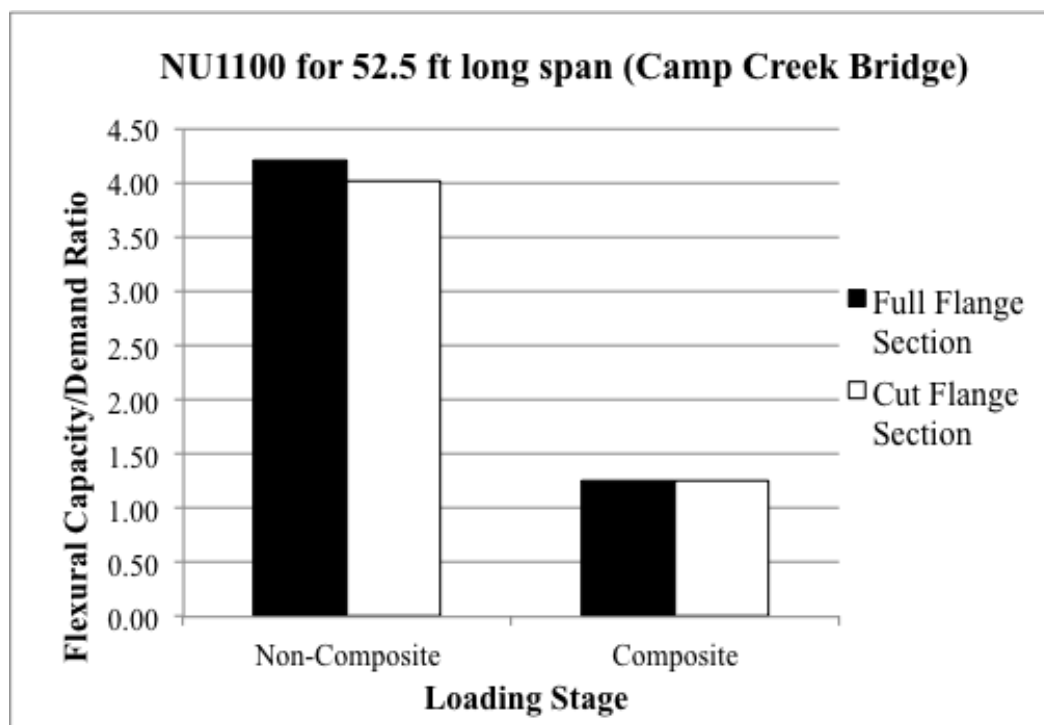
Figure 5-3 shows a graph of the capacity/demand ratio at each critical stage for the full flange section and cut flange section. The ratio in all loading stages is greater than 1.0, which is considered adequate.

FIGURE 5-3: CAPACITY/DEMAND RATIO FOR NU1100 AT ALL LOADING STAGES

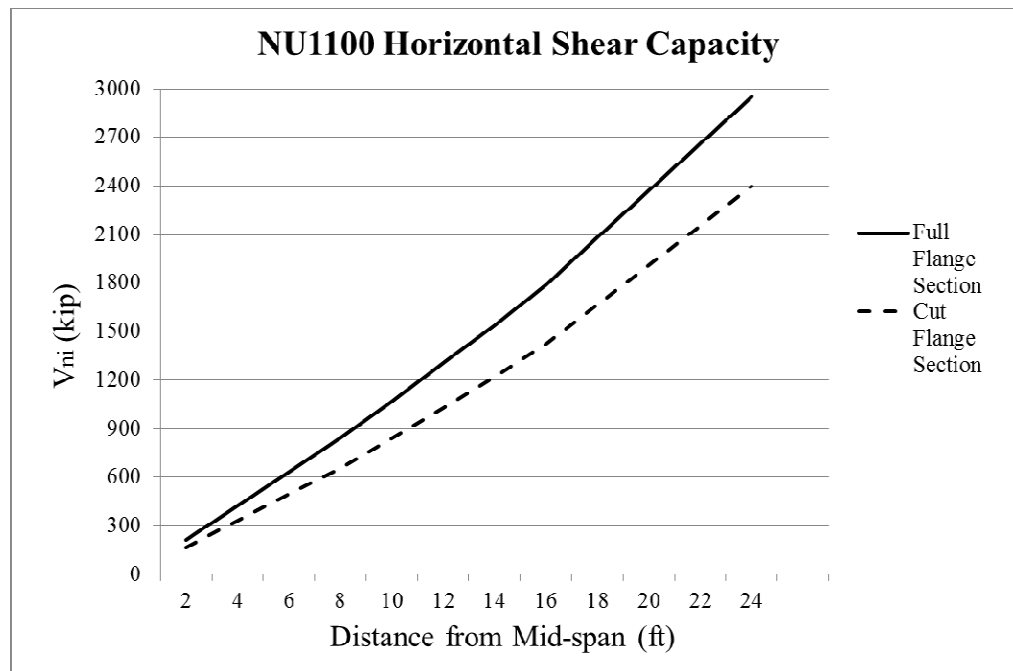
Nominal horizontal shear capacity values are calculated for distances from the mid-span in increments of 2 ft. Stirrup reinforcement area for 2#3 bars is 0.22 in<sup>2</sup>. The results are obtained and graphed in Figure 5-5. From the results, it is apparent that when cutting through the top flange, some horizontal shear capacity is lost due to a reduction in top flange width. The average percent loss in horizontal shear capacity over 24 ft from mid-span is 20.75%.

FIGURE 5-5: EFFECT OF CUTTING TOP FLANGE ON HORIZONTAL SHEAR CAPACITY FOR NU1100

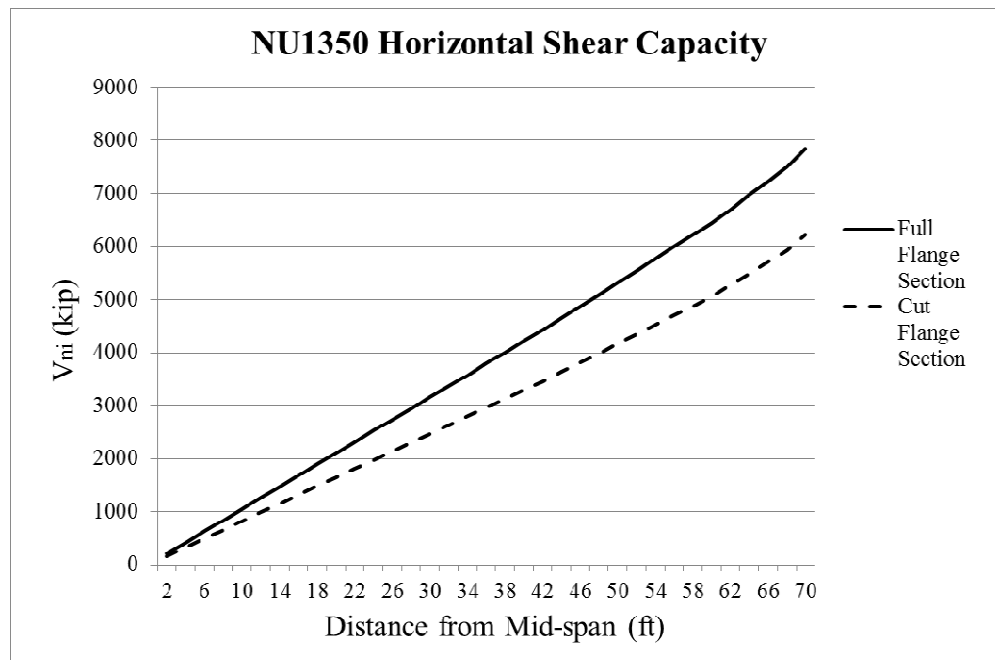
Nominal horizontal shear capacity values are calculated for distances from the mid-span in increments of 2 ft. The results are obtained and graphed in Figure 5-9. From the results, the average percent loss in horizontal shear capacity over 24 ft from mid-span is 21.87%.

FIGURE 5-9: EFFECT OF CUTTING TOP FLANGE ON HORIZONTAL SHEAR CAPACITY FOR NU1350

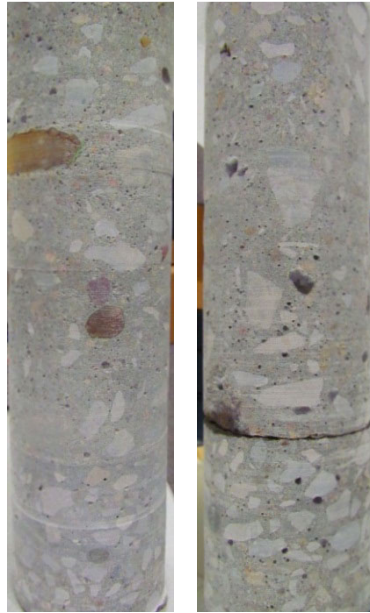
For each girder, four cores were drilled; two on each side of the two girders. On each side of the girders, one core was drilled in the bonded area, and one in the debonded area between the deck and the girder, shown in Figure 6-3. The cores taken in the bonded area remained in one piece, the cores taken in the debonded area split at the deck to girder interface. The orange-colored surface shown in Figure 6-4 is due to the use of debonding agent. Concrete cores were also used to estimate compressive strength of the two girders.

FIGURE 6-3: CORES TAKEN FROM BONDED ZONE (LEFT) AND FROM DEBONDED ZONE (RIGHT)

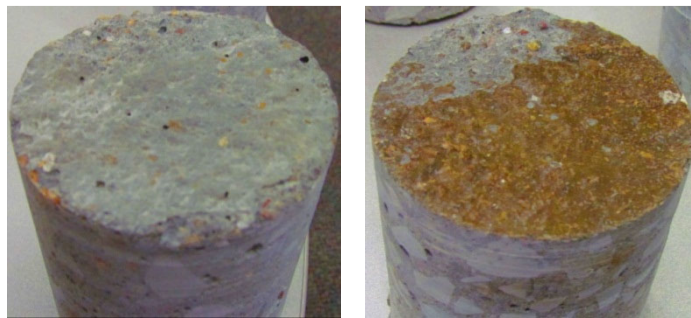
FIGURE 6-4: BONDED CONCRETE SURFACE (LEFT) AND DEBONDED CONCRETE SURFACE (RIGHT)
