# Evaluation of Critical Flare Rates for the Midwest Guardrail System

*Midwest States' Regional Pooled Fund Research Program  
Fiscal Years 2003-2005 (Years 14 and 15)  
Research Project Number SPR-3(017)  
NDOR Sponsoring Agency Code RFPF-04-03 and RFPF-05-05*

# **EVALUATION OF CRITICAL FLARE RATES FOR THE MIDWEST GUARDRAIL SYSTEM (MGS)**

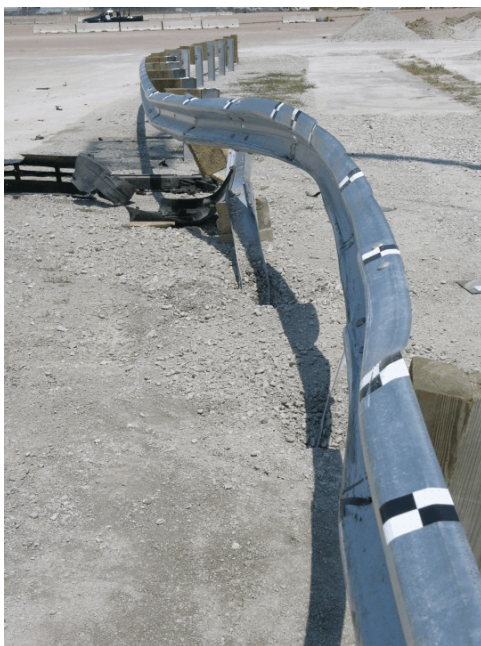
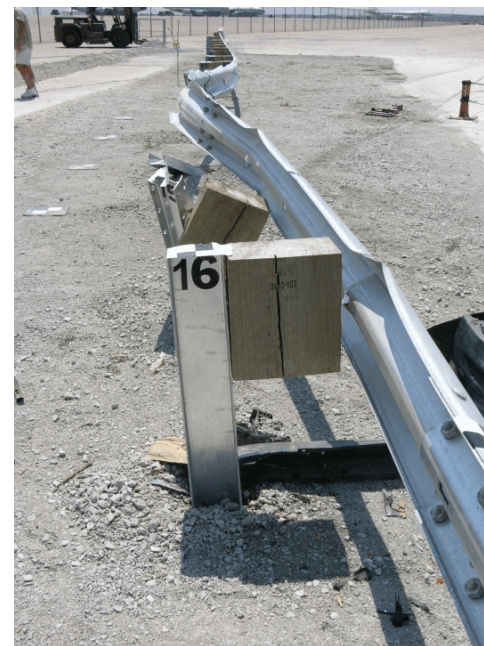
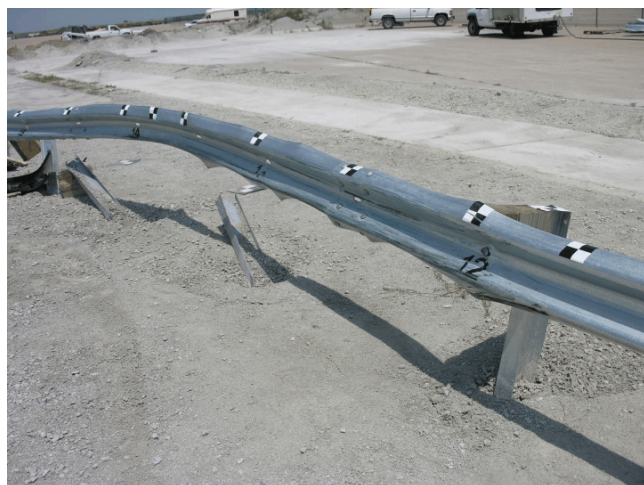
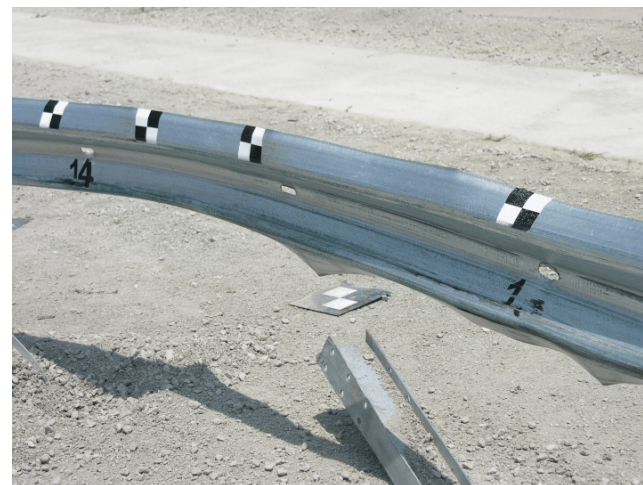
Figure 133. System Damage, Test FR-5

Damage to the barrier system was minimal, as shown in Figures 132 through 140. Barrier damage consisted of deformed guardrail posts, deformed and disengaged blockouts, deformed guardrail, and contact marks on a guardrail section. The length of vehicle contact along the system was approximately 6.14 m (20 ft - 4.75 in.), which spanned from 425 mm (16.75 in.) upstream from the centerline of post no. 12 through the centerline of post no. 15.

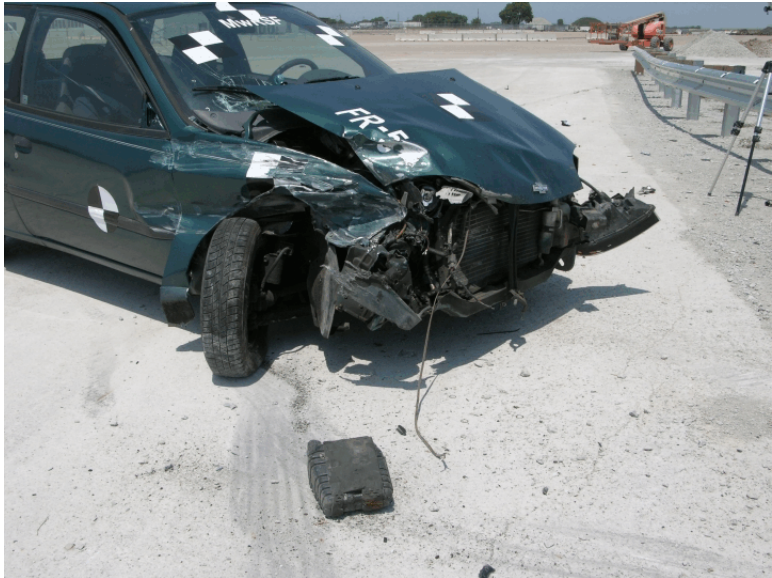
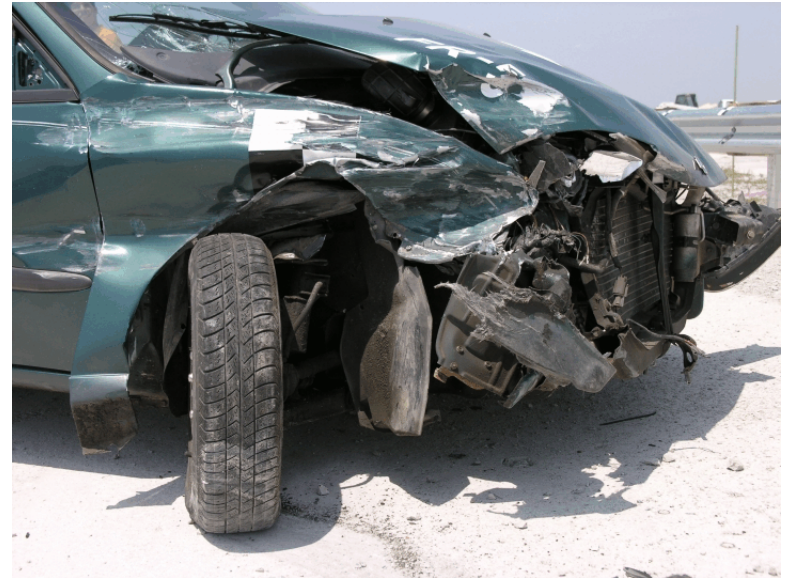
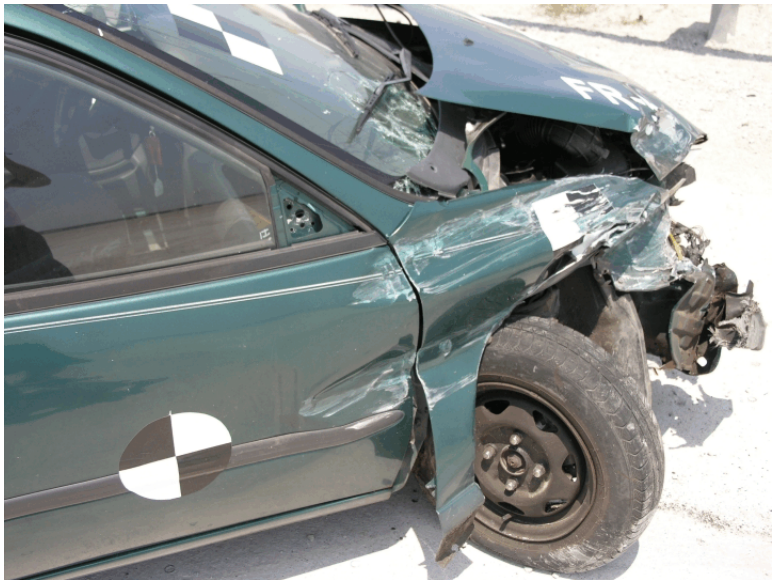
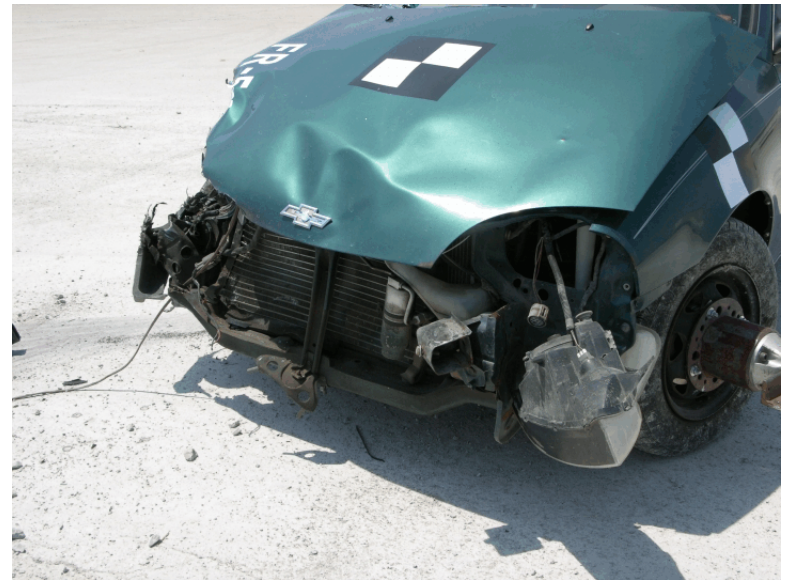
Figure 142. Vehicle Damage, Test FR-5

Exterior vehicle damage was moderate, as shown in Figures 141 through 145. Occupant compartment deformations to the right side and center of the floorboard were judged insufficient to cause serious injury to the vehicle occupants. The occupant compartment deformation is shown in Figure 145. Complete occupant compartment deformations and the corresponding locations are provided in Appendix M.

Damage was concentrated on the right-front corner of the vehicle. The right-front quarter panel, bumper, and radiator were deformed and crushed inward toward the engine compartment. Significant sheet metal tears occurred to the right-front corner of the hood, the right-front quarter panel, and the right door panel. The right-side door could not be opened. The front of the hood was crushed, deformed, and shifted to the right side, causing the right-side hood clips to fracture. Dents and scratches occurred to the entire right side of the vehicle and the exhaust system. The bumper cover disengaged from the vehicle. The right-side headlight was fractured and removed from the housing. The right-front tire was twisted at the wheel attachment and deformed into the wheel well. The right-side lower control arm and steering arm were fractured. The right-side sway bar was bent at the connection to the wheel. The lower-right corner of the windshield encountered “spider-web” cracking due to hood contact. The left side, rear, roof, and all window glass except the windshield remained undamaged.
