DEVELOPMENT OF A TL-3 F-SHAPE TEMPORARY CONCRETE MEDIAN BARRIER

MIDWEST ROADSIDE SAFETY FACILITY

IOWA DEPARTMENT OF TRANSPORTATION

MwRSF Research Report No. TRP-03-64-96 December 1996

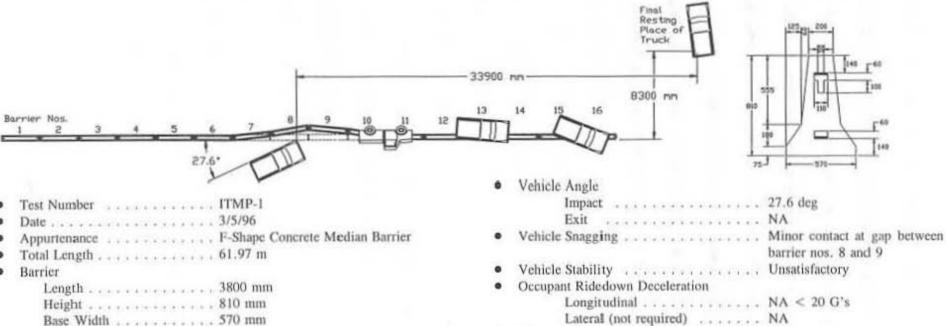
Figure 13. Summary of Test Results and Sequential Photographs, Test ITMP-1

The 2,000-kg pickup truck impacted the concrete barrier (Design No. 1) at a speed of 103.1 km/hr and an angle of 27.6 degrees. A summary of the test results and the sequential photographs are shown in Figure 13. Additional sequential photographs are shown in Figure 14. Documentary photographs of the crash test are shown in Figures 15 and 16.

Barrier damage was extensive, as shown in Figures 19 through 22. Concrete damage consisted of tire marks, scrapes, gouges, spalling, and fractured concrete pieces. The ends of barriers nos. 7 through 10 were cracked and fractured at various locations, and two cracks were also observed to extend through barrier no. 9. Ten of the steel connector pins were also deformed, ranging from slight to extensive. The maximum permanent set deflection of the barrier was 0.99 m.

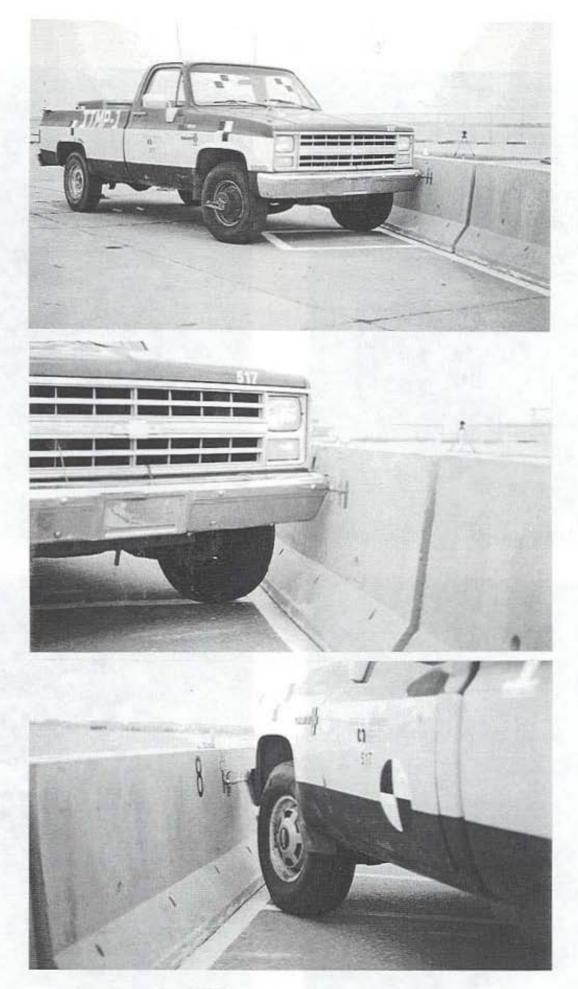
Figure 17. Impact Location, Test ITMP-1

Initial impact occurred 1.15 m upstream from the centerline of the gap between barrier nos. 8 and 9, as shown in Figure 17. After impact, the left-front tire of the vehicle became airborne as it began to climb the face of the barrier, and the left-front corner of the vehicle was crushed inward. In addition, the trafficside face of barrier no. 9 was uplifted off the ground. Shortly thereafter, the left-front tire was deflated as it passed the gap between barrier nos. 8 and 9. The front tires then turned sharply left toward the barrier as the vehicle continued to climb the barrier's front face. The front bumper became dislodged as it neared the top of the barrier. Subsequently, the right-front tire became airborne. The left-rear tire was also deflated as it passed the gap between barrier nos. 8 and 9. At 0.284 sec, the vehicle was parallel to the barrier with the undercarriage positioned above the top of the barrier. The vehicle continued to travel parallel to and above the barrier, reaching an approximate maximum roll angle 47.5 deg at 0.587 sec. with the right-front tire on the front face of the barrier. The vehicle's undercarriage then contacted the top of the barrier and continued to travel on the barrier's top with the left-side tires behind the barrier. The vehicle came off the end of the barrier system with the left-rear tire contacting the ground behind the barrier, and the left-front wheel became dislodged. The vehicle came to rest 33.90 m downstream from impact and 8.30 m behind

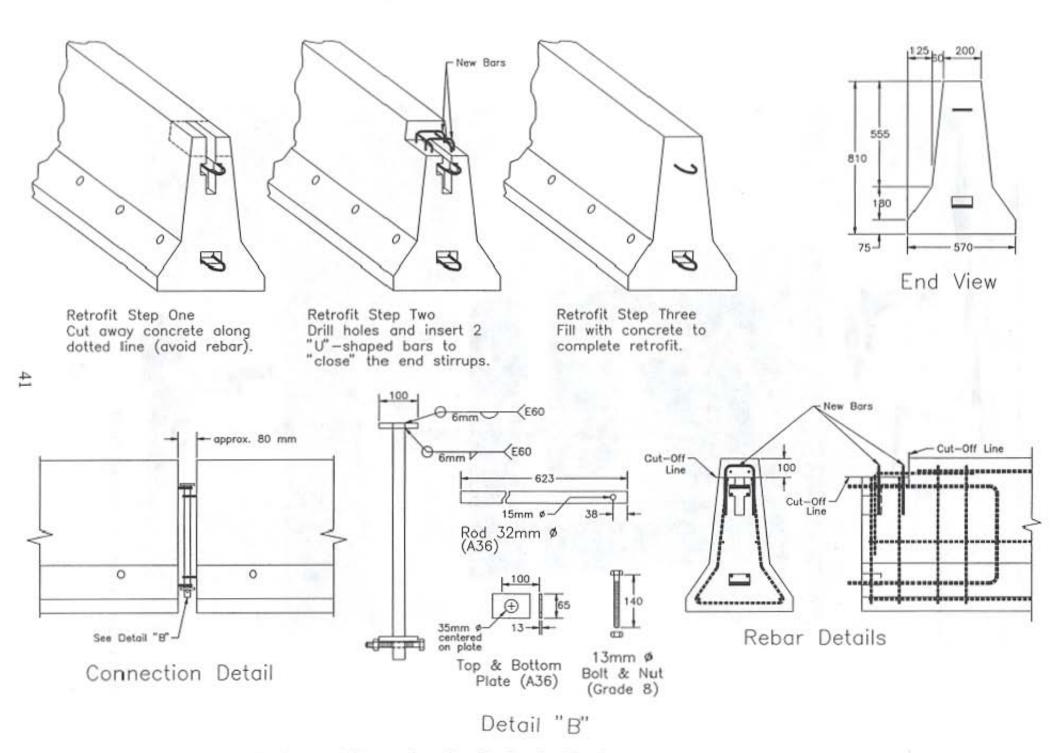
Figure 23. Barrier Modifications and Connections Details, Design No. 2

Following the unsuccessful crash test on Design No. 1, it was necessary to determine the cause of the poor barrier performance so that design modifications could be made to the system. A careful examination of the damaged barrier system revealed that considerable damage occurred at the barrier joints, most likely resulting from the inherently weakened recessed areas located at the top end of each barrier. It is believed that the recessed areas weakened the pin and rebar connection causing the rebar loops to deform significantly during the impact, thus allowing for excessive joint rotations and barrier uplift. This joint and barrier movement led to increased vehicle climbing and penetration over the barrier system.

In order to reduce the joint rotations between barrier segments as well as to prevent barrier uplift, it was necessary to strengthen the barrier ends by eliminating the recessed areas. This retrofit was completed in a three step process, as shown in Figures 23 and 24. First, concrete was removed at the top end of each barrier to expose both the vertical shear and longitudinal reinforcement. Second, vertical holes were drilled in the exposed concrete region at each end of the barrier. Two U-shaped steel bars were then epoxied into the holes to close the tops of the two end-stirrups. Finally, concrete was placed at each end to return the barrier to its original shape. In addition, it was deemed necessary to reduce pin deformations by decreasing the clearance between the bottom of the lower rebar loop and the top of the bottom plate. This 25-mm reduction in clearance was achieved by shortening the 31.8-mm diameter steel pin and repositioning the 12.7-mm diameter hole near the base, as shown in Figure 23. A photograph of the modified pin and rebar connection is shown in Figure 25.

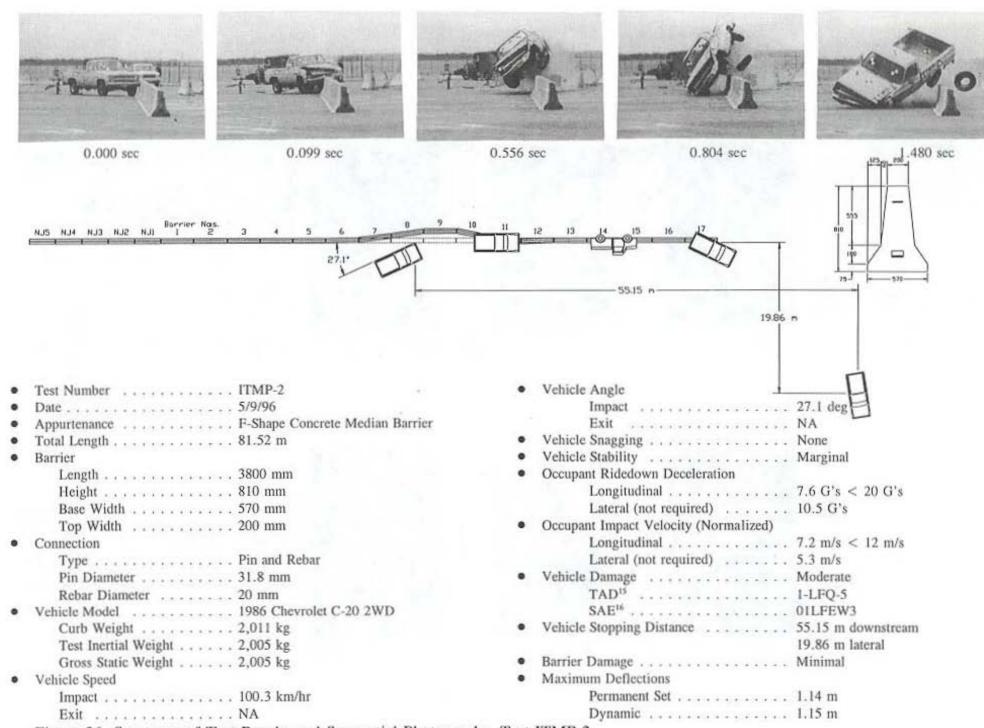
Figure 26. Summary of Test Results and Sequential Photographs, Test ITMP-2

The 2,005-kg pickup truck impacted the concrete barrier (Design No. 2) at a speed of 100.3 km/hr and an angle of 27.1 degrees. A summary of the test results and the sequential photographs are shown in Figure 26. Additional sequential photographs are shown in Figure 27. Documentary photographs of the crash test are shown in Figures 28 and 29. It is noted that five additional barrier sections were placed on the upstream end of the installation to provide extra weight for resisting longitudinal barrier movement.

of 48.7, 22.8, and 64.3 deg occurred at 0.836, 1.61, and 1.34 sec after impact, respectively. The vehicle then became airborne as the right-front tire bounced into the air. The left-rear tire recontacted the barrier, and then the left-front wheel hub struck the ground. The vehicle came to rest 55.15 m downstream from impact and 19.86 m away from the traffic-side face of the barrier, as shown in Figure 26.

Barrier damage was minor, as shown in Figures 32 through 34. Concrete damage was mostly cosmetic, consisting of tire marks, scrapes, gouges, and minor spalling. Nine steel pins were also deformed, ranging from slight to extensive. The maximum permanent set deflection of the barrier was 1.14 m.

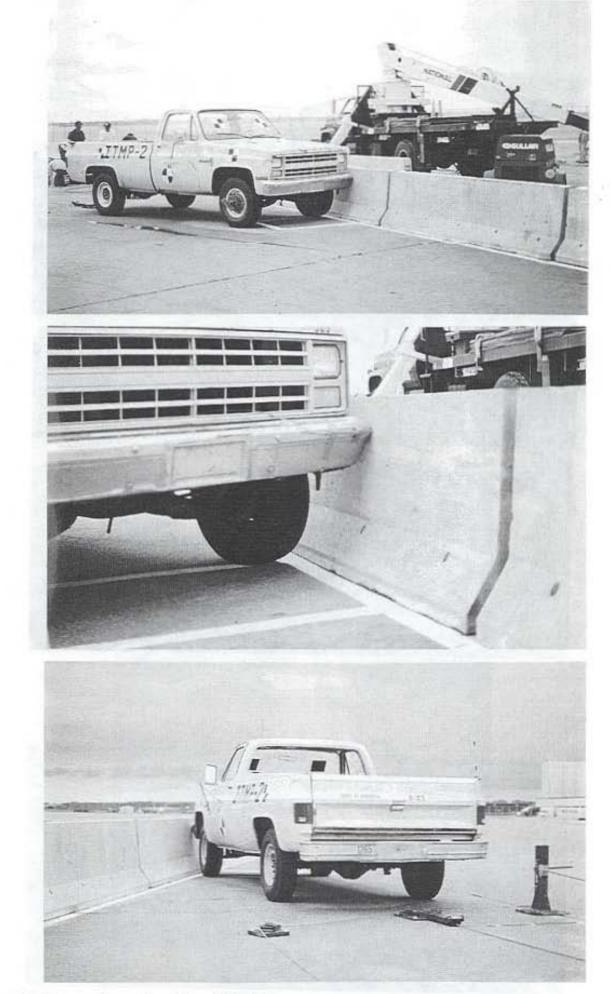
Figure 30. Impact Location, Test ITMP-2

Initial impact occurred 1.20 mupstream from the centerline of the gap between barrier nos. 8 and 9, as shown in Figure 30. After impact, the left-front tire of the vehicle became airborne as it began to climb the face of the barrier, and the left-front corner of the vehicle was crushed inward. Shortly thereafter, the left-front tire was deflated as it passed the gap between barrier nos. 8 and 9. The front tires then turned sharply left toward the barrier as the left-front corner continued to crush inward and extend over the top of the barrier. The right-front tire became airborne as the vehicle continued to climb up the barrier's front face. Subsequently, the left-front tire was observed to be on top of the barrier. At 0.268 sec, the vehicle was parallel to the barrier with the left-side of the vehicle's undercarriage positioned above the top of the barrier. The vehicle continued to travel above and on the traffic side of the barrier with the left-rear tire contacting the top of the barrier. After the vehicle became completely airborne with no barrier contact, it was evident that the left-front tire was dislodged from the vehicle. The vehicle then began to fall toward the ground with a moderate clockwise roll angle. At 0.695 sec, the right-front tire contacted the ground, while at 0.804 sec, the vehicle experienced significant pitch and roll. The maximum roll, pitch, and yaw angles
