# Post-Fire Damage Geospatial Assessment via Point Clouds of a Highway Bridge Structure

**ABSTRACT:** This paper discusses the quantitative post-fire damage assessment of a steel girder bridge via point clouds. In this case study, the point cloud was collected using light detection and ranging (lidar) for a detailed geometric and shape analysis. The out-of-plane deformation was analyzed to locate and quantify buckling across the length of the steel girders.

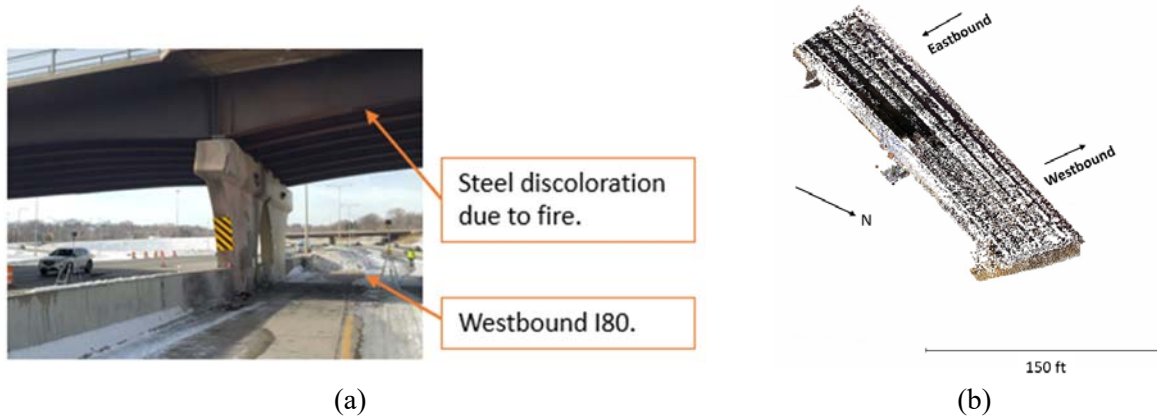
On Friday, June 1<sup>st</sup>, 2018, a vehicle caught fire on the I-80 westbound shoulder directly adjacent to the north side of the pier of the 10th street bridge in Omaha, Nebraska. The fire caused damage to the I-80 westbound pavement, barrier rail, north face of the bridge pier, steel girders and cross-frames of the superstructure, bridge deck, and utilities attached to the bridge (Figure 1a). Visual assessment was conducted following the event with observations including out-of-plane buckling of the steel girders as well as spalling and cracking of the concrete deck and pier. However, the visual damage assessment was not able to quantify the various damage patterns, nor indicate the extents of the damage along the girders due to the complex geometry of the structure [1]. Therefore, this study collected detailed geometric data using light detection and ranging (lidar) technology to analyze the complex buckling patterns of the bridge girders guide possible interventions.

Figure 1. The case study structure: (a) bridge view including lidar scanners deployed for point cloud collection, and (b) isometric view of aligned point cloud.
