Evaluation of Dowel Bar Inserter Practices in PCC Pavements with Magnetic Tomography Technology

Report MPMC-04

Final Report
26-1121-4027-001

December 2016

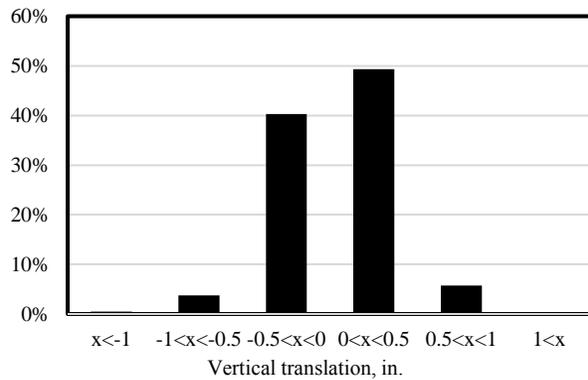
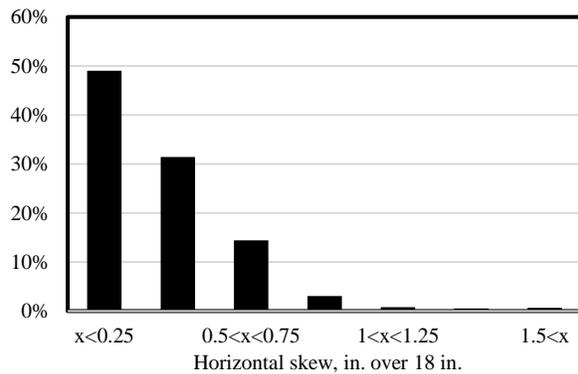
Figure 3.5 Comparison of MIT Scan-2 data with results of NCHRP study

To compare the performance of the DBI used in these 4 projects with typical DBI and dowel basket practices, misalignment graphs of all projects have been juxtaposed with data from the study by Khazanovich et al. (2009) for over 2,300 joints. Figure 3.5 shows that longitudinal translation values of the dowels placed by the DBI are higher than the average reported by the NCHRP study. This could have happened due to inaccurate marking of the joints for saw-cut operations, as well as using a defective DBI. The vertical translation of the dowels, however, was

better than NCHRP values, which could mean that the concrete mix used with the DBI was stable enough to hold the dowels in place after insertion. Horizontal skew and vertical tilt values for the scanned joints are comparable with average values reported by Khazanovich et al. (2009).
