## Crashworthy Perforated Square Steel Tube (PSST) Mailbox Support – Phase I

# **CRASHWORTHY PERFORATED SQUARE STEEL TUBE (PSST) MAILBOX SUPPORT – PHASE I**

MwRSF Research Report No. TRP-03-473-23

July 7, 2023

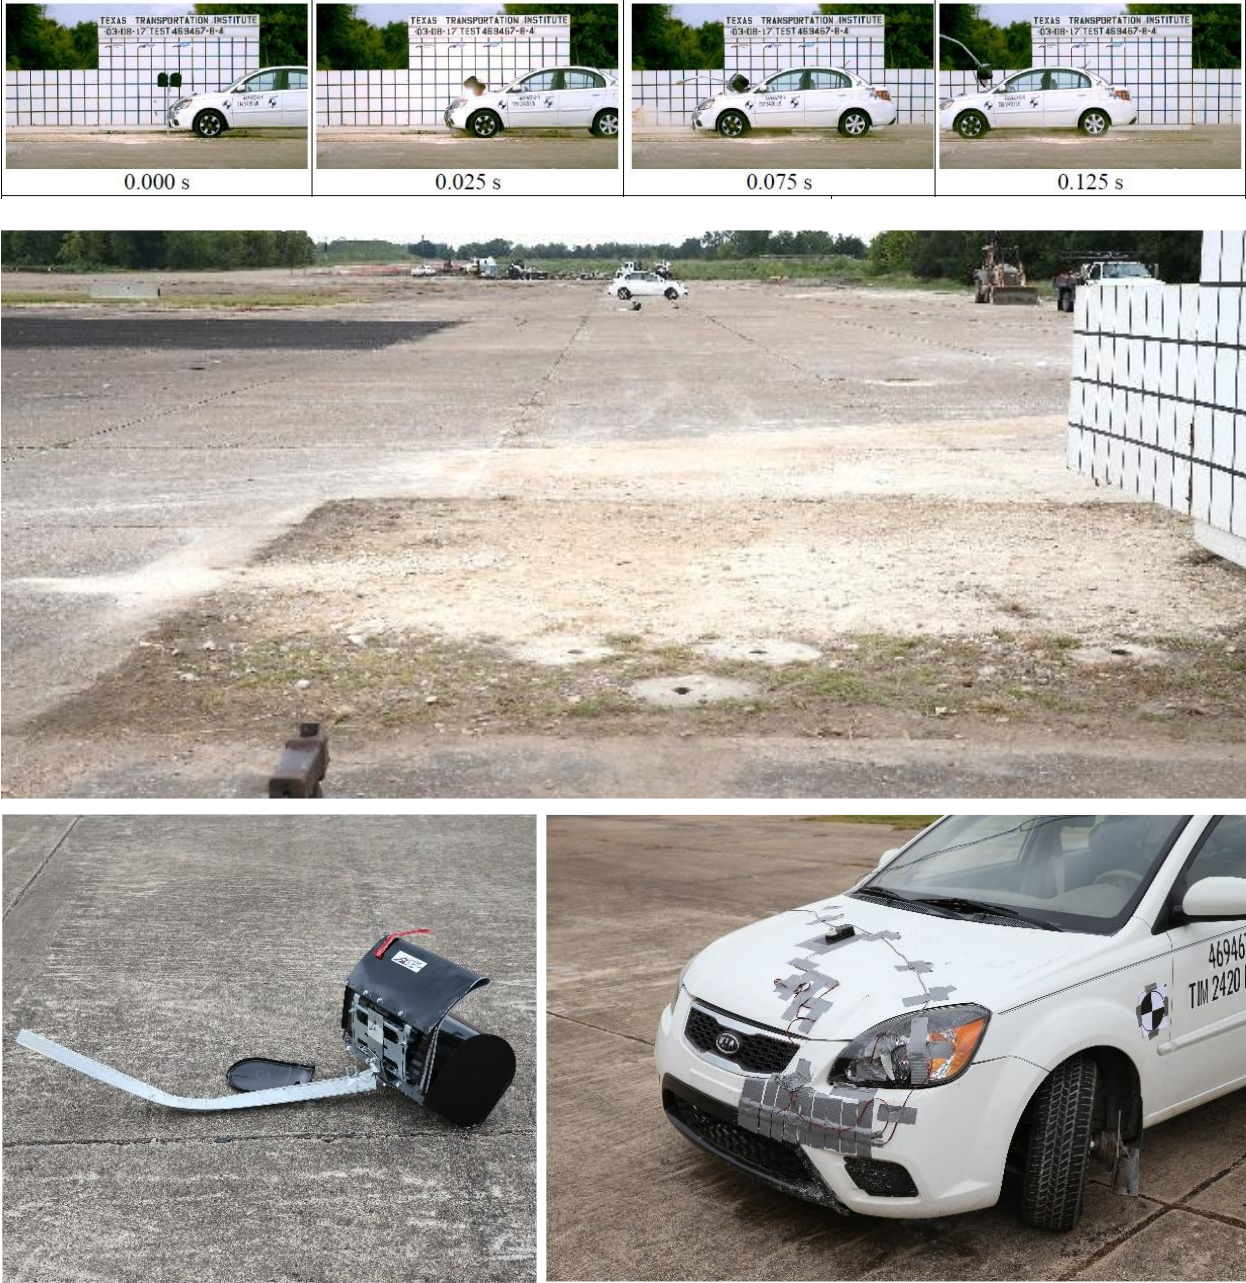
Figure 3. TxDOT Winged-Channel Mailbox Support - Test No. 469467-8-4, Test Results

impacted the mailbox at a speed of 63.3 mph and an angle of 0 degrees. Following initial impact, the support post deformed about the front bumper of the vehicle, which caused the mailbox to be pulled down onto the vehicle's hood. As the vehicle proceeded downstream, the support post fractured near the ground line, and the support post and mailbox were propelled up and over the top of the vehicle. The mailbox remained attached to the support post throughout the impact. The test was deemed acceptable according to the MASH criteria as all occupant risk criteria and occupant compartment deformation and penetration criteria were met during the test. Post test photographs and sequential images of the test are shown in Figure 3. A summary of the relevant test results is shown in Table 1.

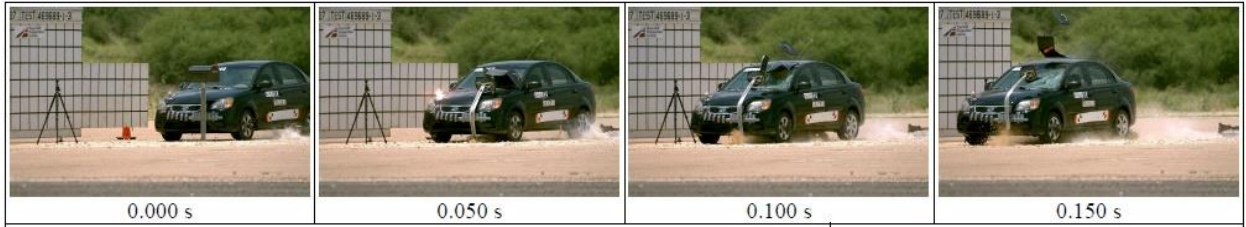
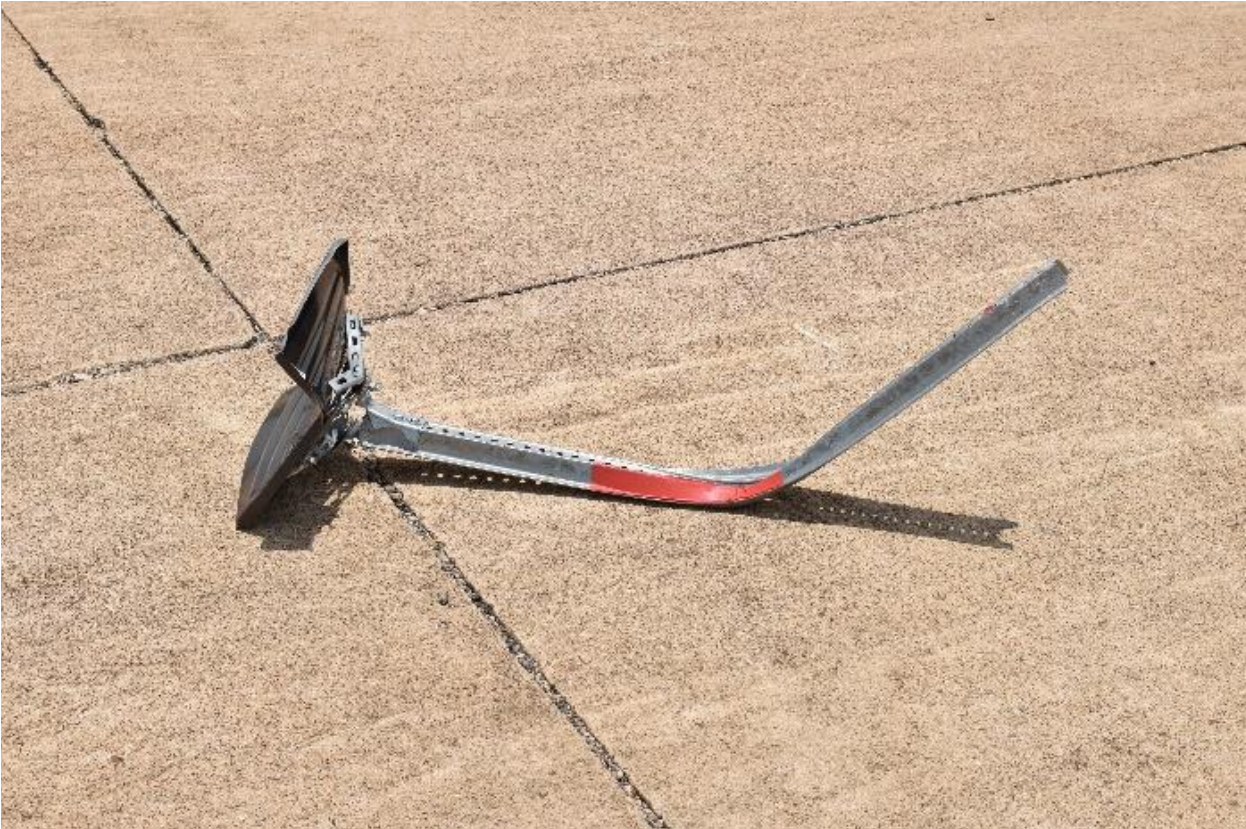
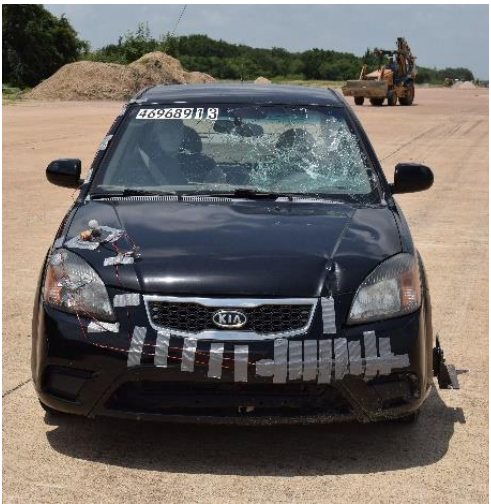
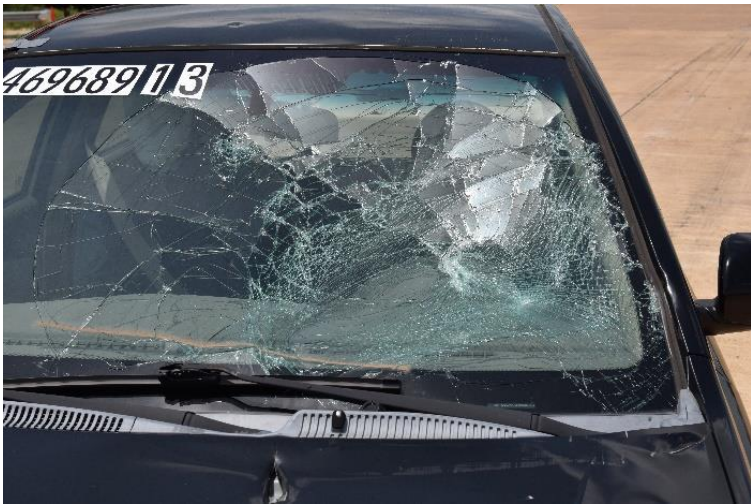
Figure 7. TxDOT Large Mailbox on Type 3 Support - Test No. 469689-1-3, Test Results

The mailbox system was evaluated using MASH test designation no. 3-61, which consisted of a 2,420-lb 1100C small car vehicle impacting the mailbox system at an impact speed of 62 mph and an angle of 0 degrees with a ¼ vehicle offset. In test no. 469689-1-3, the test vehicle impacted the mailbox system at 63.9 mph and an angle of 0 degrees. Following initial impact, the support post of the mailbox deformed about the front bumper of the vehicle which caused the mailbox to be pulled down onto the hood of the vehicle. As the vehicle proceeded downstream, the support post was pulled from the ground. The upper section of the mailbox detached from its base which remained attached to the support post. The detached upper section of the mailbox then impacted the windshield, causing 4.6 in. of deformation to the windshield and creating a tear in the windshield lining. The test was deemed unacceptable according to the MASH criteria due to the windshield damage observed during the test. Post test photographs and sequential images of the test are shown in Figure 7. A summary of the relevant test results is shown in Table 3.

<b>Test no.</b>	469689-1-3
<b>Test Designation</b>	3-61
<b>Test Vehicle</b>	1100C
<b>Impact Speed (mph)</b>	63.9
<b>Vehicle Orientation</b>	¼ Offset
<b>Longitudinal OIV/ Change in Velocity (ft/s)</b>	NA < 16 ft/s
<b>Longitudinal ORA (g's)</b>	NA
<b>Mailbox Release Time (sec)</b>	mailbox releases, but no time given
<b>Post Release Time (sec)</b>	0.018
<b>Test Result</b>	Fail – windshield deformation

Following the failure observed in test no. 469689-1-3, TTI modified the mailbox-to-support post attachment with the addition of four slotted L brackets measuring 2 in. × 6 in. × ⅞ in. × ⅛ in thick. The L-brackets allowed for attachment using four additional ¼-in. diameter hex bolts on the side flanges of the mailbox, as shown in Figure 8. TTI conducted a repeat test using the modified version of the single large mailbox mounted on a 2-lb/ft U-channel post. In test no. 469689-1-4, the test vehicle impacted the mailbox system at 63.9 mph and an angle of 0 degrees. Following initial impact, the support post deformed about the front bumper of the vehicle, which caused the mailbox to be pulled down onto the vehicle’s hood. As the vehicle proceeded downstream, the support post was pulled from the ground. The mailbox remained attached to the

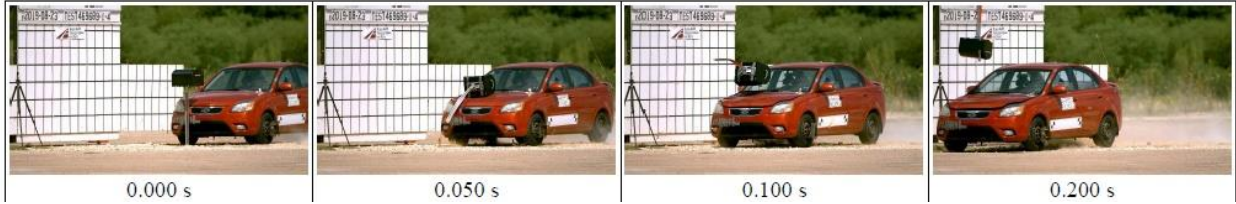
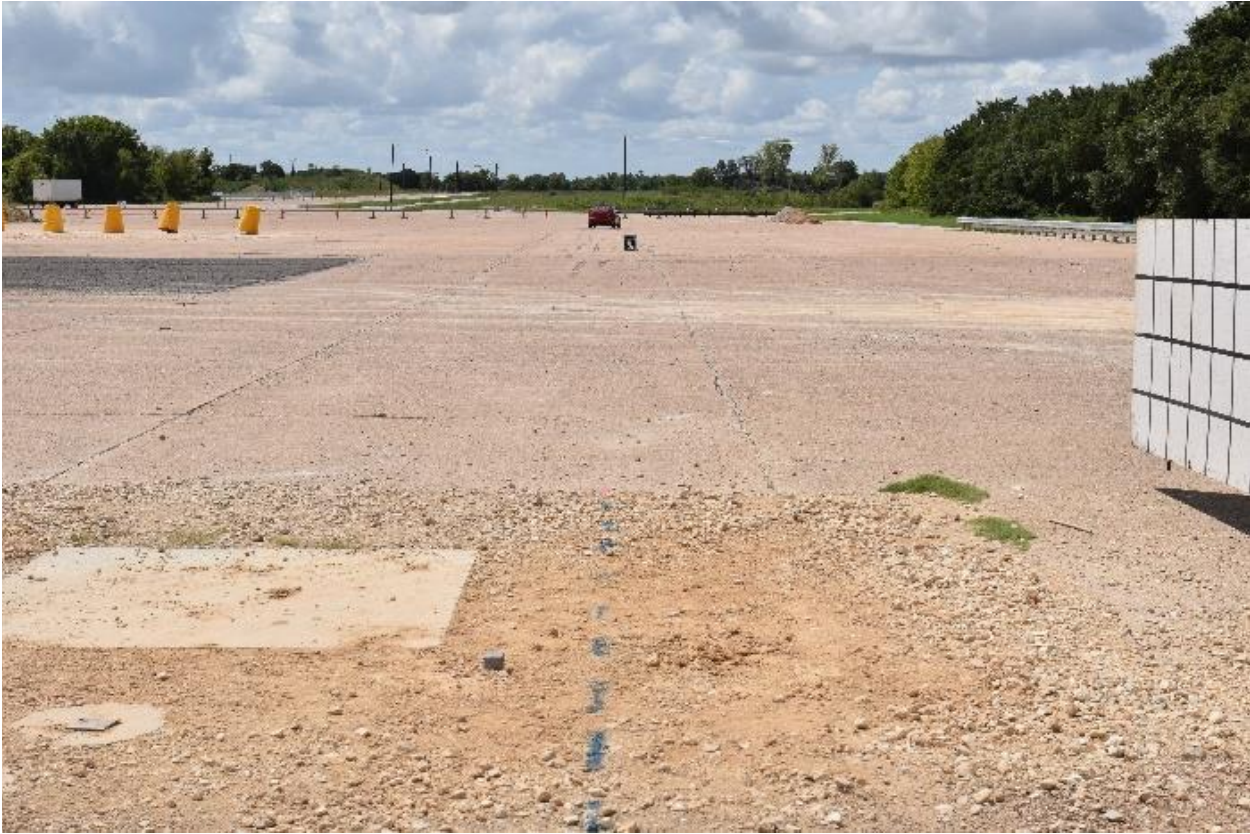
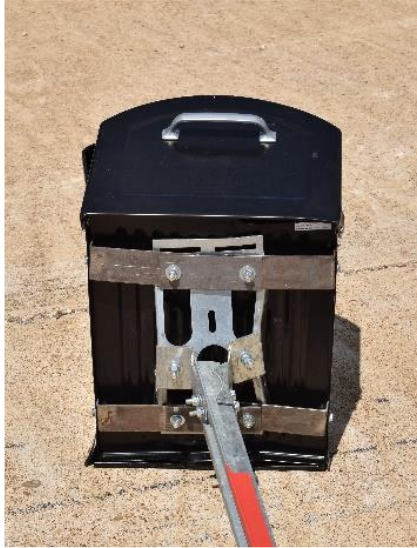
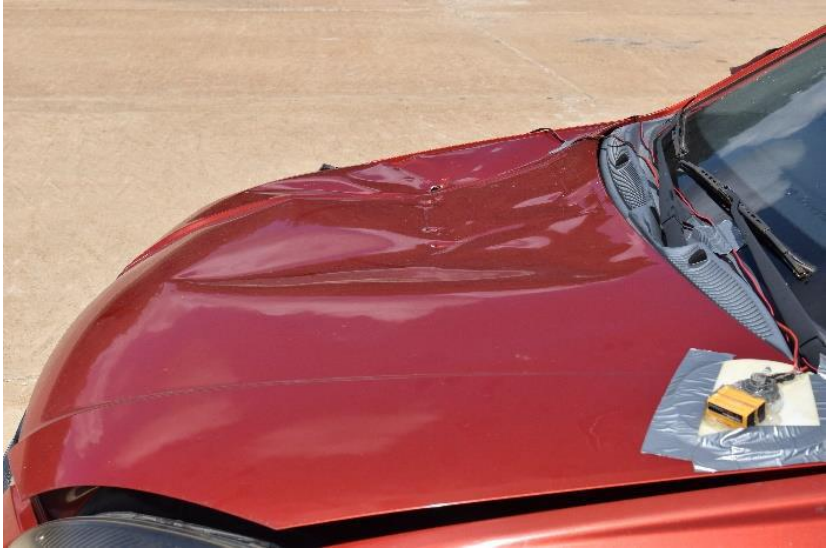
Figure 9. TxDOT Large Mailbox on Type 3 Support - Test No. 469689-1-4, Test Results

support post and was eventually propelled up and over the vehicle. The test was deemed acceptable according to the MASH criteria as all occupant risk criteria and occupant compartment deformation and penetration criteria were met during the test. Post test photographs and sequential images of the test are shown in Figure 9. A summary of the relevant test results is shown in Table 4.

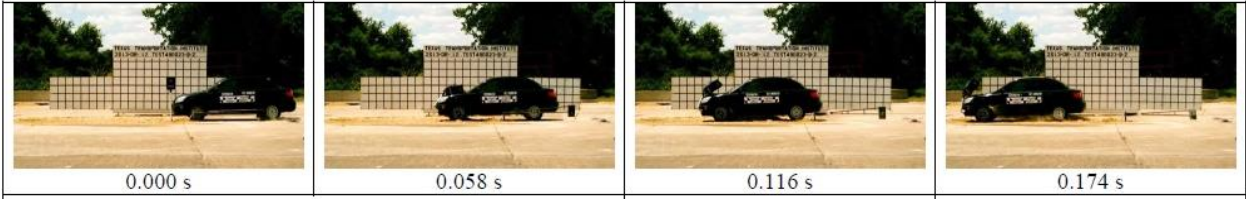
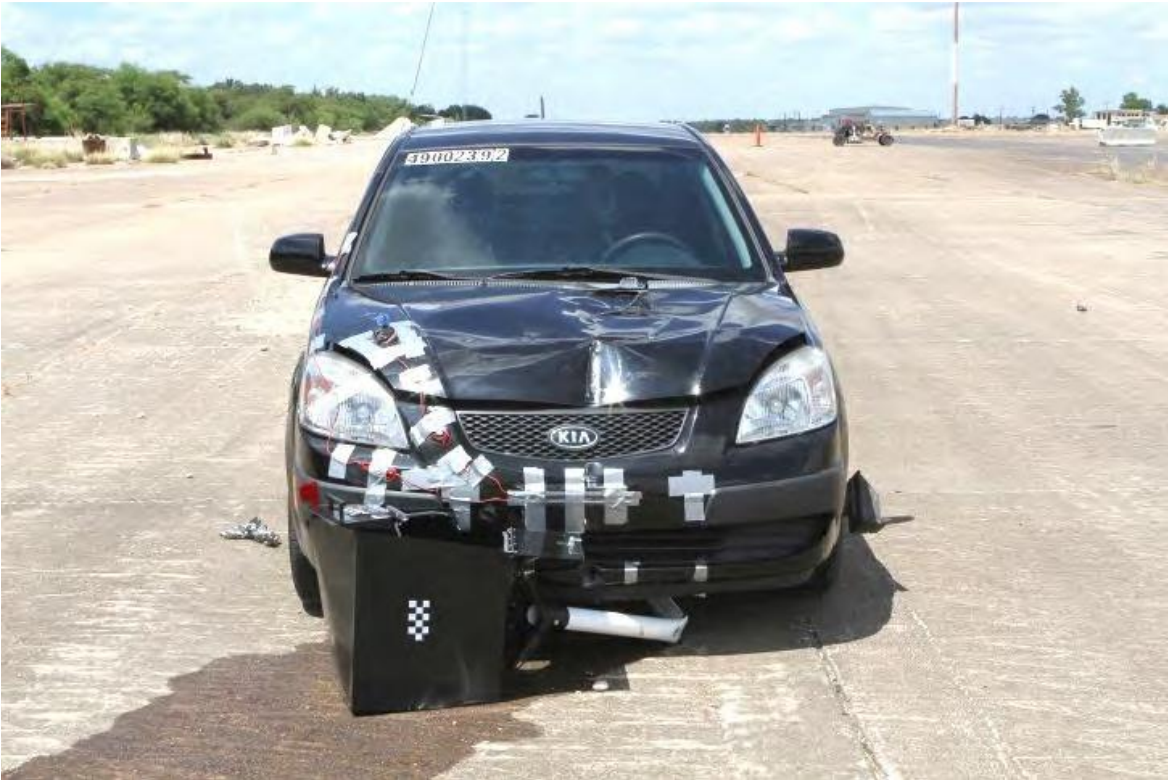
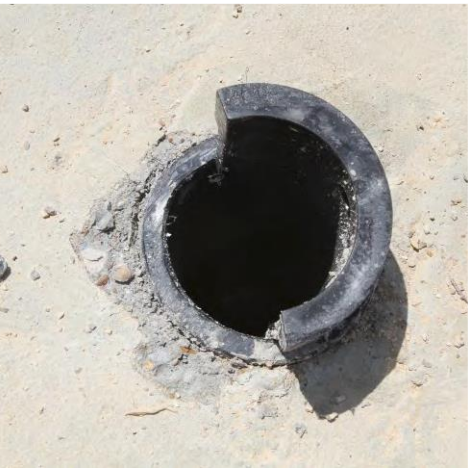
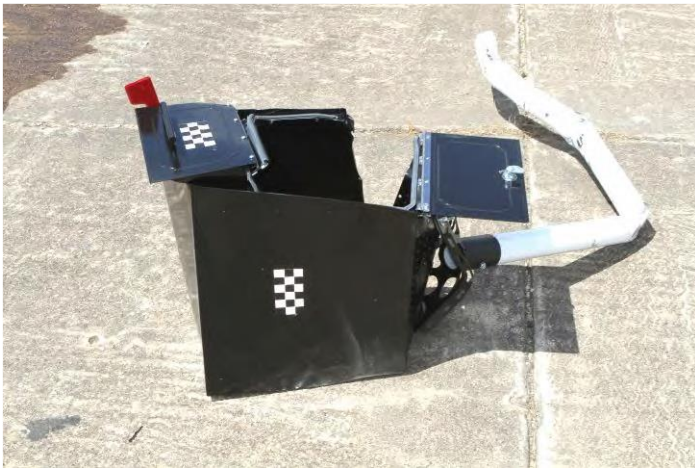
Figure 14. Locking Architectural Mailbox on Single Mount Post - Test No. 490023-9-2, Test Results

In test no. 490023-9-2 (test designation no. 3-61), the test vehicle impacted the mailbox system at 63.8 mph and an angle of 0 degrees. Following initial impact, the support post deformed about the front bumper of the vehicle, which caused the mailbox to be pulled down onto the vehicle's hood. The support post detached from the socket and was propelled downstream. The mailbox remained attached to the support post. The test was deemed acceptable according to the MASH criteria as all occupant risk criteria and occupant compartment deformation and penetration criteria were met during the test. Post test photographs and sequential images of the test are shown in Figure 14. A summary of the relevant test results is shown in Table 7.

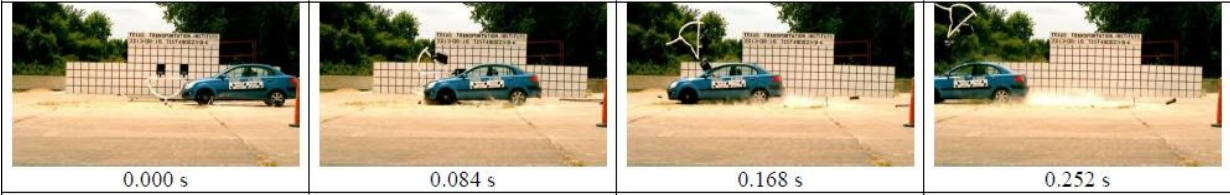
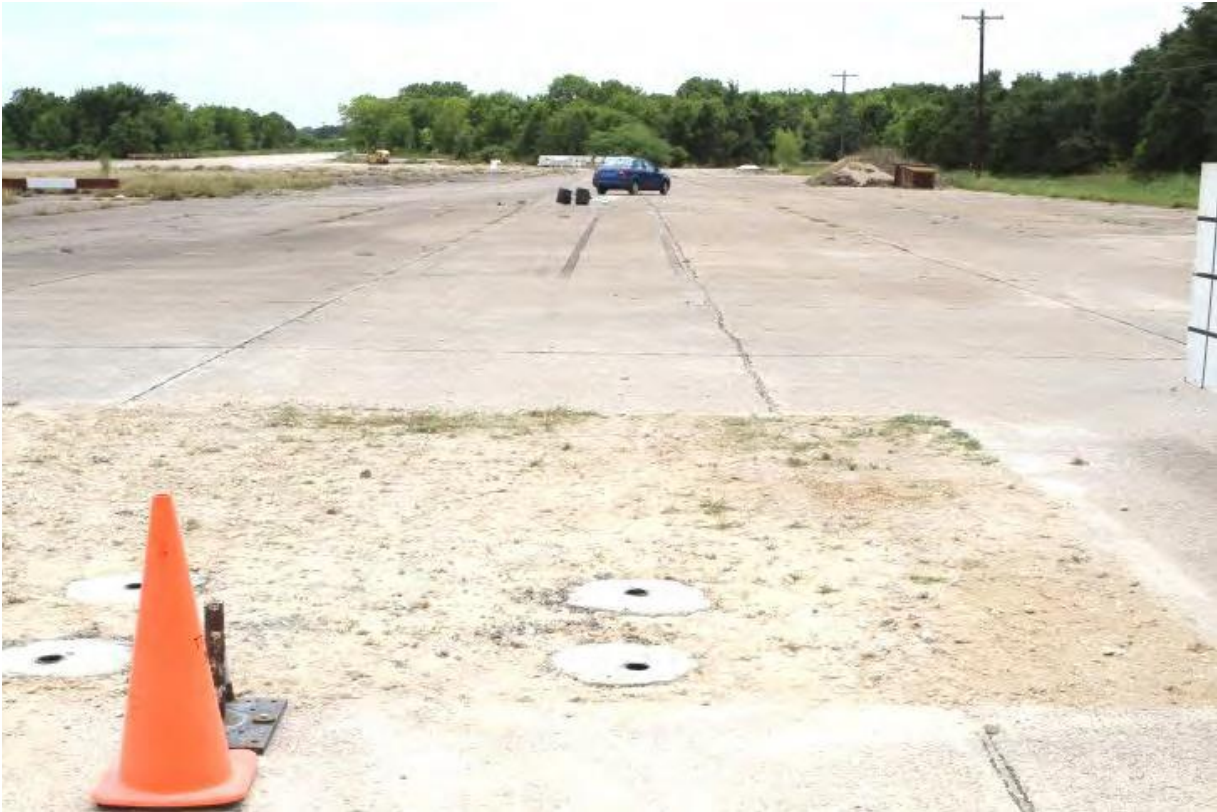
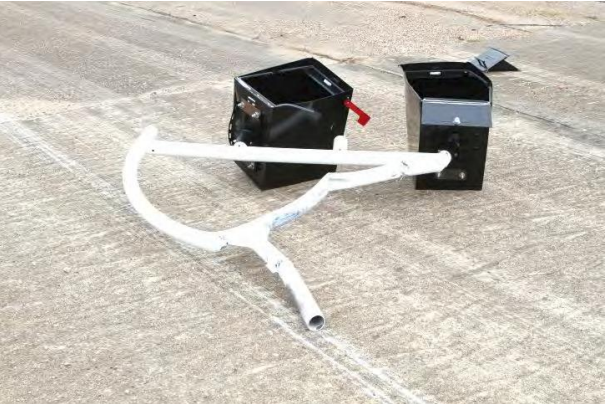
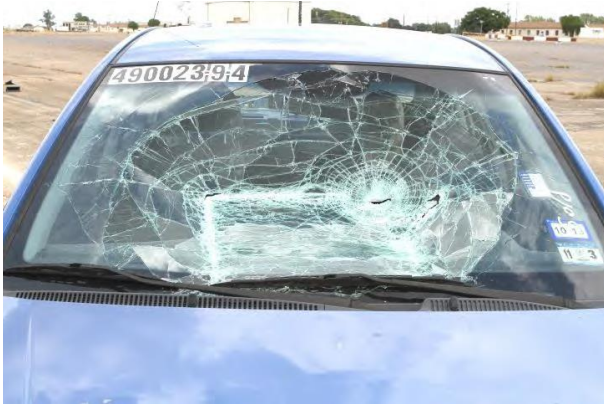
Figure 17. Locking Architectural Mailbox on Dual Mount Post - Test No. 490023-9-4, Test Results

In test no. 490023-9-4 (test designation no. 3-61), the test vehicle impacted the mailbox system at 63.0 mph and an angle of 0 degrees. Following initial impact, the support post deformed and collapsed and the mailboxes rotated toward the vehicle. The support post then pulled out of the socket and moved up on the hood of the vehicle, which allowed the leading mailbox to contact and fracture the windshield. The mailboxes remained attached to the support post. There was 4.5 in. of windshield deformation and penetration of the windshield. The test was deemed unacceptable according to the MASH criteria due to the windshield damage. Post test photographs and sequential images of the test are shown in Figure 17. A summary of the relevant test results is shown in Table 9.

<b>Test no.</b>	490023-9-4
<b>Test Designation</b>	3-61
<b>Test Vehicle</b>	1100C
<b>Impact Speed (mph)</b>	63.0
<b>Vehicle Orientation</b>	¼ Offset
<b>Longitudinal OIV/ Change in Velocity (ft/s)</b>	4.9 ft/s < 16 ft/s
<b>Longitudinal ORA (g's)</b>	1.0
<b>Mailbox Release Time (sec)</b>	No mailbox release
<b>Post Release Time (sec)</b>	0.014 – 0.31 sec
<b>Test Result</b>	Failure windshield penetration and deformation
