# **PERFORMANCE LIMITS FOR 6-IN. (152-MM) HIGH CURBS PLACED IN ADVANCE OF THE MGS USING MASH VEHICLES PART II: FULL-SCALE CRASH TESTING**

MwRSF Research Report No. TRP-03-221-09

October 30, 2009

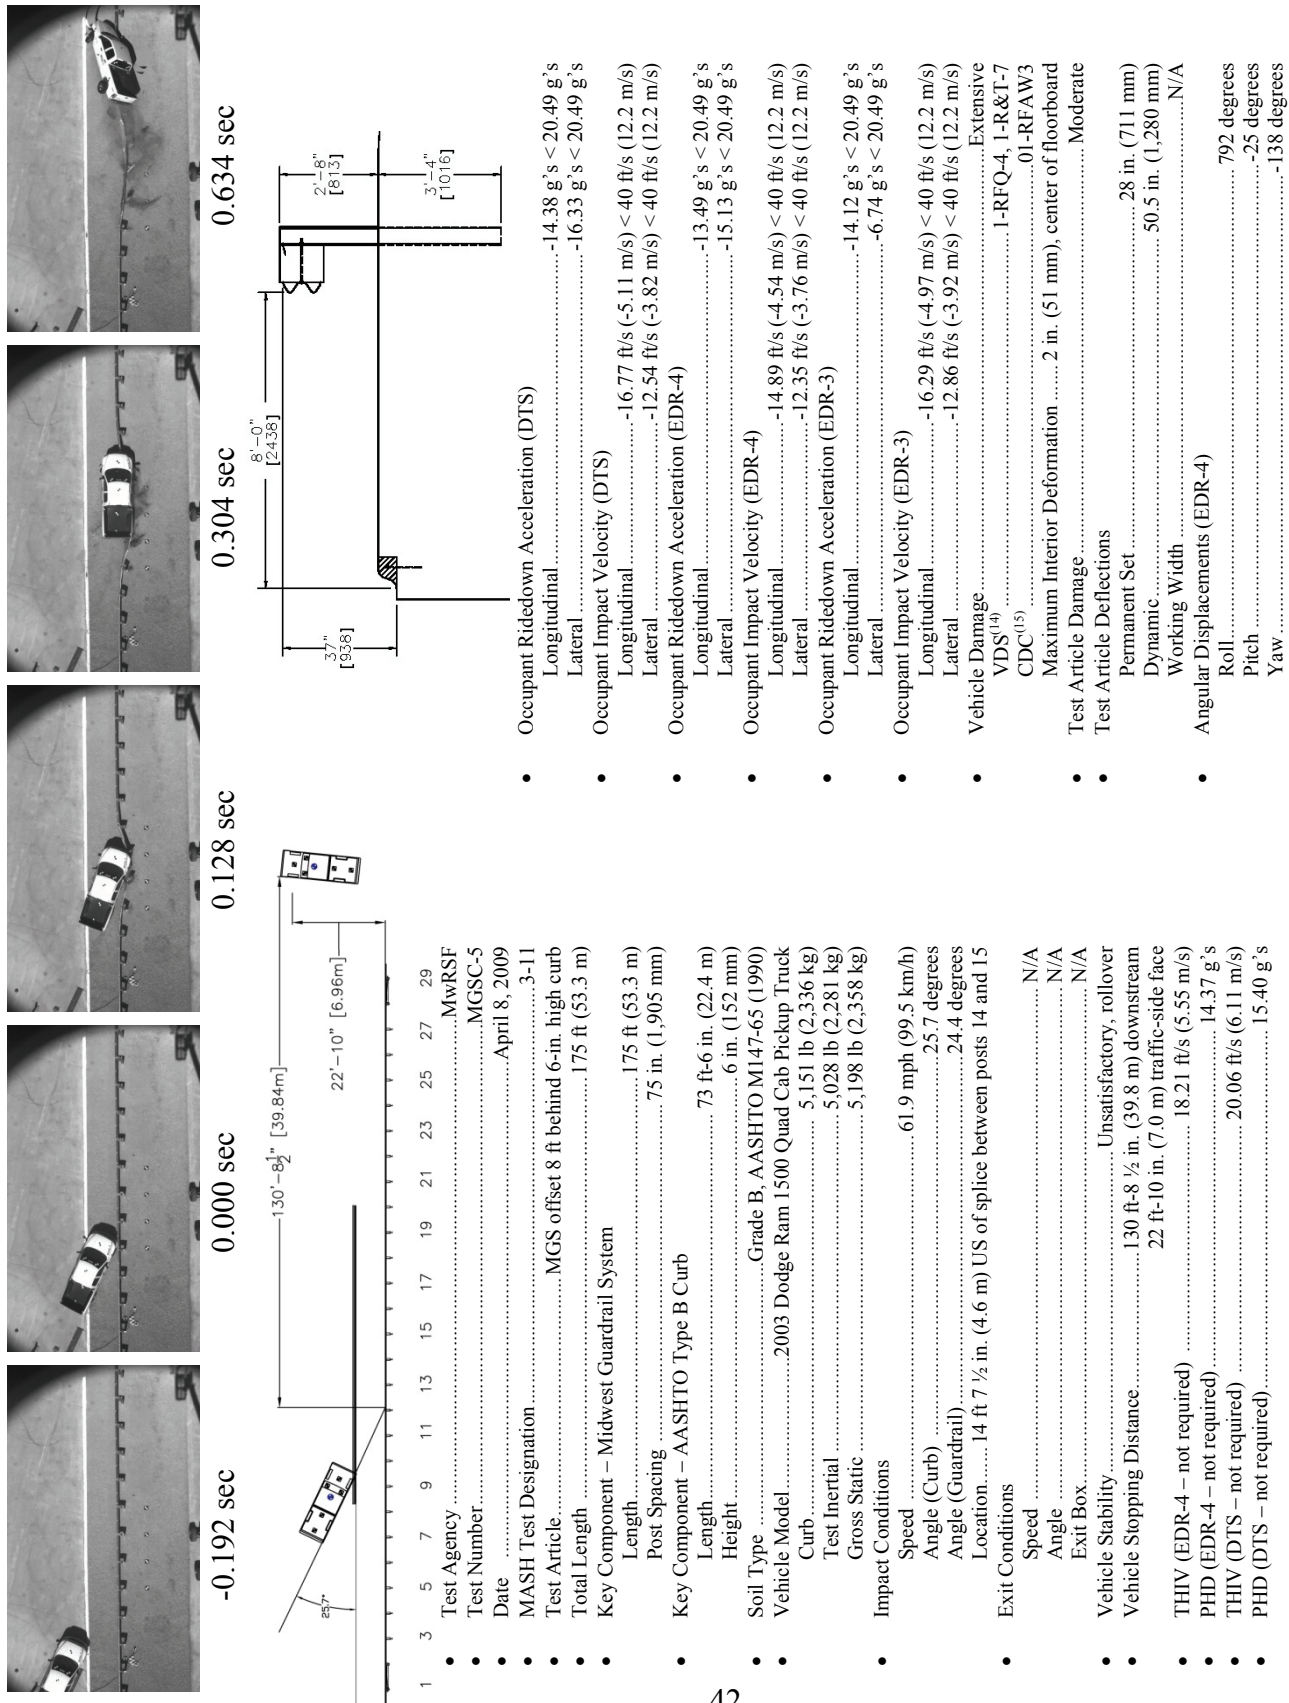
Figure 20. Summary of Test Results and Sequential Photographs, Test No. MGSC-5

The analysis of the test results for test no. MGSC-5 showed that the MGS guardrail and curb configuration did not adequately contain nor redirect the 2270P vehicle, since the vehicle did not remain upright after collision with the barrier. There were no detached elements nor fragments which showed potential for penetrating the occupant compartment nor presented undue hazard to other traffic. Deformations of, or intrusions into the occupant compartment that could have caused serious injury did occur with the deformation of the vehicle's roof. Vehicle roll, pitch, and yaw angular displacements were noted, as shown in Appendix E, and were deemed unacceptable because they adversely influenced occupant risk safety criteria. Therefore, test no. MGSC-5 conducted on the MGS offset 8 ft (2.438 m) behind a 6-in. (152-mm) high curb was determined to be unacceptable according to test designation no. 3-11 of the TL-3 safety performance criteria found in MASH.

Following the unacceptable test results, the causes of vehicle rollover were determined from a series of events. As the vehicle impacted the guardrail, redirection was initiated; however, due to the upward lift of the truck following curb contact, the right-front wheel contacted the guardrail. As the system rotated, post no. 15 applied an upward force on the vehicle's front end, causing the front of the vehicle to pitch upward and the front bumper to rise above the guardrail. At this same time, the right-front wheel snagged on post no. 15, causing the pickup to roll toward the system. Subsequently, the right-front wheel detached from the vehicle due to the snag and was pulled underneath the pickup truck. As the vehicle continued along its path, the right-rear wheel then contacted the disengaged right-front wheel and overrode it. This caused the rear end of the vehicle to pitch upward, and shortly thereafter the vehicle became airborne. The pickup, which previously began to roll due to wheel snag, lost contact with the guardrail and continued to roll while airborne. This in turn caused the vehicle to roll over completely.

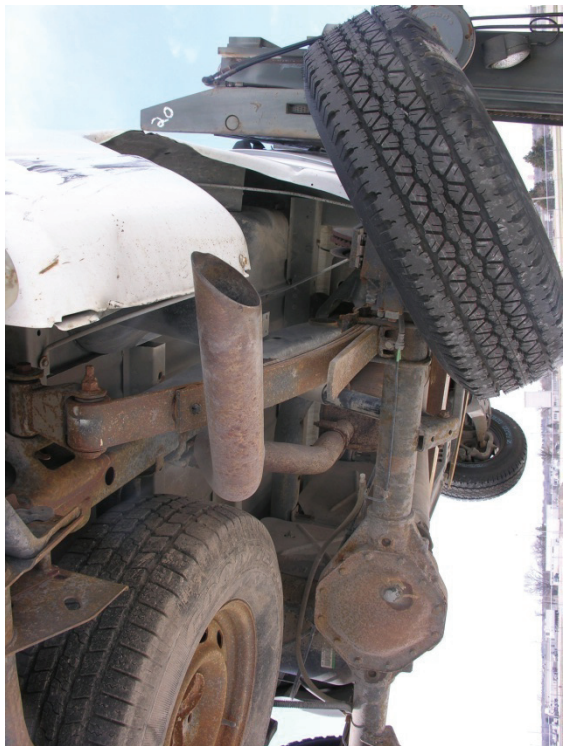
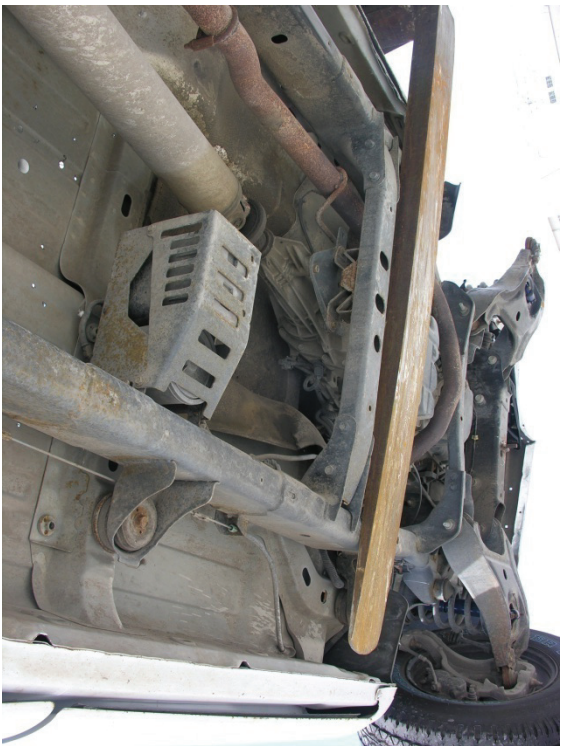
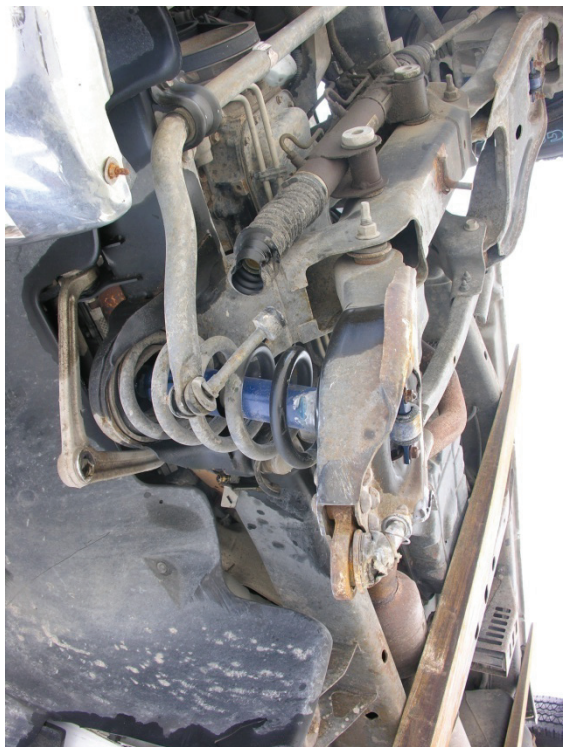
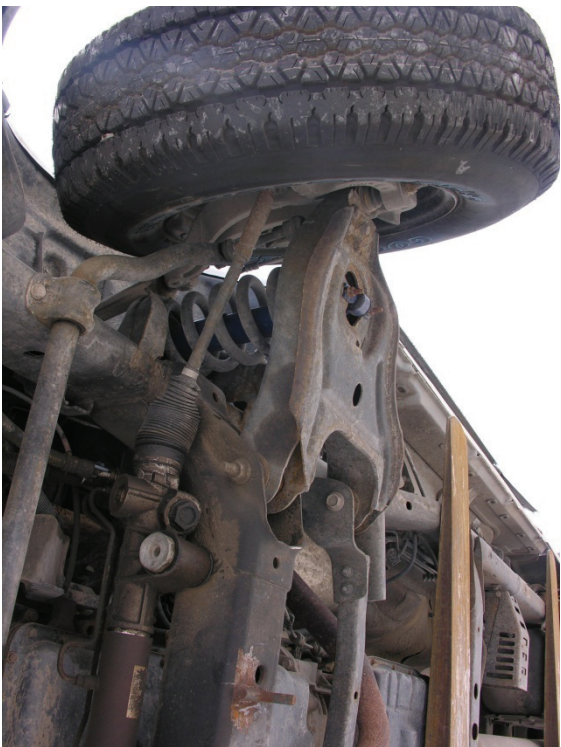
Figure 42. Undercarriage Damage, Test No. MGSC-5

Exterior damage was located on all portions of the vehicle. Both right-side wheel assemblies were detached from the vehicle. The right-front wheel spindle and assembly detached from the suspension control arms. The rear axle fractured at the right-rear wheel. The right-front quarter panel and bumper were deformed inward toward the engine compartment. Scrapes and gouges were found along the right-side doors and right-rear quarter panel. The right-side headlight and both rear tail lights fractured. The left side of the truck box was significantly deformed and bent away from the cab. Minor deformations occurred along the left-side doors, left-front quarter panel, and rear bumper. Both the left- and right-side mirrors disengaged from the truck. The hood and grill were slightly deformed and displaced. The roof was crushed inward, especially on the left side. The windshield was severely shattered and partially displaced. The right-front door, rear, and both left-side door window glass was fractured and removed from the vehicle. The right-rear door window glass remained undamaged.

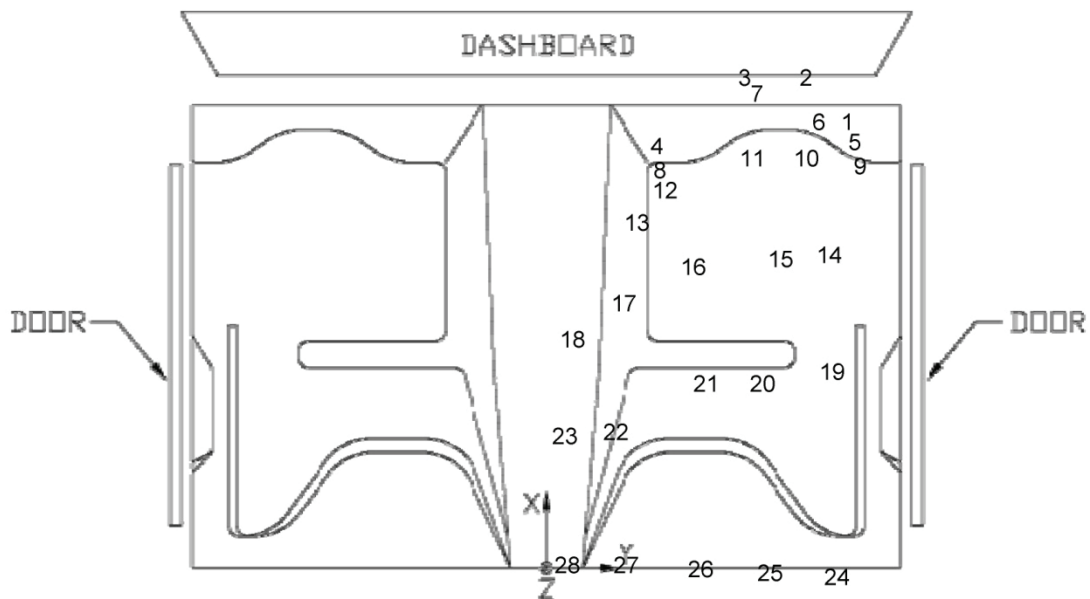
Figure D-1. Floor Pan Deformation Data – Set 1, Test No. MGSC-5

The damage to the vehicle was extensive, as shown in Figures 39 through 43. Occupant compartment deformations were judged to be significant to cause serious injury to vehicle occupants. Deformations to the vehicle floorboard were relatively minor, with maximum longitudinal, lateral, and vertical deflections of  $\frac{1}{4}$  in. (6 mm) located throughout the right-side floorboard,  $\frac{1}{2}$  in. (13 mm) located along the right side of the right-side floorboard, and 2 in. (51 mm) located near the center of the vehicle's floorboard, respectively. Complete occupant compartment and vehicle deformations and the corresponding locations are provided in Appendix D.
