Phase II Development of a Non-Proprietary, Four-Cable, High Tension Median Barrier

TESTING CERT # 2937.01

Midwest States Regional Pooled Fund Research Program

Research Project Number TPF-5(091) Suppl #1

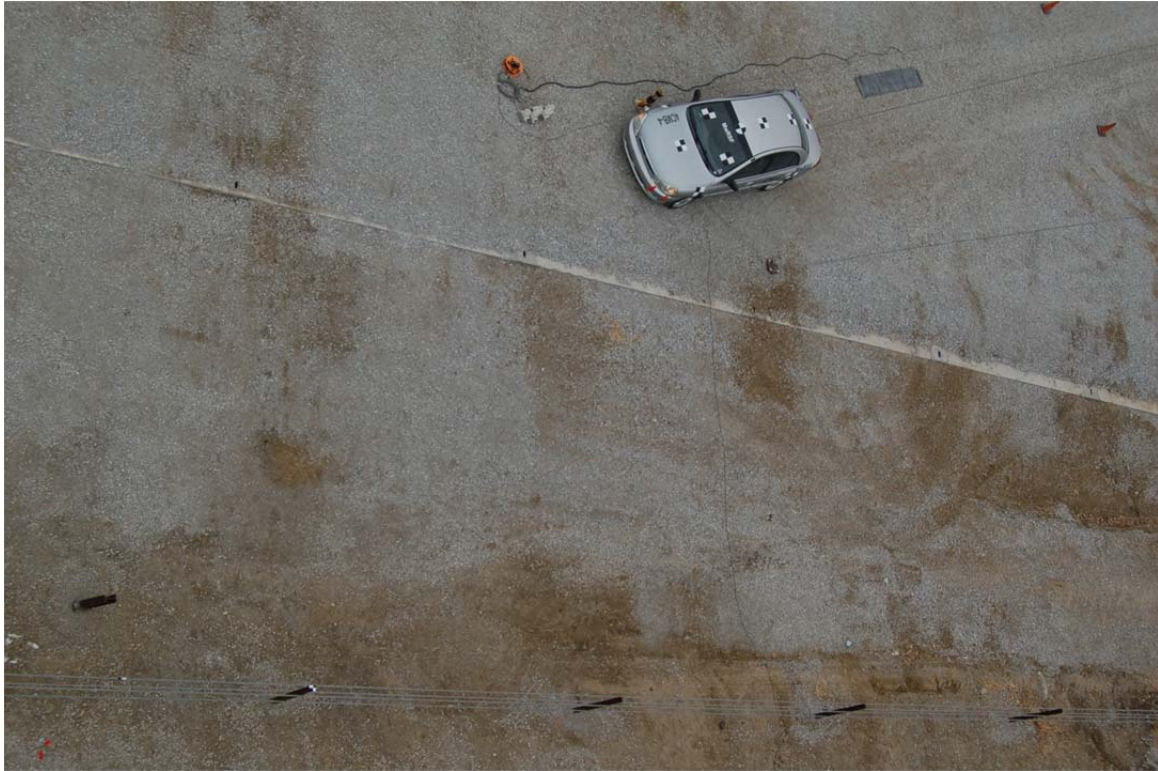
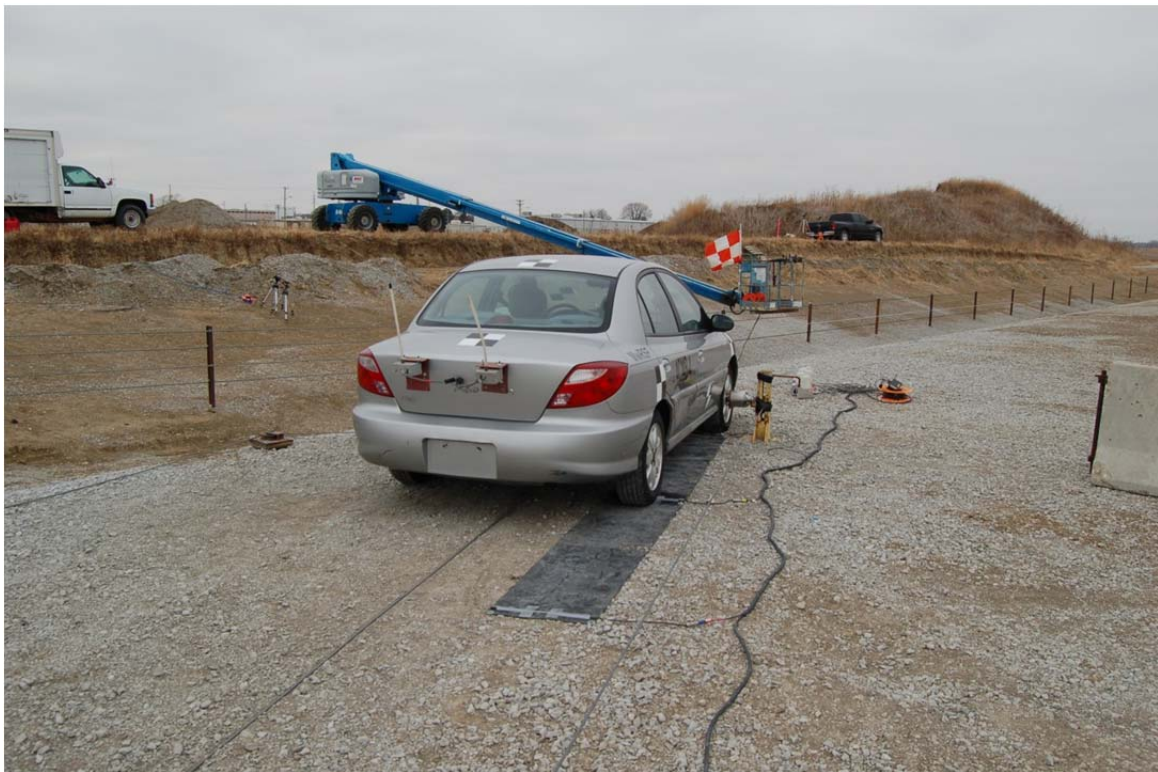
Figure 40. Impact Location, Test No. 4CMB-4

Initial vehicle impact was to occur 5 ft – 4 in. (1.6 m) downstream of post no. 16, as shown in Figure 40, which was selected using an analysis of the vehicle trajectory over the slope to maximize the potential for vehicle underride. The actual point of impact was 5 ft – 4in. (1.6 m) downstream of post no. 16. A sequential description of the impact events is contained in Table 5. The cables were numbered from 1 to 4, from the top to bottom, respectively. The vehicle came to rest parallel to the system captured in the cables 85 ft – 8 in. (26.1 m) downstream and 4 ft – 4 in. (1.3 m) to the left of the initial impact. The vehicle trajectory and final position are shown in Figures 36 and 41.
