Safety Performance Evaluation of the Non-Blocked Midwest Guardrail System

*Midwest States Regional Pooled Fund Research Program
Fiscal Years 2011 (Year 21)
Research Project Number TPF-5(193) Supplemental #33
NDOR Sponsoring Agency Code RFPF-11-MGS-3*

SAFETY PERFORMANCE EVALUATION OF THE NON-BLOCKED MIDWEST GUARDRAIL SYSTEM (MGS)

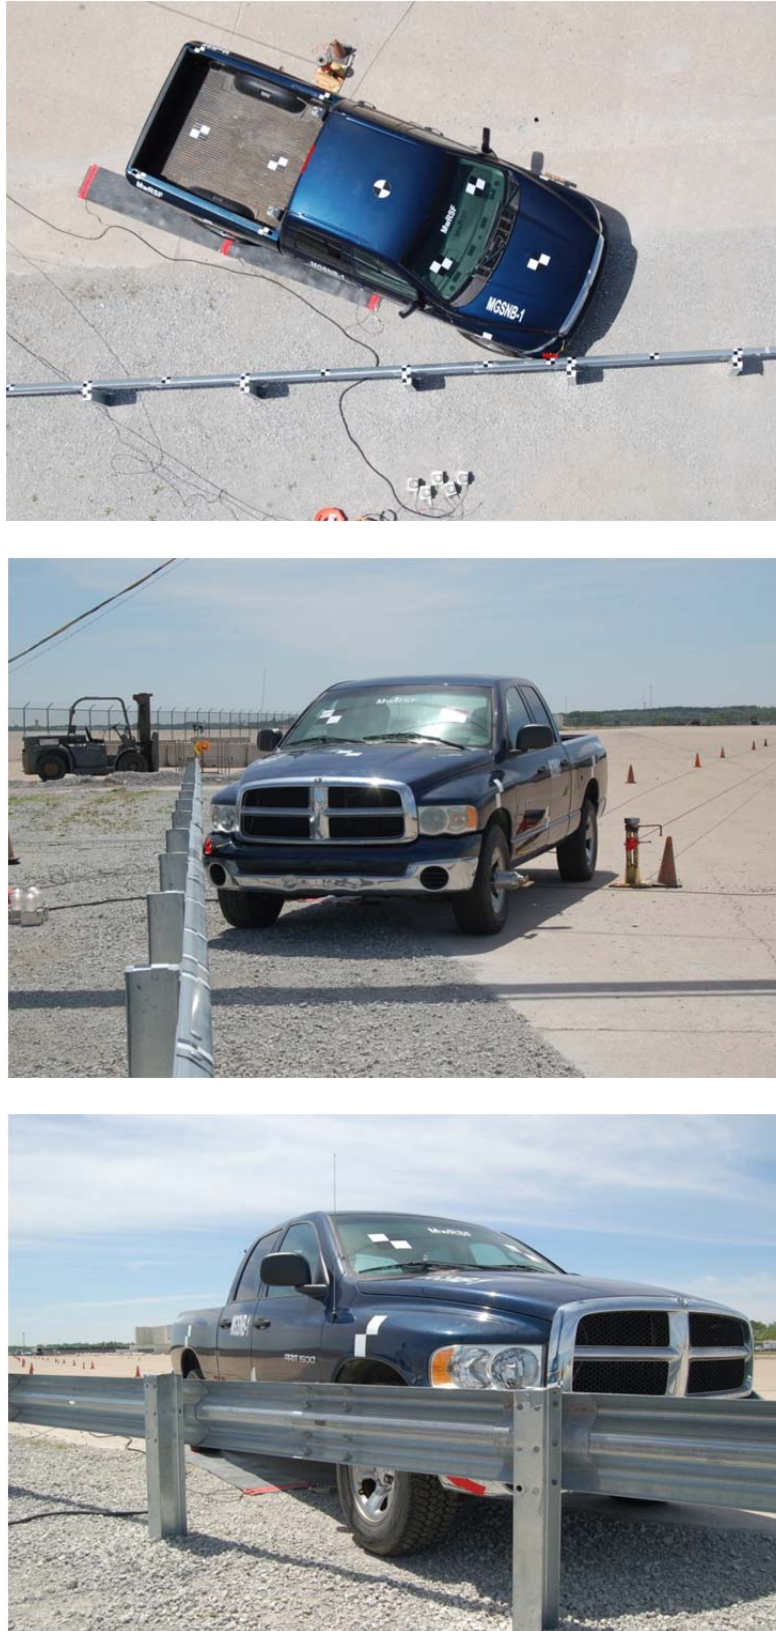
Figure 37. Impact Location, Test No. MGSNB-1

Initial vehicle impact was to occur 13 ft – 3½ in. (4.1 m) upstream of the centerline of post no. 15, as shown in Figure 37, which was selected using the critical impact point (CIP) plots found in Section 2.3 of MASH. The actual point of impact was the intended impact point. A sequential description of the impact events is contained in Table 4. The vehicle came to rest located 190 ft – 4 in. (58.0 m) downstream from impact and 51 ft (15.6 m) laterally behind the traffic-side face of the rail. The vehicle trajectory and final position are shown in Figures 32 and 38.

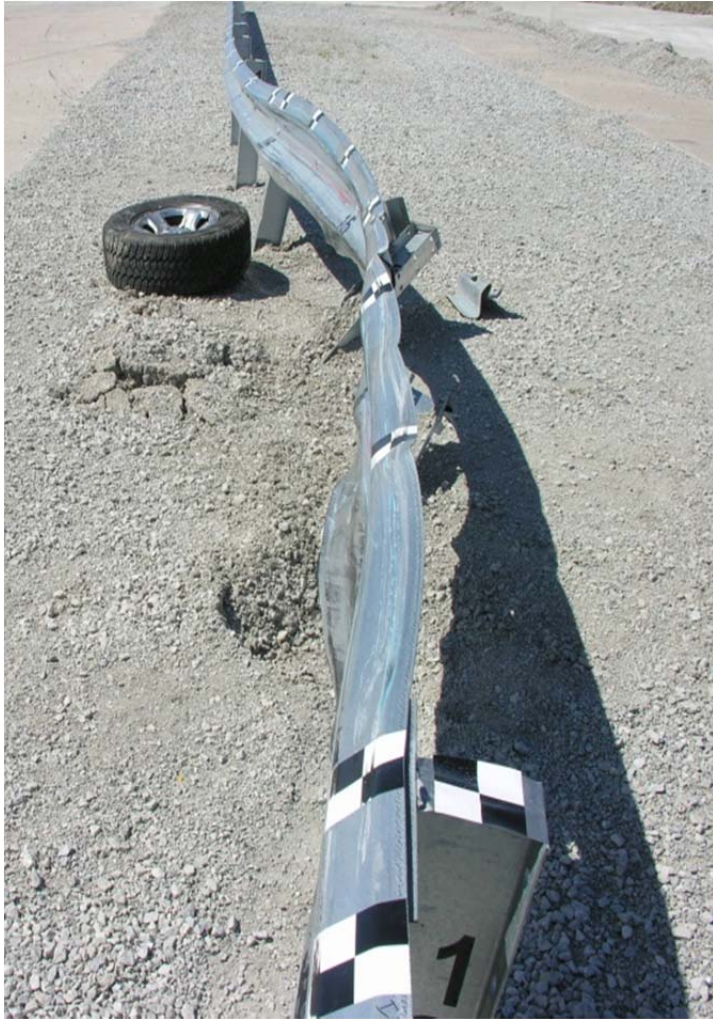
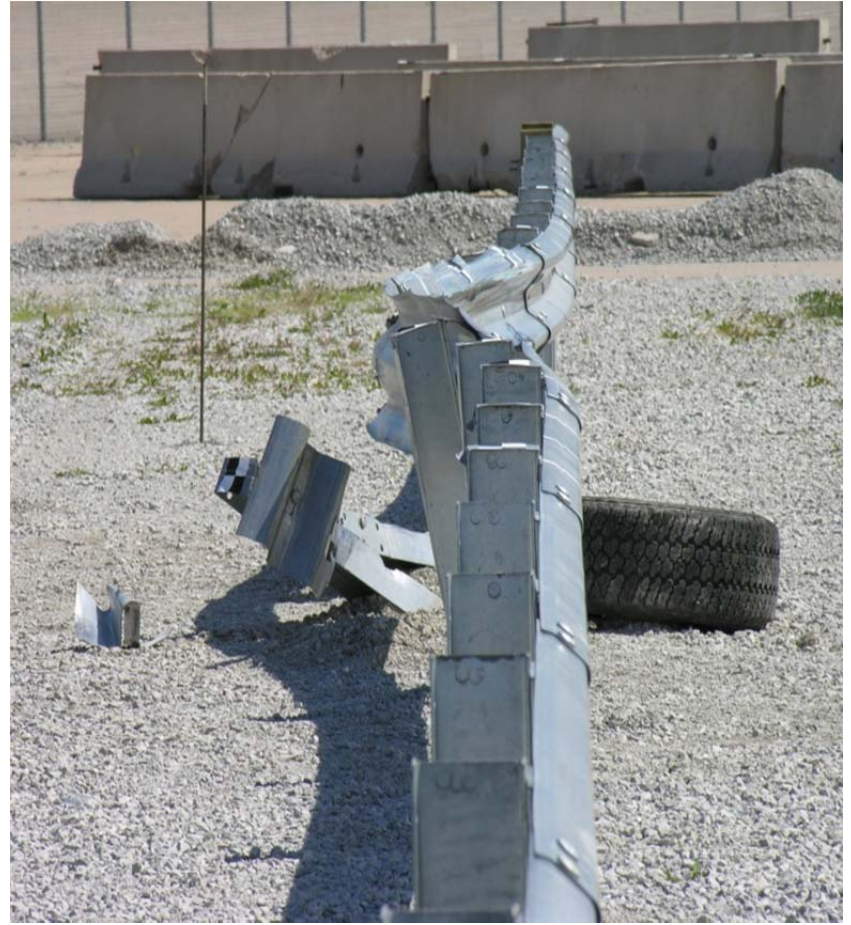
Figure 39. System Damage, Test No. MGSNB-1

Damage to the barrier was moderate, as shown in Figures 39 through 42. Barrier damage consisted of deformed W-beam rail, deformed posts, and contact marks on sections of guardrail and posts. The length of vehicle contact along the barrier was approximately 23 ft – 6 in. (7.2 m) which spanned from 21 in. (533 mm) upstream of the centerline of post no. 13 to 41¾ in. (1,060 mm) downstream of the centerline of post no. 16.

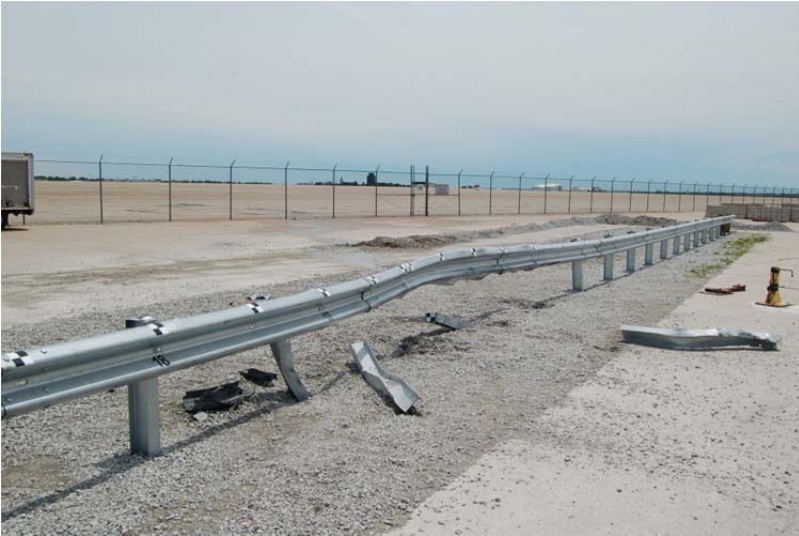
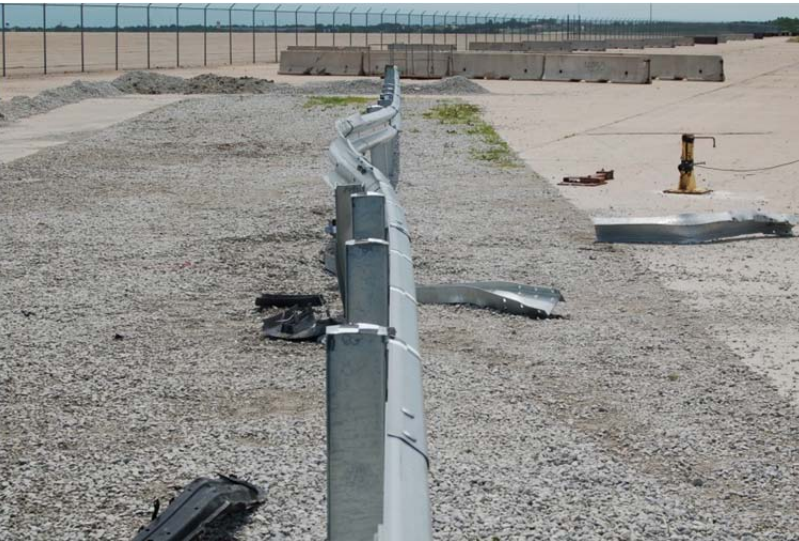
Figure 54. System Barrier Damage, Test No. MGSNB-2

Damage to the barrier was moderate, as shown in Figures 54 through 56. Barrier damage consisted of deformed W-beam rail, deformed posts, and contact marks on sections of guardrail and posts. The length of vehicle contact along the barrier was approximately 20 ft – 7¼ in. (6.3 m) which spanned from 2 ft – 8¼ in. (0.8 m) upstream from the center of post no. 14 to 10 in. (254 mm) upstream from the center of post no. 17. Secondary vehicle contact was 9 ft – 10 in.

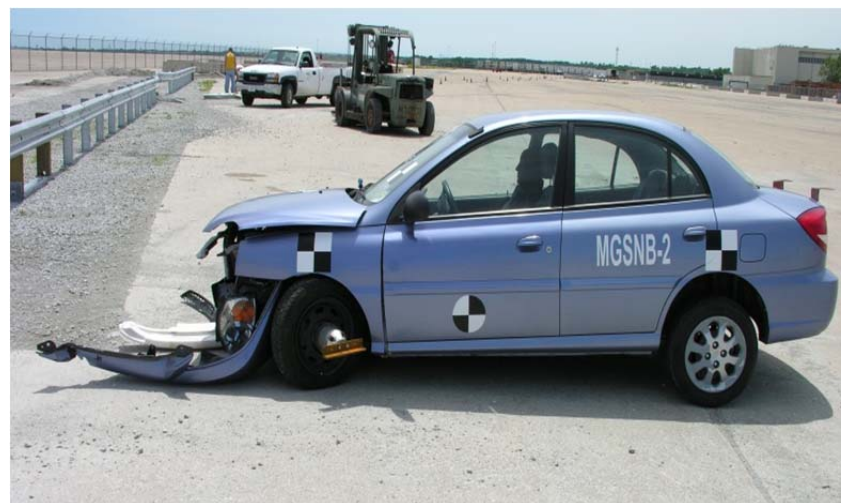
Figure 57. Vehicle Damage, Test No. MGSNB-2

Damage to the vehicle was moderate, as shown in Figures 57 and 58. The maximum occupant compartment deformations are listed in Table 9 along with the deformation limits established in MASH for various areas of the occupant compartment. None of the MASH established deformation limits were violated. Complete occupant compartment and vehicle deformations and the corresponding locations are provided in Appendix D.

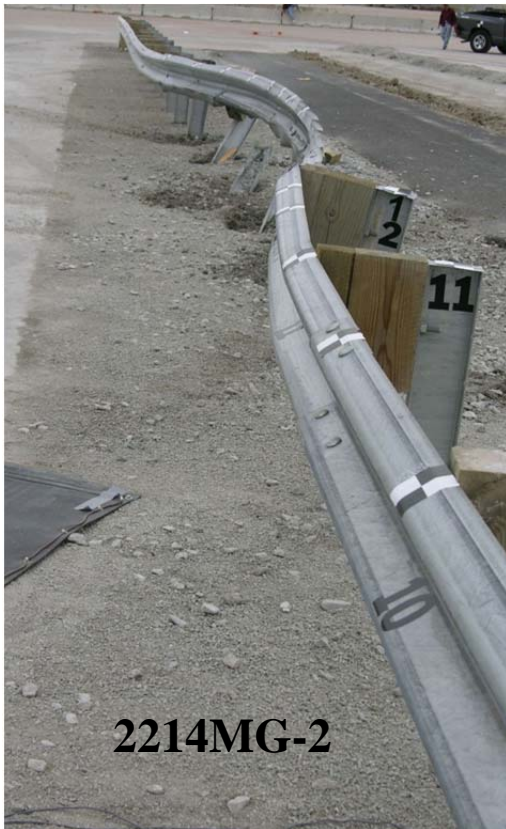
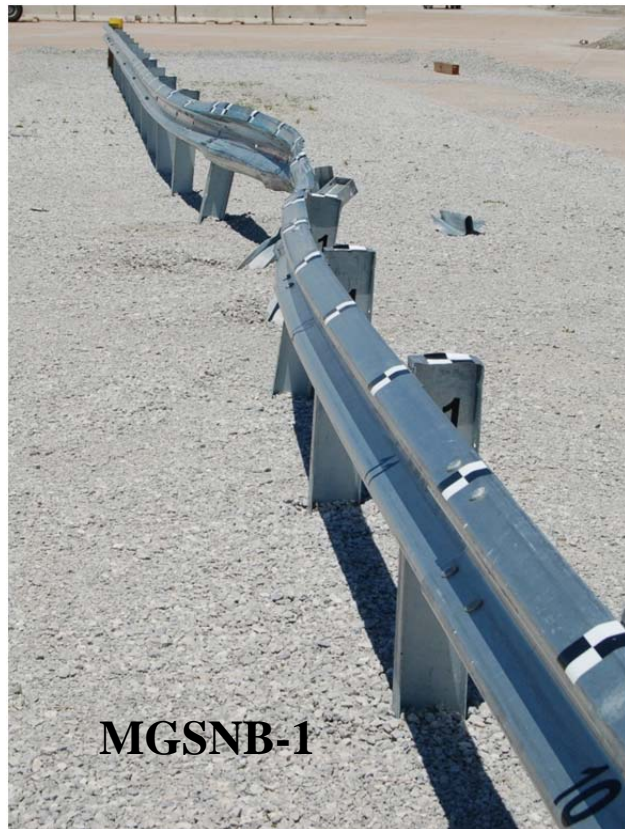
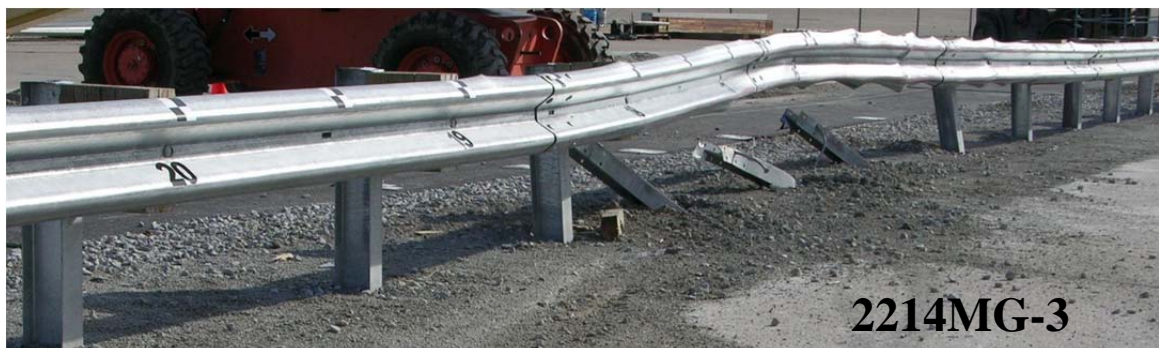
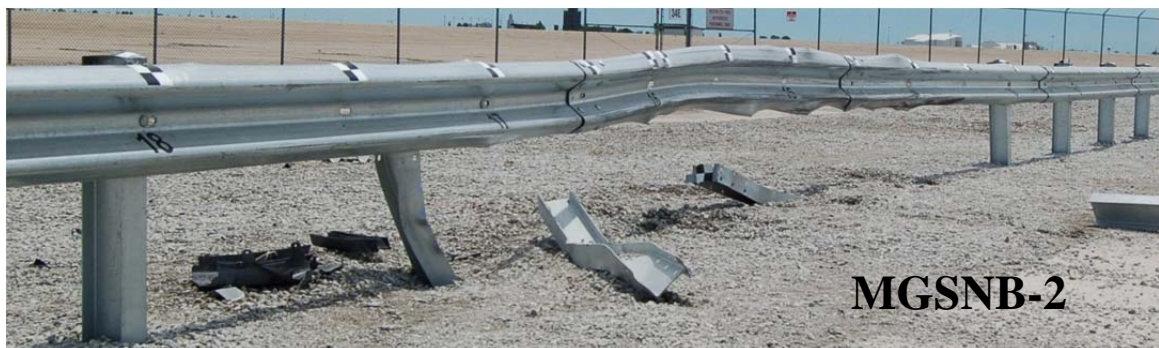
Figure 62. Barrier Damage

A comparison between the blocked and non-blocked MGS for both the 2270P truck and 1100C small car is presented in Table 11. Rear-view sequentials for the 2270P and 1100C tests are shown in Figures 60 and 61, respectively. Barrier damage and vehicle damage are shown in Figures 62 and 63, respectively. Longitudinal and lateral change in velocity plots are shown in Figure 64.

Much of the rail deflection differences can probably be attributed to the soil conditions. The more recent non-blocked MGS testing was performed in soil that used a relatively new compaction method, which has been determined to provide a somewhat stiffer soil condition. This, most likely, reduced dynamic deflections. Soil conditions for all tests were well within MASH recommendations.

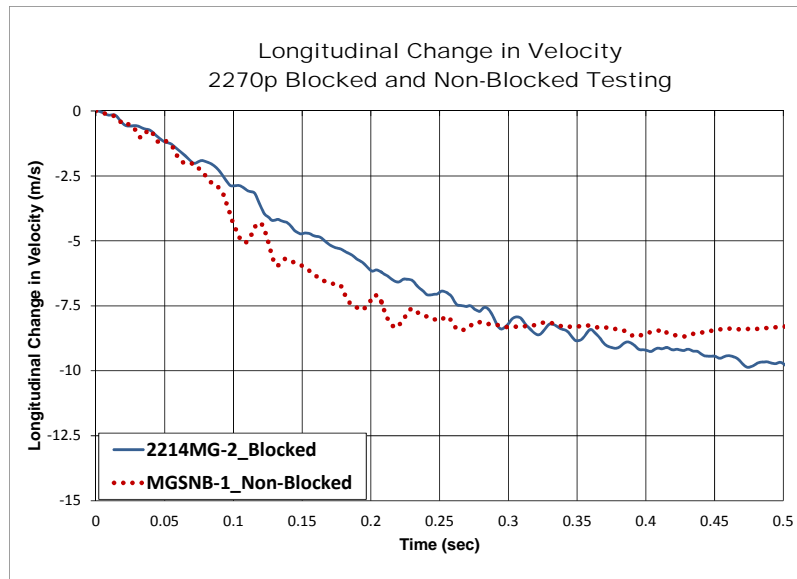
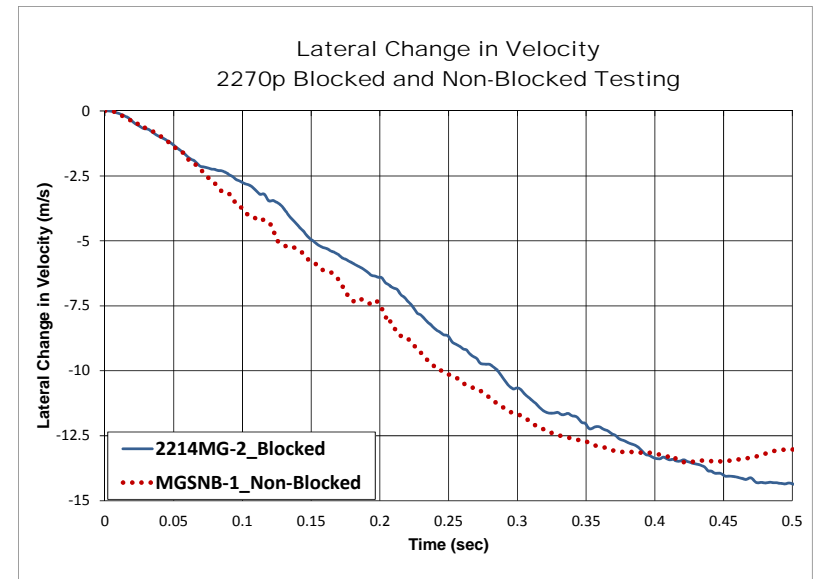
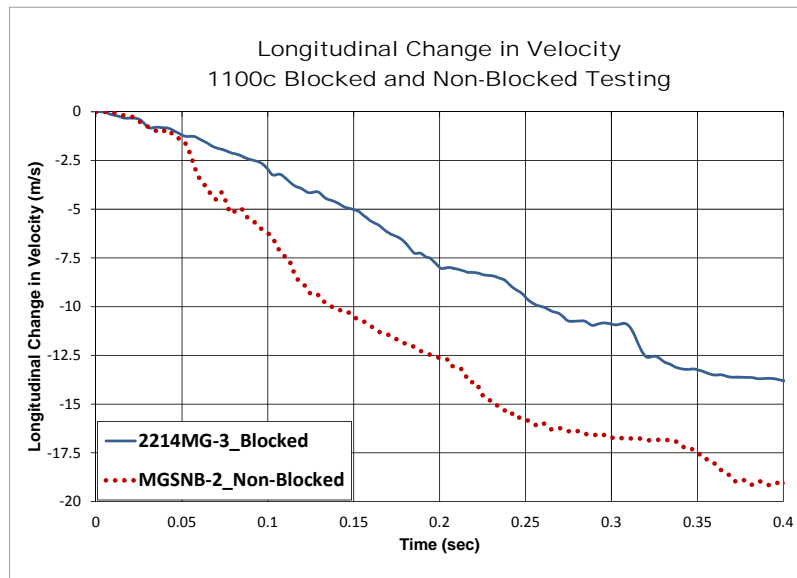
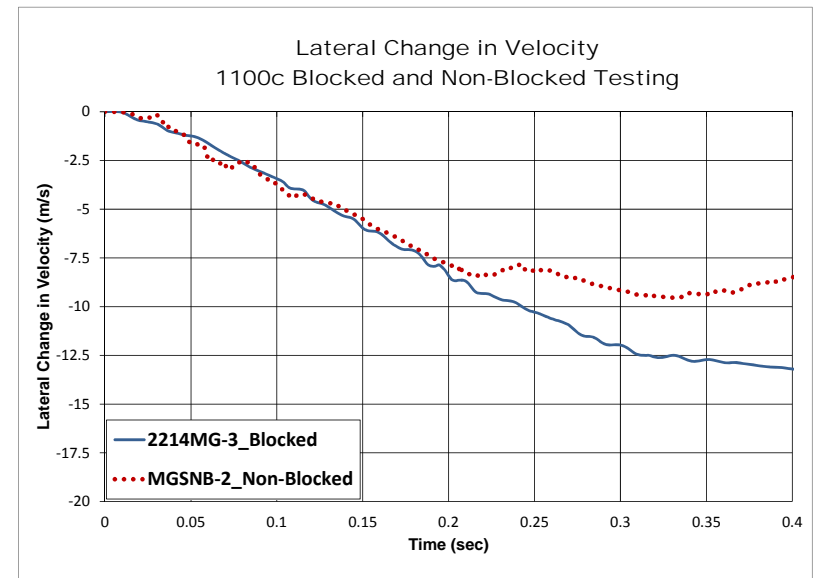
Figure 64. Longitudinal and Lateral Change in Velocity

Based on the full-scale testing results, the main advantages of using a blockout for the MGS are threefold: (1) there is improved stability for both vehicles, lower roll and pitch for the pickup truck partially due to an effective rail height increase during post rotation, and smoother redirection for the small car as seen by the consistent/smooth yaw motion; (2) reduced snag on posts which provides for lower longitudinal velocity change for the small car, smoother yaw motion of the small car, and lower longitudinal decelerations for both vehicles, and (3) reduced occupant risk measures, all are better for the truck, while the small car's longitudinal OIV is much better. Additionally for the small car, the non-blocked test did have lower lateral ORD but that was due to lack of yaw caused by wheel snag, and its lower longitudinal ORD was due to high initial longitudinal decelerations, as seen in the early steep drop of longitudinal change in velocity (see Figure 64). Overall, it was concluded that the blocked system performed better than the non-blocked system.

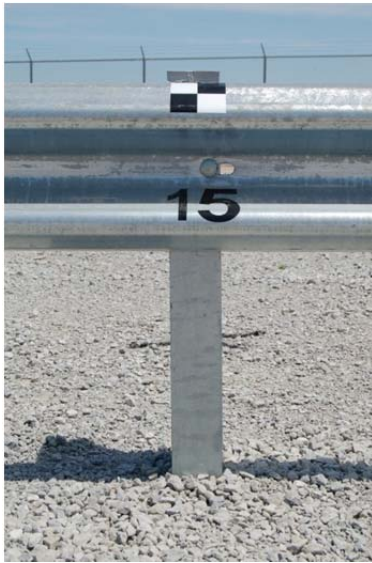
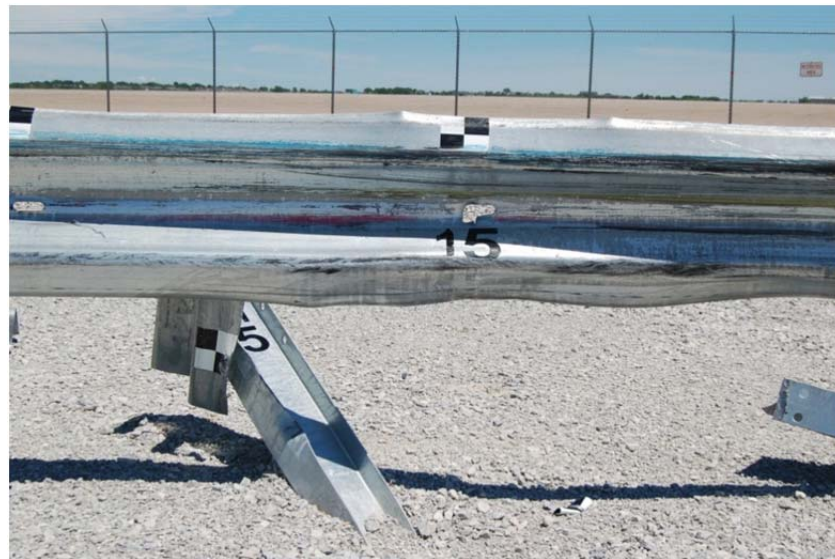
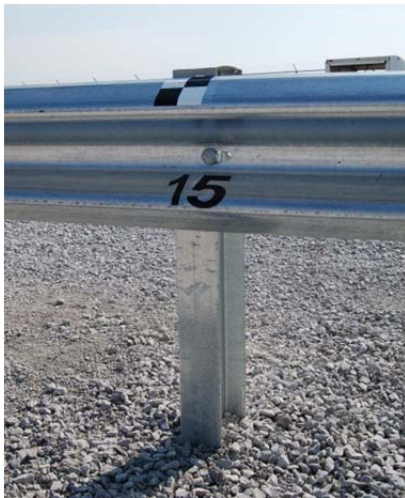
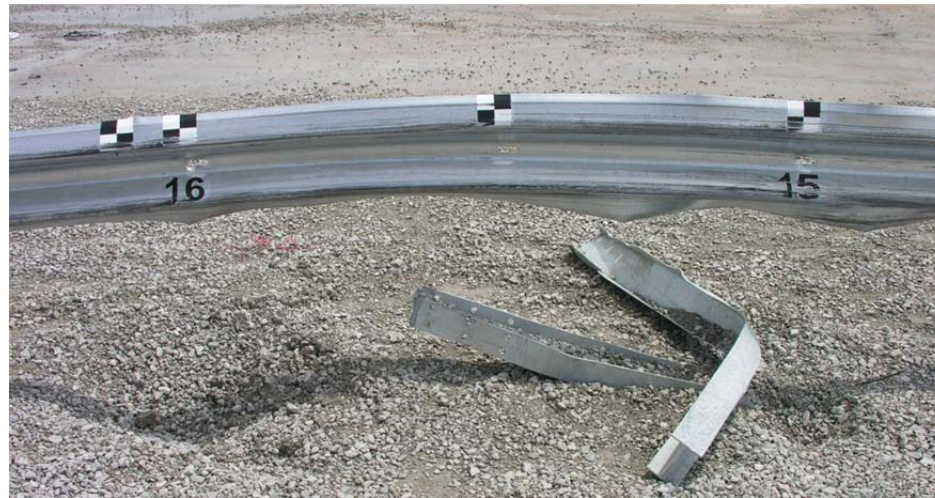
Figure 65. Bolt Located in Worst Case Location – Pull-Through Behavior Still Occurred

During test nos. MGSNB-1 and MGSNB-2, the locations of the post bolts were varied within the rail slots in order to investigate rail release away from the posts, as indicated in Figure 1 and shown in Figure 65. Post no. 15 was most likely the worst case scenario if the rail did not release from the post during impact. As a result, the post bolt was located at the downstream end of the rail slot. For both the pickup and small car tests, the guardrail detached from post no. 15 as the bolt head was pulled through the rail. Slight tearing of the rail was evident around the rail bolt hole, but nothing of significance was observed to cause concern for rail rupture. Video analysis also showed that the release of the rail occurred considerably before the post could pull the rail down as the posts rotated in the soil.

In order to prevent the rail from being pulled down as a post rotates in the soil as well as a possible vehicle override of the barrier during an impact event, the rail may need to detach away from the post. Fortunately, it has been shown that the bolt attachment mechanism used for the MGS, the same one used for standard W-beam guardrail systems for several decades, provides for satisfactory rail detachment.

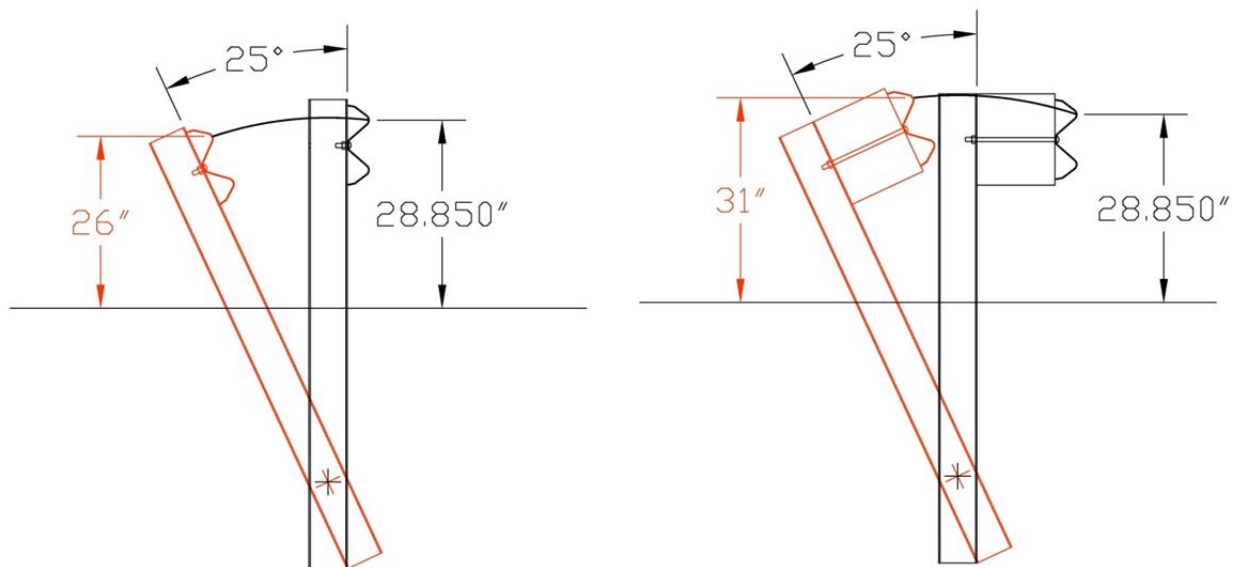
Figure 66. Blockout Holds Rail Up

The 31-in. (787-mm) mounting height is only one component which contributes to the enhanced performance of the MGS. It is well acknowledged that blockouts serve two primary purposes in the strong-post system. The first, and most important, is causing the rail to rise during an impact. As illustrated in Figure 66, during an impact, the rotation of the posts in conjunction with the blockout causes the rail to rise in the MGS (as well as in Standard W-Beam Guardrail Systems). This is not the case for the 31-in. (787-mm) W-Beam guardrail system without blockouts; where the rail immediately begins to drop as the post rotates in the soil. The deeper blockout on the MGS has significantly improved performance in concert with the increased mounting height.

A comparison of the rotated rails in the schematic above would not lead one to conclude that the non-blocked MGS system is unsafe; since, successful crash testing was performed. Even though the rail is dropping upon post rotation in the non-blocked system, it is not dropping below a critical height during the initial 25 degrees of rotation. In fact, the rail of the 31-in. (787-mm)

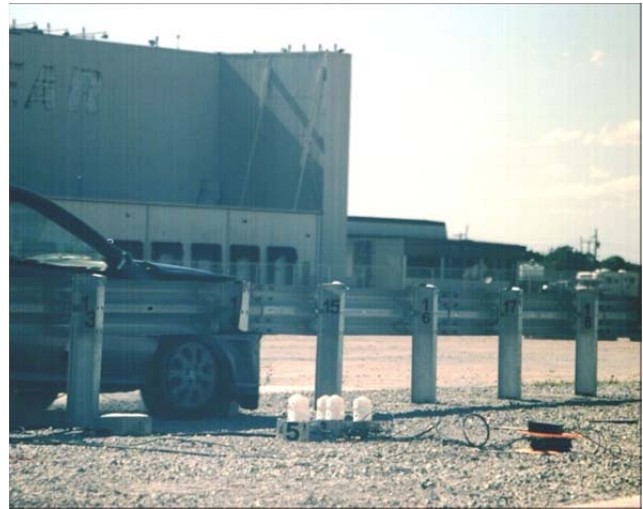
Figure 67. 1100C Crash Tests at Post No. 14 – Blockout Reduces Wheel Snag

A significant wheel snag occurred at post 14 during test no. MGSNB-2, which did not occur during test no. 2214MG-3, as shown in Figure 67. Initial impact for both tests was just upstream of post no. 13, and each vehicle easily cleared post no. 13 without tire-post overlap. The wheel snag at post no. 14 during test no. MGSNB-1 was the cause for the relatively abrupt change in longitudinal velocity (see Figure 64), as well as the relatively high OIV compared to the blocked test, test no. 2214MG-3 (31.3 ft/s versus 14.8 ft/s). It also helped pull post no. 14 out-of-the-ground as well as helped disengage the tire/wheel during the test.

MGSNB-2 – Non-Blocked
