U.S. Army Corps of Engineers Omaha District Monthly Drought Report, December 2005

U.S. Army Corps of Engineers Omaha District Monthly Drought Report December 2005

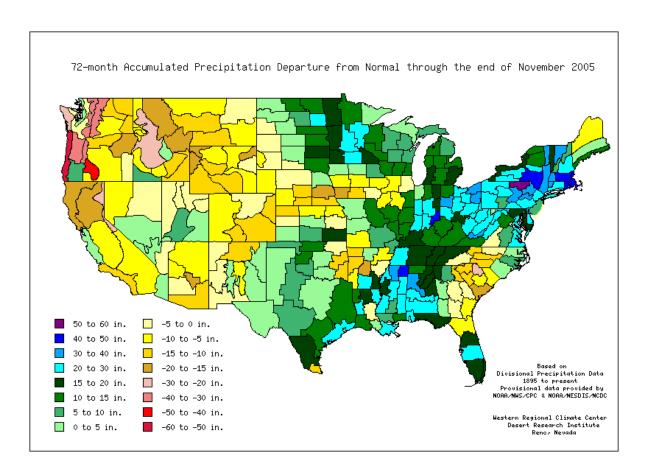
Precipitation accumulations in the Western U.S. have largely affected the severity and extent of the drought since 2000. Precipitation departures from normal during the last 72-months for the United States are shown in Figure 1. Precipitation departures or deficits in the Western U.S. have shown significant improvement due to recent moisture. In much of western and southwestern Montana, accumulated precipitation is well below normal (deficit of 5 to 20 inches). The majority of Wyoming's accumulated precipitation remains 10 to 15 inches below normal for the observation period. Southeast Nebraska and southwest Iowa have received from near normal to 10 inches less than normal precipitation. The Dakotas have largely received a surplus (10 to 15 inches) of precipitation in the central and eastern regions, while western regions remain normal to 5 inches below normal. The South Platte River Basin in Colorado still shows precipitation deficits of 10 to 15 inches during a majority of the 72-month period.

Figure 1 – 72 month Precipitation Departure From Normal http://www.wrcc.dri.edu/cgi-bin/spiFmap.pl?dep72

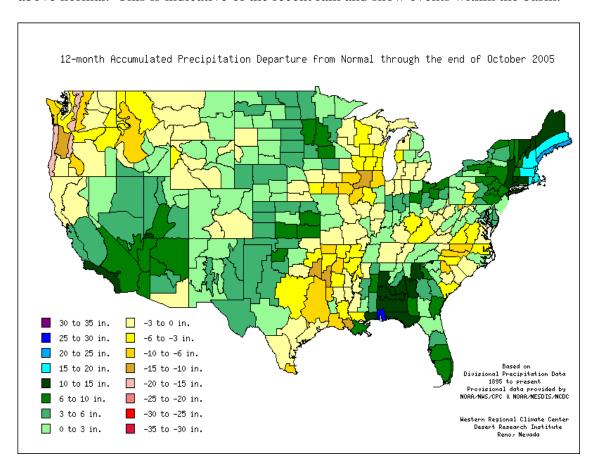
The 12-month precipitation accumulation in Figure 2 indicates that precipitation throughout much of the western and northwestern District is from normal to six-inches above normal. This is indicative of the recent rain and snow events within the basin.

Figure 2 – 12 month Precipitation Departure From Normal http://www.wrcc.dri.edu/cgi-bin/spiFmap.pl?dep12

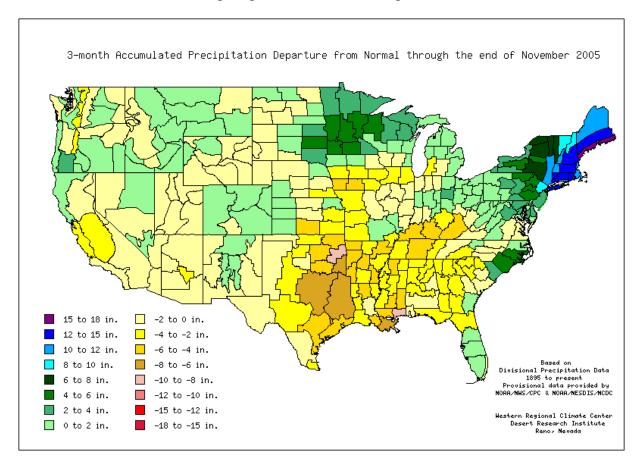
The three-month period (Figure 3) shows precipitation ranges are near normal throughout the District. Continued winter precipitation will further improve this condition.

Figure 3 – 3 month Precipitation Departure From Normal http://www.wrcc.dri.edu/cgi-bin/spiFmap.pl?dep03

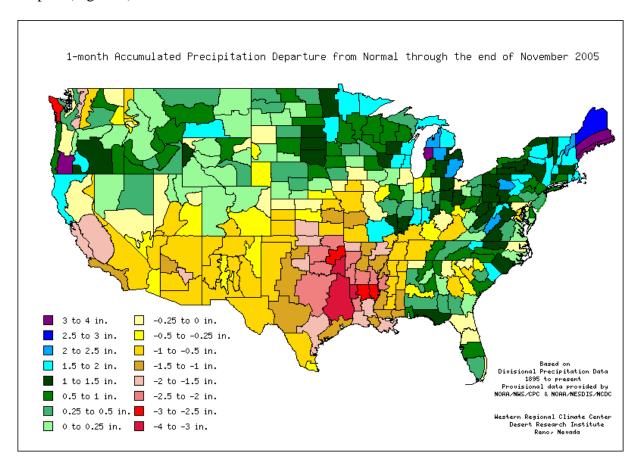
During November, the majority of the basin received normal to a one-inch rainfall surplus (Figure 4).

Figure 4 – 1 month Precipitation Departure From Normal http://www.wrcc.dri.edu/cgi-bin/spiFmap.pl?dep01

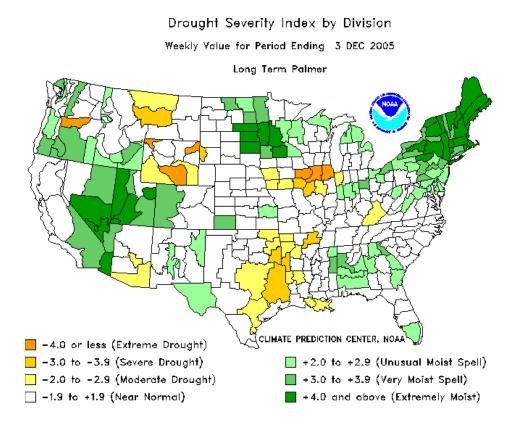
Changes to the PDSI are more immediate in response to heavy precipitation over short periods. The PDSI shown in Figure 5 reflects near normal to extremely moist spells in the majority of the Omaha District with only small portions of Montana exhibiting moderate to severe drought conditions.

Figure 5 – Long-Term Palmer Drought Indicator Ending 26 NOV 2005 http://www.cpc.ncep.noaa.gov/products/analysis_monitoring/regional_monitoring/palmer.gif

Figure 8 is the weekly precipitation needed to reduce the current Palmer Drought Severity Index value to -0.5 or near normal conditions. According to the PDSI (Figure 5) drought currently is affecting portions of Montana, Wyoming, southeastern South Dakota and portions of southeastern Nebraska.

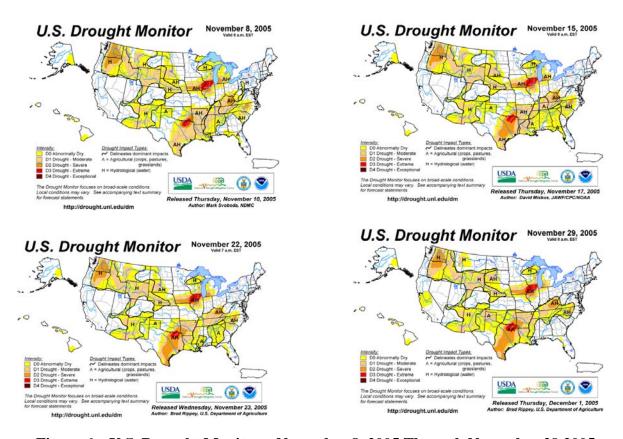
Omaha District drought has steadily improved throughout the spring, summer, and fall. Above-normal rainfall and increased pool levels in Oahe Reservoir, Lake Sakakawea, and Ft. Peck reservoir have helped reduce the drought impacts. Portions of Nebraska, South Dakota, Montana and Wyoming are currently classified as Abnormally Dry to Moderate Drought. The western half of South Dakota and North Dakota are currently classified as exhibiting Normal conditions.

Figure 6 – U.S. Drought Monitor – November 8, 2005 Through November 29 2005 http://drought.unl.edu/dm/monitor.html

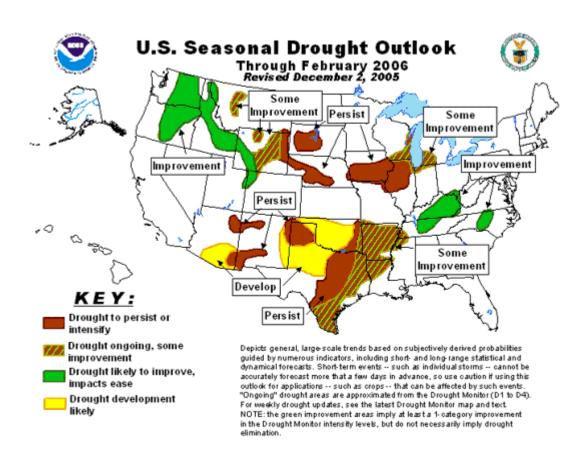
The basin drought outlook uses several expert products that indicate precipitation needs necessary to reduce the Palmer Drought to normal conditions, a one- and three-month climate outlook, and the impacts that future climate predictions could have on the current drought situation. The three-month Drought Outlook (Figure 7) indicates that the majority of the basin is returning to normal moisture conditions with the exception southcentral and western Nebraska, small areas of Montana, and the majority of Wyoming.

Figure 7 – Three-Month Seasonal Drought Outlook Through February 2006 http://www.cpc.ncep.noaa.gov/products/expert_assessment/seasonal_drought.html

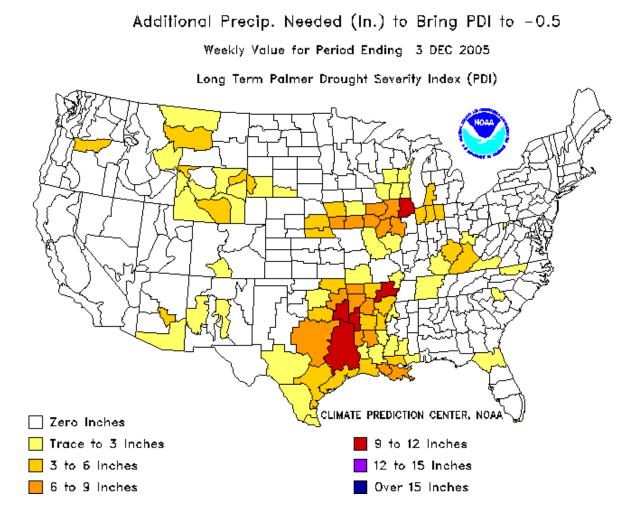
Figure 8 – Weekly Precipitation Need to Bring PDI to -0.5 http://www.cpc.ncep.noaa.gov/products/analysis_monitoring/regional_monitoring/addpcp.gif

In order to reach near normal Palmer Drought conditions, Montana would need approximately 3 to 6 inches of precipitation across the western portion of the state, the North Platte River basin in Wyoming would require 3 to 6 inches of precipitation and the southwestern portion of South Dakota would require approximately 3 inches in a week; while southeastern Nebraska would require 3 to 6 inches. Water supply deficits in large reservoirs, groundwater reserves, and possibly subsoil moisture reserves would receive limited benefit from the weekly Palmer precipitation needs. Mitigation of a multi-year drought would likely require multiple years of normal and above-normal water inflow conditions.

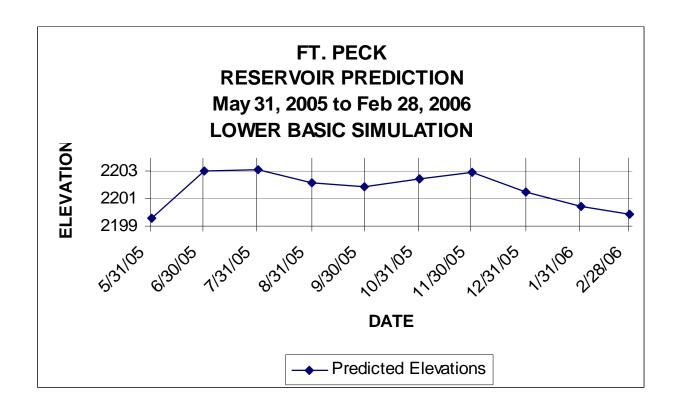
30-Day	60-Day	90-Day**
	Current Lake	Projected	Projected	Projected
Lake Elevation	Elevation	Elevation*	Elevation*	Elevation*
7/01/2005	11/30/2005	(12/31/2005)	(1/31/2006)	(2/28/2006)
(ft. msl)	(ft. msl)	(ft. msl)	(ft. msl)	(ft. msl)
2203.0	2202.9	2201.5	2200.4	2199.9

- 1. Current reservoir elevation is 31.5-feet below the top of conservation pool (elevation 2234.0 ft. msl).
- 2. *Projections provided are based upon the Lower Basic Simulation prepared by the Reservoir Control Center.
- 3. Current elevation is 2.7-ft. higher than elevation on 10/31/2004 (2199.8).
- 4. **90-day projection used in lieu of 180-day due to 2/28/06 being the end of the water year.

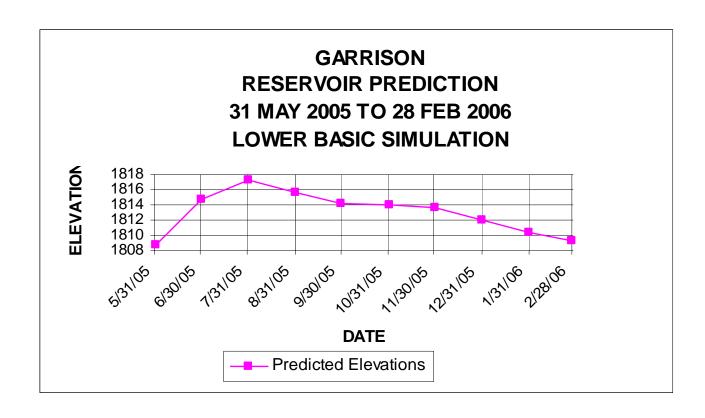
30-Day	60-Day	90-Day**
	Current Lake	Projected	Projected	Projected
Lake Elevation	Elevation	Elevation*	Elevation*	Elevation*
5/31/2005	(11/30/2005)	(12/31/2005)	(1/31/2006)	(2/28/2006)
(ft. msl)	(ft. msl)	(ft. msl)	(ft. msl)	(ft. msl)
1808.8	1813.6	1812.0	1810.3	1809.2

- 1. Current reservoir elevation is 23.5-feet below the top of conservation pool (elevation 1837.5 ft. msl).
- 2. *Projections provided are based upon the Lower Basic Simulation prepared by the Reservoir Control Center.
- 3. Current reservoir elevation is 1.1 ft. higher than elevation on 10/31/04.
- 4. **90-day projection used in lieu of 180-day due to 2/28/06 being the end of the water year.

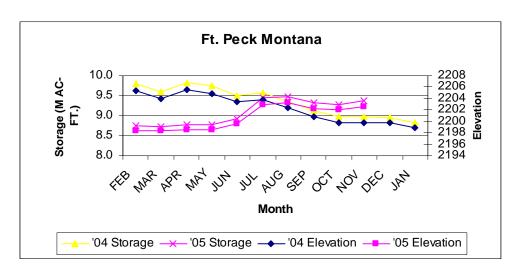
Fort Peck, Montana

Water Year 20		Water Year 2005				
(FE	B 2004 - JAN	Storage (MAC-	(FEB 2	2005 - JAN 2	Storage (MAC-		
Date	Elevation	Ft.)	Date	Elevation	Ft.)		
FEB	2205.3	9.806	2/1/2005	2198.4	8.749		
MAR	2204	9.603	3/1/2005	2198.3	8.732		
APR	2205.5	9.837	4/1/2005	2198.5	8.773		
MAY	2204.9	9.740	5/1/2005	2198.5	8.773		
JUN	2203.4	9.507	6/1/2005	2199.6	8.935		
JUL	2203.8	9.565	7/1/2005	2203.0	9.448		
AUG	2202.4	9.357	8/1/2005	2203.2	9.472		
SEP	2200.9	9.121	9/1/2005	2202.2	9.325		
ОСТ	2199.8	8.969	10/1/2005	2202.0	9.286		
NOV	2199.8	8.963	11/1/2005	2202.6	9.371		
DEC	2199.8	8.961	12/1/2005	2202.9	9.432		
JAN	2198.9	8.829	1/1/2006

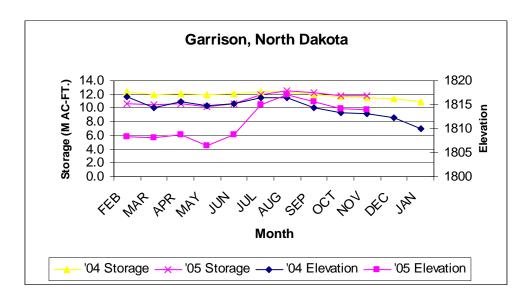
Garrison, ND

Water Year	2004	2005					
(FE	B 2004 – J <i>A</i>	AN 2005)	(FEB 2	2006)				
		Storage			Storage (MAC-			
Date	Elevation	(MAC-Ft.)	Date	Elevation	Ft.)			
FEB	1816.7	12.446	2/1/2005	1808.4	10.574			
MAR	1814.3	11.891	3/1/2005	1808.2	10.537			
APR	1815.6	12.110	4/1/2005	1808.65	10.632			
MAY	1814.7	11.989	5/1/2005	1806.47	10.189			
JUN	1815.3	12.121	6/1/2005	1808.8	10.665			
JUL	1816.5	12.426	7/1/2005	1814.9	12.026			
AUG	1816.5	12.401	8/1/2005	1817.17	12.591			
SEP	1814.3	11.914	9/1/2005	1815.56	12.216			
ост	1813.3	11.645	10/1/2005	1814.11	11.861			
NOV	1813.1	11.589	11/1/2005	1814.00	11.837			
DEC	1812.3	11.422	12/1/2005	1813.50	11.707			
JAN	1810	10.936	1/1/2006

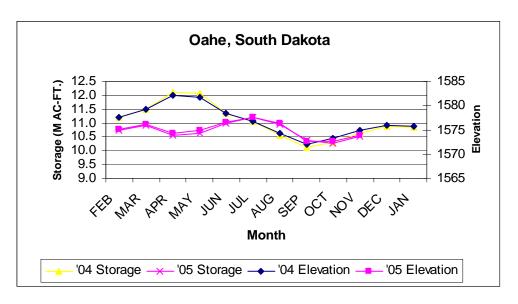
Oahe, SD

Water Year 2004			2005		
(FEB 2004 - JAN 2005) Storage		(FEB 2005 - JAN 2006) Storage			
		Storage			(MAC-
Date	Elevation	(MAC-Ft.)	Date	Elevation	Ft.)
FEB	1577.6	11.204	2/1/2005	1575.2	10.715
MAR	1579.2	11.504	3/1/2005	1576.2	10.924
APR	1582.1	12.110	4/1/2005	1574.29	10.568
MAY	1581.6	12.056	5/1/2005	1574.82	10.608
JUN	1578.4	11.338	6/1/2005	1576.47	10.980
JUL	1576.8	11.045	7/1/2005	1577.6	11.214
AUG	1574.3	10.540	8/1/2005	1576.38	10.958
SEP	1572.1	10.112	9/1/2005	1572.64	10.363
ОСТ	1573.2	10.316	10/1/2005	1572.63	10.267
NOV	1574.8	10.608	11/1/2005	1573.90	10.501
DEC	1576	10.866	12/1/2005	1575.6	10.814
JAN	1575.8	10.824	1/1/2006
