Improving Building Control and System Operation Through the Continuous Commissioning® Process: A Case Study

Architectural Engineering
Energy Systems Laboratory
University of Nebraska – Lincoln
Omaha, Nebraska

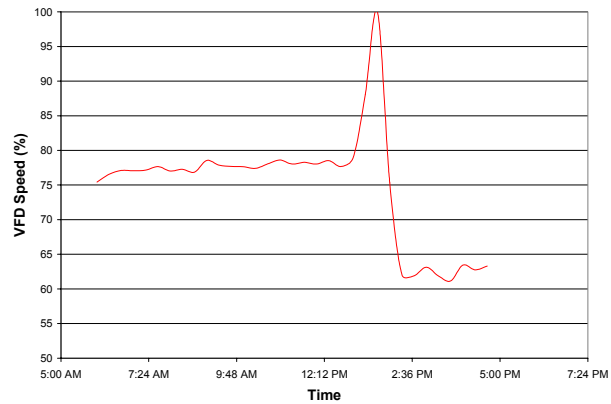
Figure 1. Illustrative pre & post-commissioning VFD speed

Figure 1 shows a trend of the VFD speed of a 7.5 hp supply fan before and after relocating the static pressure sensor and reducing the static pressure setpoint. The period where the VFD speed was 100% occurred during the relocation of the static pressure sensor. In this instance, the approximate reduction in VFD speed was 13% with an associated 35% reduction in fan power.

In this case, constant static pressure control was maintained with a reduced setpoint. The difference is the location of the static pressure sensor. In contrast to the often mentioned location of 2/3 downstream of the supply fan, the static pressure sensor was moved to the entrance of the most hydraulically remote terminal box on the system. By doing so, the system is essentially self resetting. The supply fan is controlled to the lowest possible speed, while maintaining adequate static pressure in the duct system to satisfy all terminal box airflow requirements. The new setpoints are based on terminal box pressure drops at maximum design flow. Under partial load conditions the setpoints could be reset to achieve further fan power reduction, but the additional savings is minimal. Therefore, this strategy approximates the optimal reset schedules developed in the past.

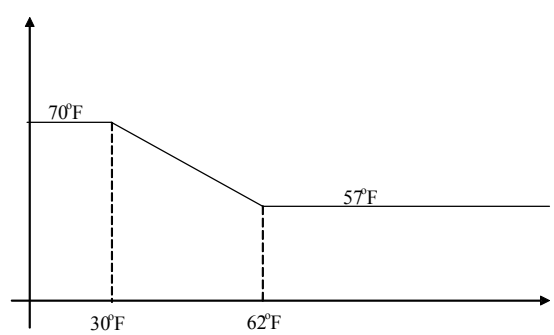
Figure 2 Supply air temperature reset schedule

To correct this issue, an optimal supply air temperature reset schedule was developed from an analysis of the air handling unit and terminal box operating characteristics. The new schedule incorporates the improved air handling unit and terminal box control. The air handling unit reaches its minimum airflow and minimum fan power at an outside air temperature of 62°F and remains there as the supply air temperature is increased to minimize reheat. Figure 2 shows the optimal supply air temperature as a function of outside air temperature.

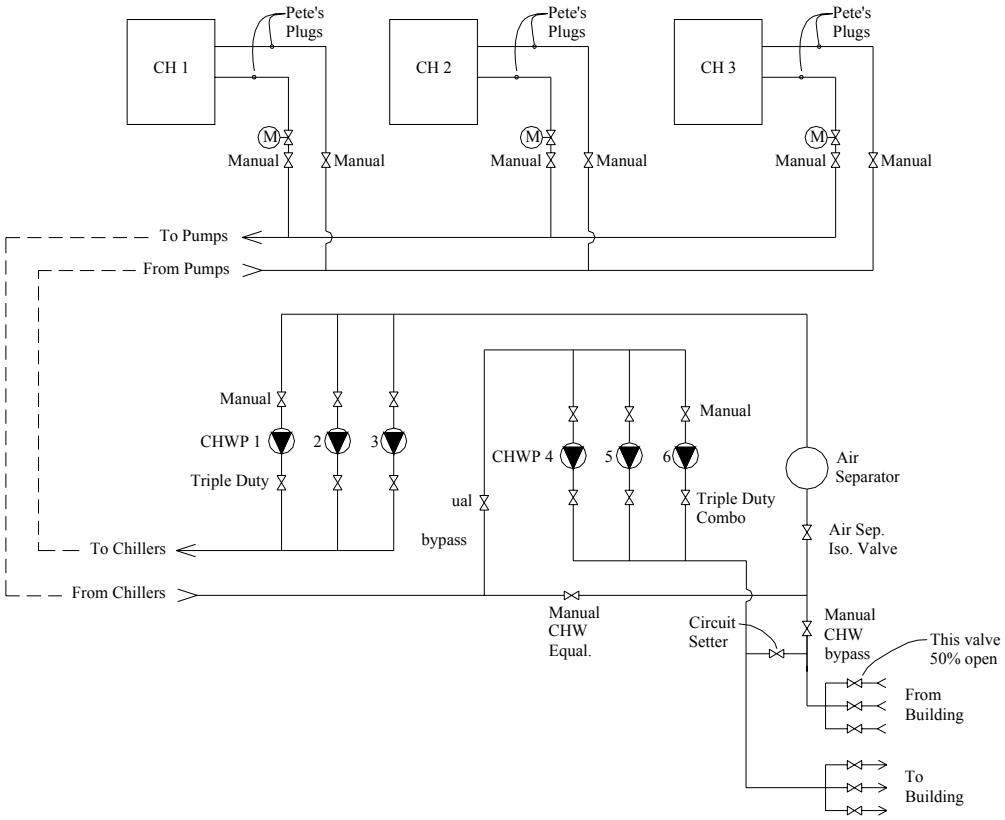
Figure 3. Chilled water system schematic

The chilled water system for the building is shown in Fig. 3. Additional information on chillers and pumps is found in Table 3.

Based on the design information for the pumps, a calculation was made to determine the system operating parameters if the primary pumps were removed from the system. As seen in Table 3, the original design was for 320 gpm. By disabling the primary pumps and operating the system with the secondary pumps alone, the flow rate will be 82% of the rated design flow. Since anecdotal evidence suggests that three chillers never operate together under the current working conditions, the 82% capacity from the secondary pumps alone (thus 423 tons capacity from the three chillers) permits the disabling of the primary pumps. Upon closing the valve in the by-pass line (Manual CHW Equal. Valve in Fig. 3), measurements of the chilled water flow were made with and without the primary pumps operating. The tests revealed that the actual flow rates were significantly higher than design. The measured data are presented in Table 4.

Based on the measured results, it was determined that disabling the primary pumps and operating the secondary pumps alone was sufficient to meet all cooling demands within the facility. This effort, combined with chilled water supply temperature reset, saves over 10% of the buildings annual cooling energy (including a 33% reduction in pump power).
