U.S. Army Corps of Engineers Omaha District Monthly Drought Report, October 2007

U.S. Army Corps of Engineers Omaha District Monthly Drought Report October 2007

Cover Photo: Lake Oahe near Ft. Yates, ND (October 2007).

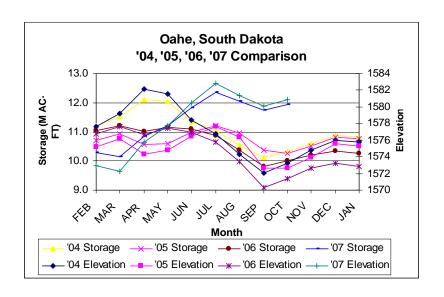
Oahe, SD

Water Year 2004		Water Year 2005		Water Year 2006		Water Year 2007	
(FEB 2004 - JAN 2005)		(FEB 2005 - JAN 2006)		(FEB 2006 - JAN 2007)		(FEB 2007 - JAN 2008)	
	Storage		Storage		Storage		Storage
Elevation	(MAC-Ft.)	Elevation	(MAC-Ft.)	Elevation	(MAC-Ft.)	Elevation	(MAC-Ft.)
1577.6	11.204	1575.2	10.715	1576.8	11.037	1572.9	10.287
1579.2	11.504	1576.2	10.924	1577.6	11.209	1572.3	10.151
1582.1	12.110	1574.29	10.568	1576.7	11.024	1575.8	10.839
1581.6	12.056	1574.82	10.608	1577.4	11.150	1577.7	11.221
1578.4	11.338	1576.47	10.980	1577.0	11.088	1580.5	11.826
1576.8	11.045	1577.6	11.214	1575.8	10.881	1582.8	12.346
1574.3	10.540	1576.38	10.958	1573.4	10.378	1581.4	12.045
1572.1	10.112	1572.6	10.363	1570.3	9.807	1580.1	11.752
1573.2	10.316	1572.63	10.267	1571.4	9.998	1580.9	11.927
1574.8	10.608	1573.9	10.501	1572.6	10.214		
1576	10.866	1575.6	10.814	1572.9	10.263		
1575.8	10.824	1575.3	10.75	1572.8	10.260
