2005 Bird Strike Committee-USA/Canada 7th Annual Meeting, Vancouver, BC

## TRASH AND WATER: MANAGING ON-AIRPORT WILDLIFE ATTRACTANTS AT PAINE FIELD, WASHINGTON

Matthew R. Stevens USDA, Wildlife Services, Olympia, WA

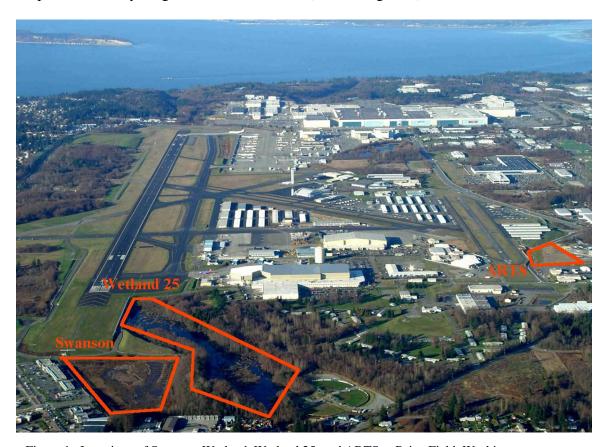
Figure 1. Locations of Swanson Wetland, Wetland 25, and ARTS at Paine Field, Washington.

Paine Field addresses many unique wildlife hazard issues, two of which include a manmade wetland/storm-water pond (hereafter referred to as Swanson wetland) and the Airport Road Recycling and Transfer Station (ARTS; Figure 1).

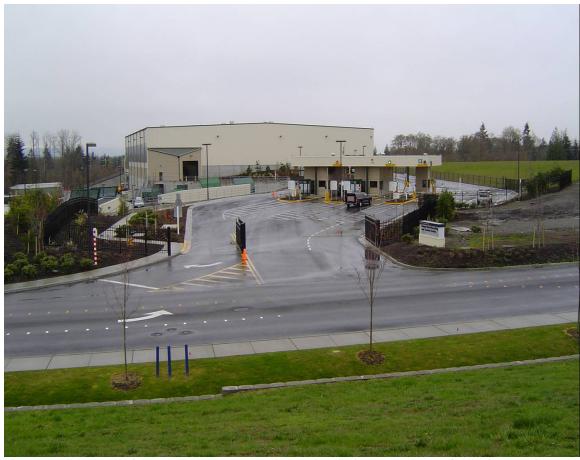
Figure 2. Photograph of the newly constructed and operational Airport Road Transfer Station at Paine Field, Washington.

The ARTS facility is fully enclosed, accommodates the disposal of household refuse and recycling, and the entire site encompasses approximately 4-ha (Figure 2). Construction of the ARTS facility began in August of 2001 and concluded in September of 2003; the facility became operational in October of 2003. Extensive monitoring of the ARTS site was conducted prior to, during construction, and since ARTS has been in operation to determine if wildlife hazardous to aviation are being attracted to the site.

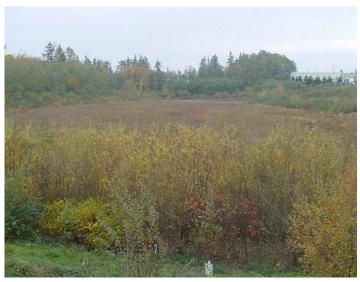
Figure 3. Photo of Swanson Wetland in November 2004, at Paine Field, Washington.

wetland with a dense, vegetative canopy so waterfowl would not be attracted to large expanses of open water (Figure 3). Approximately 41,500 plants of 34 different species were installed, including but not limited to: willow, dogwood, twinberry, ninebark, rose, salmonberry, spirea, and snowberry. These plants were 1- or 2-gallon in size and spaced 3' to 5' on center. After construction concluded in the fall of 1999, it was quickly determined that the wetland was improperly graded, leaving deep, open water that could attract waterfowl and did not comply with initial design. As a result, much of the installed vegetation either died or did not establish due to poor site conditions. In the winter of 2001 major revisions of the site took place, including:

- Grading of the higher elevation areas and re-grading of the outlet channel to allow for proper drainage.
- Back-filling of the water-inundated areas so water depth would not exceed 18 inches.
- Re-planting approximately 32,000 plants including, but not limited to: willow stakes and 1- or 2-gallon spirea, rose, salmonberry, twinberry, and cottonwood. All plants were spaced 3' to 5' on center.
- Adding a manually controlled spill valve in the outflow channel that could be opened if water depth exceeded 18 inches.

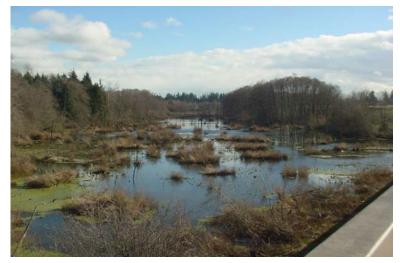
Figure 5. Photograph of Wetland 25 (adjacent to Swanson wetland), taken during February 2002, at Paine Field, Washington.

Waterfowl (ducks and geese) use of Swanson during 2004 (0.02 to 0.03 birds/min) was 94% less than during 2001. Also noteworthy was that as waterfowl use decreased at Swanson from 2001 to 2004, waterfowl use increased by 174% on an adjacent pond<sup>1</sup> with larger areas of open water (Figure 5).

<sup>&</sup>lt;sup>1</sup> The adjacent pond is referred to as Wetland 25. This 19-acre, naturally occurring pond is adjacent to Swanson wetland, but not directly under the approach/departure pattern of runway 16R-34L.

As with any type of habitat modification, deterring one or more species from one location might result in a net increase in use by these species at an adjacent or nearby location. Our study demonstrates that although waterfowl continued to use Paine Field geographically, they chose to utilize more desirable open water habitats (e.g., Wetland 25) rather than the shallow, densely vegetated Swanson wetland.
