2005 Bird Strike Committee-USA/Canada 7th
Annual Meeting, Vancouver, BC

TRASH AND WATER: MANAGING ON-AIRPORT WILDLIFE ATTRACTANTS AT PAINE FIELD, WASHINGTON

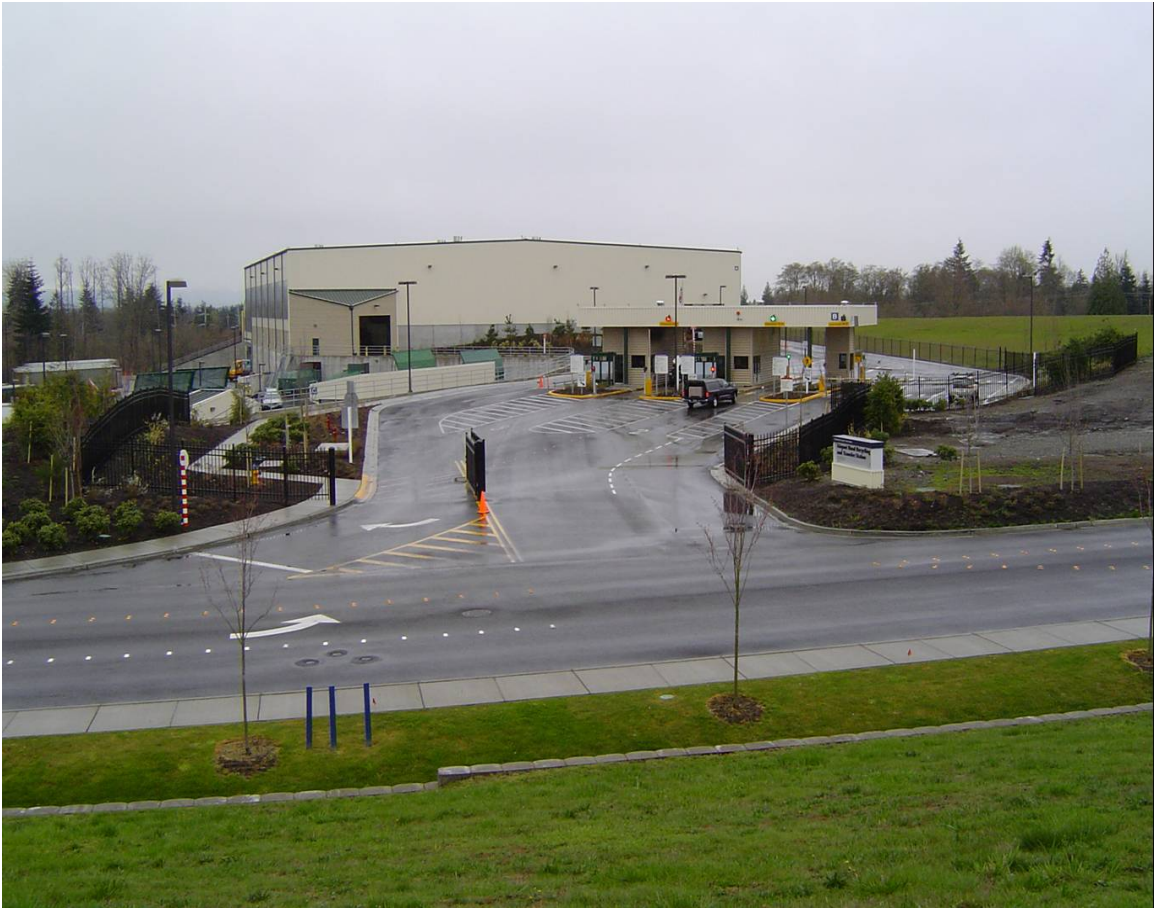
Figure 2. Photograph of the newly constructed and operational Airport Road Transfer Station at Paine Field, Washington.

The ARTS facility is fully enclosed, accommodates the disposal of household refuse and recycling, and the entire site encompasses approximately 4-ha (Figure 2). Construction of the ARTS facility began in August of 2001 and concluded in September of 2003; the facility became operational in October of 2003. Extensive monitoring of the ARTS site was conducted prior to, during construction, and since ARTS has been in operation to determine if wildlife hazardous to aviation are being attracted to the site.

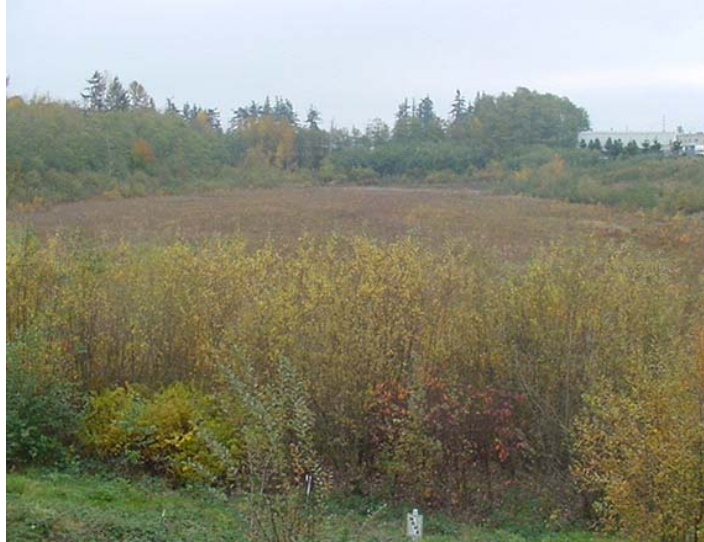
Figure 3. Photo of Swanson Wetland in November 2004, at Paine Field, Washington.

wetland with a dense, vegetative canopy so waterfowl would not be attracted to large expanses of open water (Figure 3). Approximately 41,500 plants of 34 different species were installed, including but not limited to: willow, dogwood, twinberry, ninebark, rose, salmonberry, spirea, and snowberry. These plants were 1- or 2-gallon in size and spaced 3' to 5' on center. After construction concluded in the fall of 1999, it was quickly determined that the wetland was improperly graded, leaving deep, open water that could attract waterfowl and did not comply with initial design. As a result, much of the installed vegetation either died or did not establish due to poor site conditions. In the winter of 2001 major revisions of the site took place, including:

- Grading of the higher elevation areas and re-grading of the outlet channel to allow for proper drainage.
- Back-filling of the water-inundated areas so water depth would not exceed 18 inches.
- Re-planting approximately 32,000 plants including, but not limited to: willow stakes and 1- or 2-gallon spirea, rose, salmonberry, twinberry, and cottonwood. All plants were spaced 3' to 5' on center.
- Adding a manually controlled spill valve in the outflow channel that could be opened if water depth exceeded 18 inches.

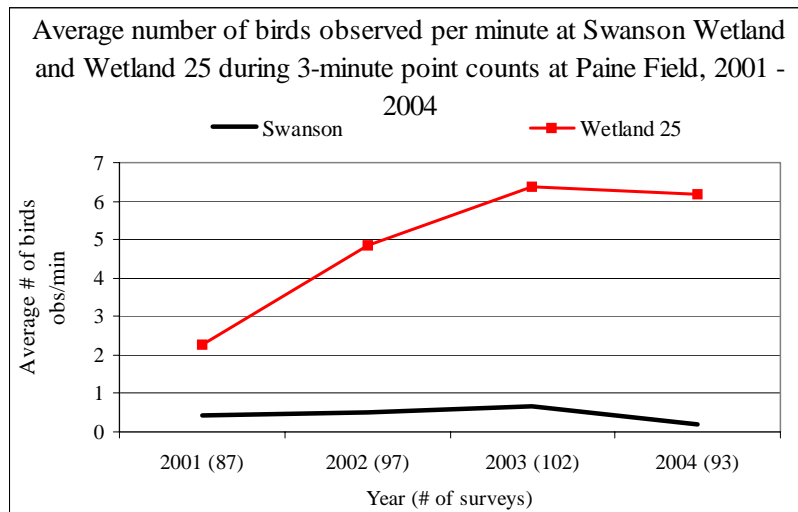
Figure 4. Average number of birds observed per minute at Swanson Wetland and Wetland 25 during 3-minute point counts at Paine Field, 2001 - 2004

In 2001, before major revisions to the site transpired, 0.4 birds/min were observed using the Swanson site (Figure 4). During 2002 and 2003, when shrubby vegetation was minimal but present, 0.5 and 0.7 birds/min were observed, respectively. Birds using the Swanson wetland during these 2 years were predominantly ducks

and some red-winged blackbirds. In 2004, following the establishment of a mature vegetation stand, bird use declined to 0.2 birds/min (annual total of 46 red-winged blackbirds, 3 ducks, and 2 Canada geese).

Waterfowl (ducks and geese) use of Swanson during 2004 (0.02 to 0.03 birds/min) was 94% less than during 2001. Also noteworthy was that as waterfowl use decreased at Swanson from 2001 to 2004, waterfowl use increased by 174% on an adjacent pond¹ with larger areas of open water (Figure 5).

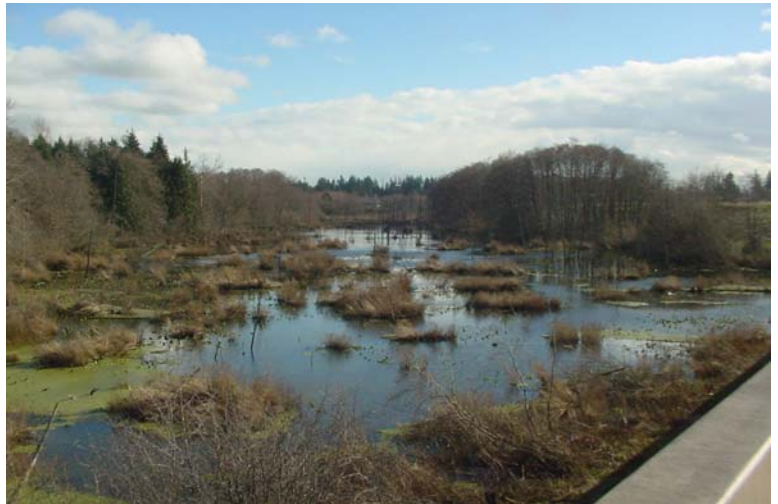
Figure 5. Photograph of Wetland 25 (adjacent to Swanson wetland), taken during February 2002, at Paine Field, Washington.

¹ The adjacent pond is referred to as Wetland 25. This 19-acre, naturally occurring pond is adjacent to Swanson wetland, but not directly under the approach/departure pattern of runway 16R-34L.
