**Baseline Assessment of the Use of a Small
Missouri River Backwater
by Fish at Ponca State Park in Dixon County, Nebraska**

Prepared By
A. Luke Wallace

Environmental Resource Specialist
U.S. Army Corps of Engineers

December 2,000

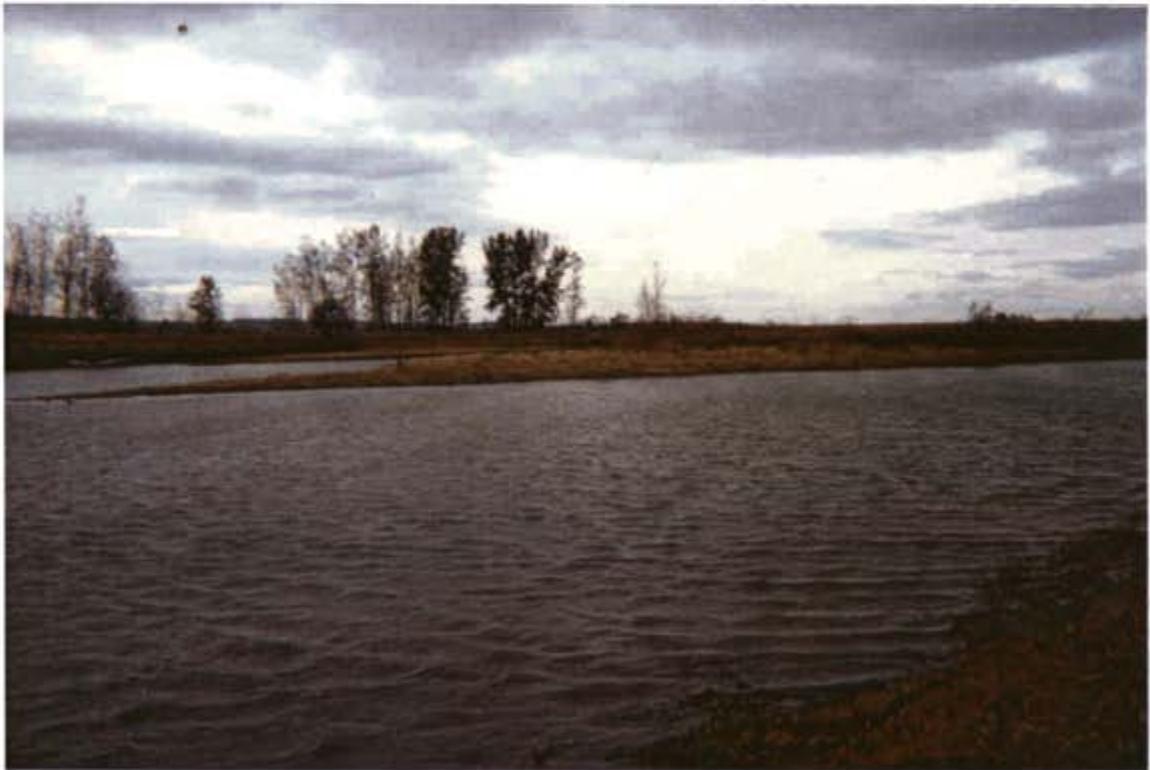
View looking northwest at the junction of Finger A and Finger B.
