U.S. Army Corps of Engineers Omaha District Monthly Drought Report, February 2006

U.S. Army Corps of Engineers Omaha District Monthly Drought Report February 2006

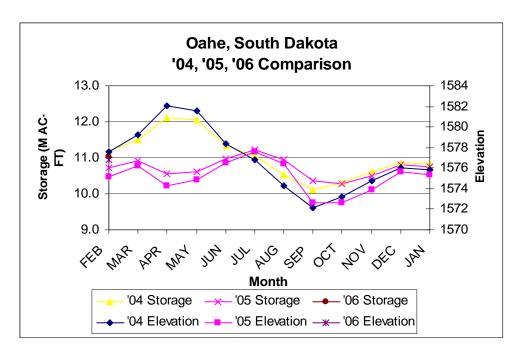
Oahe, SD

Water Year 2004		Water Year 2005 (FEB 2005 – JAN 2006)			Water Year 2006 (FEB 2006 – JAN 2007)			
(FEB 2004 – JAN 2005)		` , , , , , , , , , , , , , , , , , , ,			, ,			
Date	Elevation	Storage (MAC-Ft.)	Date	Elevation	Storage (MAC-Ft.)	Date	Elevation	Storage (MAC-Ft.)
FEB	1577.6	11.204	2/1/2005	1575.2	10.715	2/1/2006	1576.8	11.037
MAR	1579.2	11.504	3/1/2005	1576.2	10.924	3/1/2006		
APR	1582.1	12.110	4/1/2005	1574.29	10.568	4/1/2006		
MAY	1581.6	12.056	5/1/2005	1574.82	10.608	5/1/2006		
JUN	1578.4	11.338	6/1/2005	1576.47	10.980	6/1/2006		
JUL	1576.8	11.045	7/1/2005	1577.6	11.214	7/1/2006		
AUG	1574.3	10.540	8/1/2005	1576.38	10.958	8/1/2006		
SEP	1572.1	10.112	9/1/2005	1572.64	10.363	9/1/2006		
ОСТ	1573.2	10.316	10/1/2005	1572.63	10.267	10/1/2006		
NOV	1574.8	10.608	11/1/2005	1573.90	10.501	11/1/2006		
DEC	1576	10.866	12/1/2005	1575.6	10.814	12/1/2006		
JAN	1575.8	10.824	1/1/2006	1575.6	10.778	1/1/2007
