U.S. Army Corps of Engineers Omaha District Monthly Drought Report, May 2006

U.S. Army Corps of Engineers Omaha District Monthly Drought Report May 2006

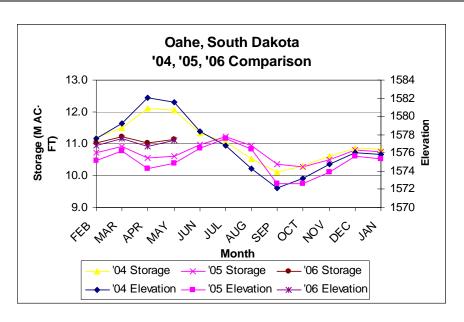
Oahe, SD

Water Year 2004 (FEB 2004 – JAN 2005)			Water Year 2005 (FEB 2005 – JAN 2006)			Water Year 2006 (FEB 2006 – JAN 2007)		
Date	Elevation	Storage (MAC-Ft.)	Date	Elevation	Storage (MAC-Ft.)	Date	Elevation	Storage (MAC-Ft.)
2/1/2004	1577.6	11.204	2/1/2005	1575.2	10.715	2/1/2006	1576.8	11.037
3/1/2004	1579.2	11.504	3/1/2005	1576.2	10.924	3/1/2006	1577.6	11.209
4/1/2004	1582.1	12.110	4/1/2005	1574.29	10.568	4/1/2006	1576.7	11.024
5/1/2004	1581.6	12.056	5/1/2005	1574.82	10.608	5/1/2006	1577.4	11.150
6/1/2004	1578.4	11.338	6/1/2005	1576.47	10.980	6/1/2006		
7/1/2004	1576.8	11.045	7/1/2005	1577.6	11.214	7/1/2006		
8/1/2004	1574.3	10.540	8/1/2005	1576.38	10.958	8/1/2006		
9/1/2004	1572.1	10.112	9/1/2005	1572.64	10.363	9/1/2006		
10/1/2004	1573.2	10.316	10/1/2005	1572.63	10.267	10/1/2006		
11/1/2004	1574.8	10.608	11/1/2005	1573.90	10.501	11/1/2006		
12/1/2004	1576	10.866	12/1/2005	1575.6	10.814	12/1/2006		
1/1/2005	1575.8	10.824	1/1/2006	1575.6	10.778	1/1/2007
