U.S. Army Corps of Engineers Omaha District Monthly Drought Report, May 2006

**U.S. Army Corps of Engineers
Omaha District
Monthly Drought Report
May 2006**

**US Army Corps
of Engineers
Omaha District**

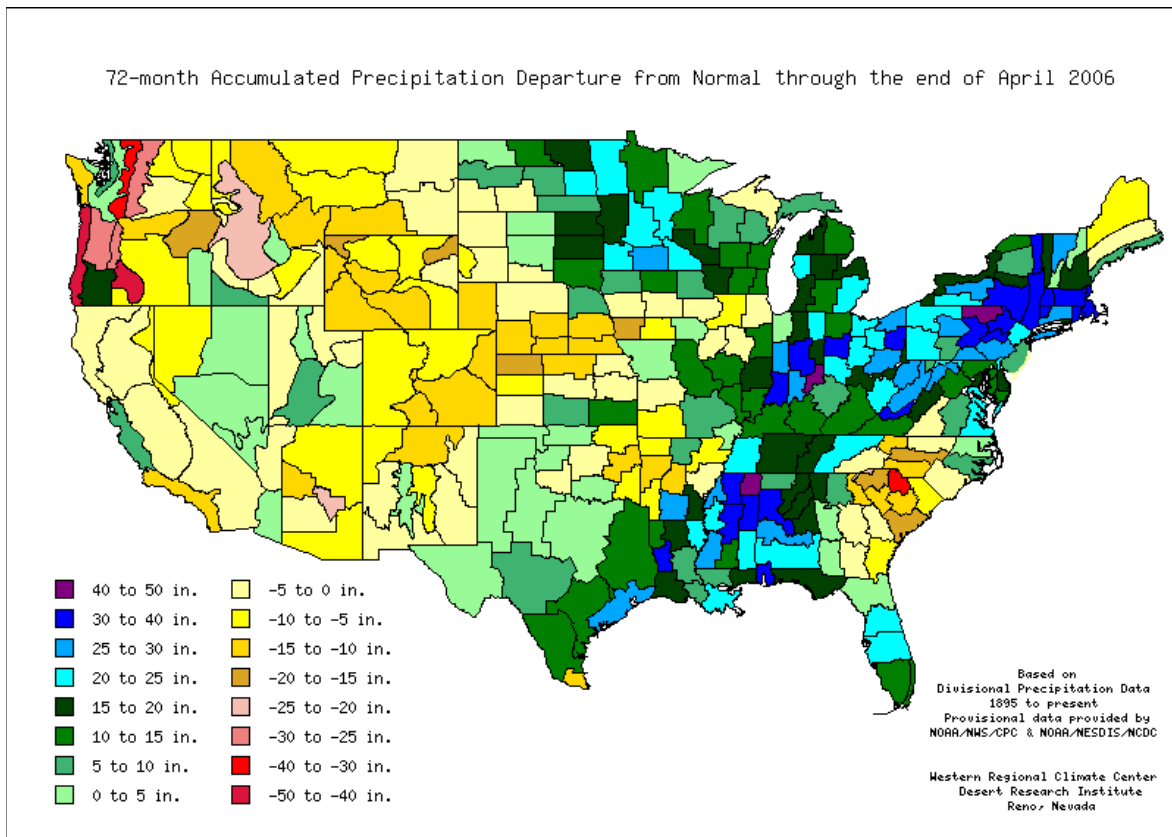
Figure 1 – 72 month Precipitation Departure From Normal

Precipitation accumulations in the Western U.S. have largely affected the severity and extent of the drought since 2000. Precipitation departures from normal during the last 72-months for the United States are shown in Figure 1. In much of Montana, accumulated precipitation is remains below normal (deficit of 5 to 15 inches). The majority of Wyoming's accumulated precipitation is 10 to 15 inches below normal for the observation period. Southeast Nebraska and southwest Iowa have received from near normal to 10 inches less than normal precipitation. The Dakotas have largely received a surplus (10 to 15 inches) of precipitation in the central and eastern regions, while western regions remain normal to 5 inches below normal. The South Platte River Basin in Colorado still shows precipitation deficits of 10 to 15 inches during a majority of the 72-month period.

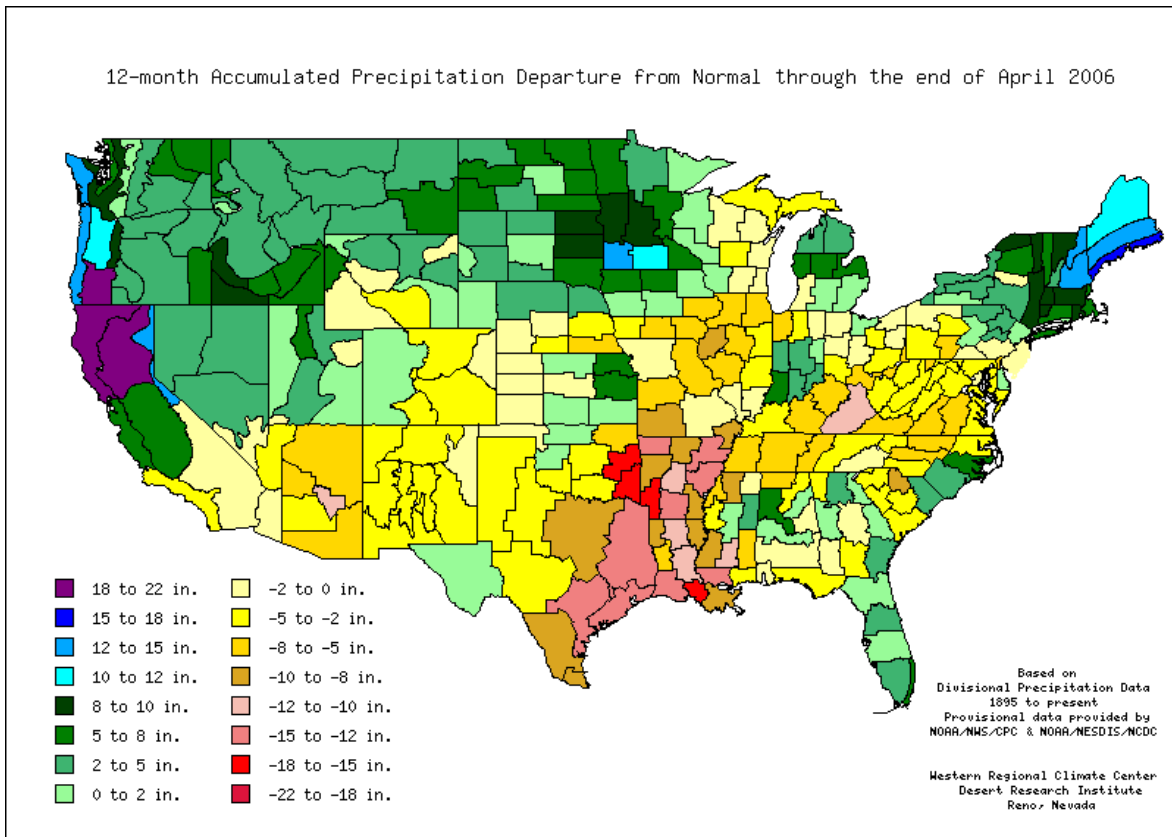
Figure 2 – 12 month Precipitation Departure From Normal
<http://www.wrcc.dri.edu/cgi-bin/spiFmap.pl?dep12>

The 12-month precipitation accumulation in Figure 2 indicates that precipitation throughout much of the western and northwestern District is from normal to ten-inches above normal. However, small areas of deficits can still be found in southeast Nebraska.

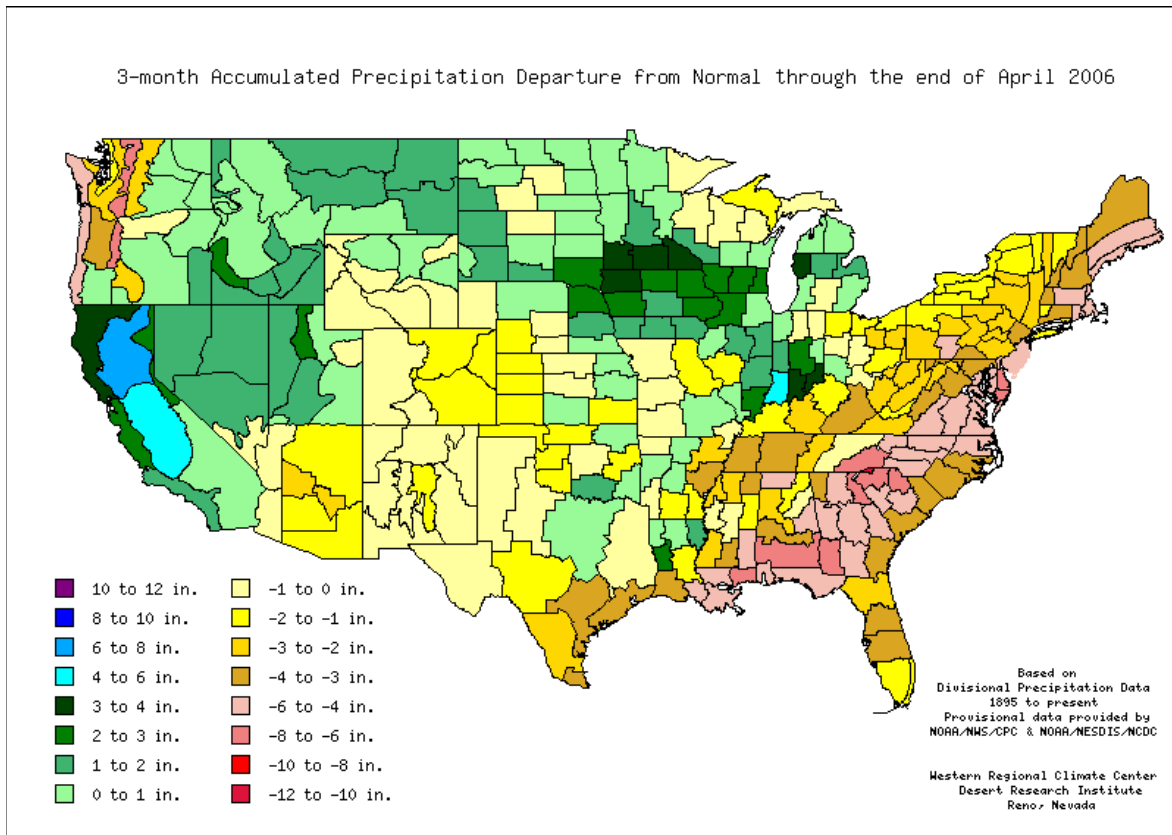
Figure 3 – 3 month Precipitation Departure From Normal
<http://www.wrcc.dri.edu/cgi-bin/spiFmap.pl?dep03>

The three-month period (Figure 3) shows a significant improvement in precipitation departures. The entire basin shows normal to a two-inch surplus in precipitation. This is a result of the recent precipitation the area has been receiving.

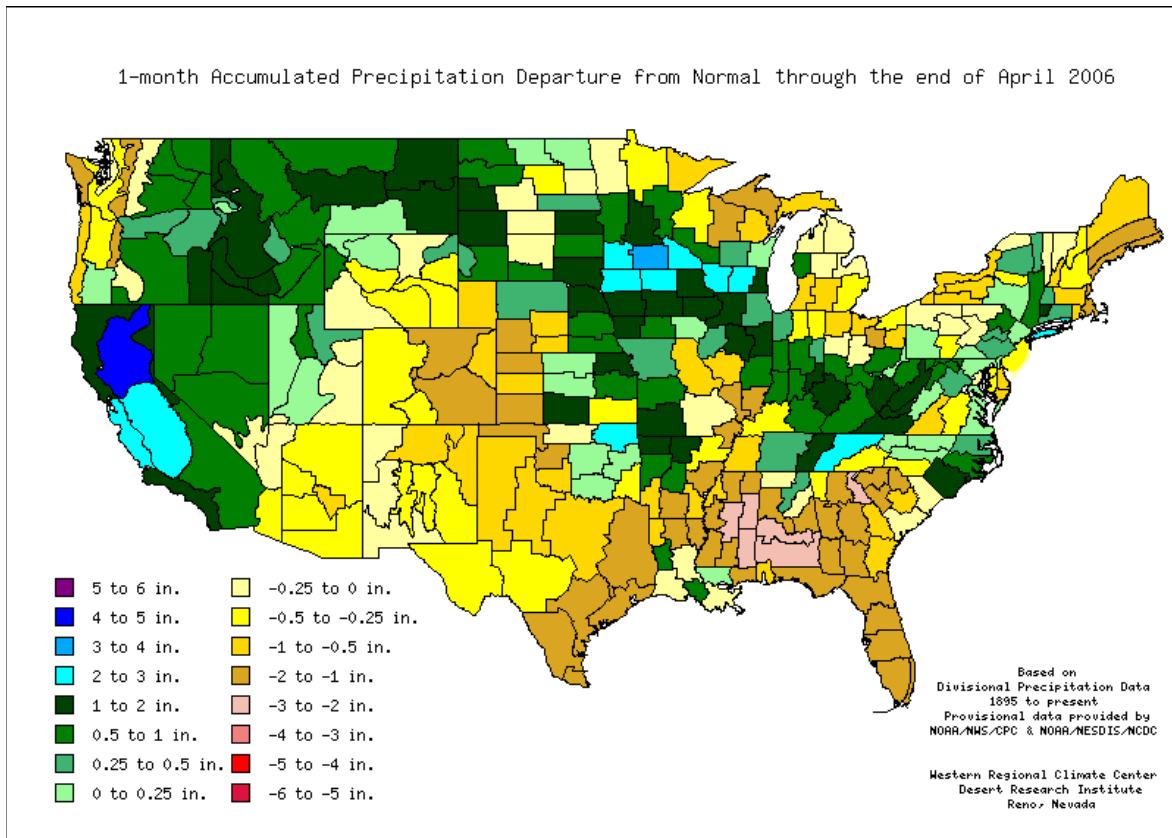
Figure 4 – 1 month Precipitation Departure From Normal

During April, the majority of the basin continued to improve and is exhibiting a near normal to precipitation surplus (Figure 4).

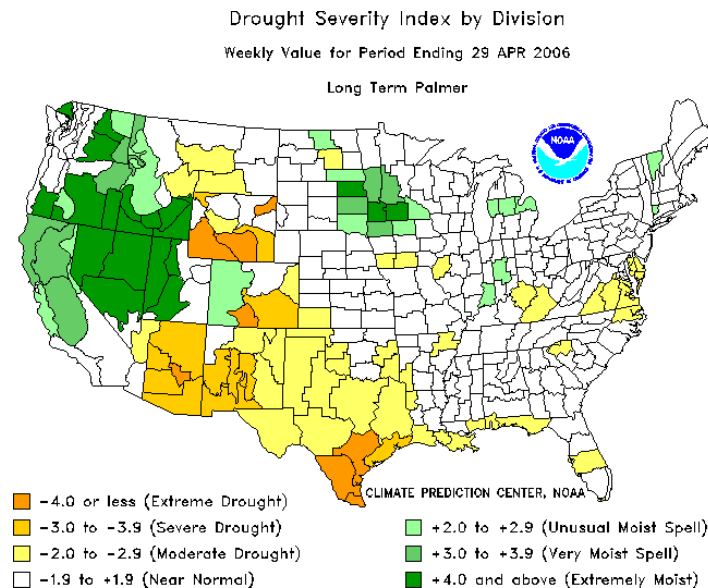
Figure 5 – Long-Term Palmer Drought Indicator Ending 29 APR 2006

Changes to the PDSI are more immediate in response to heavy precipitation over short periods. The PDSI shown in Figure 5 reflects near normal to extremely moist conditions in the majority of the Omaha District.

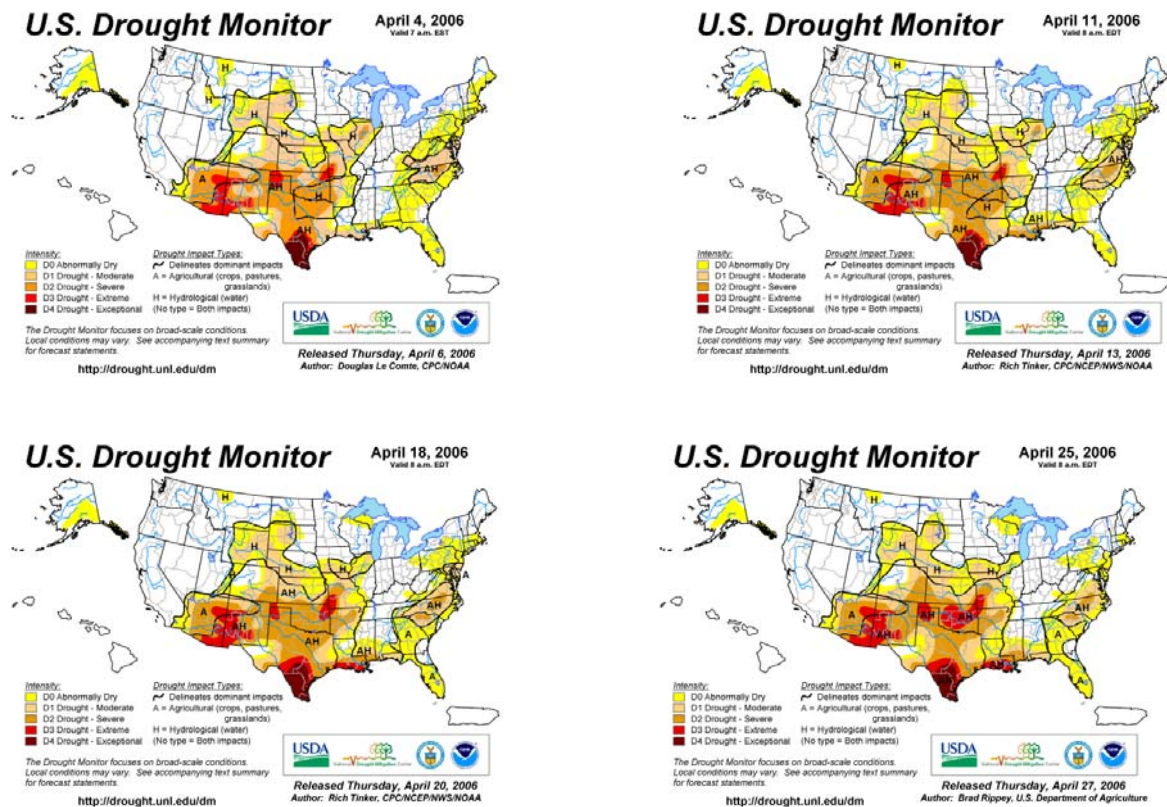
Figure 6 – U.S. Drought Monitor – April 4, 2006 through April 25, 2006

Omaha District drought has steadily improved throughout the spring. Above-normal rainfall and increased pool levels in Oahe Reservoir, Lake Sakakawea, and Ft. Peck reservoir have helped reduce the drought impacts. Portions of Nebraska, South Dakota, and Wyoming are currently classified as Abnormally Dry to Moderate Drought. North Dakota and Montana are currently classified as exhibiting Normal conditions. Currently, there are no portions of the basin classified with severe to exceptional drought.

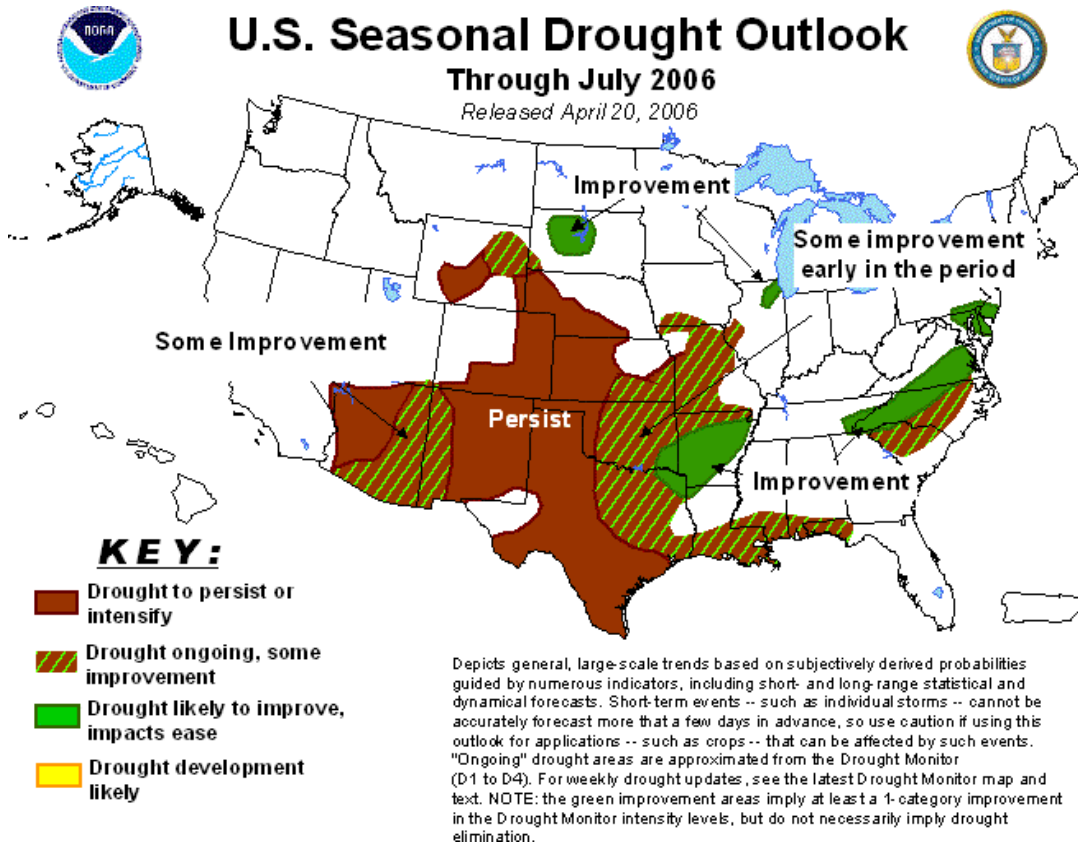
Figure 7 – Three-Month Seasonal Drought Outlook through July 2006

The basin drought outlook uses several expert products that indicate precipitation needs necessary to reduce the Palmer Drought to normal conditions, a one- and three-month climate outlook, and the impacts that future climate predictions could have on the current drought situation. The three-month Drought Outlook (Figure 7) indicates that the majority of the basin is returning to normal moisture conditions with the exception south-central and western Nebraska and portions of Wyoming. The South Dakota region around Oahe reservoir is predicted to improve with respect to the drought.

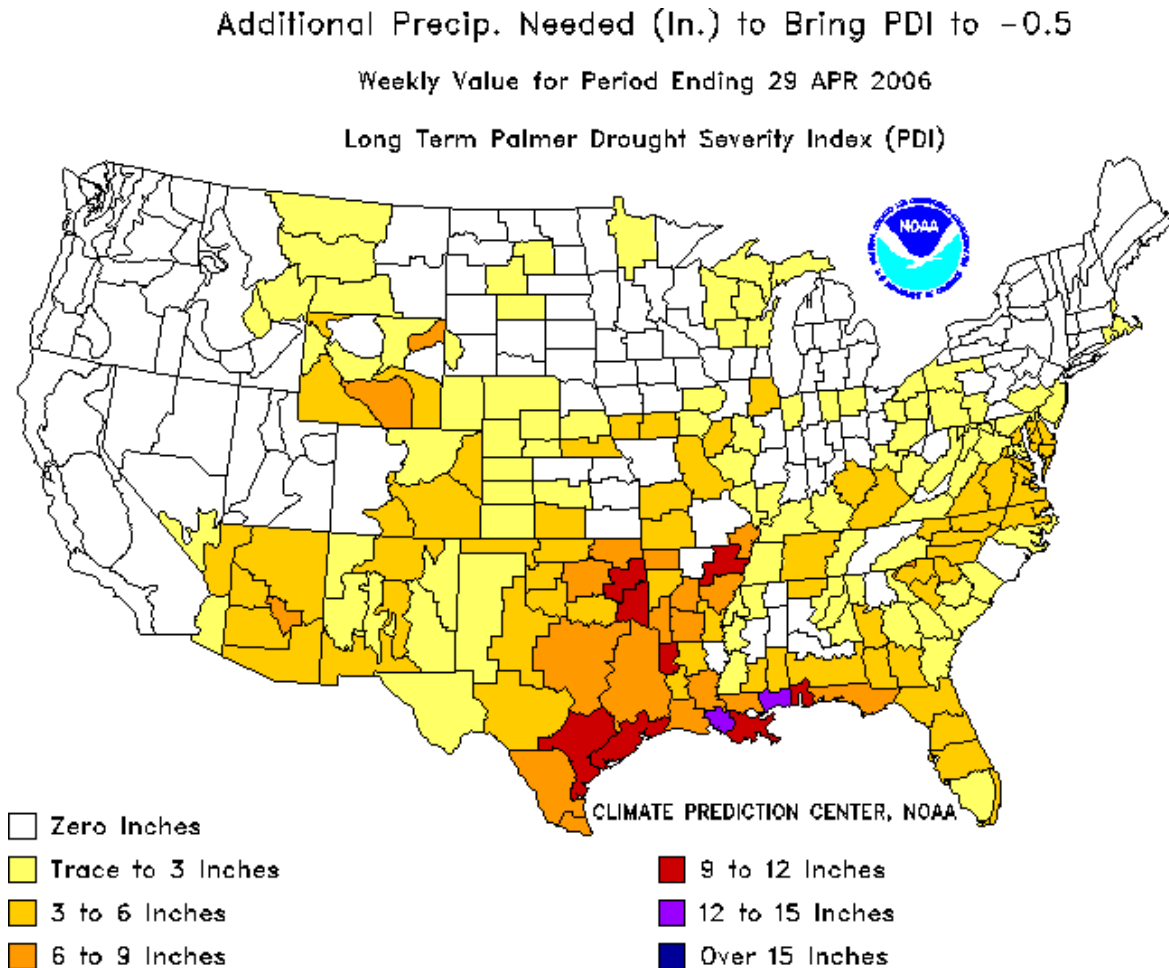
Figure 8 – Weekly Precipitation Need to Bring PDI to -0.5

Figure 8 is the weekly precipitation needed to reduce the current Palmer Drought Severity Index value to -0.5 or near normal conditions.

In order to reach near normal Palmer Drought conditions, Montana would need approximately up to 3 inches of precipitation across the western portion of the state, the North Platte River basin in Wyoming would require up to 3 to 6 inches of precipitation while southeastern Nebraska would require up to 3 to 6 inches. Water supply deficits in large reservoirs, groundwater reserves, and possibly subsoil moisture reserves would receive limited benefit from the weekly Palmer precipitation needs. Mitigation of a multi-year drought would likely require multiple years of normal and above-normal water inflow conditions.

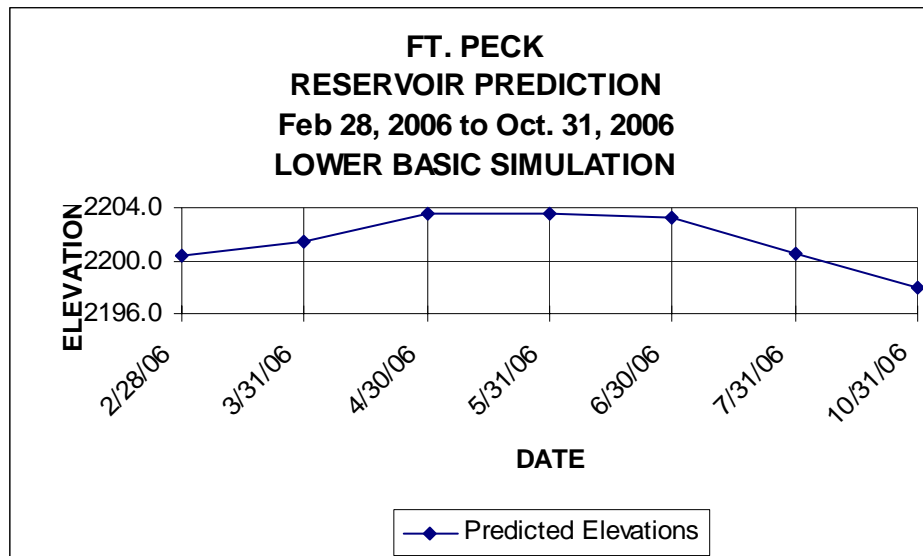
Lake Elevation 4/30/2005 (ft. msl)	Current Lake Elevation 4/30/2006 (ft. msl)	30-Day Projected Elevation* (5/31/2006) (ft. msl)	180-Day Projected Elevation* (10/31/2006) (ft. msl)
2198.5	2203.5	2203.6	2197.9

1. Current reservoir elevation is 30.5-feet below the top of conservation pool (elevation 2234.0 ft. msl).
2. *Projections provided are based upon the Lower Basic Simulation prepared by the Reservoir Control Center.
3. Current elevation is 5.0-ft. higher than elevation on 4/30/05 (2198.5).

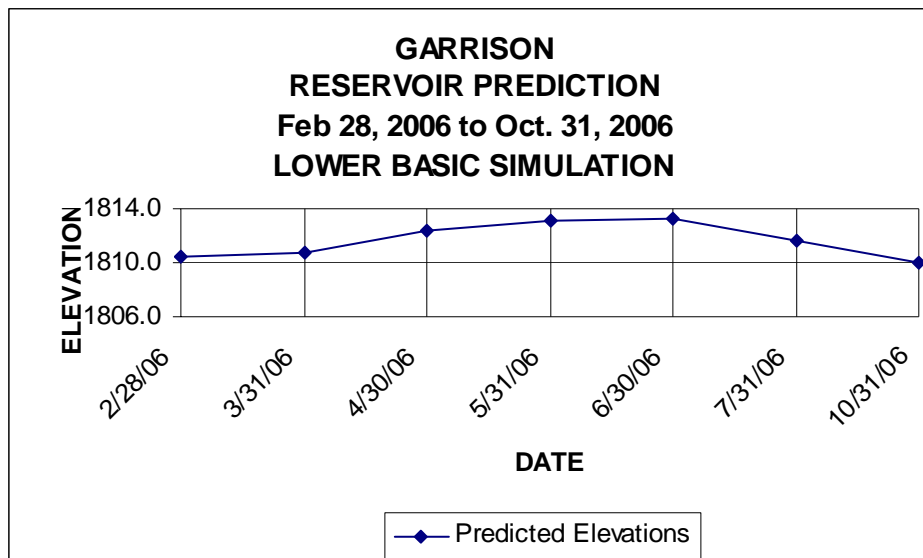
Lake Elevation 4/30/2005 (ft. msl)	Current Lake Elevation (4/30/2006) (ft. msl)	30-Day Projected Elevation* (5/31/2006) (ft. msl)	180-Day Projected Elevation* (10/31/2006) (ft. msl)
1806.6	1812.3	1813.1	1810.0

1. Current reservoir elevation is 25.2-feet below the top of conservation pool (elevation 1837.5 ft. msl).
2. *Projections provided are based upon the Lower Basic Simulation prepared by the Reservoir Control Center.
3. Current reservoir elevation is 5.7 ft. higher than elevation on 4/30/05 (1806.6).

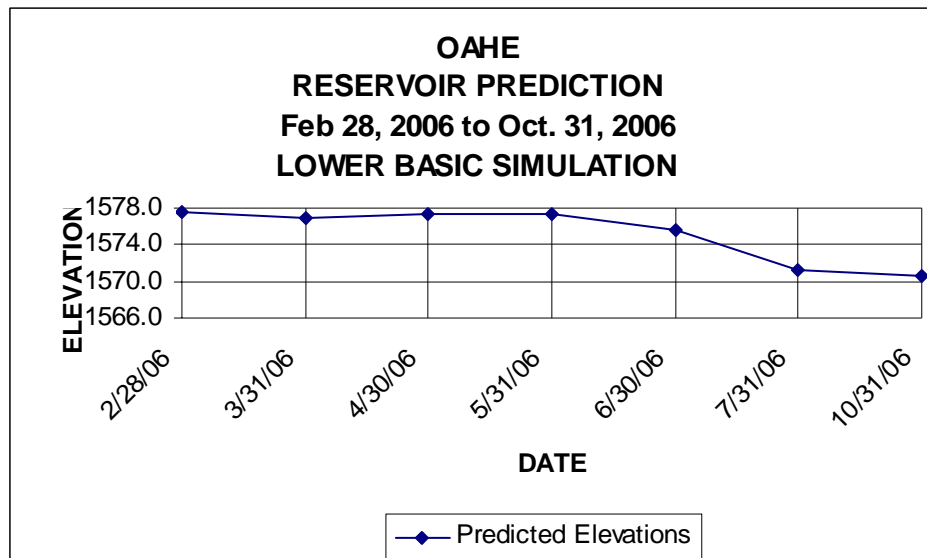
Lake Elevation 4/30/2005 (ft. msl)	Current Lake Elevation (4/30/2006) (ft. msl)	30-Day Projected Elevation* (5/31/2006) (ft. msl)	180-Day Projected Elevation* (10/31/2006) (ft. msl)
1574.4	1577.3	1577.3	1570.6

1. Current reservoir elevation is 30.8-feet below the top of conservation pool (elevation 1607.5 ft. msl).
2. *Projections provided are based upon the Lower Basic Simulation prepared by the Reservoir Control Center.
3. Current reservoir elevation is 2.9 feet higher than 4/30/05 (1574.4).

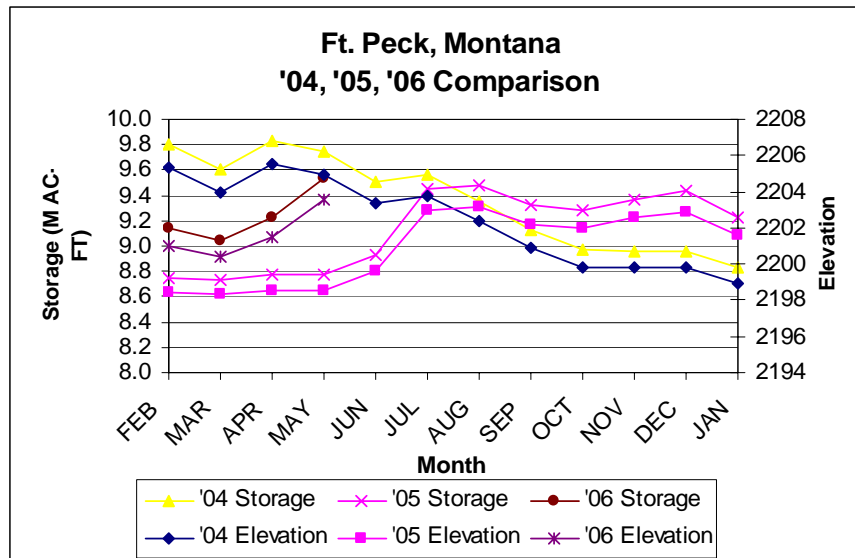
Fort Peck, Montana

Water Year 2004 (FEB 2004 – JAN 2005)			Water Year 2005 (FEB 2005 – JAN 2006)			Water Year 2006 (FEB 2006 – JAN 2007)		
Date	Elevation	Storage (MAC-Ft.)	Date	Elevation	Storage (MAC-Ft.)	Date	Elevation	Storage (MAC-Ft.)
2/1/2004	2205.3	9.806	2/1/2005	2198.4	8.749	2/1/2006	2201.0	9.134
3/1/2004	2204	9.603	3/1/2005	2198.3	8.732	3/1/2006	2200.4	9.048
4/1/2004	2205.5	9.837	4/1/2005	2198.5	8.773	4/1/2006	2201.5	9.222
5/1/2004	2204.9	9.740	5/1/2005	2198.5	8.773	5/1/2006	2203.6	9.540
6/1/2004	2203.4	9.507	6/1/2005	2199.6	8.935	6/1/2006		
7/1/2004	2203.8	9.565	7/1/2005	2203.0	9.448	7/1/2006		
8/1/2004	2202.4	9.357	8/1/2005	2203.2	9.472	8/1/2006		
9/1/2004	2200.9	9.121	9/1/2005	2202.2	9.325	9/1/2006		
10/1/2004	2199.8	8.969	10/1/2005	2202.0	9.286	10/1/2006		
11/1/2004	2199.8	8.963	11/1/2005	2202.6	9.371	11/1/2006		
12/1/2004	2199.8	8.961	12/1/2005	2202.9	9.432	12/1/2006		
1/1/2005	2198.9	8.829	1/1/2006	2201.5	9.222	1/1/2007

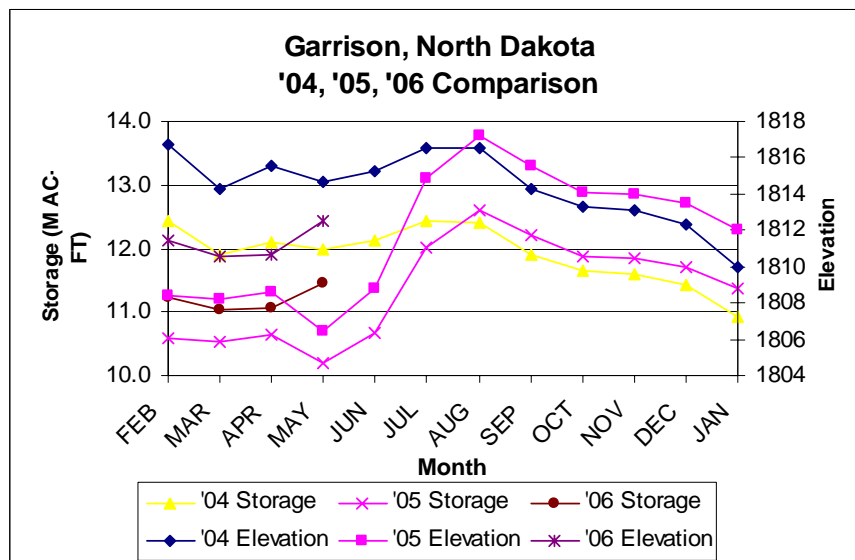
Garrison, ND

Water Year 2004 (FEB 2004 – JAN 2005)			Water Year 2005 (FEB 2005 – JAN 2006)			Water Year 2006 (FEB 2006 – JAN 2007)		
Date	Elevation	Storage (MAC-Ft.)	Date	Elevation	Storage (MAC-Ft.)	Date	Elevation	Storage (MAC-Ft.)
2/1/2004	1816.7	12.446	2/1/2005	1808.4	10.574	2/1/2006	1811.4	11.230
3/1/2004	1814.3	11.891	3/1/2005	1808.2	10.537	3/1/2006	1810.6	11.040
4/1/2004	1815.6	12.110	4/1/2005	1808.65	10.632	4/1/2006	1810.7	11.076
5/1/2004	1814.7	11.989	5/1/2005	1806.47	10.189	5/1/2006	1812.5	11.460
6/1/2004	1815.3	12.121	6/1/2005	1808.8	10.665	6/1/2006		
7/1/2004	1816.5	12.426	7/1/2005	1814.9	12.026	7/1/2006		
8/1/2004	1816.5	12.401	8/1/2005	1817.17	12.591	8/1/2006		
9/1/2004	1814.3	11.914	9/1/2005	1815.56	12.216	9/1/2006		
10/1/2004	1813.3	11.645	10/1/2005	1814.11	11.861	10/1/2006		
11/1/2004	1813.1	11.589	11/1/2005	1814.00	11.837	11/1/2006		
12/1/2004	1812.3	11.422	12/1/2005	1813.50	11.707	12/1/2006		
1/1/2005	1810	10.936	1/1/2006	1812.0	11.371	1/1/2007

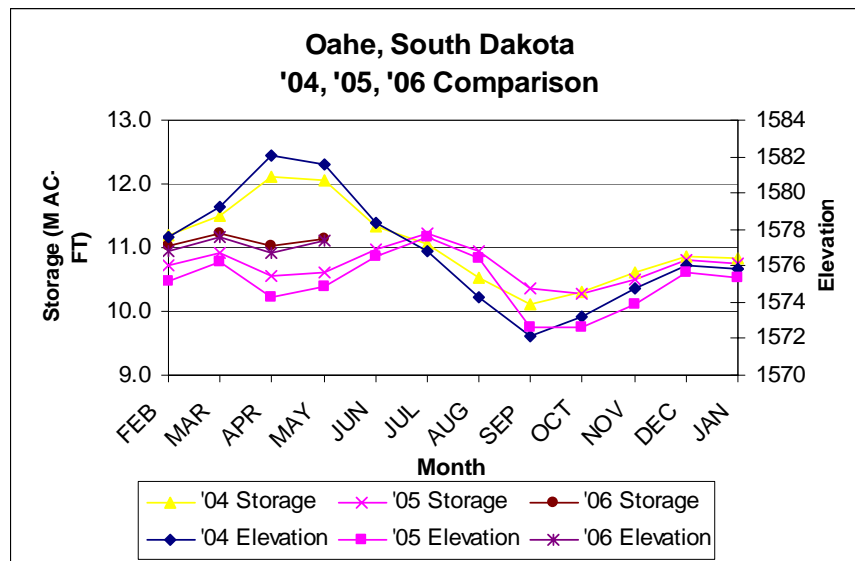
Oahe, SD

Water Year 2004 (FEB 2004 – JAN 2005)			Water Year 2005 (FEB 2005 – JAN 2006)			Water Year 2006 (FEB 2006 – JAN 2007)		
Date	Elevation	Storage (MAC-Ft.)	Date	Elevation	Storage (MAC-Ft.)	Date	Elevation	Storage (MAC-Ft.)
2/1/2004	1577.6	11.204	2/1/2005	1575.2	10.715	2/1/2006	1576.8	11.037
3/1/2004	1579.2	11.504	3/1/2005	1576.2	10.924	3/1/2006	1577.6	11.209
4/1/2004	1582.1	12.110	4/1/2005	1574.29	10.568	4/1/2006	1576.7	11.024
5/1/2004	1581.6	12.056	5/1/2005	1574.82	10.608	5/1/2006	1577.4	11.150
6/1/2004	1578.4	11.338	6/1/2005	1576.47	10.980	6/1/2006		
7/1/2004	1576.8	11.045	7/1/2005	1577.6	11.214	7/1/2006		
8/1/2004	1574.3	10.540	8/1/2005	1576.38	10.958	8/1/2006		
9/1/2004	1572.1	10.112	9/1/2005	1572.64	10.363	9/1/2006		
10/1/2004	1573.2	10.316	10/1/2005	1572.63	10.267	10/1/2006		
11/1/2004	1574.8	10.608	11/1/2005	1573.90	10.501	11/1/2006		
12/1/2004	1576	10.866	12/1/2005	1575.6	10.814	12/1/2006		
1/1/2005	1575.8	10.824	1/1/2006	1575.6	10.778	1/1/2007
