U.S. Army Corps of Engineers Omaha District Monthly Drought Report, November 2006

U.S. Army Corps of Engineers Omaha District Monthly Drought Report November 2006

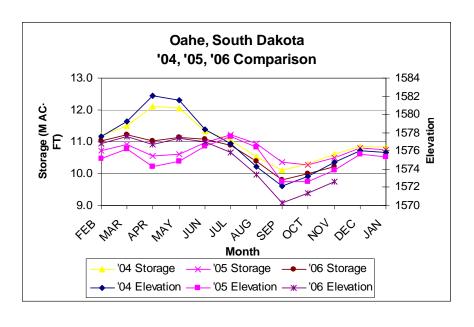
Oahe, SD

Water Year 2004 (FEB 2004 – JAN 2005)			Water Year 2005 (FEB 2005 – JAN 2006)			Water Year 2006 (FEB 2006 – JAN 2007)		
Date	Elevation	Storage (MAC-Ft.)	Date	Elevation	Storage (MAC-Ft.)	Date	Elevation	Storage (MAC-Ft.)
2/1/2004	1577.6	11.204	2/1/2005	1575.2	10.715	2/1/2006	1576.8	11.037
3/1/2004	1579.2	11.504	3/1/2005	1576.2	10.924	3/1/2006	1577.6	11.209
4/1/2004	1582.1	12.110	4/1/2005	1574.29	10.568	4/1/2006	1576.7	11.024
5/1/2004	1581.6	12.056	5/1/2005	1574.82	10.608	5/1/2006	1577.4	11.150
6/1/2004	1578.4	11.338	6/1/2005	1576.47	10.980	6/1/2006	1577.0	11.088
7/1/2004	1576.8	11.045	7/1/2005	1577.6	11.214	7/1/2006	1575.8	10.880
8/1/2004	1574.3	10.540	8/1/2005	1576.38	10.958	8/1/2006	1573.4	10.378
9/1/2004	1572.1	10.112	9/1/2005	1572.64	10.363	9/1/2006	1570.3	9.807
10/1/2004	1573.2	10.316	10/1/2005	1572.63	10.267	10/1/2006	1571.4	9.998
11/1/2004	1574.8	10.608	11/1/2005	1573.90	10.501	11/1/2006	1572.6	10.214

12/1/2004	1576	10.866	12/1/2005	1575.6	10.814	12/1/2006		
1/1/2005	1575.8	10.824	1/1/2006	1575.6	10.778	1/1/2007
