Nebraska Swine Reports

# House Mouse Damage to Insulation

Scott E. Hygnstrom<sup>1</sup>

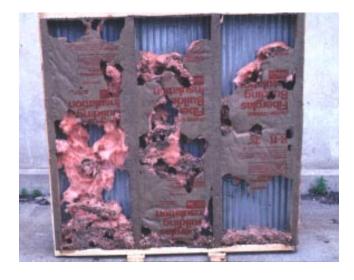
$Figure\ 2.\quad House\ mouse\ damage\ to\ a\ panel\ insulated\ with\ fiberglass\ batt\ after\ 6\ months\ of\ exposure.$

House mouse activity during the 6-month period caused an increase (P<.01) in the heat flow and resultant thermal conductance through all five insulation types (Figure 1). The damage was quite obvious (Figure 2) and equally severe among the insulation types as there were no significant differences in thermal conductance.
