Floodwater Drainage Assessment of Offutt Air Force Base, Nebraska, 2020–22

Scientific Investigations Report 2023–5053

By Christopher M. Hobza and Kellan R. Strauch

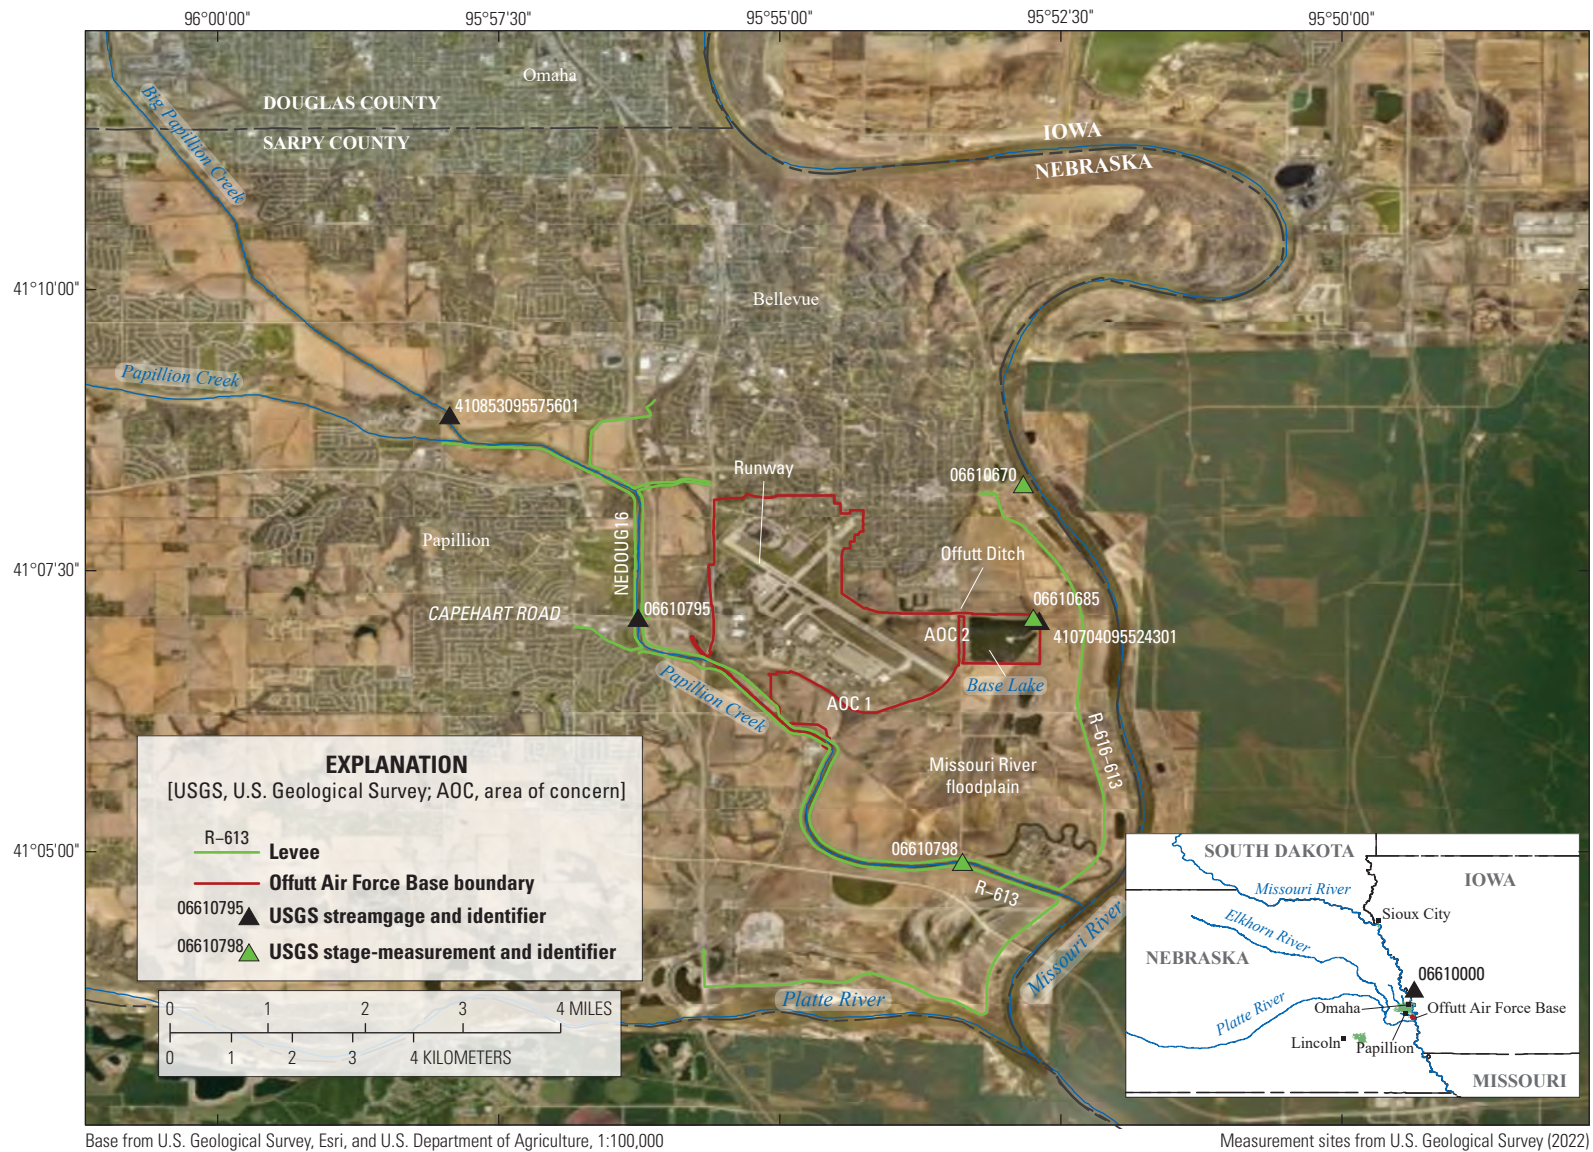
Figure 1. Locations of two areas of concern at Offutt Air Force Base, Nebraska; selected levees; selected U.S. Geological Survey streamgages; and stage-measurement stations.

climatic conditions resulted in large, sustained releases from upstream reservoirs. During that time, the streamflow measured at Omaha, Nebr. (Missouri River at Omaha, USGS site 06610000; [fig. 1](#)), ranged from 50,000 to 200,000 ft³/s between April and October 2011 (U.S. Geological Survey, 2022).

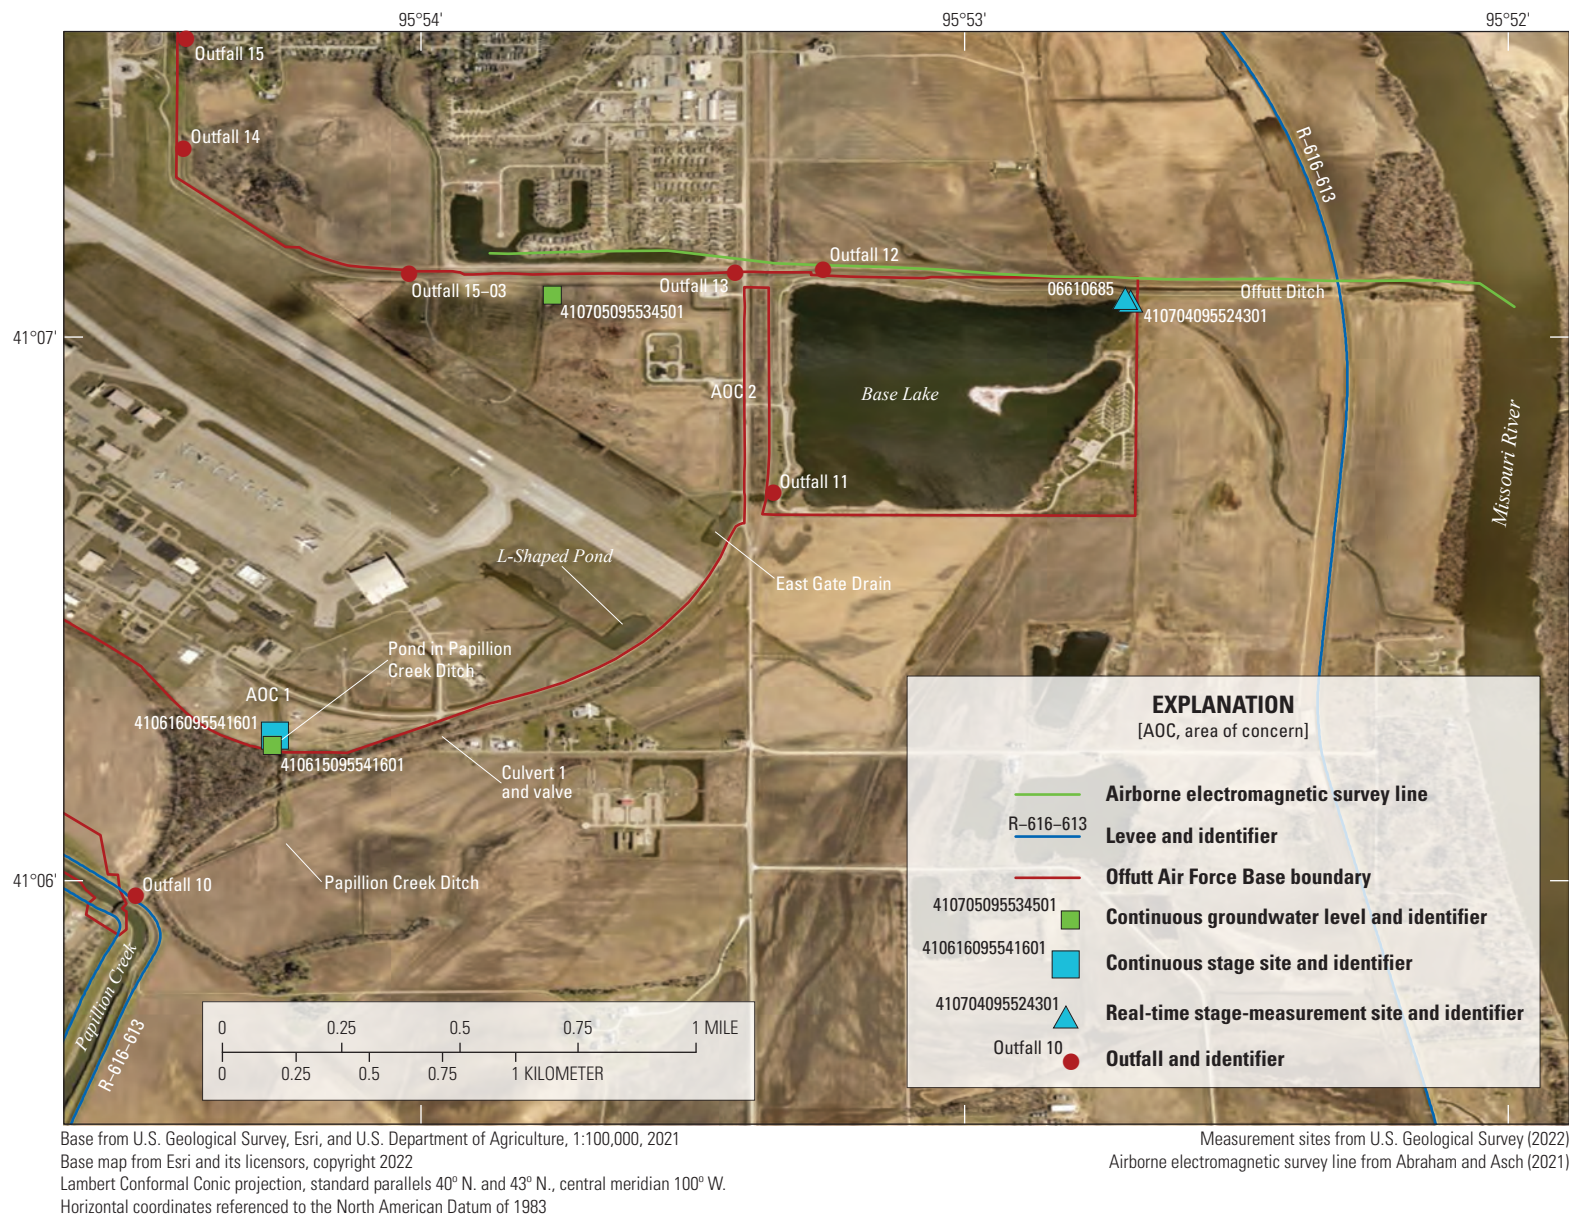
Figure 2. Water-level monitoring network and major surface-water features on and near Offutt Air Force Base, Nebraska.

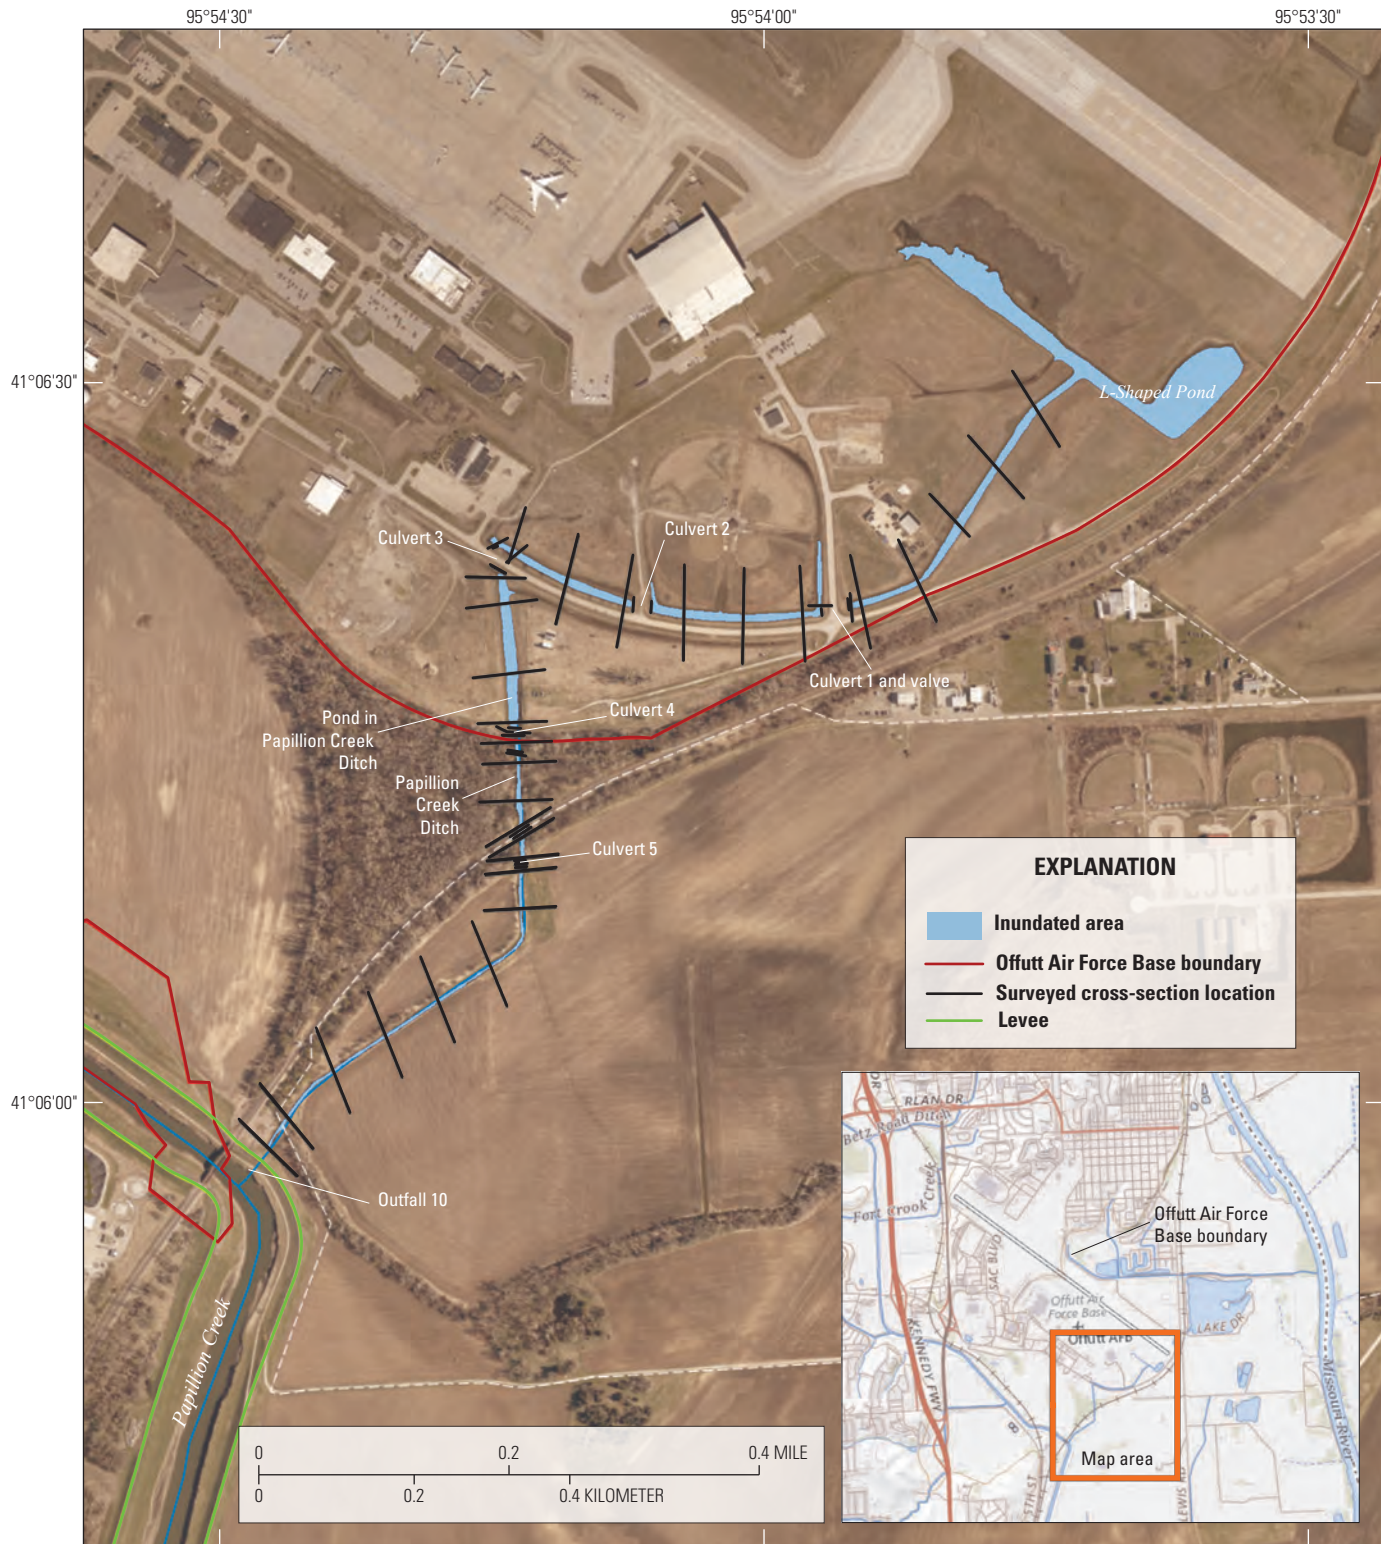
Figure 3. Surveyed cross sections of Papillion Creek Ditch upstream from outfall 10 and inundated area when Papillion Creek Ditch at culvert 5 has a water-surface elevation of 957.8 feet, December 2020.

Channel cross sections were surveyed along Papillion Creek Ditch from outfall 10 upstream to L-Shaped Pond (fig. 3) to create an elevation profile of Papillion Creek Ditch and develop an inundation map. The elevation profile was created from the minimum elevations of the channel at each surveyed cross section and was used to identify backwater control points that can create ponded conditions within Papillion Creek Ditch. A GNSS survey in which 50 channel cross sections, in addition to culvert elevations, were surveyed was completed in December 2020 (fig. 3). The elevations of channel cross sections were collected from top of bank to top of bank and adjacent areas along the cross-section line. Structural features that were surveyed included the top and bottom of culverts and top of roads. The RTN data collection procedures described in Rydlund and Densmore (2012) were used to collect the cross-section elevation data. Data collection procedures ensured the position and elevation accuracy met the criteria for a USGS level III real-time positioning survey (Rydlund and Densmore, 2012). The vertical accuracy of all survey points was within 0.20 ft and was estimated using the approach described in the “Synoptic Groundwater- and Surface-Water-Level Surveys” subsection of this report. Surveyed elevation data from cross sections are available in a USGS data release (Hobza, 2023).

The elevation of the bottom of culvert 5 (957.78 ft above NAVD 88; [fig. 3](#)) was determined to be the primary backwater control point and would likely cause prolonged standing water on Offutt Air Force Base. The water-surface elevation selected was based on the examination of the channel elevation profile ([fig. 3](#)) created from the GNSS survey. The depth raster was created by subtracting the elevation of the lidar-derived DEM from the elevation of the bottom of culvert 5 (957.78 ft above NAVD 88). Positive values from the depth raster were extracted and converted to a polygon shapefile using the raster to polygon conversion tool in ArcMap (Esri, 2022). Inundated areas that were detached from the main channel of Papillion Creek Ditch were examined to determine if these areas were connected to Papillion Creek Ditch by culverts under roadways ([fig. 3](#)). Where such connections existed, the mapped inundated areas were retained; otherwise, the mapped inundated areas were assumed to be erroneous and were deleted.

An inundation map was created to determine the potential extent of the ponded water caused by culvert 5 when the water-surface elevation is 957.78 ft above NAVD 88 (fig. 3). The inundated area shown in figure 3 illustrates that if the

water-surface elevation equaled the elevation of the upstream side of culvert 5, water would be present throughout Papillion Creek Ditch and upstream to L-Shaped Pond. It is important to note, the inundated area shown in figure 3 assumes that the valve at culvert 1 was open. Other areas within AOC 2, including East Gate Drain (fig. 2), would potentially be inundated at the water-surface elevation shown in figure 3. The pond in Papillion Creek Ditch (fig. 2) is the result of the culvert 4 invert elevation being higher than the adjacent upstream

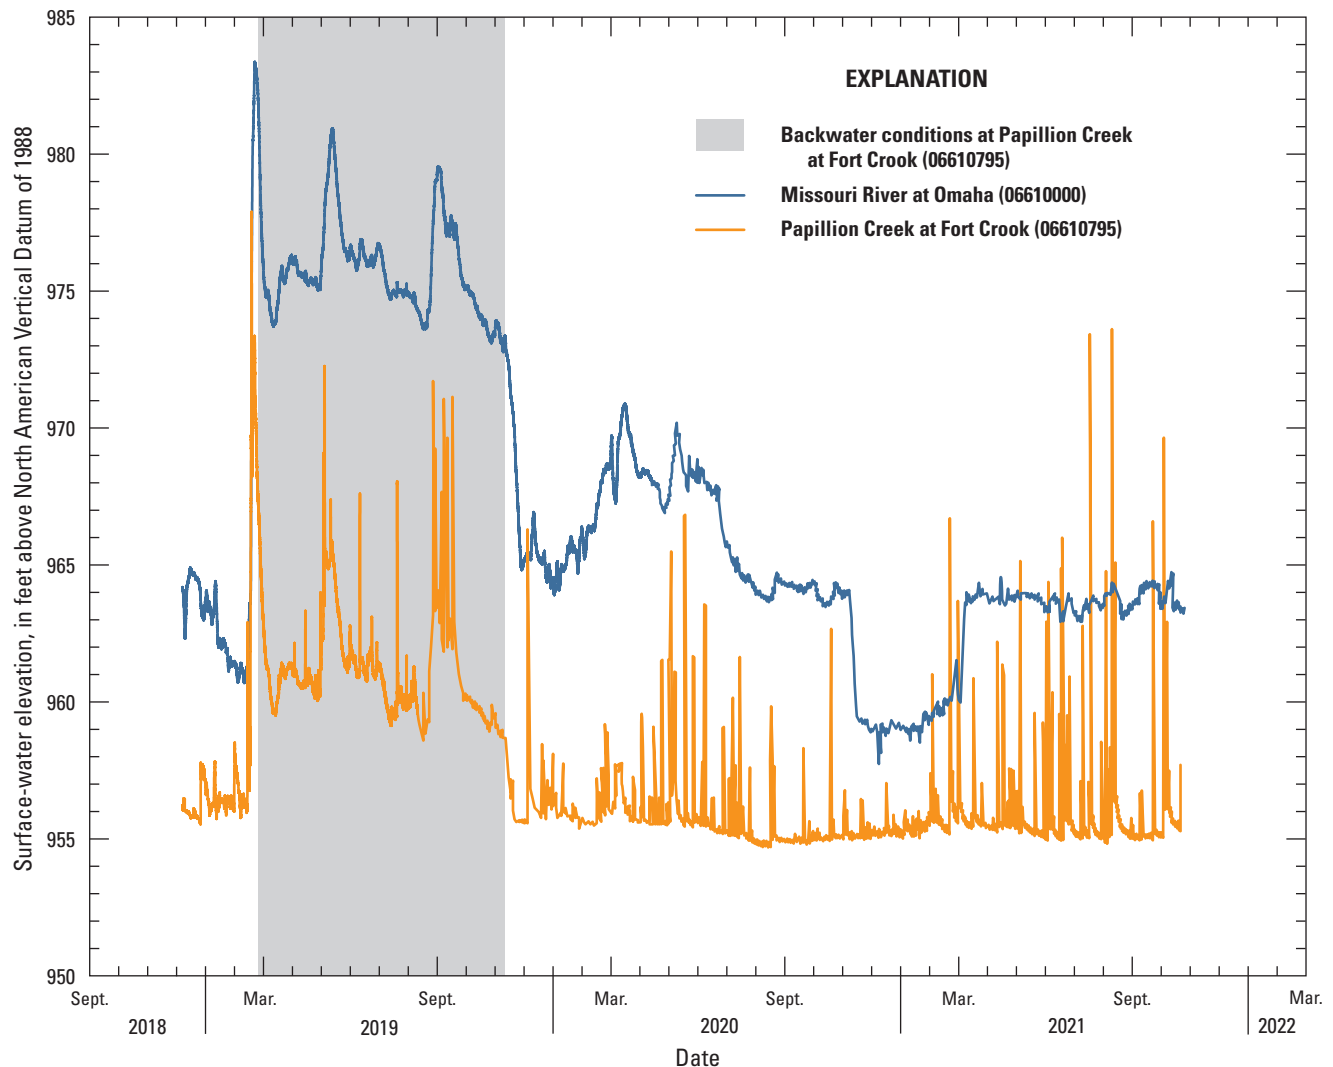
Figure 4. Surface-water elevation measured at Missouri River at Omaha (U.S. Geological Survey site 06610000) and Papillion Creek at Fort Crook (U.S. Geological Survey site 06610795), Nebraska, November 2018–November 2021.

to early December 2019. In December 2019, decreases in upstream releases lowered the water-surface elevation of the Missouri River at Omaha by about 10 ft. In response, the measured stage at the Papillion Creek at Fort Crook streamgage (USGS site 06610795) decreased about 5 ft to 955.5 ft above NAVD 88. From December 2019 to November 2021, the measured stage at the Papillion Creek at Fort Crook streamgage (USGS site 06610795) remained at that elevation with sharp, short-lived increases in stage resulting from local precipitation events ([fig. 4](#)). The surface-water-level elevation of the Missouri River remained lower than 2019 from 2020 through November 2021. From August 2020 to November 2021, the flows of the Missouri River closely followed the targeted upstream releases where the surface-water elevation during the navigation season was around 964 ft and the surface-water elevation during the nonnavigation or winter months was around 959 ft ([fig. 4](#)).

Annual precipitation measured in Bellevue, Nebr., varied from 2019 to 2021 and affected the water-surface elevation of Papillion Creek in the study area. Annual precipitation in 2019 at Bellevue, Nebr. (climate station US10sarp039), was 35.58 in., which exceeded the 30-year (1991–2020) normal of 32.58 inches per year for weather station USC00256534 in Papillion, Nebr. (National Centers for Environmental Information, 2021). Weather station USC00256534 is about 8 mi west of Offutt Air Force Base and is shown for comparison in figure 5 because it is the closest weather station with a complete precipitation record. In 2020, annual precipitation dropped below normal to 21.3 in. (National Centers for Environmental Information, 2022). The measured annual precipitation was 30 in. in 2021 but remained below the 30-year annual mean precipitation (National Centers for Environmental Information, 2021). The effect of the decreased precipitation is evident when comparing the surface-water elevations measured in 2020 and 2021 to 2019 at the Papillion Creek at Fort Crook streamgauge (USGS site 06610795; fig. 4).

events that exceed the 771-ft³/s streamflow threshold, and through an examination of streamflow measurements made in 2019 (U.S. Geological Survey, 2022), it can be inferred that many of the surface-water drainage problems experienced in 2019 were the result of backwater conditions on Papillion Creek caused by higher streamflows on the Missouri River. Backwater conditions on Papillion Creek were experienced as far upstream as the Papillion Creek at Fort Crook (USGS site 06610795) streamgage and persisted from mid-March through November 2019 (fig. 4), preventing the drainage of floodwaters from AOC 1.

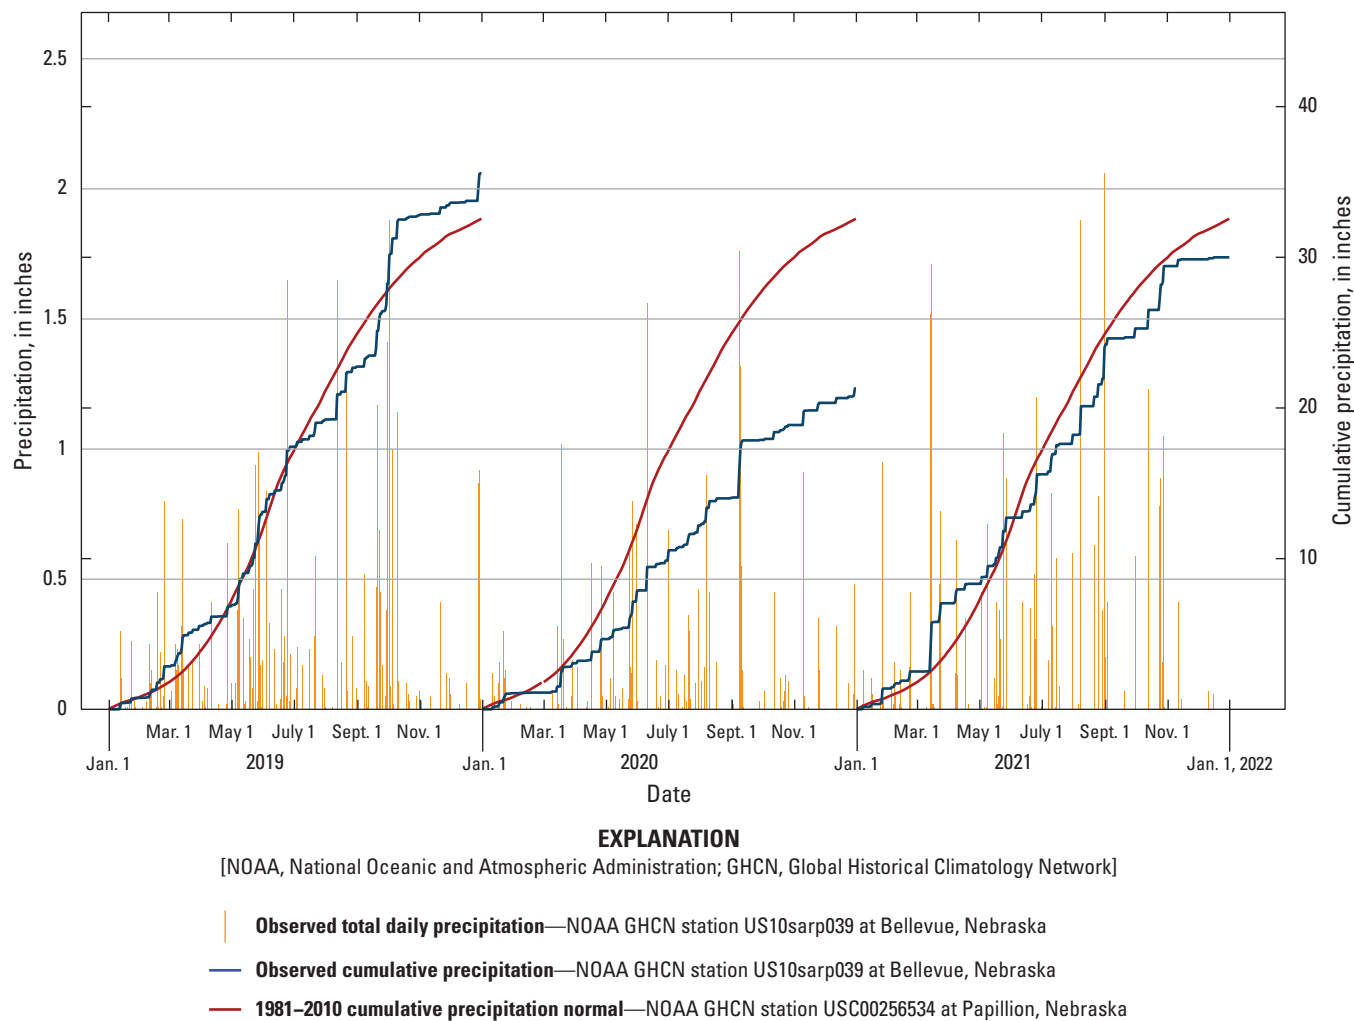
Figure 5. Observed daily and cumulative precipitation at Bellevue, Nebraska (US10sarp039), January 2019 through December 2021 (National Centers for Environmental Information, 2021), and normal cumulative precipitation from 1981 to 2010 at Papillion, Nebraska (USC00256534), about 8 miles west of Offutt Air Force Base.

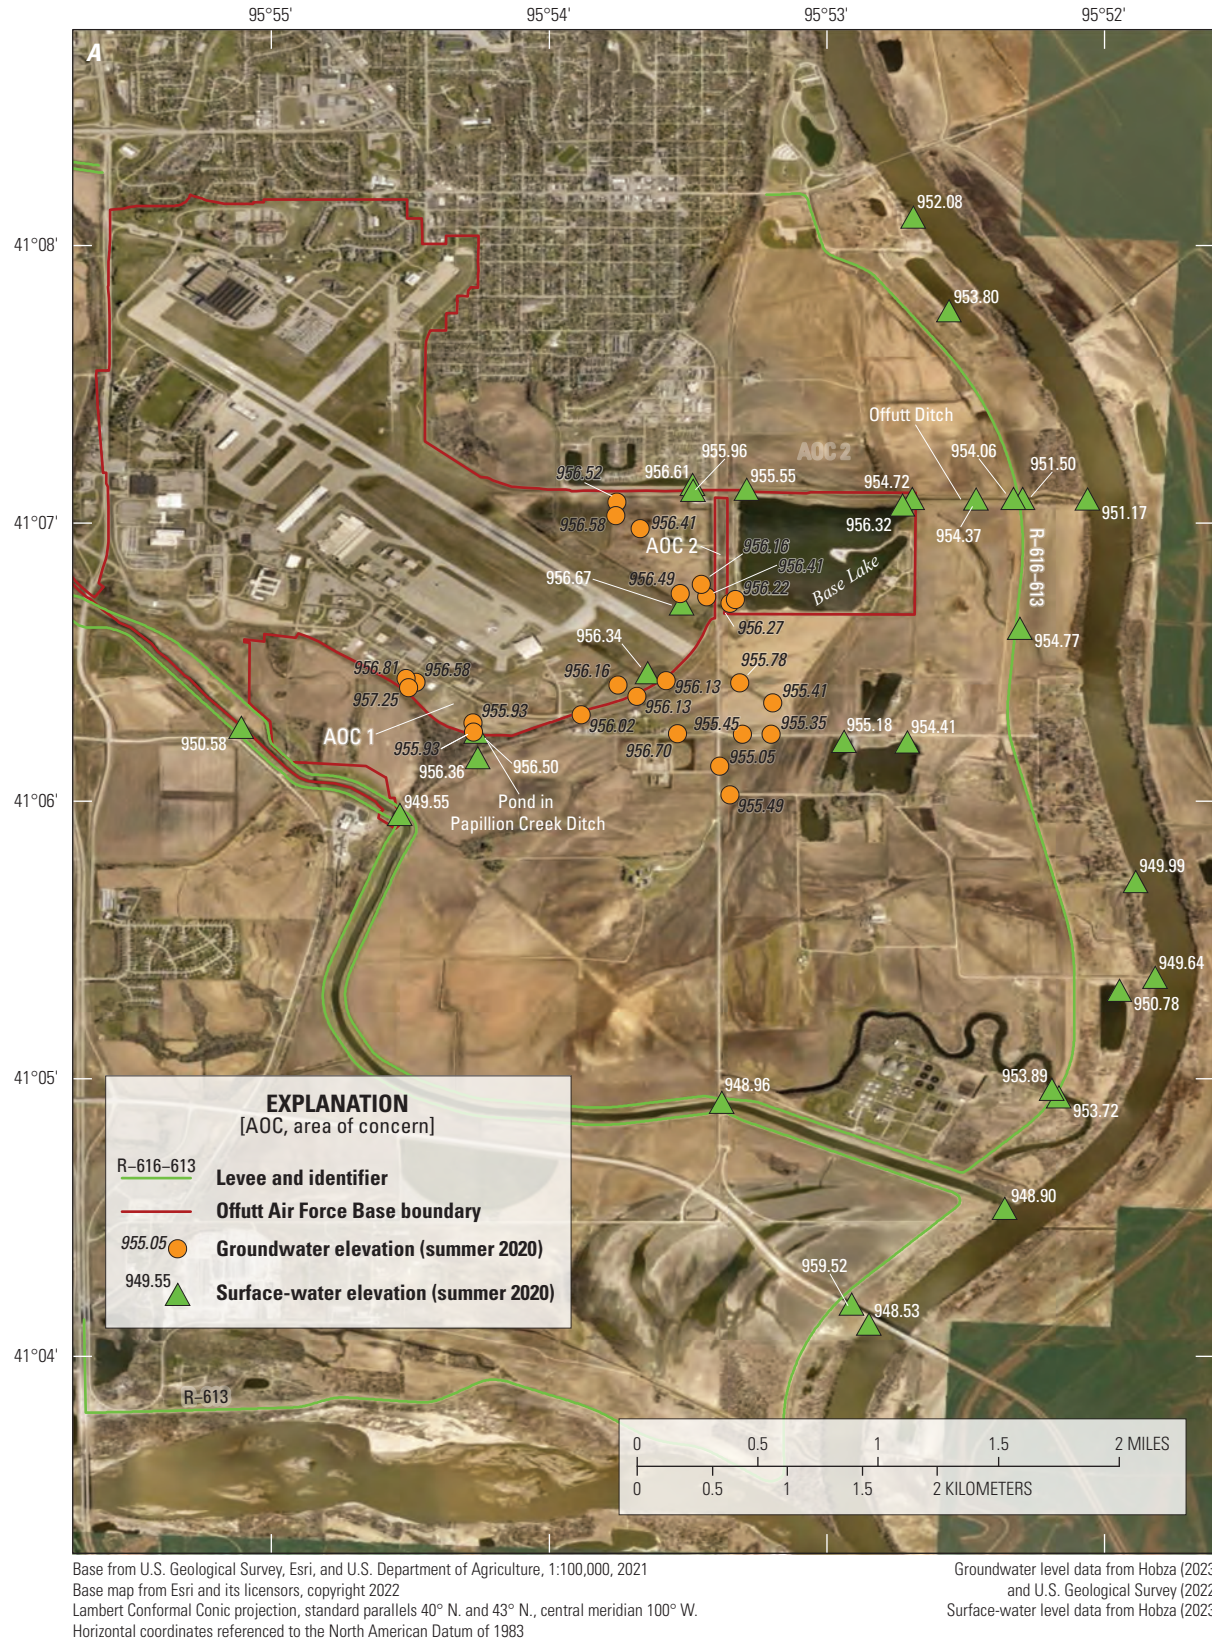
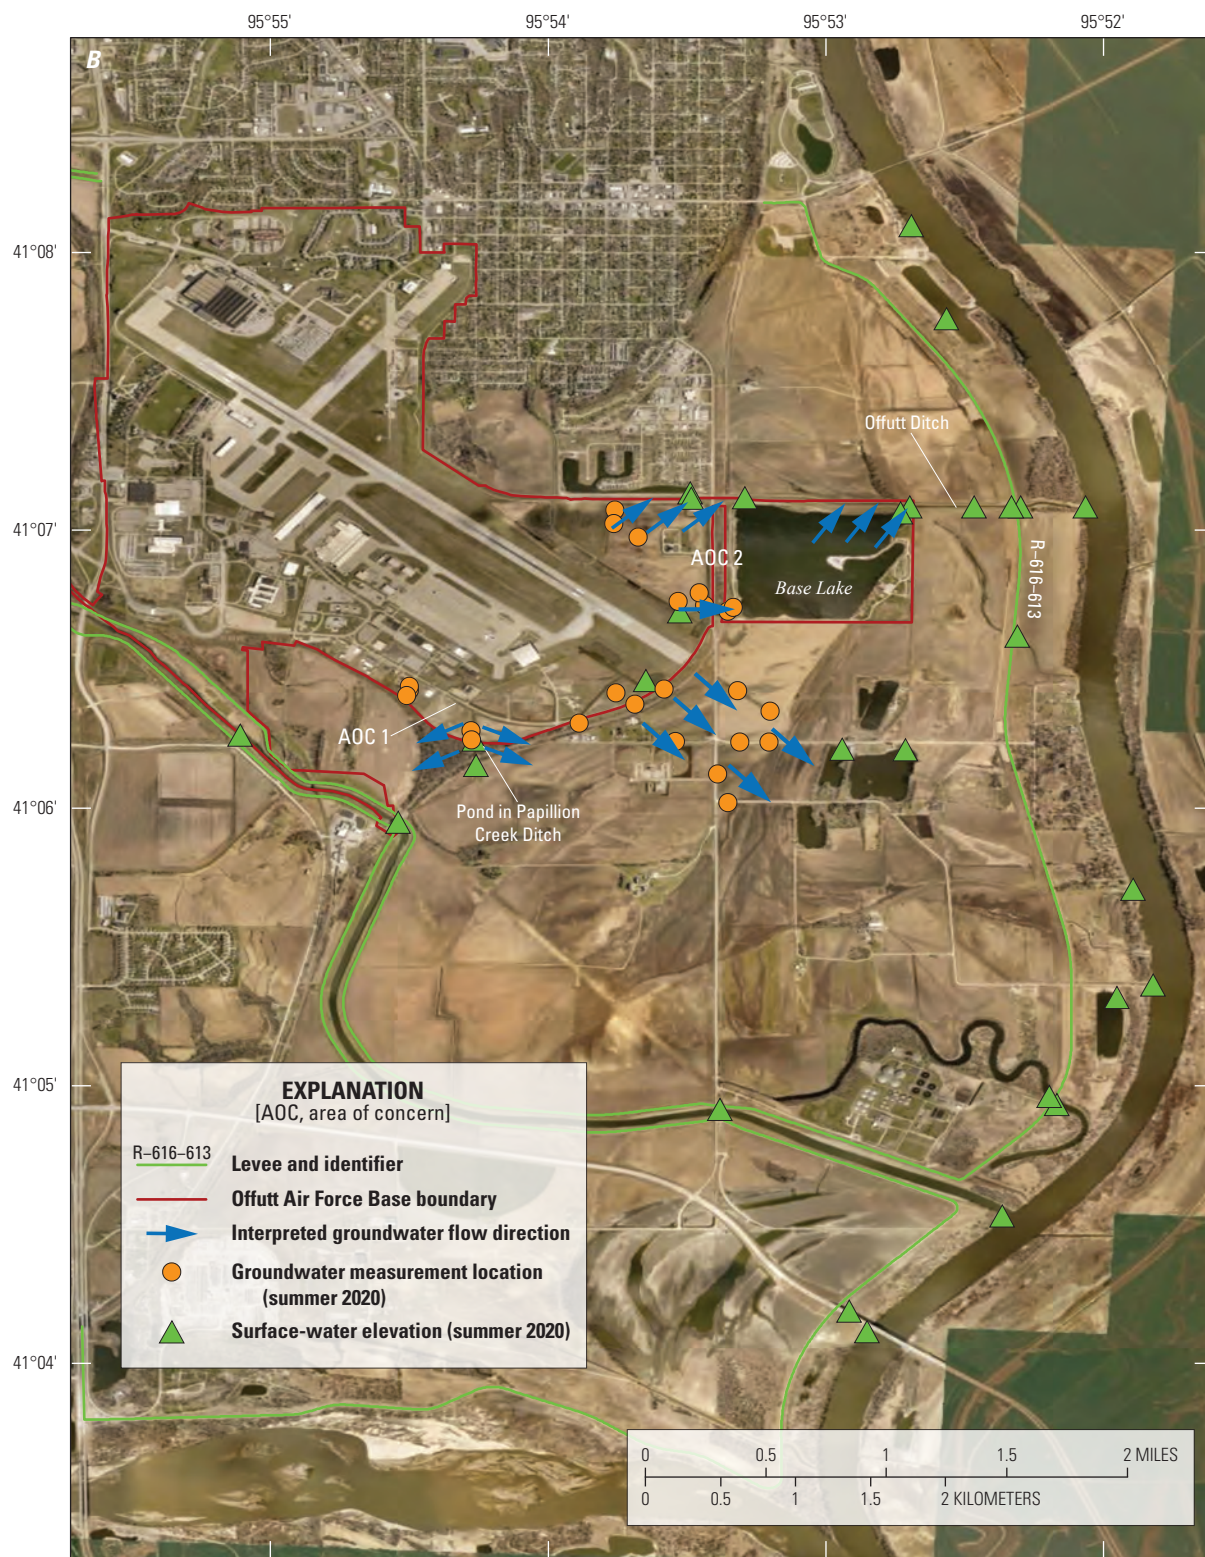
Figure 6. (A) Measured groundwater- and surface-water elevations and (B) locations of measured water levels and estimated groundwater flow direction from the late summer synoptic water-level survey data on and near Offutt Air Force Base, Nebraska, August 31–September 3, 2020. Groundwater-level elevations are shown in black labels and surface-water elevations are shown in white labels in figure 6A.

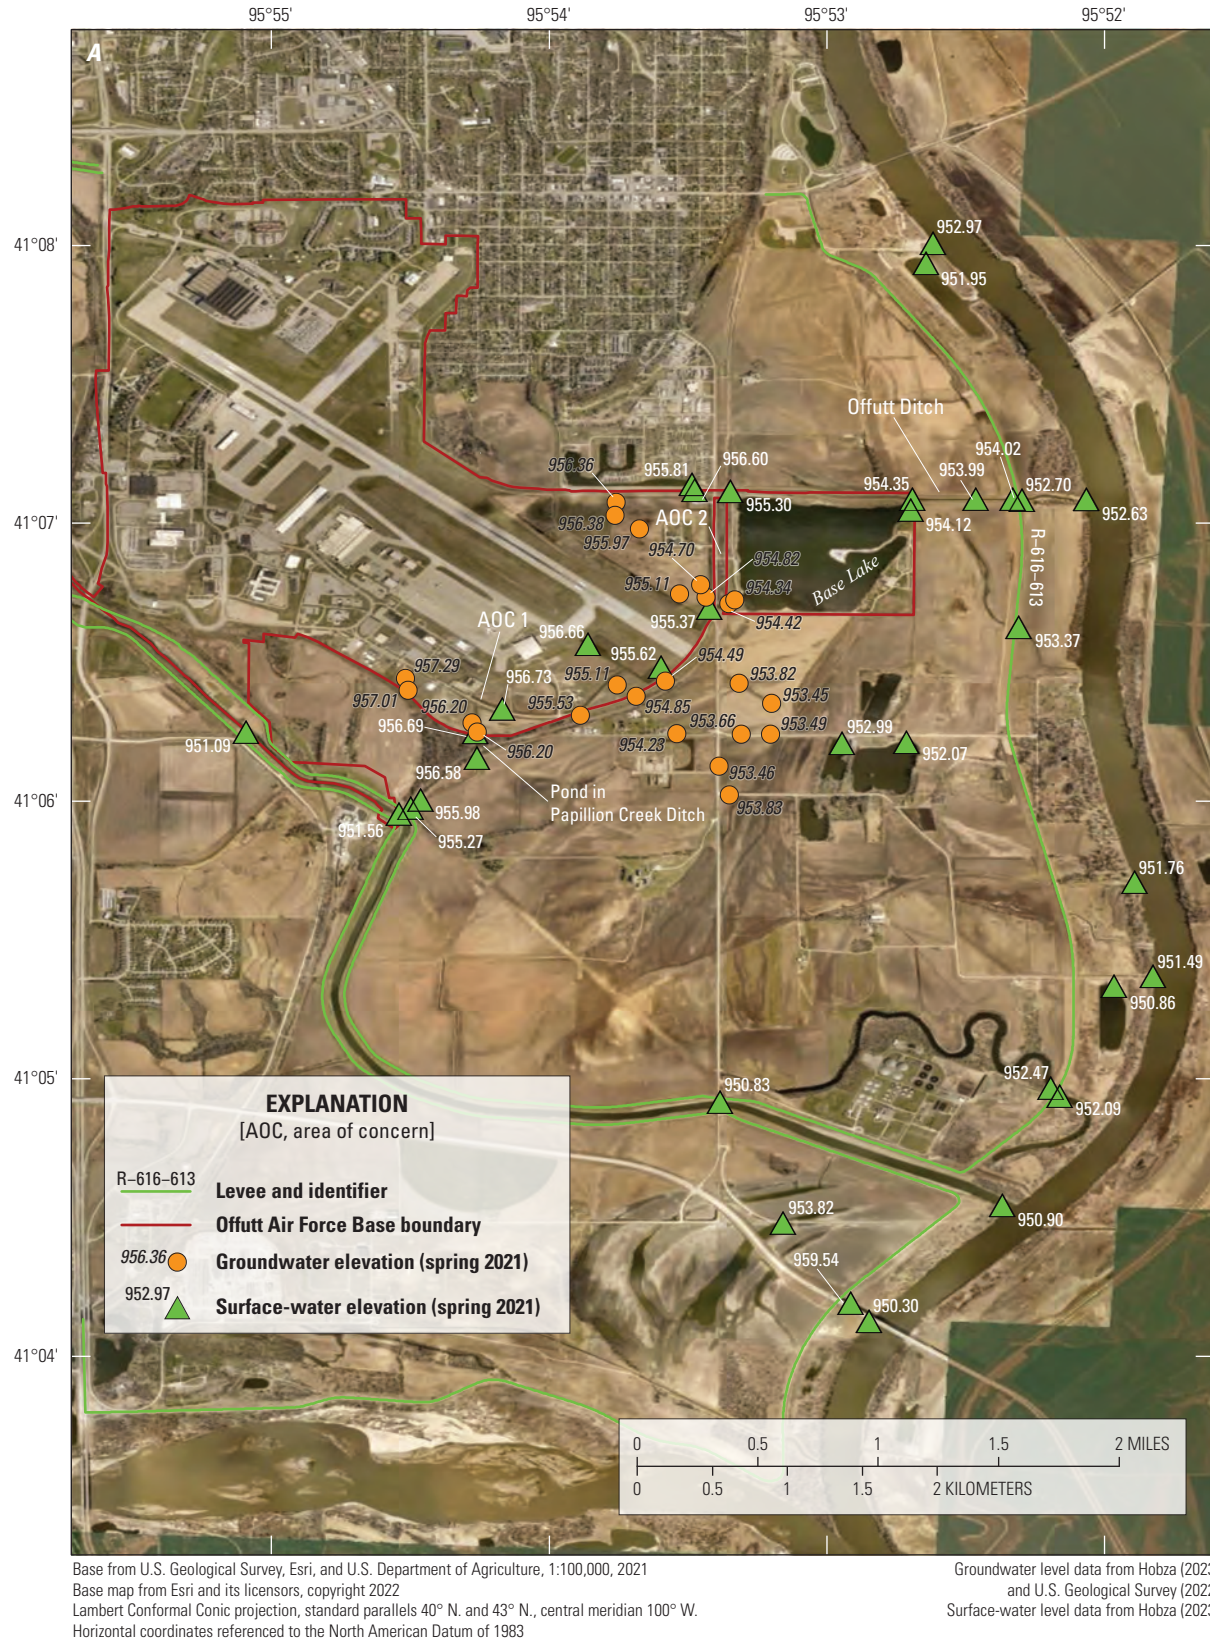
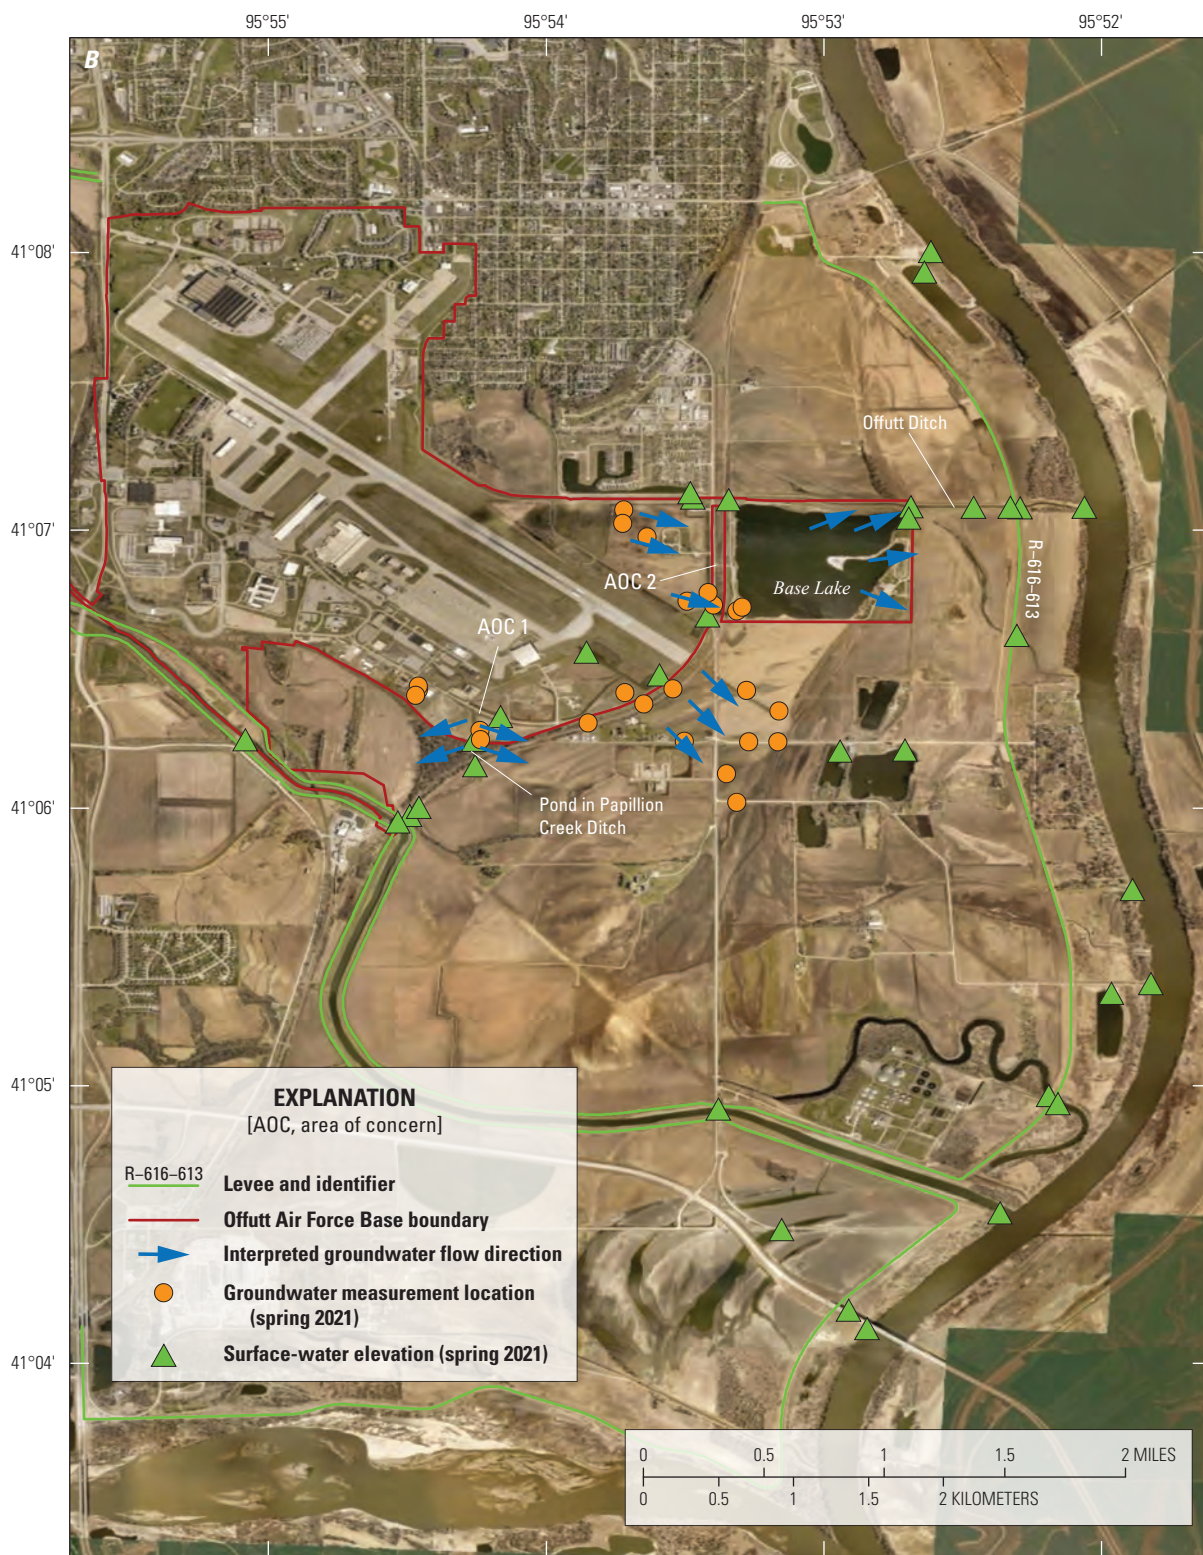
Figure 7. (A) Measured groundwater- and surface-water elevations and (B) locations of measured water levels and estimated groundwater flow direction from the late spring synoptic water-level survey on and near Offutt Air Force Base, Nebraska, May 3–5, 2021. Groundwater-level elevations are shown in black labels and surface-water elevations are shown in white labels in figure 7A.

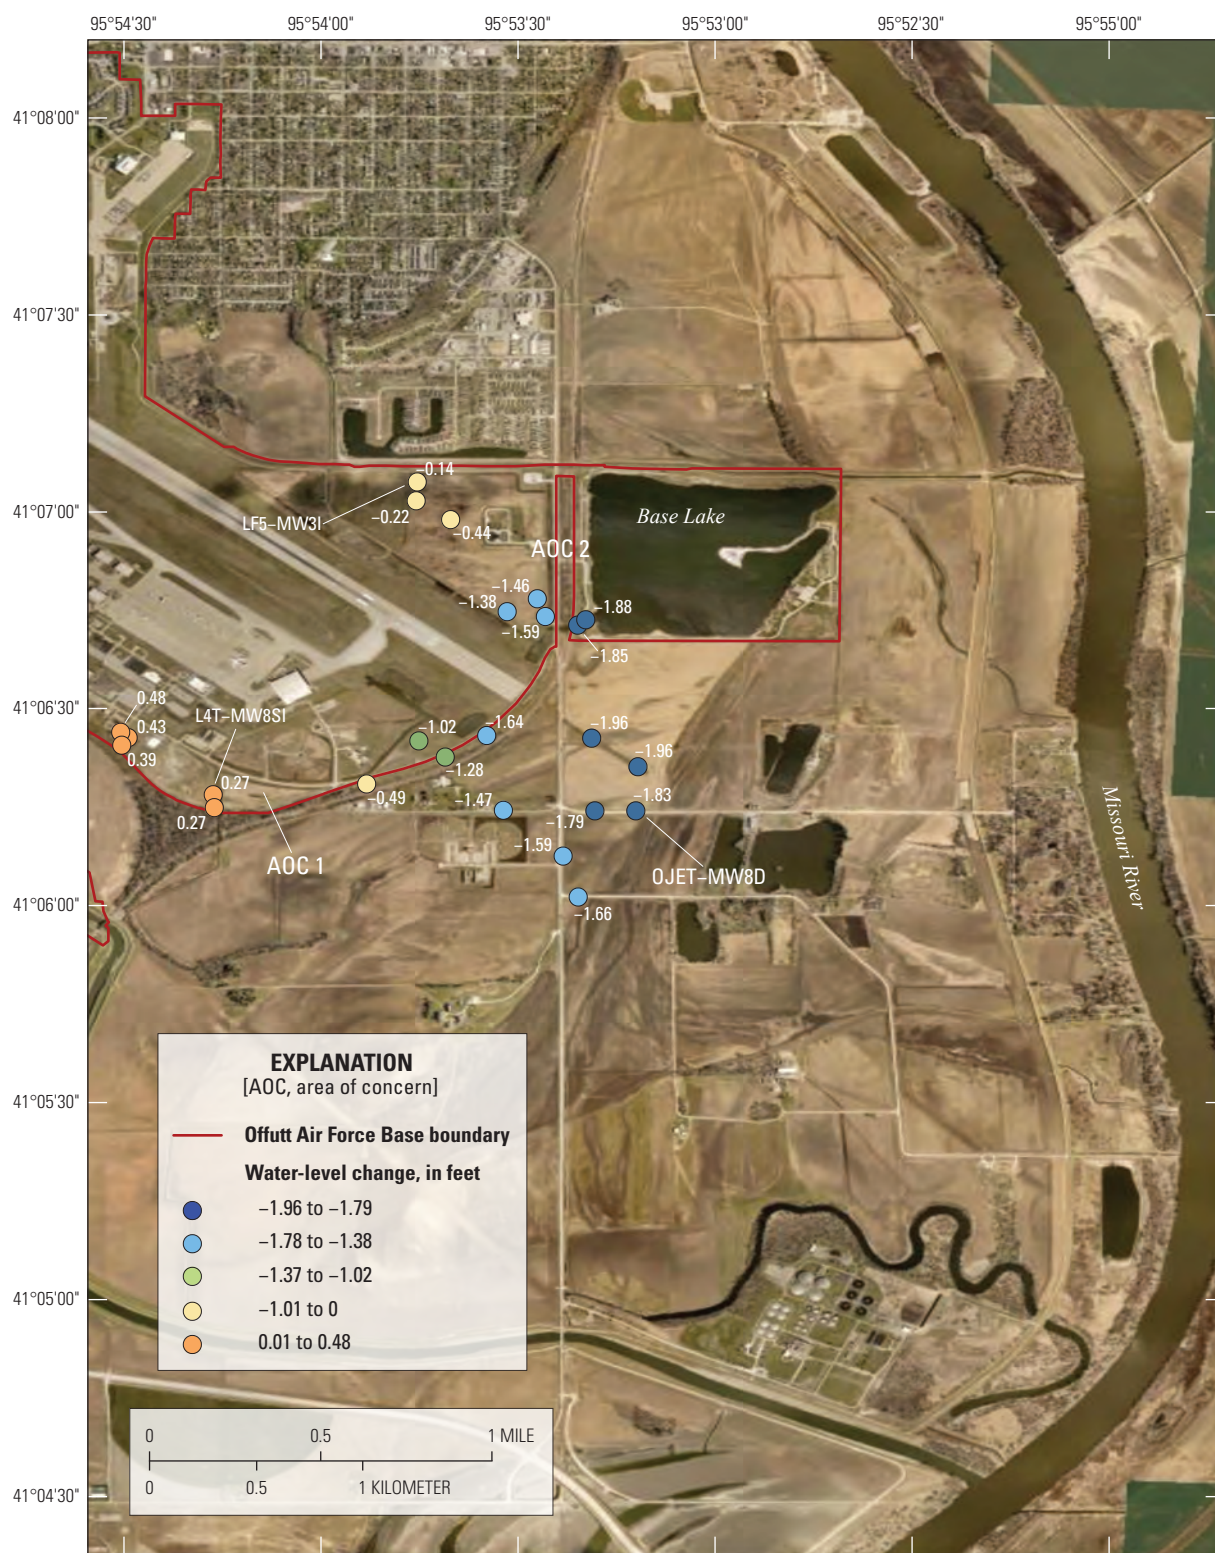
Figure 8. Change in groundwater levels in wells measured in late summer 2020 and late spring 2021 on and near Offutt Air Force Base, Nebraska.

Changes in surface-water and groundwater levels from summer 2020 to spring 2021 were the result of differences in seasonal precipitation and streamflows in the Missouri River. For most hydrologic systems, groundwater levels are highest in the spring when precipitation is greater than evapotranspiration and groundwater pumping. Groundwater levels in AOC 1 increased from summer 2020 to spring 2021 in response to increased seasonal precipitation; however, groundwater levels in AOC 2 decreased from summer 2020 to spring 2021 ([fig. 8](#)). The largest water-level decreases were observed in monitoring wells east of the runway, closer to the Missouri River and Base Lake ([fig. 8](#)).

AOC 2, decreased by about 2–3 ft (fig. 9). Groundwater-level elevations in monitoring well L4T–MW8SI (fig. 8), which is representative of water-level conditions in AOC 1 increased from winter to spring each year, likely in response to increased seasonal precipitation (fig. 9).

The difference in hydrologic response between AOC 1 and AOC 2 (fig. 8) can be linked to differences in subsurface geology. The areas that show the largest decreases in water levels from summer 2020 to spring 2021 are east of the Offutt Air Force Base boundary, within AOC 2, where groundwater levels are affected by the flows of the Missouri River. The subsurface geology in AOC 2 consists of a thin layer of fine-grained silt overlying coarser alluvial sand deposits. Although

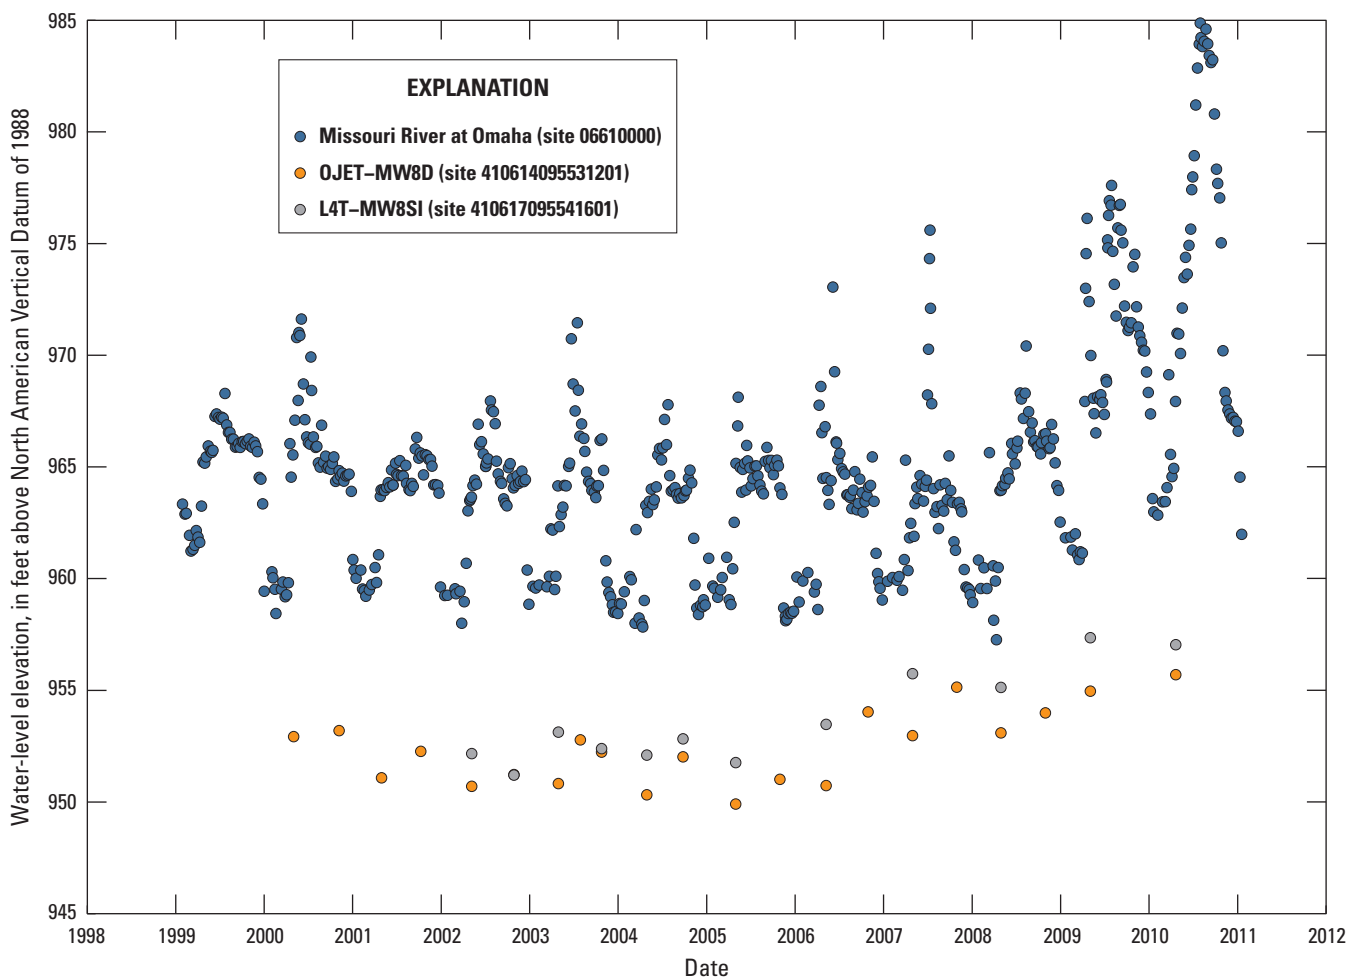
Figure 9. Comparison of water-level elevation of the Missouri River at Omaha, Nebraska (computed from measured gage height at U.S. Geological Survey site 06610000), to measured groundwater levels (URS Group, Inc., 2002, 2003, 2004, 2005, 2006a, 2007, 2008a, 2009, 2010, 2011, 2012) measured on Offutt Air Force Base, 1999–2011. The locations of monitoring wells L4T–MW8SI and OJET–MW8D are shown in figure 8.
