Floodwater Drainage Assessment of Offutt Air Force Base, Nebraska, 2020–22

Scientific Investigations Report 2023–5053

By Christopher M. Hobza and Kellan R. Strauch

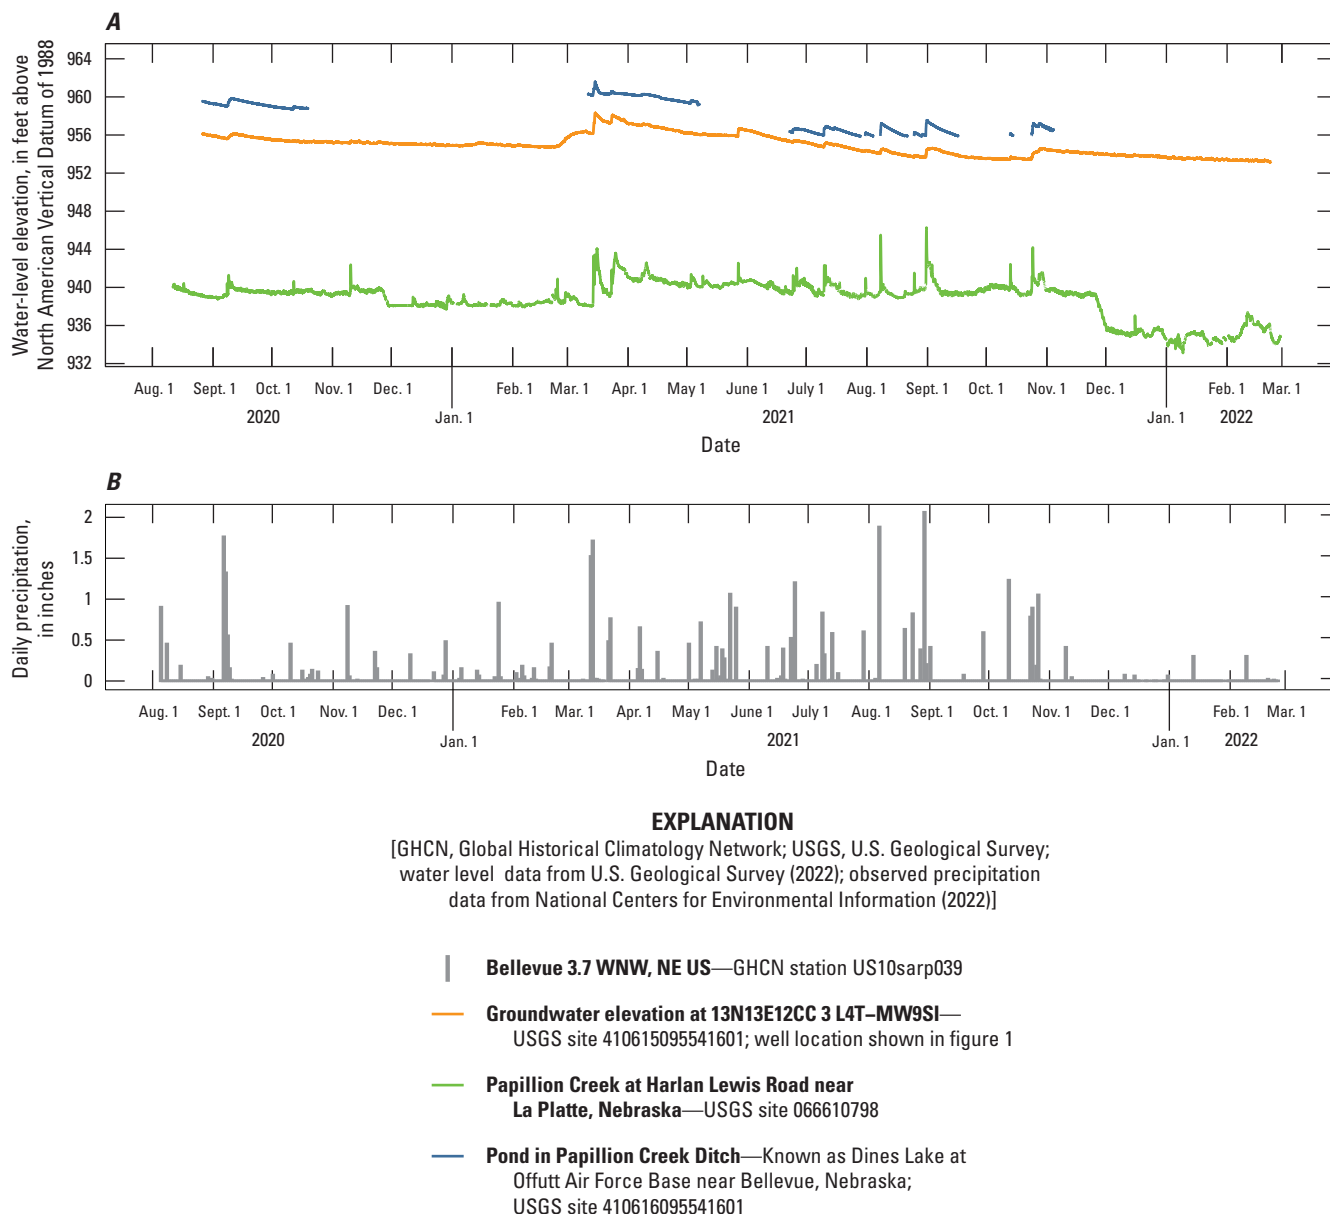
Figure 10. (A) Measured water-level elevations of the pond in Papillion Creek Ditch (Dines Lake at Offutt Air Force Base near Bellevue, Nebraska; U.S. Geological Survey site 410616095541601) and monitoring well L4T-MW9SI (U.S. Geological Survey site 410615095541601) within area of concern 1 and (B) daily precipitation about 4.7 miles from area of concern 1, on and around Offutt Air Force Base, Nebraska, August 2020–January 2022.

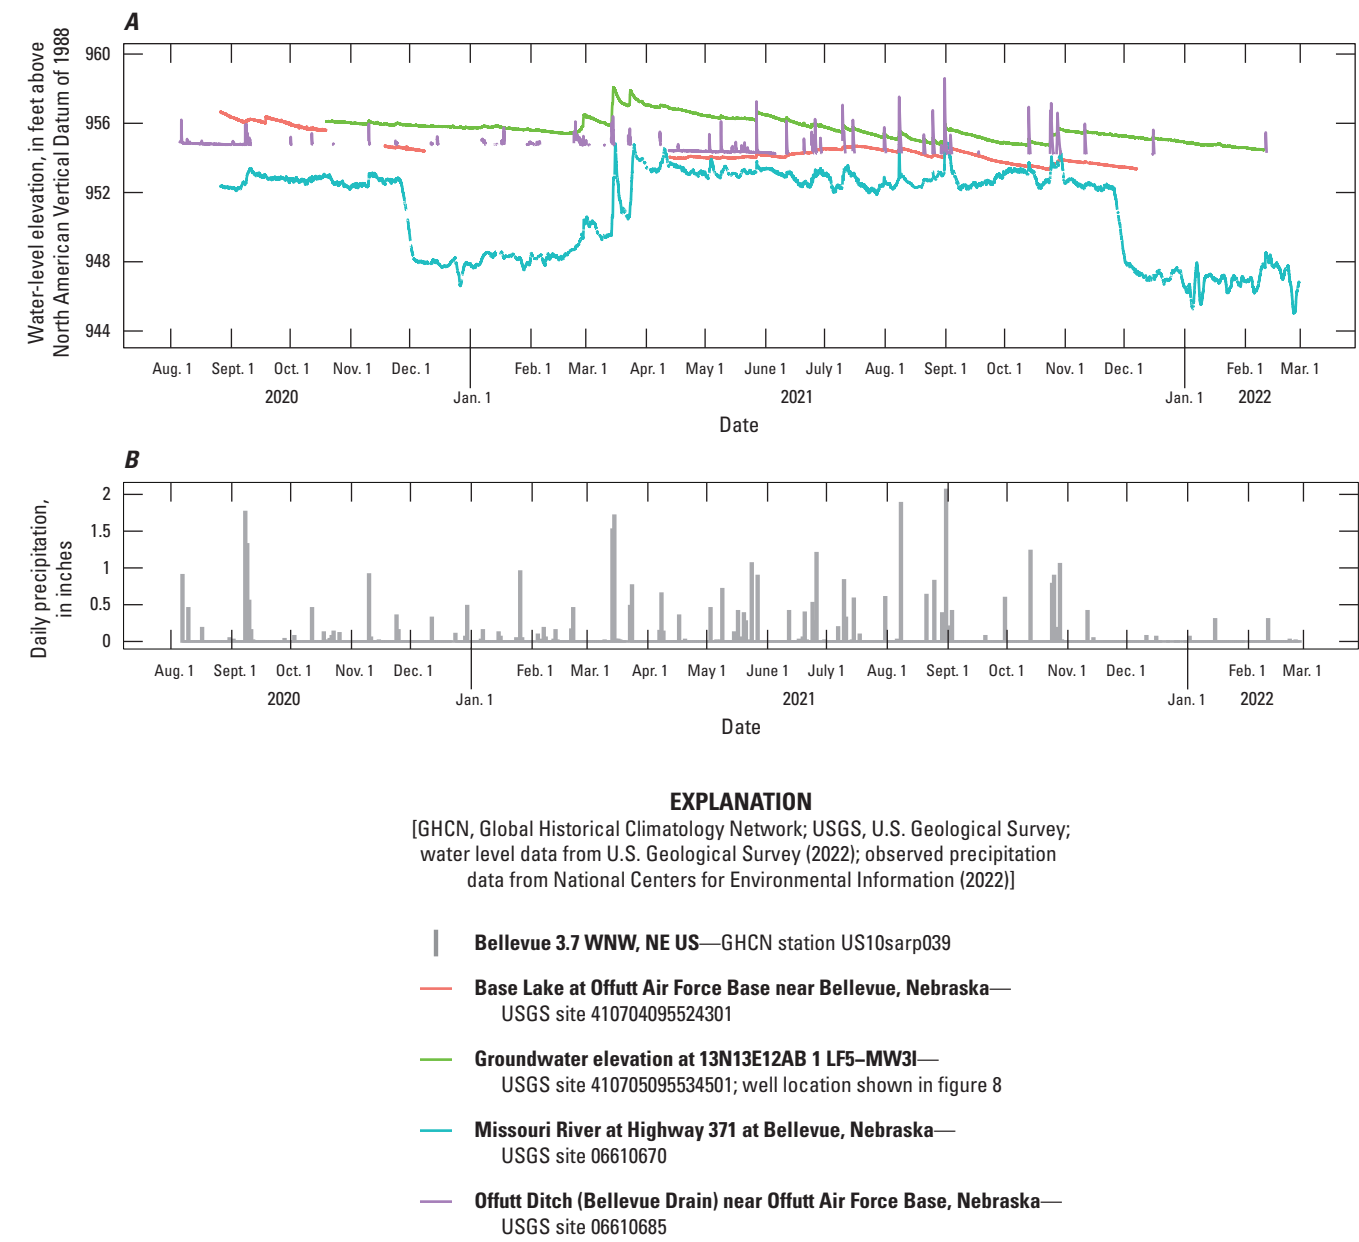
Figure 11. (A) Measured water-level elevations of the Missouri River at Highway 370 (U.S. Geological Survey [USGS] site 06610670), Base Lake (USGS site 410704095524301), Offutt Ditch (USGS site 06610685), and monitoring well LF5–MW3I (USGS site 410705095534501) within area of concern 2, August 2020–January 2022, on and around Offutt Air Force Base, Nebraska, and (B) daily precipitation about 4.5 miles from area of concern 2.

Offutt Ditch likely contributed flow to the Missouri River in later summer 2020 and acted as a drain for the local groundwater flow system. The banks of the ditch were devoid of vegetation for much of 2020, which indicated Offutt Ditch likely remained submerged after the 2019 flood event. After spring 2021, the groundwater-level elevation in well LF5–MW3I near Offutt Ditch was below the elevation of Offutt Ditch (fig. 11A), which then no longer acted as a groundwater drain but rather as a channel for moving stormwater runoff, and vegetation began to recolonize the banks. Under the spring 2021 hydrologic condition, Offutt Ditch seemed to be independent of the flows of the Missouri River and responded solely to local precipitation (fig. 11A and 11B). Stormwater runoff from outfalls on Offutt Air Force Base and from the city of Bellevue to the north resulted in abrupt gage height increases in Offutt Ditch (fig. 11A). After runoff events, stormwater can pond in Offutt Ditch behind the gate at levee R–616–613 and, while ponded, stormwater runoff can recharge the underlying Missouri River Valley alluvial aquifer. During this study, after prolonged dry periods, the water level in Offutt Ditch was below the level of the Offutt Ditch water-level sensor or completely dry, resulting in no water-level data for this period (fig. 11A). The water-level sensor was lowered in April 2021 by about 0.3 ft to better capture water-level changes in Offutt Ditch after smaller (less than 0.25 in.) runoff events (fig. 11A and 11B).

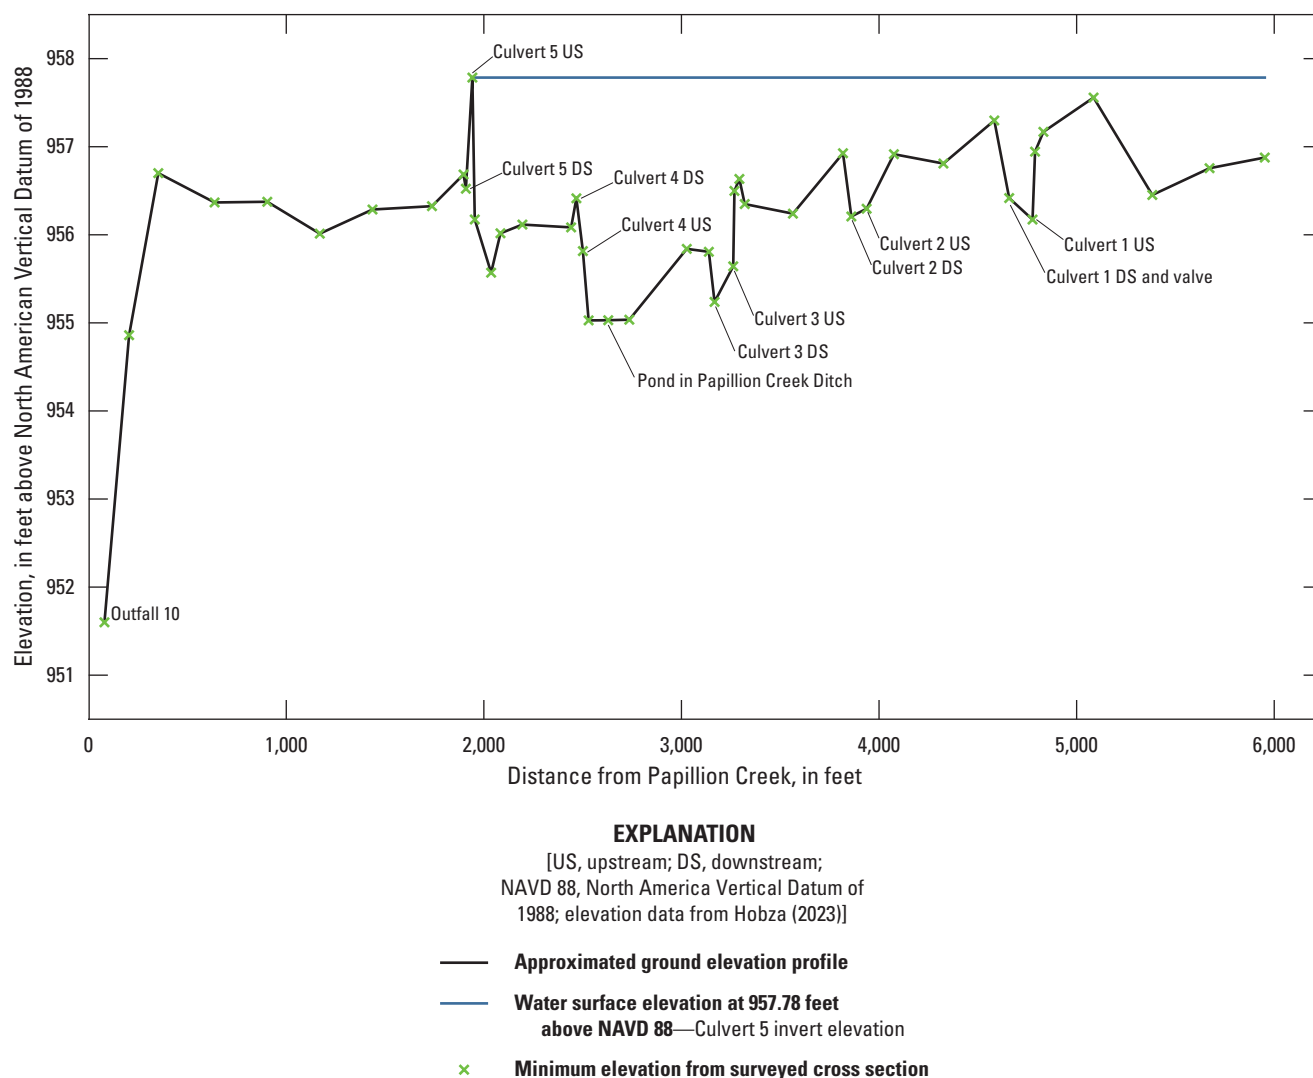
Figure 12. Approximated ground elevation profile and minimum elevations of surveyed cross sections for Papillion Creek Ditch on and near Offutt Air Force Base, Nebraska, December 2020.

last 5 percent (300 ft) of the distance along Papillion Creek Ditch (fig. 12). Culvert 4 and culvert 5 had inverted elevations (elevation of the bottom interior of the culvert) that were higher than the adjacent upstream reaches of Papillion Creek Ditch (fig. 12). High points in the elevation profile caused by elevation differences caused these culverts to act as small dams and resulted in ponded water.

channel; however, the channel profile shown in figure 12 indicates the depth of ponding is likely limited to 1.5 ft during dry periods.
