DEVELOPMENT AND EVALUATION OF BEST MANAGEMENT PRACTICES (BMPS) FOR HIGHWAY RUNOFF POLLUTION CONTROL

A THESIS

Major: Environmental Engineering

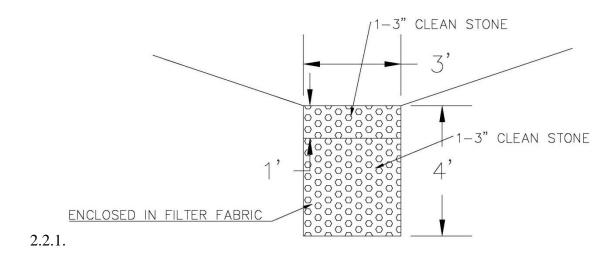
Figure 2.7 Infiltration trench cross section

The infiltration trench at the Salt Valley site is located in a drainage ditch with a 2.8 percent slope. The trench is 118 ft long, 3 ft wide and 4 ft deep. As shown in Figure 2.7, the trench was filled with 1-3 inch clean stone; the bottom and side walls were wrapped in Mirafi[®] 170N non-woven polypropylene geotextile filter fabric. The top of the filter fabric enclosure was placed 1ft below the surface keep any sediment in the upper foot of media. The WQV for the infiltration trench is calculated by multiplying the volume of the trench by the void ratio of the media (typically 0.4). The WQV treated by the infiltration trench was 566 ft³, which is 9 percent of the WQV for the watershed. The peak 10-year flow was 25.9 cfs, which was obtained by equation 2-3 and the methods explained in section

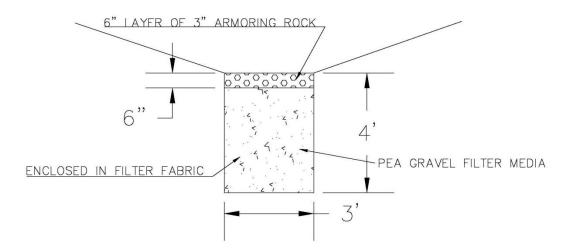
Figure 2.9 Cross section of filter trench

The total iterative process is to find the depth by guessing a manning's number and then calculating a new manning's number with the new average depth; three to four iterations should be sufficient for convergence. The final flow depth for the designed filter trench was 0.82 ft with a manning's number of 0.053 and a velocity of 4.69 ft/s by using 1-3'' clean rock as a flexible channel lining. Figure 2.9 is a cross section of the filter trench.

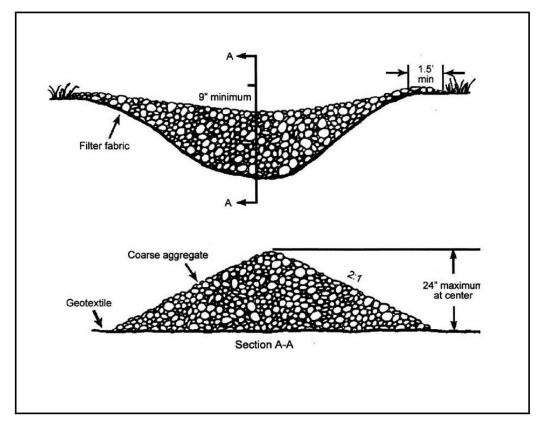
Figure 2.10 Typical riprap check dams cross and longitudinal sections (MPCA 2000)

If rock lining is not sufficient to mitigate flow velocities, rip-rap check dams may need to be installed also. The check dams designed for the filter trench were 1.5 ft in height with 2:1 slopes. The D_{50} of the rock media was 9 inches, and seven check dams were spaced equally along the trench about 35 ft apart. Due to cost and availability at the site for rip-rap, broken concrete and used concrete core samples were placed instead of rip-rap. Table 2.7 shows some typical spacing of rip-rap check dams. Figure 2.10 shows a typical cross section.

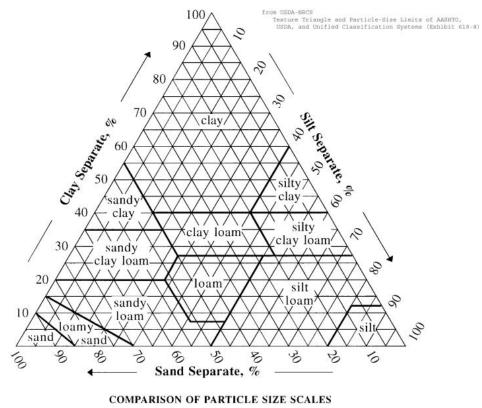
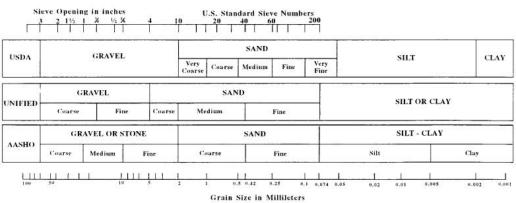
Figure 2.15 USDA-NRCS soil texture triangle

The soil texture classification at the I-street test site was Silt Loam (NRCS 2011) which was used in lab testing in chapter 3. Silt Loam has a content range of clay (0-25%), sand (0–50%), and silt (50–80%). A soil sample from the I street site was sent to Midwest Laboratories for a texture analysis, the results were a content of 24% clay, 20% sand and 56% silt. At the Salt Valley location the most predominant soils were Silty Clay and Silty Clay Loam (NRCS 2011). Silty Clay and Silty Clay Loam have a relatively wide content range of clay (25–60%), sand (0–20%), and silt (40–70%). Because soil texture classifications have content ranges, any calculations used in the design mixtures were assumed to have sand, silt and clay content equal to the area centroid of the NRCS-USDA soil texture classification triangle shown in Figure 2.15. The minimum infiltration rates for silt loam, silty clay, and silty clay loam are 0.15–0.30, 0-0.05, and 0-0.05 in/hr, respectively (Gupta 2008). Due to these moderate to low infiltration rates, if any native soil was used as media, it had to be supplemented to improve infiltration rates. Also, because of low infiltration rates of the native soil under drains had to be installed.

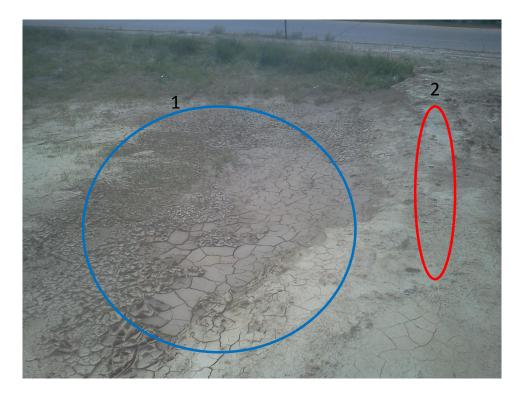
Figure 2.17 Check dam filter clogging

preventing sediment transport after BMP construction, b) how to quantify the sediment transport and their effects on BMPs, c) how to remove sediment once they clog the BMPs. For example, future projects can use photos or measurements to monitor the amount of sediment accumulation. A baseline measurement before any rain events is crucial in monitoring procedures. Depth of sediment can be measured and general area can be measured semi-quantitatively by photos.

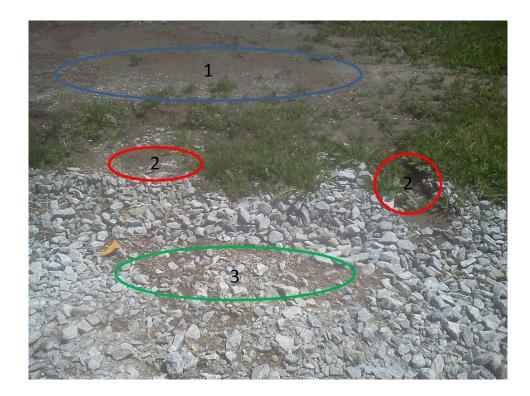
Figure 2.19 Infiltration trench clogging

The infiltration trench experienced very little sediment buildup. Initial buildup was from a small area of disturbed soil near the trench as indicated by the blue circle in Figure 2.19. The contributing watershed for the infiltration trench remained stable during and after construction otherwise. Some further buildup continued to occur from the area entering the trench at the red circles indicated in Figure 2.19. The sedimentation experienced on the infiltration trench did not prove detrimental to its operation because the general size of the sediment deposited on the trench was about a 5' by 3' area out of the total 118' by 3' area of the trench shown by the green circle in Figure 2.19. The sediment buildup experienced by the infiltration trench can be prevented by stabilizing this area with erosion control blanketing and establishing permanent vegetation. Temporary erosion control can be done by placing silt fencing along the trench.

Monitoring of the clogging of infiltration trenches can be done semi-quantitatively by photos or by measuring the depth and areas of sediment deposits. One method attempted was to bury an aggregate filled bucket in the top section of trench in hopes of catching sediment then removing the bucket and analyzing the amount of sediment captured (see Appendix B for photo). It was unsuccessfully because of little rain events in this study.

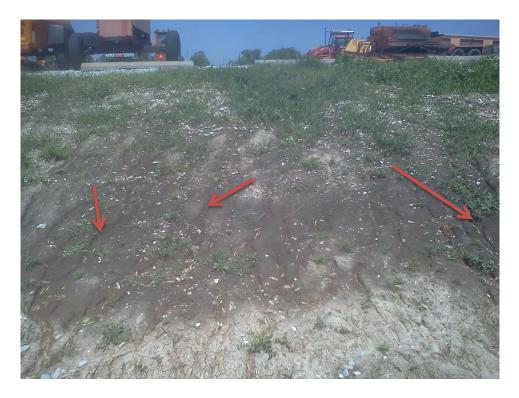
Figure 2.20 Filter trench side slope rills

The filter trench experienced high amounts of clogging from the ditch side slopes Figure 2.20. The side slopes of the 250' long disturbed site were 3:1 and were not covered with erosion control blanketing and were not stabilized during construction. During construction, rain events occurred with enough precipitation to cause riling on the side slopes (Figure 2.20). This side slope erosion could have been prevented with erosion control blanketing or silt fencing installed along the bottom of the slope. Because no baseline measurement was taken, accurate monitoring of these rills was not accomplished. In the future, monitoring of rills can be done by counting the number of rills and measuring their size and length to get a volume of soil eroded, which can also linked with rain events if such measurements are done before and after the rain events.

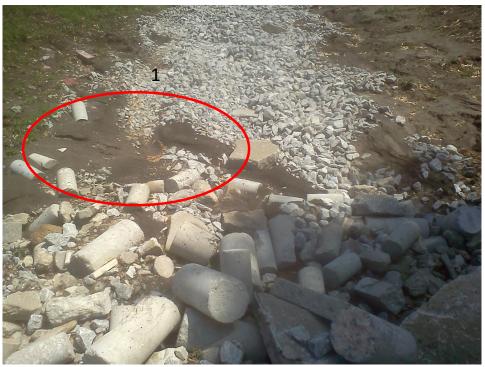
Figure 2.21 Filter trench sediment buildup on armoring and check dams

The check dams installed on the filter trench caught some of this sediment, and so did the armoring (Figure 2.21). To prevent the buildup of sediment on the BMP, material erosion control must be done as soon as possible on any disturbed soil area within the watershed of the BMP. Just like in the monitoring of the rill erosion sediment, deposition can be monitored with measuring the depth and area of the deposits. This was impracticable for this study because a majority of the trench was clogged. Monitoring of the deposits can also be done semi-quantitatively with photo logging to acquire a general surface area of the deposit.

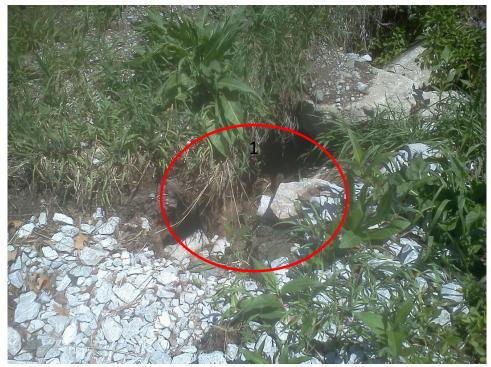
Figure 2.23 Filter trench undermining at beginning of trench

Some problems arouse related to the structural integrating of the filter trenches setup. Undermining occurred at the beginning of the trench, creating a hole as shown in Figure 2.23. This problem was mitigated by adding more rock material up to the top of the ditch as shown in the blue circle where the hole was located at the bottom of the blue circle Figure 2.24. The knowledge gained from this situation is that the armoring needs to extend above the beginning of the trench or the trench needs to start at the pipe outlet to the ditch. Undermining also occurred at a couple spots along the trench as shown in Figure 2.25. This is thought to be from higher than expected flow velocities within the pea gravel filter media eroding the sides of the underground trench. This could be fixed by filling the hole with 1-3 inch rock or in the design of the trench by using smaller treatment media to slow the filter flow rate.

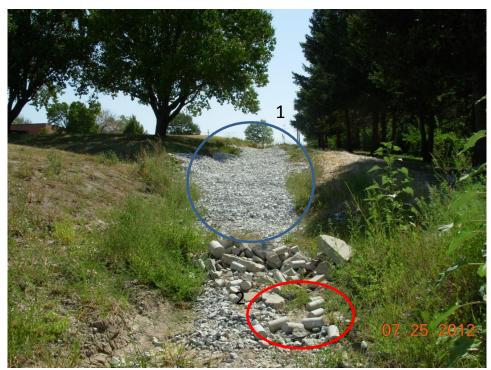
Figure 2.24 Filter trench added 1-3 inch rock at beginning and check dam material migration (water flow direction: from the top to bottom of the picture)

Flows in the ditch were high because evidence shows that some of the check dam material (used concrete core samples) was being washed or moved down slope (shown in the red circle in Figure 2.24). This is a good example that concrete debris (i.e. used core samples and broken concrete) is not useful as rip rap because the shape of the concrete debris is not irregular or interlocking like rock brought in from a quarry. The force of water can move this concrete debris more easily.

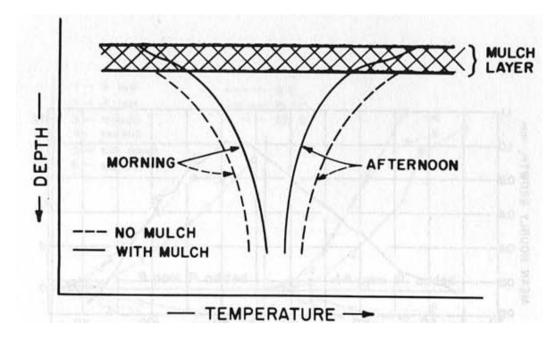
Figure 2.26 Expected soil temperature profiles with and without mulch (Willis and Power 2012)

All of these mixtures may have too high infiltration rates to support excellent plant growth. This is only speculation because no substantial rain events occurred during testing. Soil temperature has an influence on plant growth and any kind of mulch on the soil's surface influences soil temperatures as shown by the solid and dotted line in Figure 2.26 (Willis and Power 2012). Mulch can keep the soil cooler in the morning hours and hold the heat from the day longer into the evening helping plant growth as well as contributing moisture holding capacity and nutrients. Soil temperatures at or above 110°F to 125°F can kill weed seeds and plant seeds (Stapleton 2008). Mulch and other heat holding materials in to high of content percentages can also hurt root growth by raising soil temperatures to high from absorbing the suns heat.

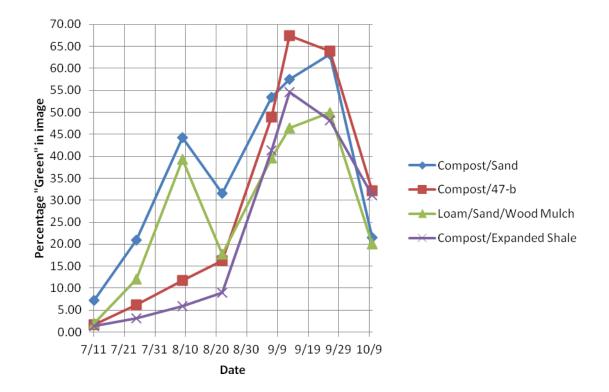
Figure 2.29 Percent of image that is green from Image J analysis

The dip (after 8/20) on Figure 2.29 is due to the cutting of weeds by the NDOR maintenance group between measurement dates, which lowered the green in the image although only weeds were removed. Some example images of percent plant growth from

testing and the control check image can be found in Appendix B (Figs. B.14–B18). The effect of removing the weeds on the amount of green vegetation in the images is one of the drawbacks to using image analysis for plant growth. The use of this image analysis is indiscriminant on what in the image is green weather it is grass, weed, or a piece of green litter. One problem that occurred in image analysis is that some creeping ground cover grew on the edges of the compost expanded shale test cells contributing to the green amount although the plant roots were not necessarily in the test cell but the plant cover was. Another aspect of this image analysis to comment on is that the green in the image was specified by a hue of 47–100 (Patton et al. 2005). This hue can be adjusted slightly to adjust what the user considers green. The benefit of a hue range is that dead plant growth or deleterious brown material is not counted and only good quality growth is. What outweighs the drawbacks of image analysis is that it is unbiased measurement compared to some traditional methods and a large area can be tested at once instead of random test plotting. The extreme slump in the last week (10/9) is explained by shadows because the images were taken in the dawn hours, indicating that light conditions may affect image analysis from shadows (Karcher and Richardson 2003).

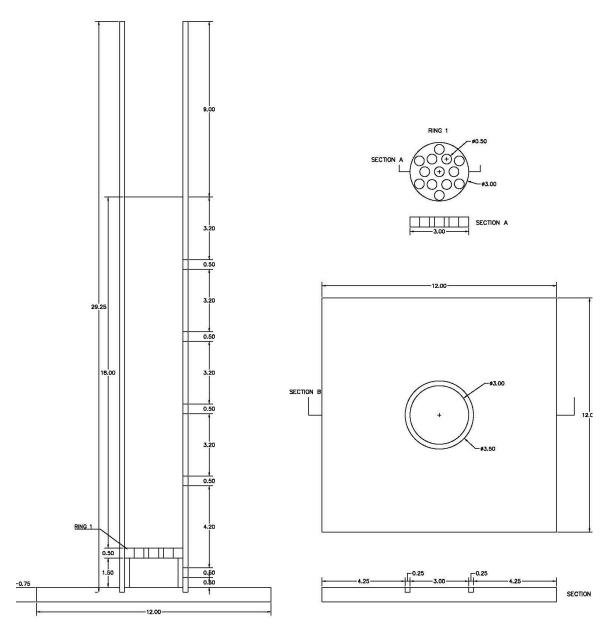
Figure 3.1 Reactor plans

Column reactors. The reactor columns were made with 3-inch diameter PVC pipe. The total height of the columns was 29 inches, 9 inches for ponding depth, 18 inches of media, and 2 inches of free drain space at the bottom. Sampling ports, effluent ports, and an overflow were located along the side of the column (Figure 3.1).

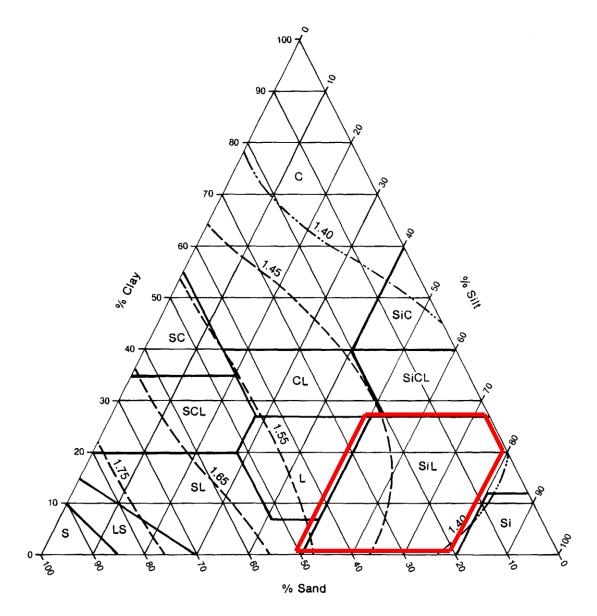
Figure 3.2 Growth-limiting bulk density textural triangle (Daddow and Warrington 1983).

Figure 3.2 is used to find the growth limiting bulk density by first locating the soils percent sand, silt, and clay on the figure and finding or interpolating its growth limiting bulk density value. For example, the silty loam used in testing was 20 percent sand, 56 percent silt and 24 percent clay. The textural point is located on the 1.45 g/cm³ isodensity line. So the growth limiting bulk density of this soil is 1.45 g/cm³.

*Only applicable on soils with less than 3 percent organic matter, less than 10 percent coarse fragments. For silty loam (SiL), the growth-limiting bulk density is about 1.40 to 1.50.

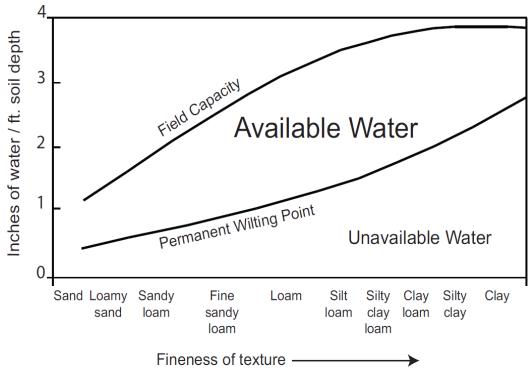
Figure 3.3 General relationship between soil moisture and texture (USDA 2008)

The addition of compost or other types of organic matter is important for plant growth and field capacity. For silt loam with rubber column (SLR) media, the field capacity measured was 19.77 percent or 2.37 inches of water per foot of soil, and the permanent wilting point measured was 13.32 or 1.6 inches of water per foot of soil, which are lower and higher than those shown in figure 3.3, respectively. The rubber chips added to the silty loam narrowed the range between the field capacity and permanent wilting point, decreasing the available moisture percentage. Therefore, the rubber chips did not add any moisture benefits to the media as expressed in the silty loam sample. The best media, based on moisture characteristics, were the compost rubber mixture followed by the silty loam rubber mixture. The available moisture of rubber and the sand rubber mixtures were around 6 times lower than the silty loam rubber or compost rubber mixtures. The result of the compost rubber mixture having the best moisture characteristics shows the benefits of amending soil media with compost.

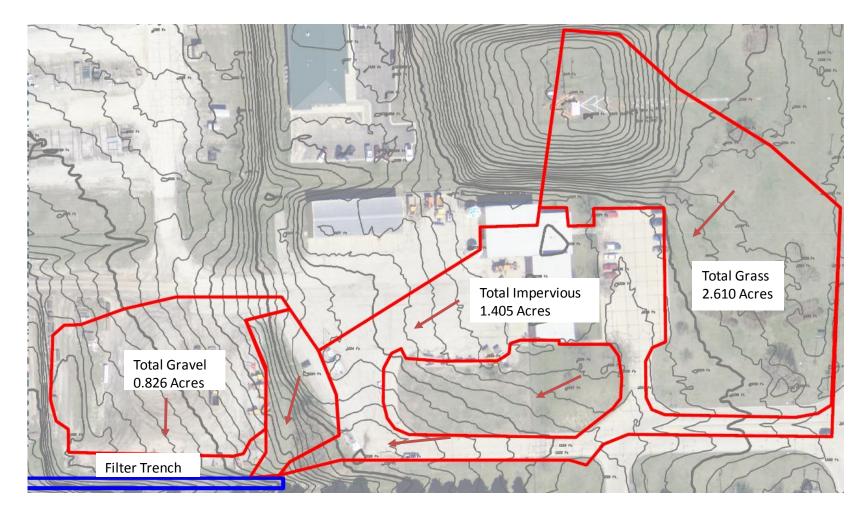
Figure A.1 Filter trench example watershed

concentration. The peak flow-rates are calculated for each sub-basin then added together. The rational method coefficients used in this example are 0.95 for impervious areas, 0.35 for grass areas, and 0.45 for gravel areas. The time of concentration was found using equation 2-4 for the most hydraulically remote sub-basin and is 6.5 minutes. From Figure 2.4 the rainfall intensity to be used in the rational method equation is 8 in/hr based on the time of concentration of 6.5 minutes. From equation 2-3 the peak flows for each sub basin are 10.68 cfs, 7.31cfs, and 2.97 cfs from the impervious, grass and gravel areas, respectively. The total flow-rate for the watershed is 20.96 cfs.
