Phase I Development of an Aesthetic, Precast Concrete Bridge Rail

Report TRP-03-239-12
SPR-P1(07) P596

Final Report

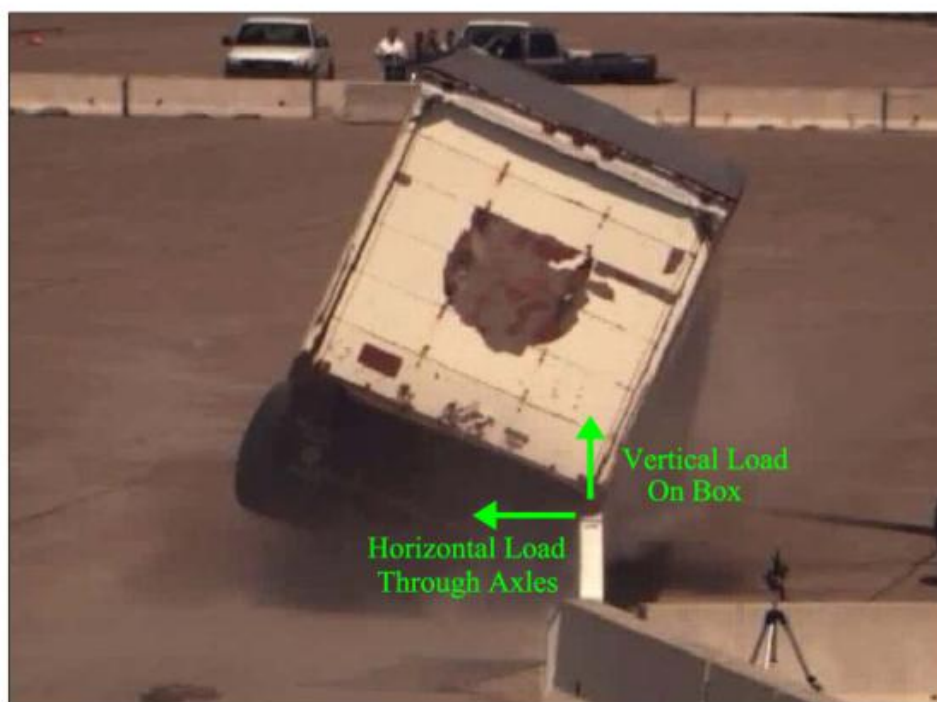
Figure 3.3 Barrier Forces Acting on Single-Unit Truck During Impact

shorter barriers during impact events. For example, the MASH 10000S single-unit truck (SUT) has a ballast center of gravity (c.g.) height of 63 in. (1,600 mm). Thus, these heavier and taller vehicles, such as single-unit trucks, are redirected and prevented from rolling over the top of rigid barriers due to a combination of a vertical barrier load being applied to the outer underside of the cargo box and a lateral barrier resistance imparted to the wheels and axle assemblies, as shown in Figure 3.3.

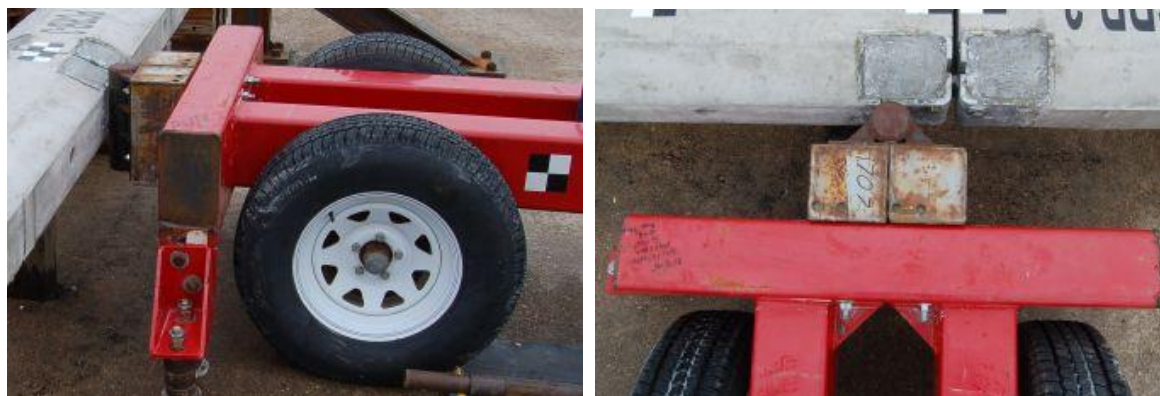
Figure 8.1 Bogie Impact Head with Steel Tube Blockouts

The same bogie vehicle from the first round of bogie testing was used during the second round of testing. However, the wooden blockouts used to offset the bogie head from the vehicle frame were damaged during test no. PCRB-2. As such, steel tubes were used instead of wooden blockouts to provide a more robust bogie head. These steel tubes were filled with concrete and capped with a steel plate, as shown in Figure . The weight of the bogie with the addition of concrete filled steel tubes to the impact head was 1,707 lbs (774 kg).
