Nebraska's Modified-Open-Front Farrowing Houses Design and Operation

Gerald R. Bodman, Donald G. Levis, Duane E. Reese

ABSTRACT

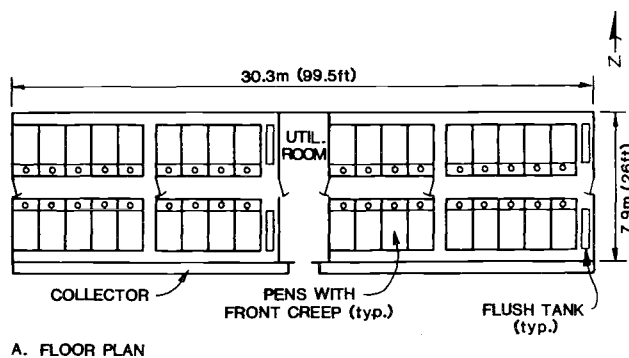
A. FLOOR PLAN

B. PARTIAL SECTION

Fig. 1—Paus solar heated modified-open-front 36-sow farrowing house.

The first unit is on the farm of Art and Doug Paus, Fairfield, NE (40° 24' N, 98° 11' W) who operate a 150-sow enterprise. The MOF farrowing facility consists of two 18-sow rooms in a 7.9 × 30.3 m (26 × 99.5 ft) building (Fig. 1). The 18-sow capacity was selected to match the size of sow groups. The two farrowing rooms are separated by a central service/utility room housing collector fans, electrical service, hot water heater, medication storage, on-site records, etc. Each of the two rooms is further divided by a partial partition—continuous from the north alley to the south alley—to reduce longitudinal airflow and associated drafts in the pig zone, thus forming one 8-sow and one 10-sow space. Each 18-sow room is operated independently, including heating, ventilation, manure handling and "all in/all out" movement of sows and litters. Each room is used for eight to nine farrowings per

Ventilation is provided by openable windows and a slot outlet on the south wall and openable panels on the north wall (Fig.1). The translucent passive solar/ventilation panels consist of three 1.2×0.6 m (4×2 ft) sections per 1.2×1.8 m (4×6 ft) unit. The bottom two sections slide up past the top section to provide a variable opening up to 1.2 m (4 ft) the length of the building. An external non-breathing flexible curtain can be lowered to reduce infiltration during windy conditions, reduce conductive heat loss during cold weather or provide partial shading for the south row of pens. A continuous and adjustable 7.6 cm (3 in.) high air outlet slot is located at the top of the south wall. The north wall is fitted with a continuous row of 0.6 m (2 ft) high insulated vent doors. All ventilation system openings and components are manually adjusted. Drip coolers are used to enhance sow comfort during hot weather.

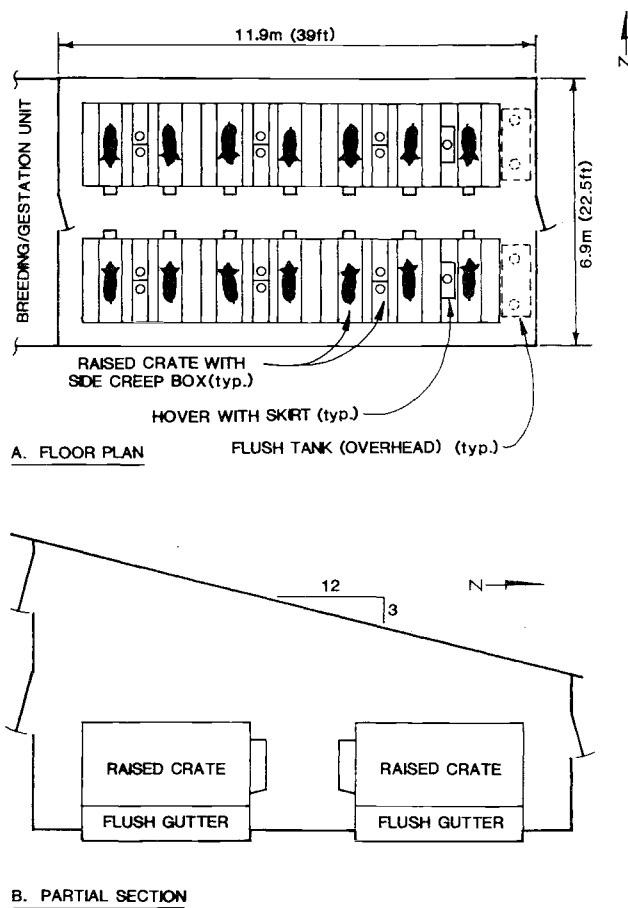
Fig. 4—Burkey 14-sow modified-open-front farrowing house.

Ventilation is provided through two continuous rows of insulated 0.6 m (2 ft) high panels along the south wall and a 0.6 m (2 ft) high row of insulated panels along the north wall (Fig. 4). Each row of panels is operated as two separate openings. Vent panel adjustment is by
