Crash-Tested Bridge Railings for Timber Bridges

In: Proceedings of 4th International bridge engineering conference; 1995 August 28–30; San Francisco, CA. Washington, DC: National Academy Press: 395-404; 1995. Vol. 2.

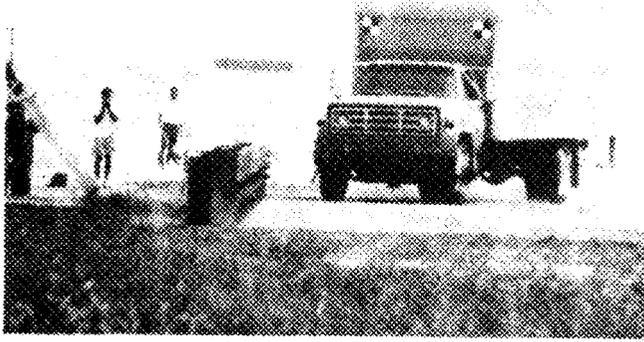
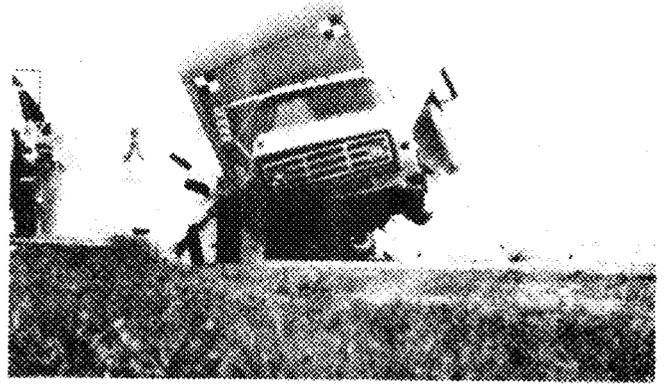
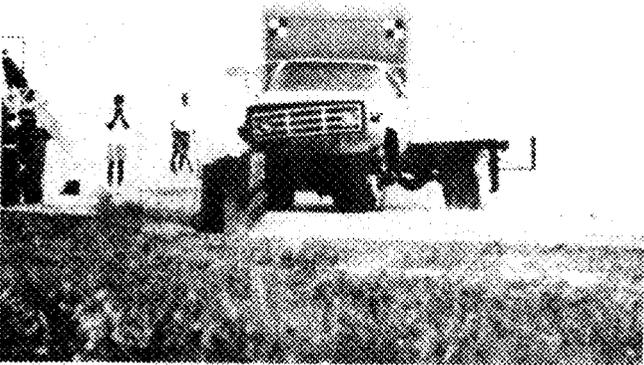
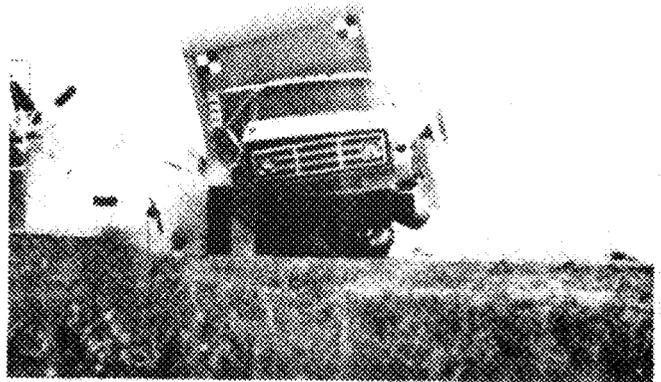
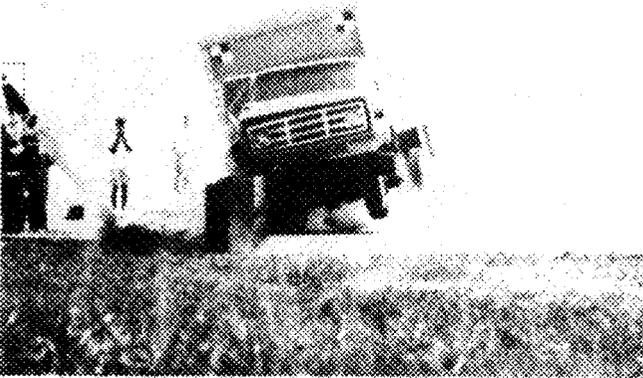
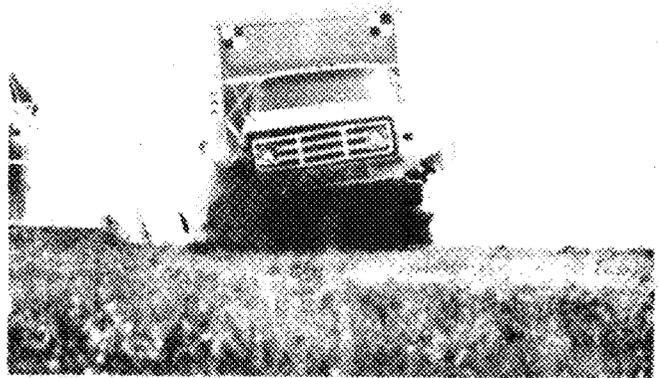
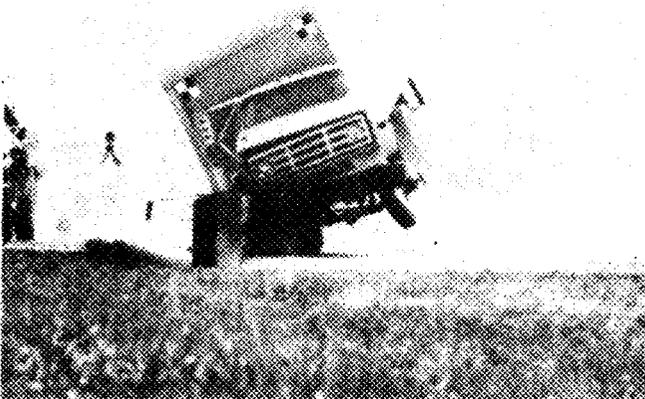
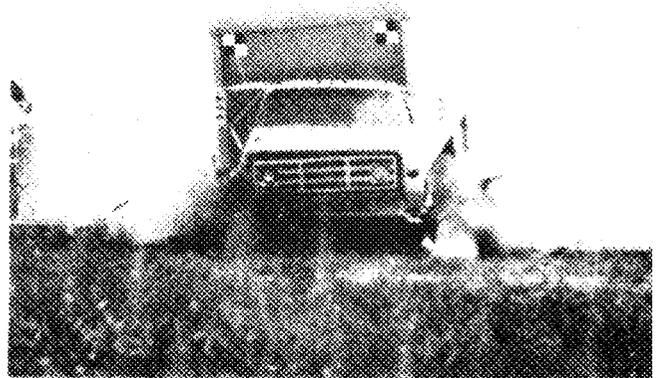
FIGURE 1 Crash-test sequence for 8172-kg (18,000-lb) truck traveling at 80.5 km/hr (50 mph), hitting railing at 15-degree angle to longitudinal railing axis.

Vehicle propulsion and guidance were provided by steel cable configurations. For propulsion, a reverse cable tow with a 1:2 mechanical advantage was used. A cable was attached to the front of the vehicle, routed through a series of pulleys, and connected to a tow vehicle that traveled in a direction opposite to the test vehicle. The unoccupied test vehicle was then pulled by the tow vehicle and released from the tow cable approximately 9.2 m (30 ft) before impact. A vehicle guidance system developed by Hinch was used to steer the test vehicle (9). Using this system, the left front wheel hub is attached to a tensioned steel cable that maintains the vehicle's direction along a designated straight path. Approximately 9.2 m (30 ft) from impact, the guidance connection is sheared off and the vehicle separates from the guidance cable. A crash-test sequence for an 8172-kg (18,000-lb) vehicle is shown in Figure 1.
