## Technical Brief 18: Protecting Archeological Sites on Eroding Shorelines: A Hay Bales Approach protecting Archeological Sites on Eroding Shorelines: A Hay Bales Approach

## Technical Brief 18: Protecting Archeological Sites on Eroding Shorelines: A Hay Bales Approach

Robert M. Thorne, Pickering Environmental Consultants, Inc., Jackson, MS

Published by the DOI Departmental Consulting Archeologist/NPS Archeology Program, National Park Service, Washington, DC, July 2004.

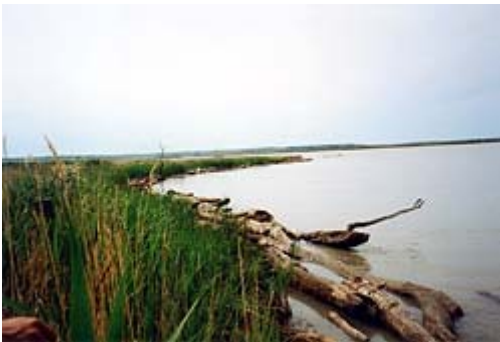
**Figure 1.** An Army Corps (WES) stabilization project using logs cabled in place and revegetation planted on bankline. Lake Sharpe, South Dakota, June 1994.

The revegetation effort at the lake—designed and directed by Hollis Allen—had already proved successful, alone and in combination with driftwood trees (Figure 1). The use of bales, which was untried previously, also proved effective. But the test setting—a relatively well protected bank sloping gently to the water’s edge—was not representative of conditions at Lake Sharpe (Figure 2). The revegetation techniques were common (e.g., Thorne 1990); their efficiency was really never in doubt. The primary purpose was to test the bales in actual conditions.

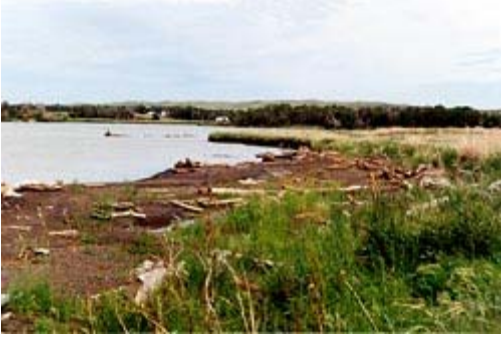
**Figure 2. A beach development zone behind hay bales put in place in 1991.** Lake Sharpe, South Dakota, June, 1994.

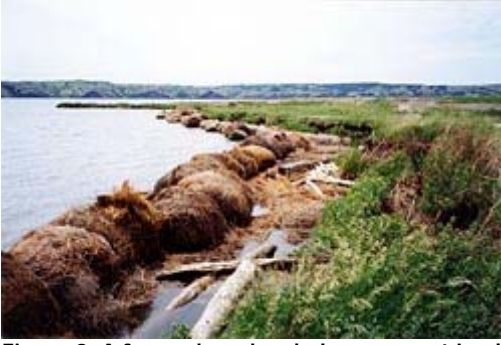
**Figure 3. A farm where hay bales were put in place Sept/Oct of 1993. Note the height of the vertical cutbanks in the background, which are common to the entire lake. Lake Sharpe, South Dakota, June, 1994.**

Most of the bales at Lake Sharpe were placed slightly opposite vertical banks, up to six feet high (Figure 3). Because of the near constant water level—and the lack of ebb and flow—there were few beaches to use as staging areas. Initially, the bales were lifted from the top of the banks by a crane or a dragline fitted with a clamshell bucket or specially designed clamp (Figure 4).

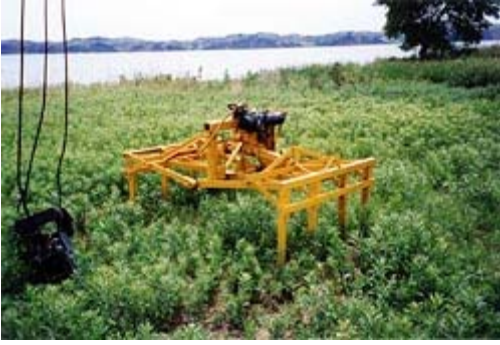
**Figure 4. Commercially manufactured hay bale tongs for a crane. Were these actually attached to a crane, they would be hydraulically operated from inside the cab.** Lake Sharpe, South Dakota, June, 1994.

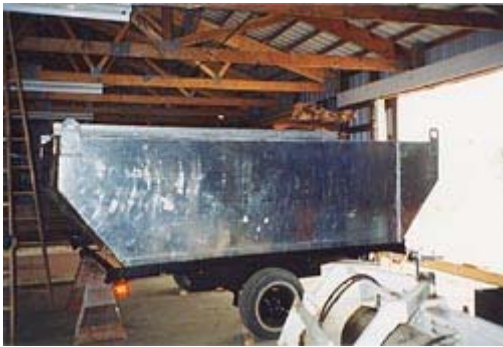
**Figure 5. An Army Corps "shop built" barge for use with an airboat to place bales.** Lake Sharpe, South Dakota, June, 1994.

For the Lake Sharpe project, a barge was designed to place bales in areas not accessible from the bank. This small, light, shallow-draft vessel, which was transported easily by trailer, also could be pushed or towed by boats with small motors (Figure 5). People wading alongside maneuvered it into position; a hydraulic lift dumped the bale in front of the vessel.

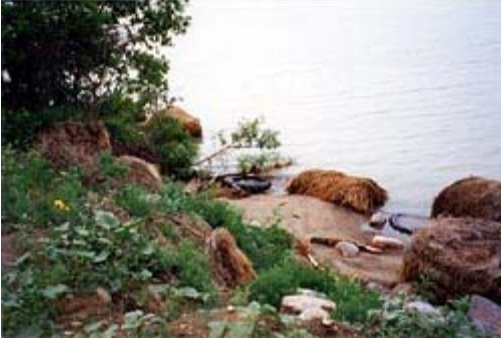
**Figure 6. A stabilization at the Fort George Game & Fish Commission (with no Army Corps involvement) attempted to use tractor tires and hay bales. Note the sand buildup behind the center bale. Lake Sharpe, South Dakota, June, 1994.**

As is the case with all stabilization techniques (Figure 6), no one approach is appropriate for every setting. This technique was not suited to the entire shoreline; in some places the bank was too high, in others the water too deep. Normally, the harsh environment may have disqualified this approach. In this case, however, it provided an excellent testing ground for developing and refining the technique. Winter temperatures are well below freezing, and the lake freezes to a depth of over three feet. This is not particularly destructive in and of itself, but during spring strong winds drive broken pieces of ice into the bales. At the least they could be pushed out of alignment; at the worst destroyed.

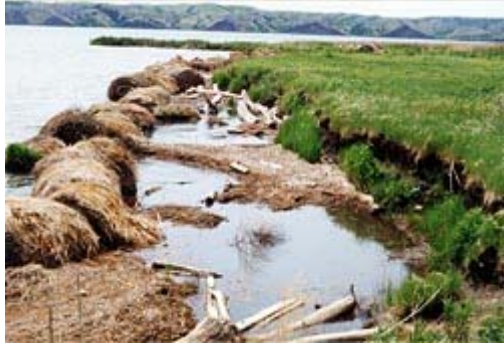
**Figure 7. A south-by-southwest view of the farm.** Lake Sharpe, South Dakota, June, 1994.

There have been no complaints that the barriers are unsightly, nor have any been vandalized. Less than a year later, fish were spawning in the basins; a mallard and her hatchlings were using one as a refuge (Figure 7). Even though some slumping continued, grass was growing in large patches. The benefit to the environment cannot be overemphasized.
