TRASH AND WATER: MANAGING ON-AIRPORT WILDLIFE ATTRACTANTS AT PAINE FIELD, WASHINGTON

Stevens, Matthew R.; Schafer, Laurence M.; and Washburn, Brian E., "TRASH AND WATER: MANAGING ON-AIRPORT WILDLIFE ATTRACTANTS AT PAINE FIELD, WASHINGTON" (2005). *2005 Bird Strike Committee-USA/Canada 7th Annual Meeting, Vancouver, BC*. 9.

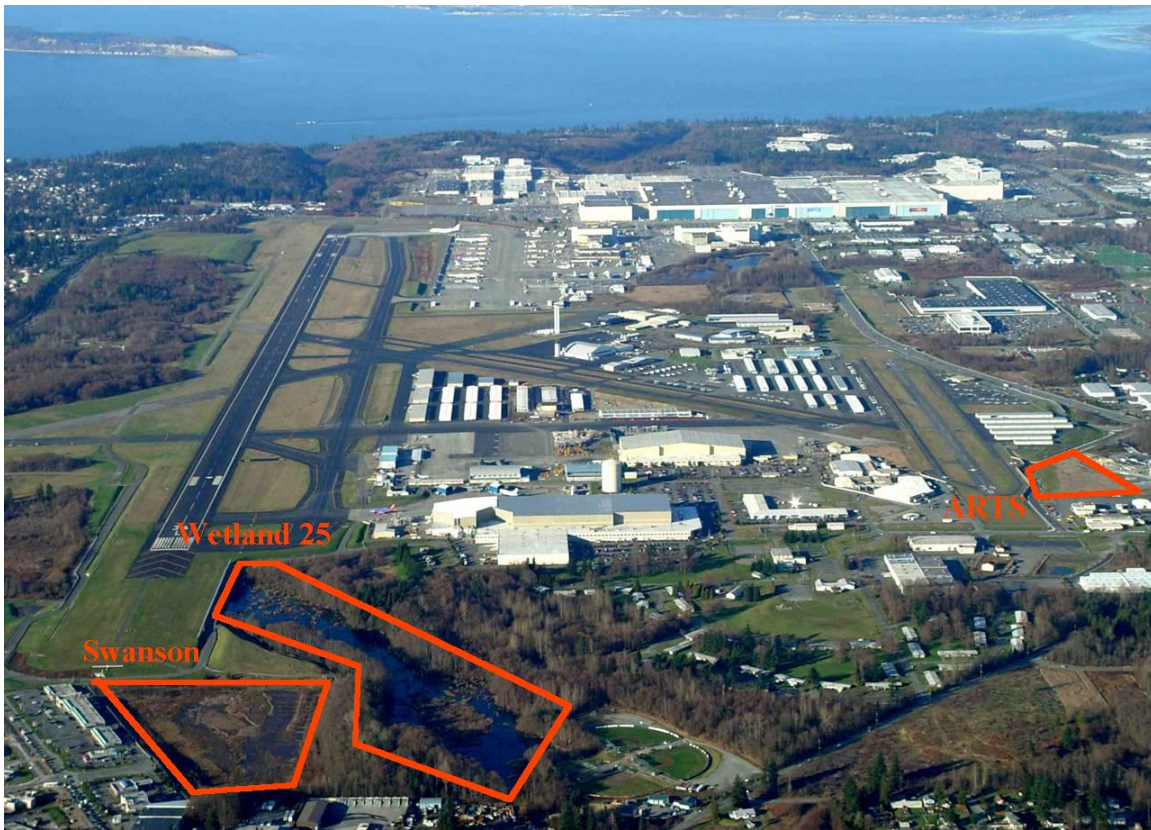
Figure 1. Locations of Swanson Wetland, Wetland 25, and ARTS at Paine Field, Washington.

Paine Field addresses many unique wildlife hazard issues, two of which include a man-made wetland/storm-water pond (hereafter referred to as Swanson wetland) and the Airport Road Recycling and Transfer Station (ARTS; Figure 1).

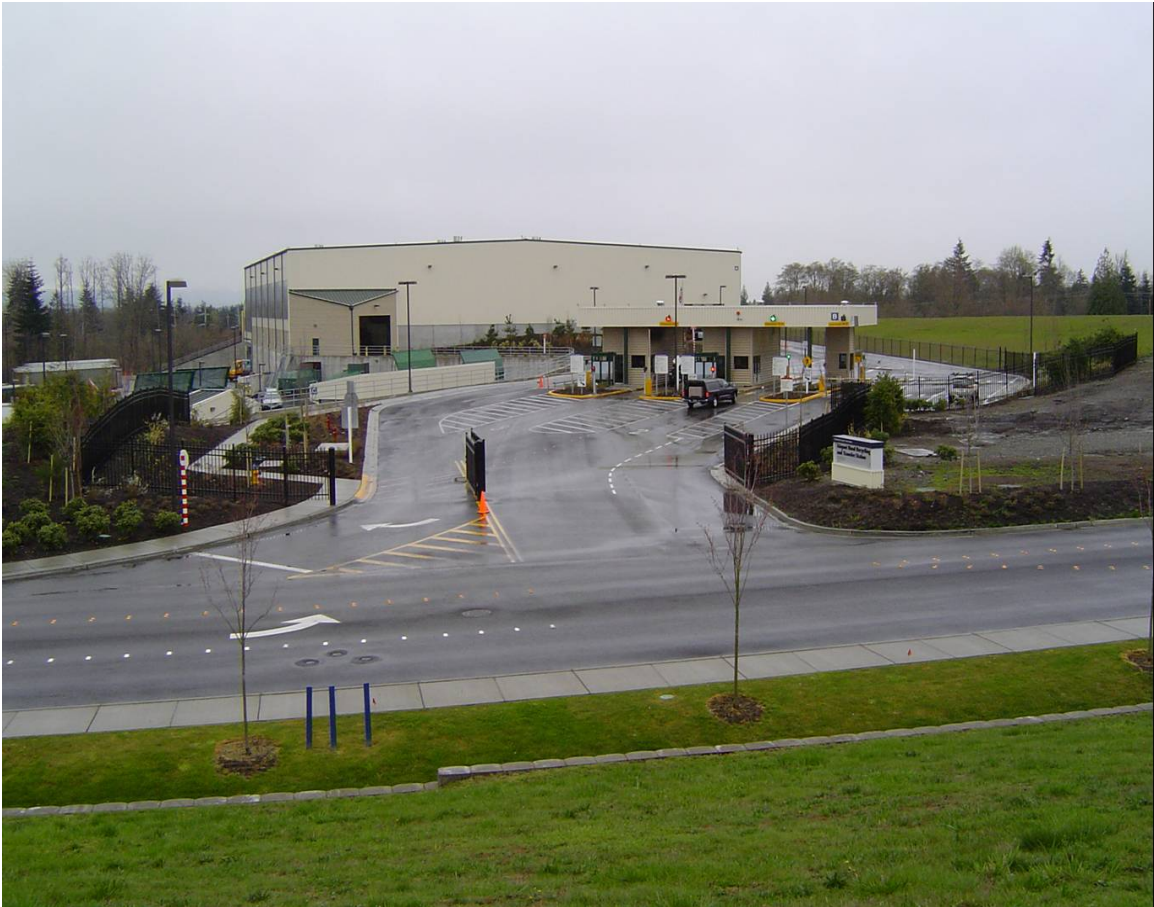
Figure 2. Photograph of the newly constructed and operational Airport Road Transfer Station at Paine Field, Washington.

The ARTS facility is fully enclosed, accommodates the disposal of household refuse and recycling, and the entire site encompasses approximately 4-ha (Figure 2). Construction of the ARTS facility began in August of 2001 and concluded in September of 2003; the facility became operational in October of 2003. Extensive monitoring of the ARTS site was conducted prior to, during construction, and since ARTS has been in operation to determine if wildlife hazardous to aviation are being attracted to the site.

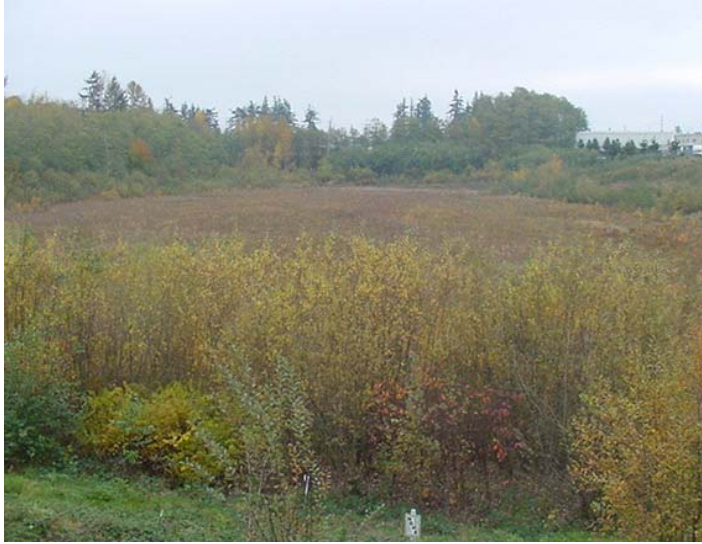
Figure 3. Photo of Swanson Wetland in November 2004, at Paine Field, Washington.

wetland with a dense, vegetative canopy so waterfowl would not be attracted to large expanses of open water (Figure 3). Approximately 41,500 plants of 34 different species were installed, including but not limited to: willow, dogwood, twinberry, ninebark, rose, salmonberry, spirea, and snowberry. These plants were 1- or 2-gallon in size and spaced 3' to 5' on center. After construction concluded in the fall of 1999, it was quickly determined that the wetland was improperly graded, leaving deep, open water that could attract waterfowl and did not comply with initial design. As a result, much of the installed vegetation either died or did not establish due to poor site conditions. In the winter of 2001 major revisions of the site took place, including:

- Grading of the higher elevation areas and re-grading of the outlet channel to allow for proper drainage.
- Back-filling of the water-inundated areas so water depth would not exceed 18 inches.
- Re-planting approximately 32,000 plants including, but not limited to: willow stakes and 1- or 2-gallon spirea, rose, salmonberry, twinberry, and cottonwood. All plants were spaced 3' to 5' on center.
- Adding a manually controlled spill valve in the outflow channel that could be opened if water depth exceeded 18 inches.

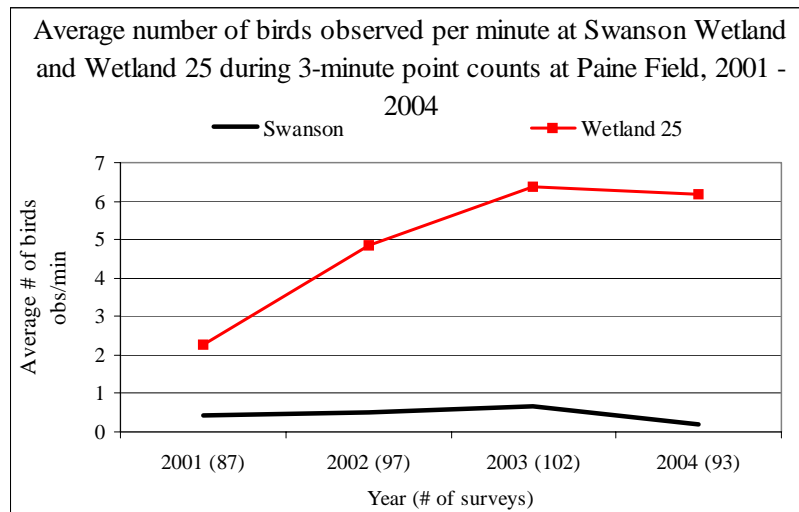
In 2001, before major revisions to the site transpired, 0.4 birds/min were observed using the Swanson site (Figure 4). During 2002 and 2003, when shrubby vegetation was minimal but present, 0.5 and 0.7 birds/min were observed, respectively. Birds using the Swanson wetland during these 2 years were predominantly ducks

Figure 4. Average number of birds observed per minute at Swanson Wetland and Wetland 25 during 3-minute point counts at Paine Field, 2001 - 2004

and some red-winged blackbirds. In 2004, following the establishment of a mature vegetation stand, bird use declined to 0.2 birds/min (annual total of 46 red-winged blackbirds, 3 ducks, and 2 Canada geese).

Waterfowl (ducks and geese) use of Swanson during 2004 (0.02 to 0.03 birds/min) was 94% less than during 2001. Also noteworthy was that as waterfowl use decreased at Swanson from 2001 to 2004, waterfowl use increased by 174% on an adjacent pond¹ with larger areas of open water (Figure 5).

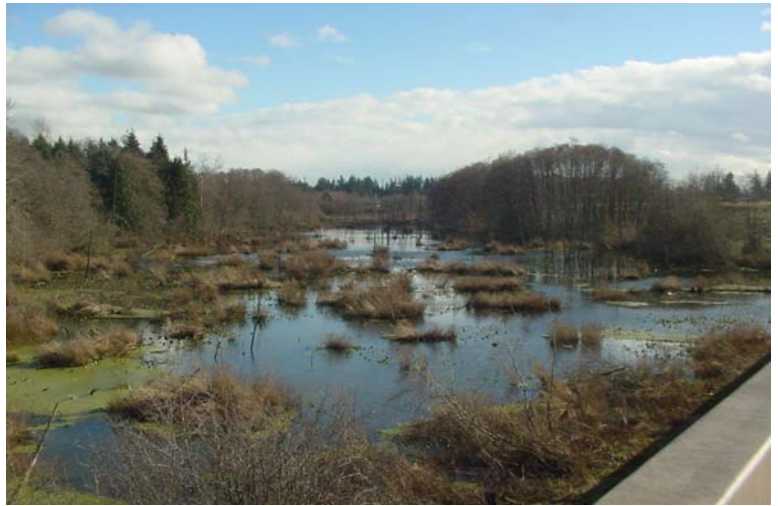
Figure 5. Photograph of Wetland 25 (adjacent to Swanson wetland), taken during February 2002, at Paine Field, Washington.

¹ The adjacent pond is referred to as Wetland 25. This 19-acre, naturally occurring pond is adjacent to Swanson wetland, but not directly under the approach/departure pattern of runway 16R-34L.

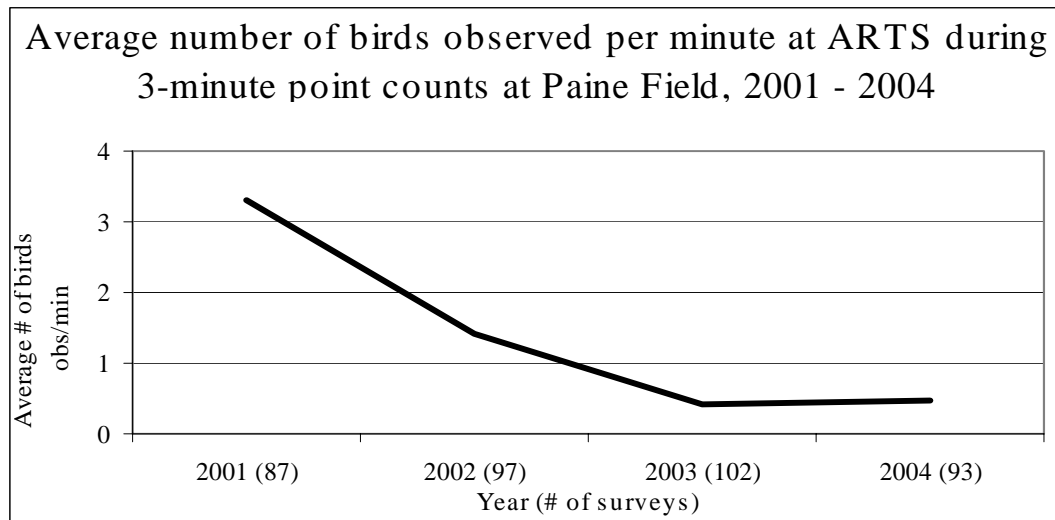
Prior to the development of ARTS, the site was an undeveloped grass field. During 2001, we observed 3.3 birds/min., consisting mostly of blackbirds (2.8 birds/min) and killdeer/swallows (0.5 birds/min; Figure 6). Following the construction of ARTS and during its first year of operation (2004), bird use of the ARTS (0.5 birds/min) was 86% lower than when the site was an undeveloped grassland (2001). Twelve American crows, thirty-three blackbirds, forty-one Canada geese, twenty-six killdeer, two red-tailed hawks, and twenty barn swallows were observed at ARTS during 2004. Ninety-two of the observations were related to feeding activity associated with short grass landscapes, whereas the other forty-two observations were either loafing or flying. No observations of bird feeding on refuse or debris were recorded.

Figure 6. Average number of birds observed per minute at ARTS during 3-minute point counts at Paine Field, 2001 - 2004.
