March 2002

# Planning Biotechnical Streambank Protection

## Planning Biotechnical Streambank Protection

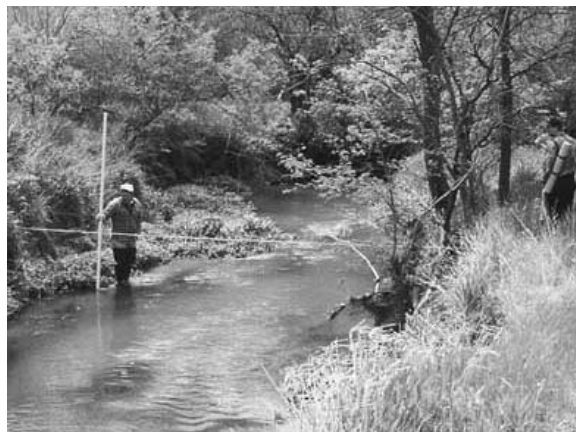
Measuring stream dimensions helps to understand the stream's dynamics.
