# Nebraska's Modified-Open-Front Farrowing Houses Design and Operation

Gerald R. Bodman

Gerald R. Bodman, Donald G. Levis, Duane E. Reese

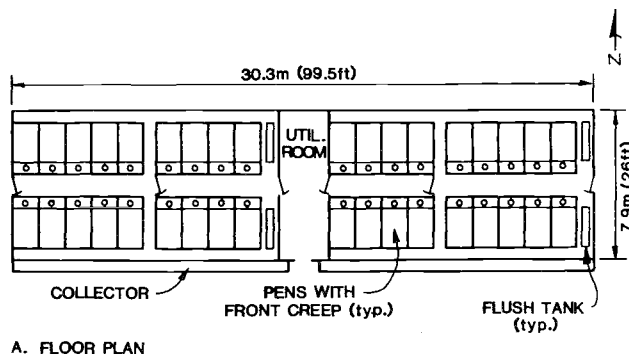
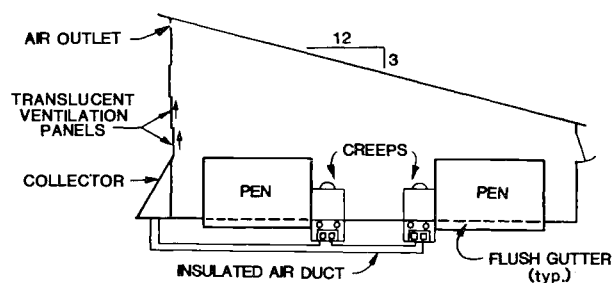
A. FLOOR PLAN

B. PARTIAL SECTION

Fig. 1—Paus solar heated modified-open-front 36-sow farrowing house.

The first unit is on the farm of Art and Doug Paus, Fairfield, NE (40° 24' N, 98° 11' W) who operate a 150-sow enterprise. The MOF farrowing facility consists of two 18-sow rooms in a 7.9 × 30.3 m (26 × 99.5 ft) building (Fig. 1). The 18-sow capacity was selected to match the size of sow groups. The two farrowing rooms are separated by a central service/utility room housing collector fans, electrical service, hot water heater, medication storage, on-site records, etc. Each of the two rooms is further divided by a partial partition—continuous from the north alley to the south alley—to reduce longitudinal airflow and associated drafts in the pig zone, thus forming one 8-sow and one 10-sow space. Each 18-sow room is operated independently, including heating, ventilation, manure handling and "all in/all out" movement of sows and litters. Each room is used for eight to nine farrowings per

Ventilation is provided by openable windows and a slot outlet on the south wall and openable panels on the north wall (Fig.1). The translucent passive solar/ventilation panels consist of three  $1.2 \times 0.6$  m ( $4 \times 2$  ft) sections per  $1.2 \times 1.8$  m ( $4 \times 6$  ft) unit. The bottom two sections slide up past the top section to provide a variable opening up to 1.2 m (4 ft) the length of the building. An external non-breathing flexible curtain can be lowered to reduce infiltration during windy conditions, reduce conductive heat loss during cold weather or provide partial shading for the south row of pens. A continuous and adjustable 7.6 cm (3 in.) high air outlet slot is located at the top of the south wall. The north wall is fitted with a continuous row of 0.6 m (2 ft) high insulated vent doors. All ventilation system openings and components are manually adjusted. Drip coolers are used to enhance sow comfort during hot weather.

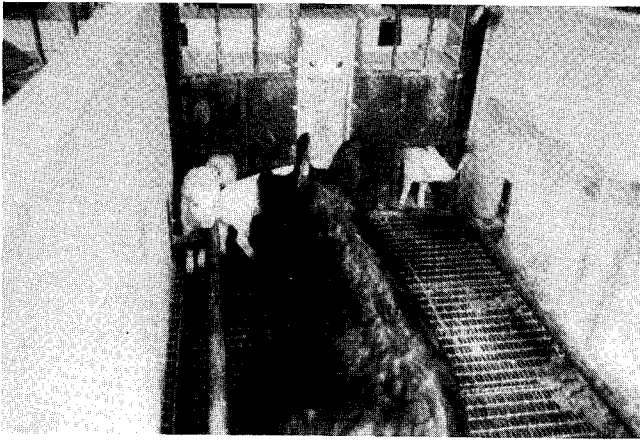
Fig. 2—The farrowing/lactation pens in the Paus unit feature woven mesh floors, concrete partitions, pipe guard rails and creep boxes in front of the pens for the pigs.

Sows are kept in 1.3 × 2.1 m (50 in. × 7 ft) pens with 10 cm (4 in.) concrete partitions, "open" vertical metal rod front and rear gates, woven wire floors, 5 cm (2 in.) pipe guard rails on three sides, and a 1.3 × 0.6 × 0.6 m (50 × 24 × 24 in.) front creep box (Figs. 2 and 3). The guard rails are positioned 15 cm (6 in.) out from the partitions and 20 cm (8 in.) above the floor. Manure is removed by an under-pen fresh water flush system. Manually operated flush tanks are emptied twice per day. Both sows and pigs are provided with nipple waterers (19 and 9.5 mm [¾ and 3/8 in.], respectively).

To help assure that the thermal requirements of the small pigs could be met, creep boxes (Figs. 2 and 3) were installed in the Paus unit as part of the original construction. With the in-floor heat, creep floor temperatures were maintained in the range of 35.0 to 40.6 °C (95 to 105 °F). The simultaneous "air" temperature in the creep box (30.5 to 38.1 cm [12 to 15 in.] above the floor and between the creep feeder and front of creep box) was 23.9 to 36.7 °C (75 to 80 °F) with a room ambient temperature (1.5 m [5 ft] above pen floor) of 15.6 to 21.1 °C (60 to 70 °F).

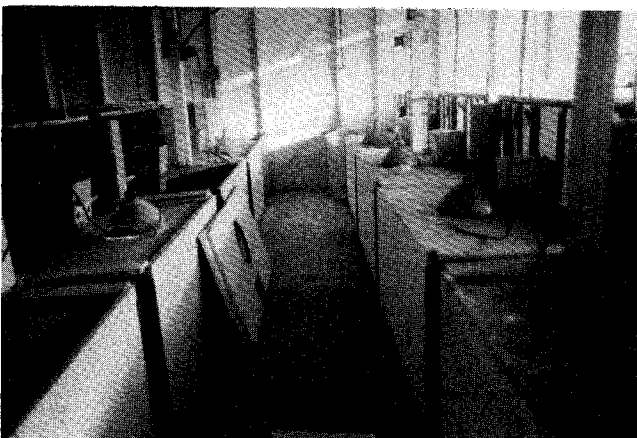
Fig. 3—The front creep boxes used in the Paus facility have removable covers and provisions for auxiliary heat.

Pigs access the front creep boxes through two 20 × 25 cm (8 × 10 in.) openings. The tops of the creep boxes are removable to allow observation of and access to the pigs (Fig. 3). Heat is provided in the painted plywood creep

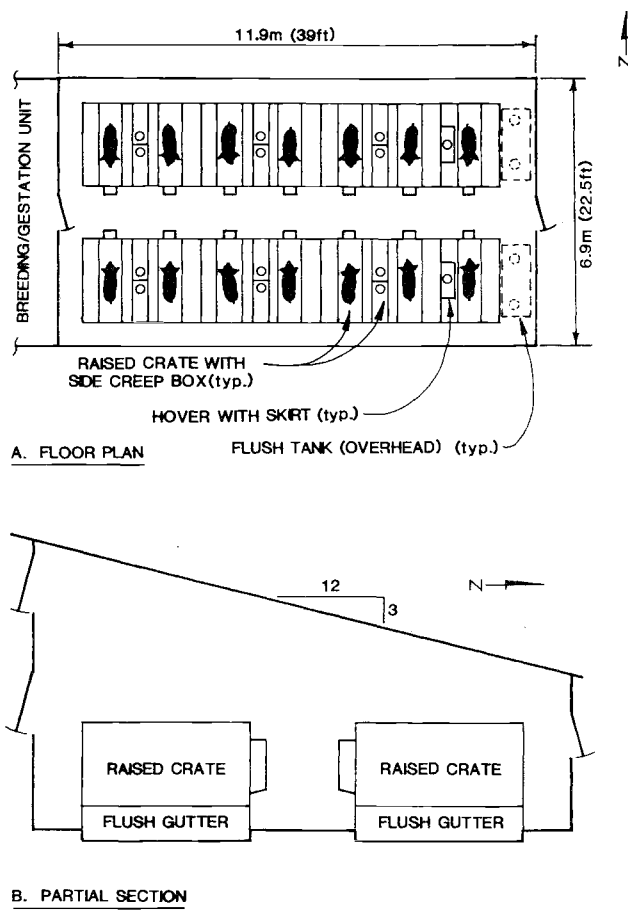
Fig. 4—Burkey 14-sow modified-open-front farrowing house.

Ventilation is provided through two continuous rows of insulated 0.6 m (2 ft) high panels along the south wall and a 0.6 m (2 ft) high row of insulated panels along the north wall (Fig. 4). Each row of panels is operated as two separate openings. Vent panel adjustment is by

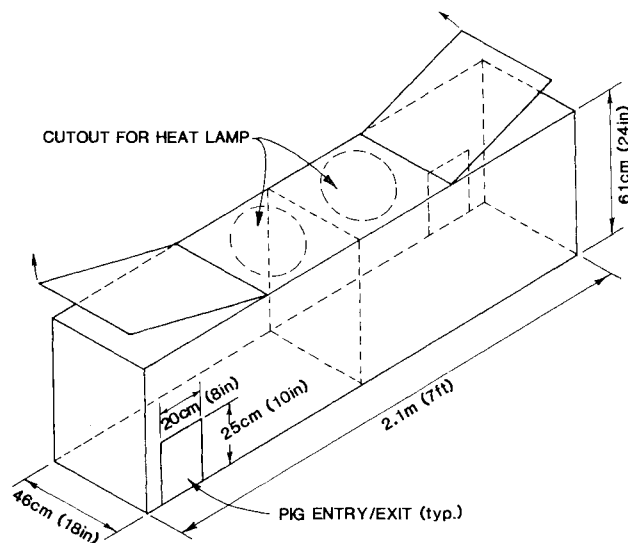
Fig. 5—Schematic of plywood side-creep boxes used in the Burkey farrowing house.

A propane-fired unit heater (unvented) is used to maintain an ambient room temperature in the 15 to 18 °C (60 to 65 °F) range. Plywood side creep boxes 0.4 m (16 in.) wide  $\times$  0.6 m (24 in.) high  $\times$  2.1 m (7 ft.) long are used to provide a warmer environment for the small pigs (Fig. 5). The creep boxes replace alternate crate dividers and have a partition at mid-length so each creep box services two farrowing crates. Pigs access the creep box through a single  $20 \times 25$  cm ( $8 \times 10$  in.) opening. Additional heat is provided in the creep boxes with 100 W conventional light bulbs during the first week and with 60 W light bulbs during the second through fourth weeks. Sows are removed when the pigs are 4-weeks old. At about 5-weeks of age pigs are moved to a mechanically ventilated nursery unit.

The known performance of creep boxes in the Paus installation led to creep boxes, as previously described and as shown in Fig. 5, being installed. The result was pig zone (creep box) temperatures 8.3 to 11.1 °C (15 to 29 F°) above ambient. These higher temperatures were achieved with lower wattage light bulbs and, hence, reduced expenditures for energy.
