## Crash-Tested Bridge Railings for Timber Bridges

In: Proceedings of 4th International bridge engineering conference; 1995 August 28–30; San Francisco, CA. Washington, DC: National Academy Press: 395-404; 1995. Vol. 2.

Michael A. Ritter, *Forest Service, U.S. Department of Agriculture*  
Ronald K. Faller, *University of Nebraska-Lincoln*  
Sheila R. Duwadi, *Federal Highway Administration*

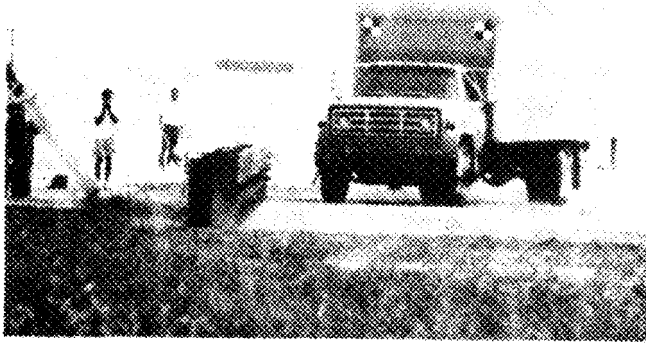
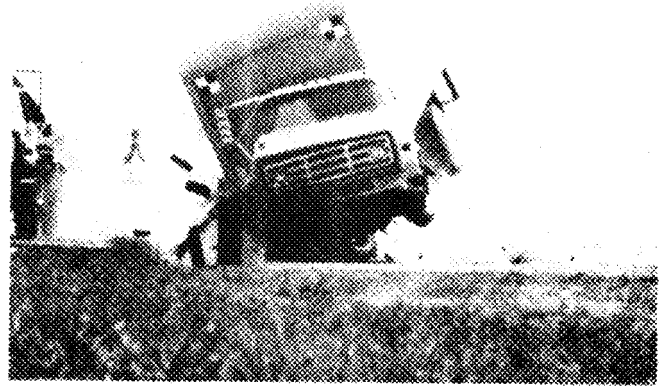
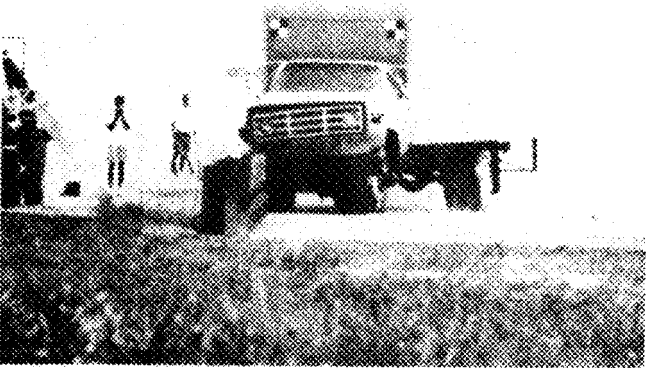
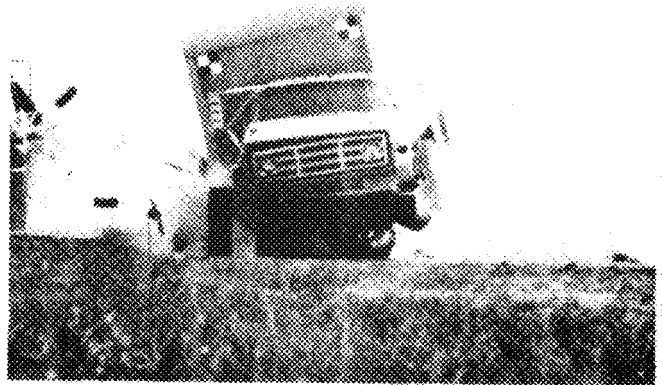
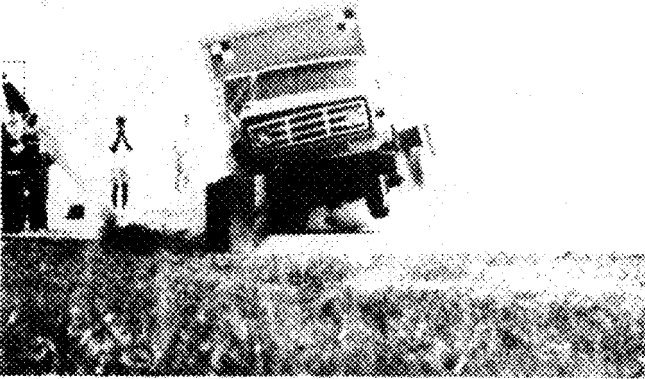
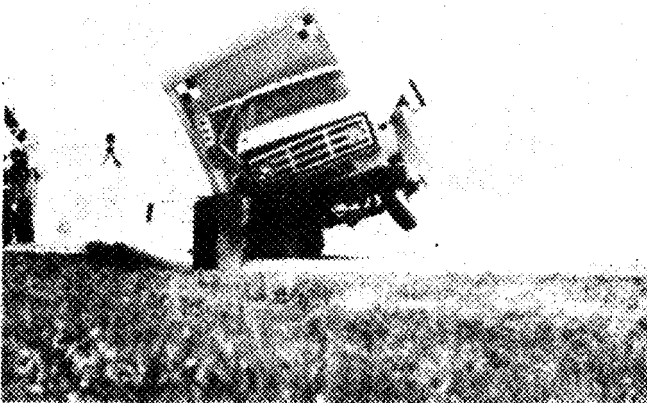
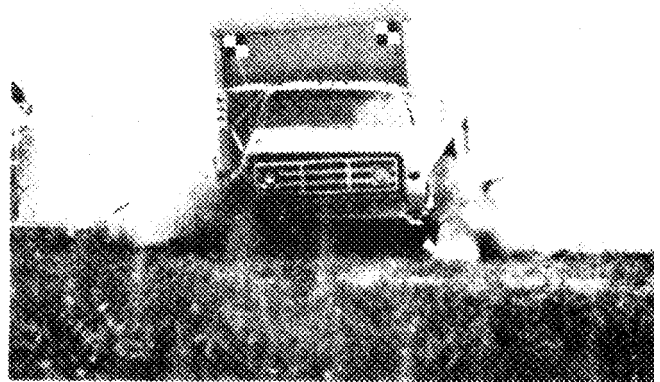
**FIGURE 1** Crash-test sequence for 8172-kg (18,000-lb) truck traveling at 80.5 km/hr (50 mph), hitting railing at 15-degree angle to longitudinal railing axis.

Vehicle propulsion and guidance were provided by steel cable configurations. For propulsion, a reverse cable tow with a 1:2 mechanical advantage was used. A cable was attached to the front of the vehicle, routed through a series of pulleys, and connected to a tow vehicle that traveled in a direction opposite to the test vehicle. The unoccupied test vehicle was then pulled by the tow vehicle and released from the tow cable approximately 9.2 m (30 ft) before impact. A vehicle guidance system developed by Hinch was used to steer the test vehicle (9). Using this system, the left front wheel hub is attached to a tensioned steel cable that maintains the vehicle's direction along a designated straight path. Approximately 9.2 m (30 ft) from impact, the guidance connection is sheared off and the vehicle separates from the guidance cable. A crash-test sequence for an 8172-kg (18,000-lb) vehicle is shown in Figure 1.
