# Material Selection and Design Consideration for Moisture Damage of Asphalt Pavement

Dr. Yong-Rak Kim and  
Jamilla Sudo Lutfi

Sponsored By  
Nebraska Department of Roads

December, 2006

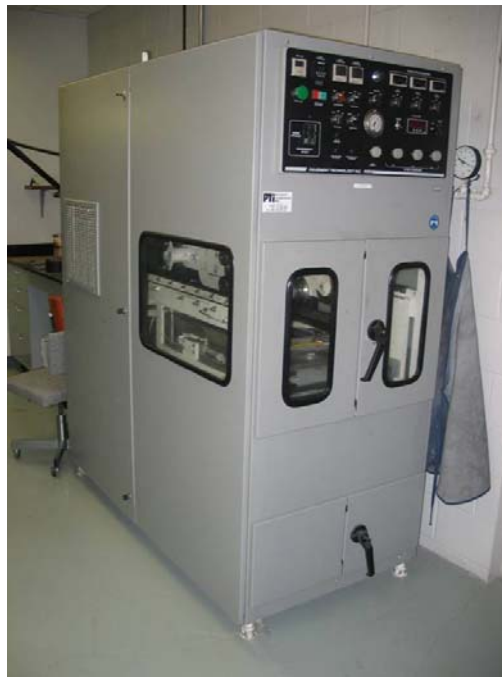
Rutting susceptibility and moisture resistance of asphalt concrete samples can be evaluated using the asphalt pavement analyzer (APA) shown in Figure 3.6. The APA is an automated, new generation of Georgia Load Wheel Tester (GLWT) used to evaluate rutting, fatigue, and moisture resistance of asphalt concrete mixtures. During the APA test, the rutting susceptibility of compacted specimens is tested by applying repetitive linear loads through three pressurized hoses via wheels to simulate trafficking. Even though it has been reported that APA testing results are not very well matched with actual field performance, APA testing is relatively simple to do and produces rutting potential of mixes by simply measuring sample rut depth. To evaluate moisture damage and susceptibility, asphalt concrete samples from each mix are maintained under water at the desired temperature during the test, and submerged deformations are measured with an electronic dial indicator. Due to its simplicity and popularity, the APA was employed in this project to estimate effects of additives and application methods of hydrated lime on moisture-related rut damage of HMA mixes. Testing results are presented and discussed in Chapter 4.

**Figure 3.6** APA Testing Machine

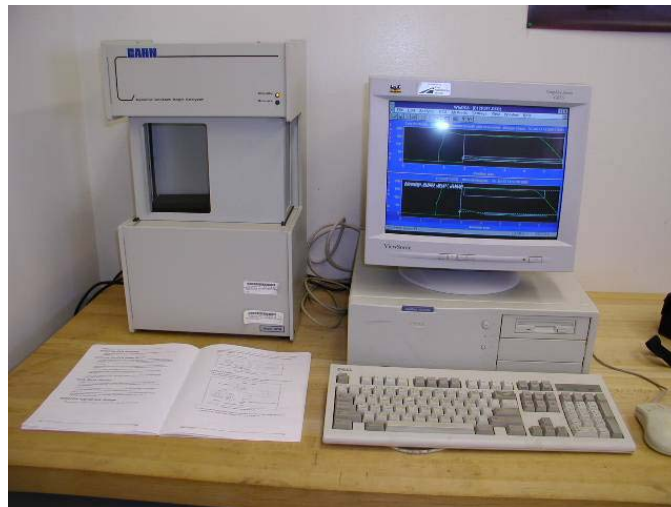
**Figure 3.14** Wilhelmy Plate Testing Device

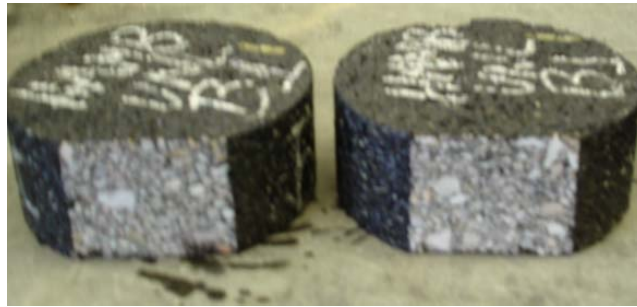
Cylindrical specimens were compacted with  $7.0\% \pm 1.0\%$  air voids using a Superpave gyratory compactor, and then the specimens were cut to the required dimensions in order to fit in the molds prior to performing the test. Figure 4.5 shows the specimens after being cut.

**Figure 4.5** Hamburg Specimens After Being Cut

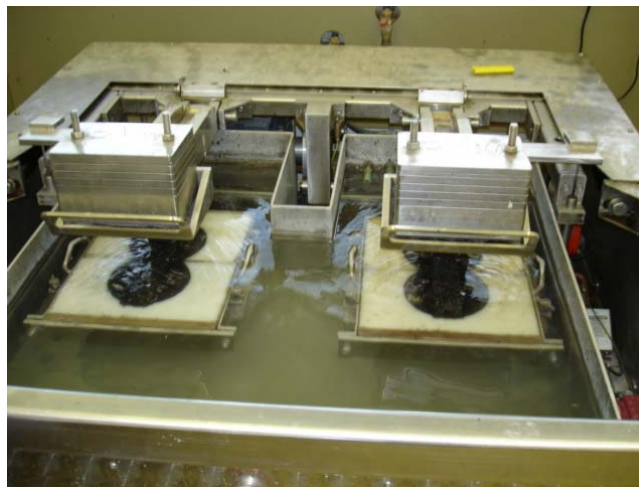
The specimens were then submerged in water at  $158^{\circ}\text{F}$ , as shown in Figure 4.6. A pair of steel wheels with a  $158 \pm 22$  lbs passed on top of specimens under water at a constant rate of 50 wheel passes per minute until the specimens failed. The rut depth induced by the wheel trafficking was measured by linear variable differential transducers (LVDTs).

**Figure 4.6** Hamburg Specimens under Testing

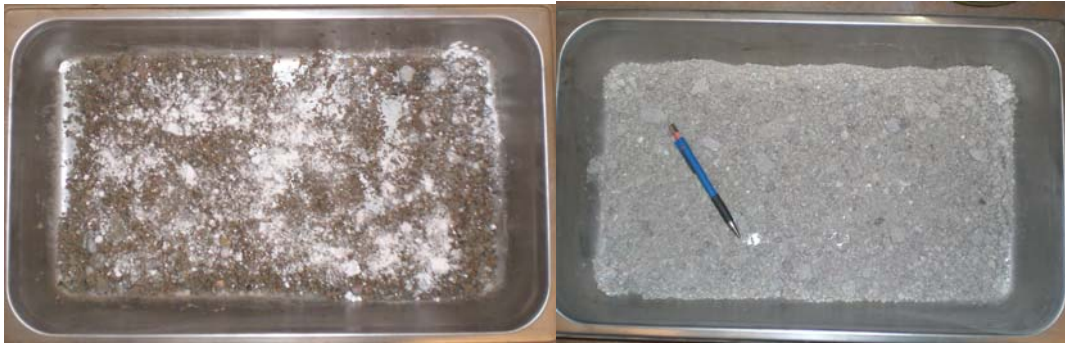
**Figure 4.8** Dry Lime Treated Aggregates (Before and After Oven Dry)

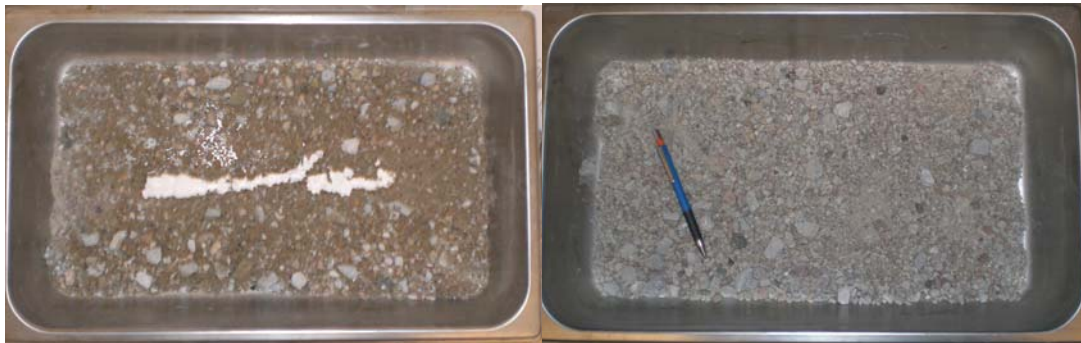
**Figure 4.9** Lime Slurry Treated Aggregates (Before and After Oven Dry)

presented in Figure 4.10, the new lime slurry-treated mixture (i.e. mixture with diluted lime slurry) was much more homogeneous with better dispersion of lime particles than the original lime slurry-treated mixture, which may eliminate unfavorable surfaces of some aggregates observed from the original B3 mixes (Figure 4.9).

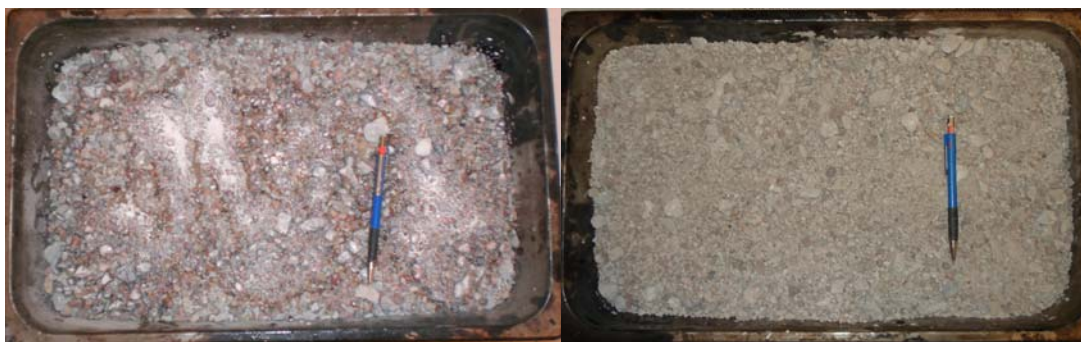
**Figure 4.10** Diluted Lime Slurry Treated Aggregates (Before and After Oven Dry)
