NDOR Project No. SPR-P1(07) P596

PHASE I DEVELOPMENT OF AN AESTHETIC, PRECAST CONCRETE BRIDGE RAIL

MIDWEST ROADSIDE SAFETY FACILITY (MwRSF)

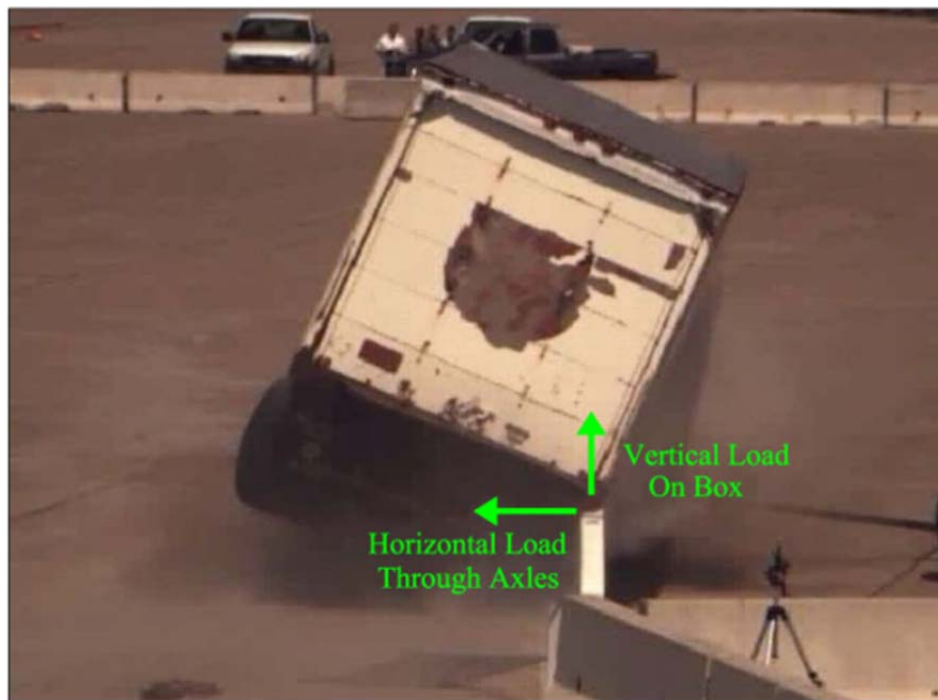
shorter barriers during impact events. For example, the MASH 10000S single-unit truck (SUT) has a ballast center of gravity (c.g.) height of 63 in. (1,600 mm). Thus, these heavier and taller vehicles, such as single-unit trucks, are redirected and prevented from rolling over the top of rigid barriers due to a combination of a vertical barrier load being applied to the outer underside of the cargo box and a lateral barrier resistance imparted to the wheels and axle assemblies, as shown in Figure 3.

Figure 3. Barrier Forces Acting on Single-Unit Truck During Impact

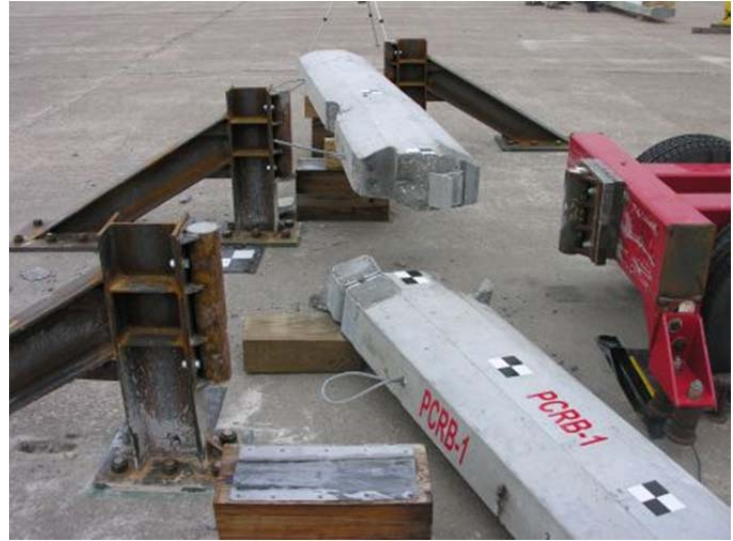
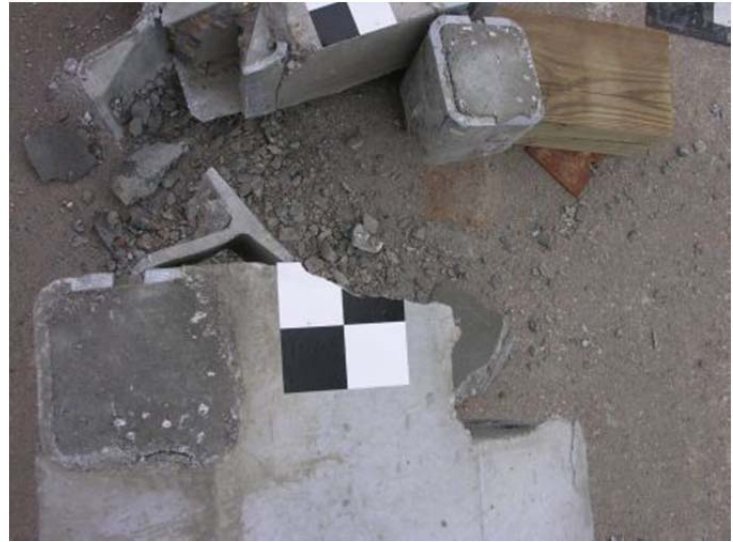
Figure 78. Component Damage, Test No. PCRB-1

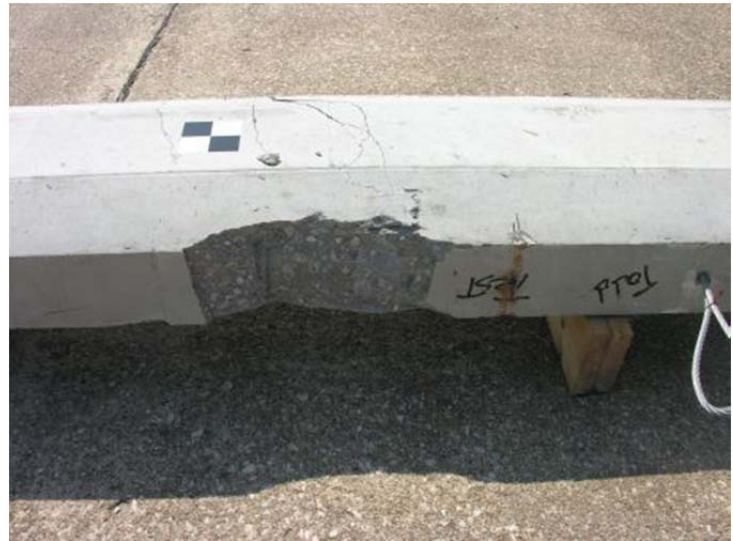
Figure 81. Bending Damage of Long Rail Segment, Test No. PCRB-1

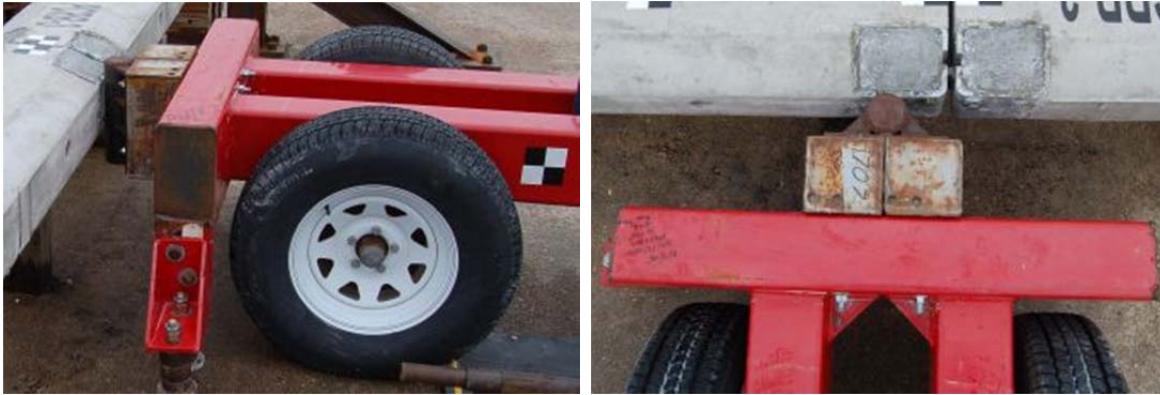
The same bogie vehicle from the first round of bogie testing was used during the second round of testing. However, the wooden blockouts used to offset the bogie head from the vehicle frame were damaged during test no. PCRB-2. As such, steel tubes were used instead of wooden blockouts to provide a more robust bogie head. These steel tubes were filled with concrete and capped with a steel plate, as shown in Figure 95. The weight of the bogie with the addition of concrete filled steel tubes to the impact head was 1,707 lbs (774 kg).

Figure 95. Bogie Impact Head with Steel Tube Blockouts

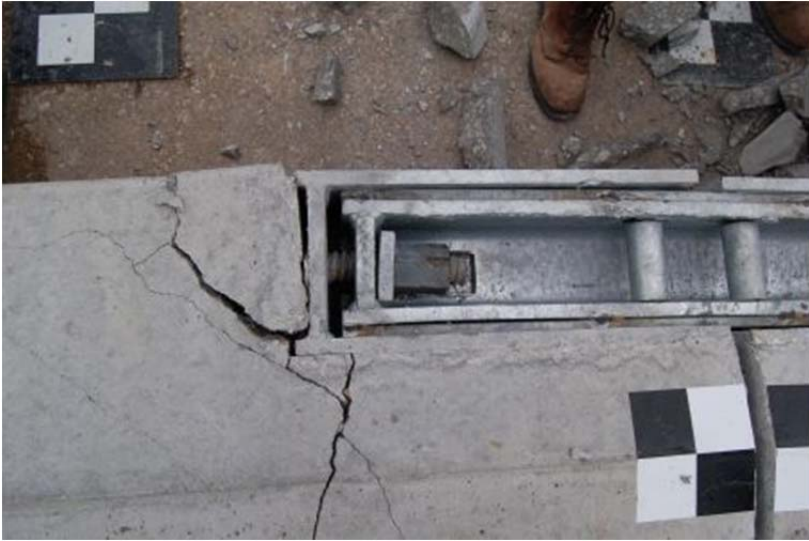
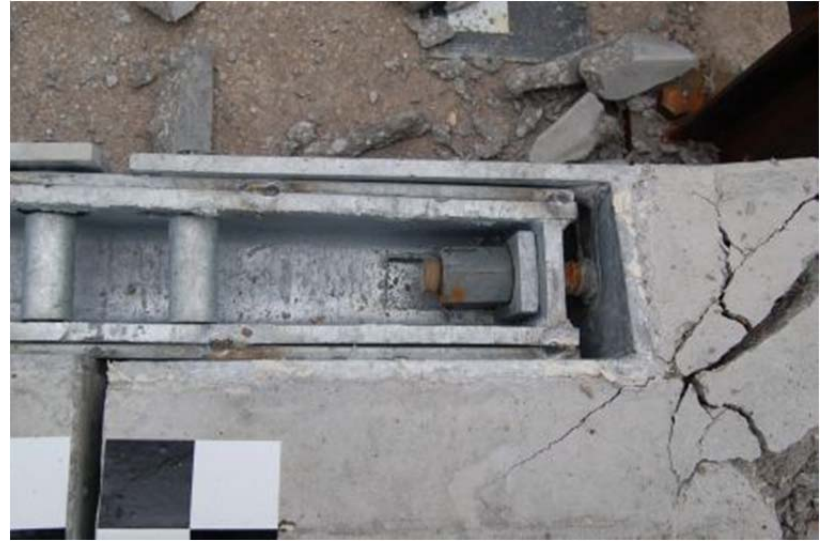
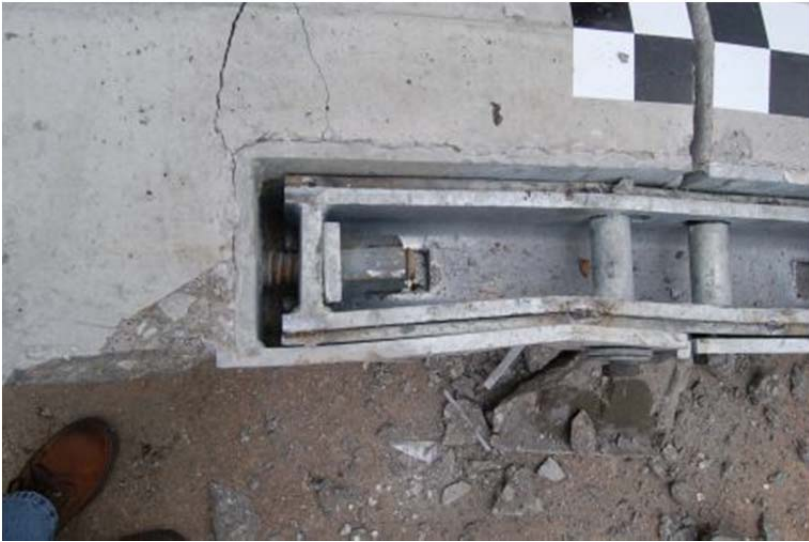
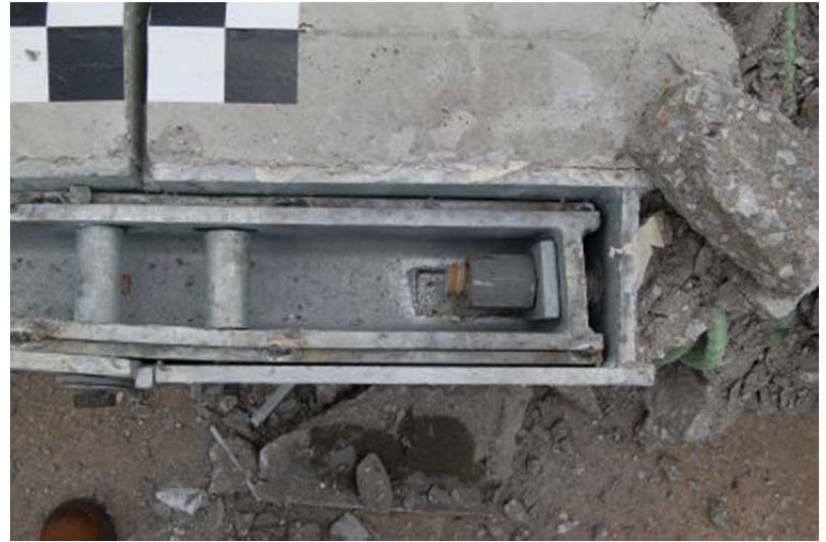
Figure 155. Component Damage – Steel Pockets, Test No. PCRB-4

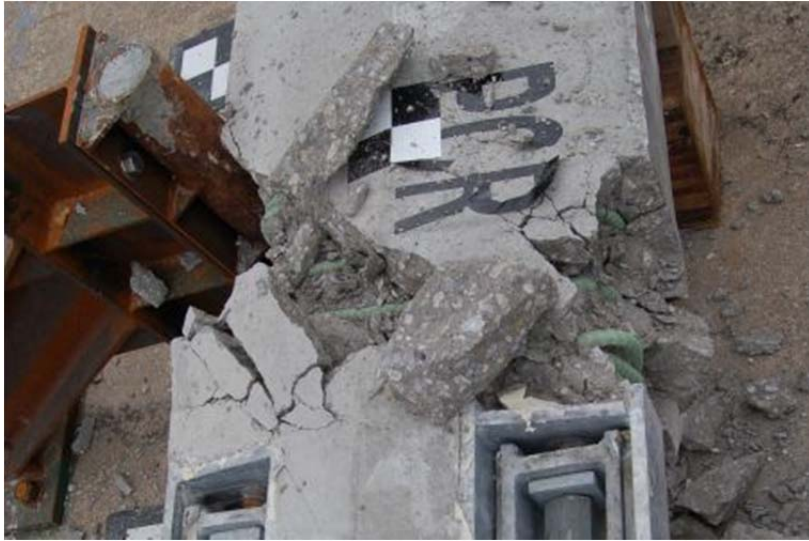
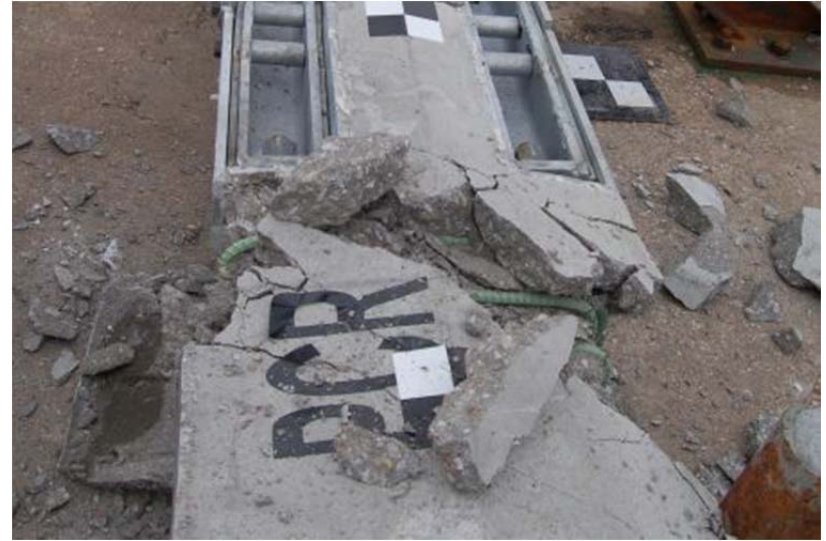
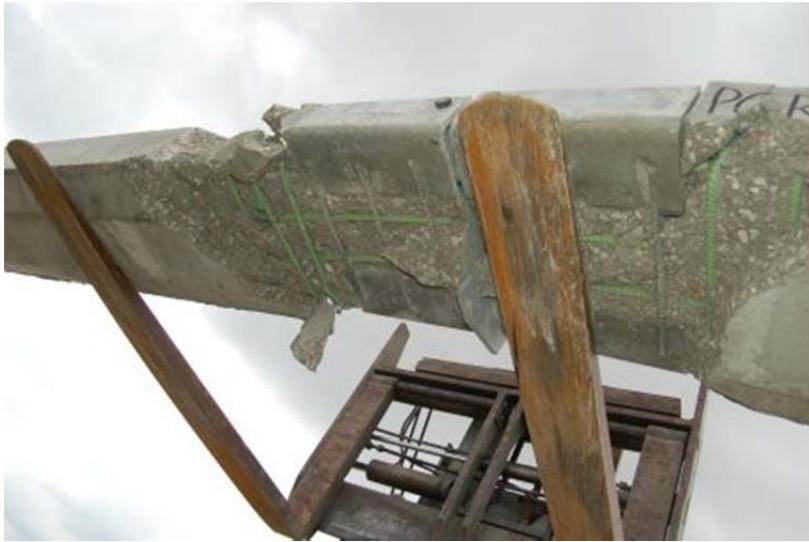
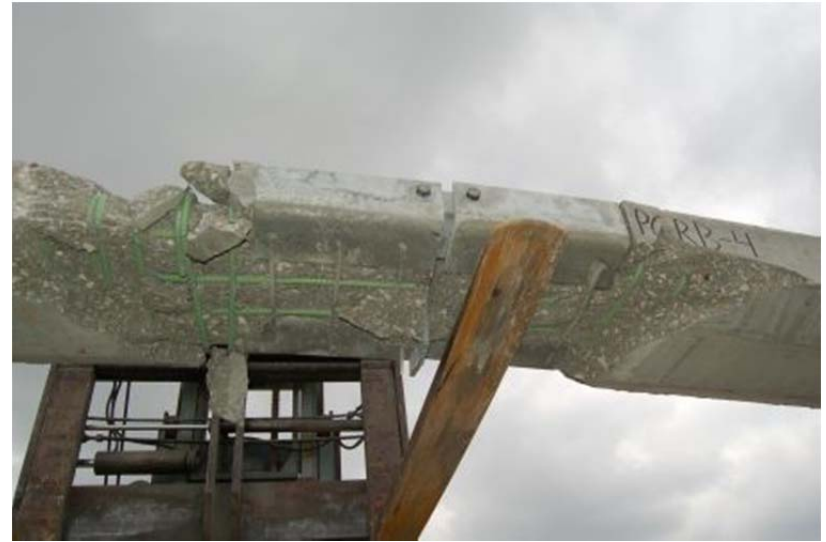
Figure 156. Component Damage – Concrete Damage, Test No. PCRB-4
